ELECTRONIC STORAGE GRADING AND EROSION CONTROL PLAN GRADING DETAILS SHEET

EXTENDED DETENTION BASIN AS-BUILT
 DANE FRANK, TERRA NOVA ENGINEERING, 2024/10/30

ELECTRONIC STORAGE
 PROPOSED DRAINAGE MAP
 PROPOSED DRAINAGE MAP

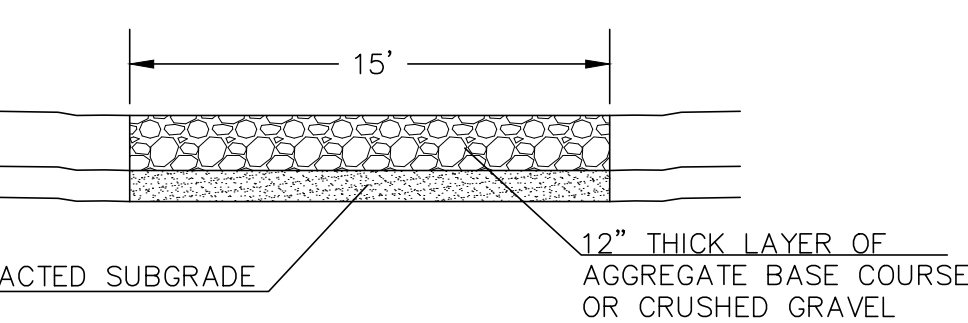
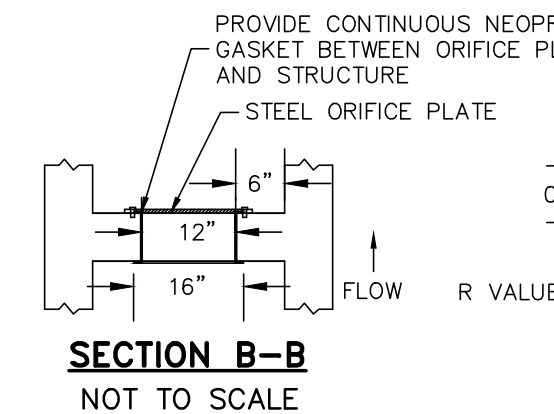
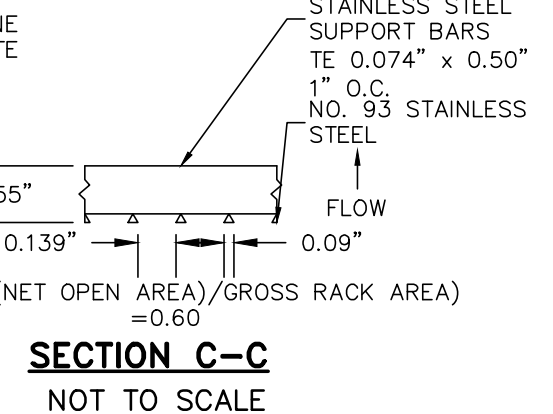
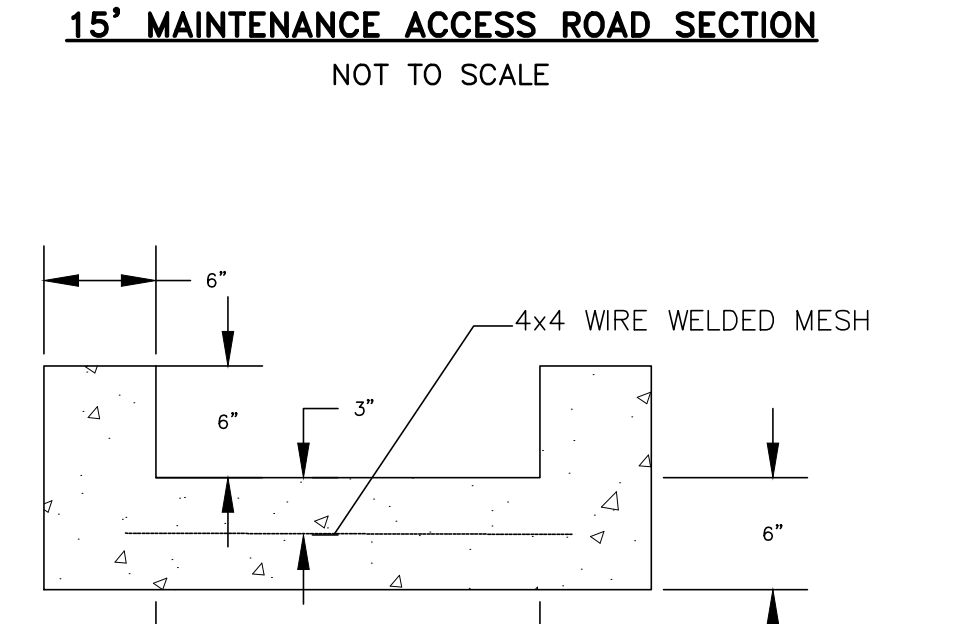
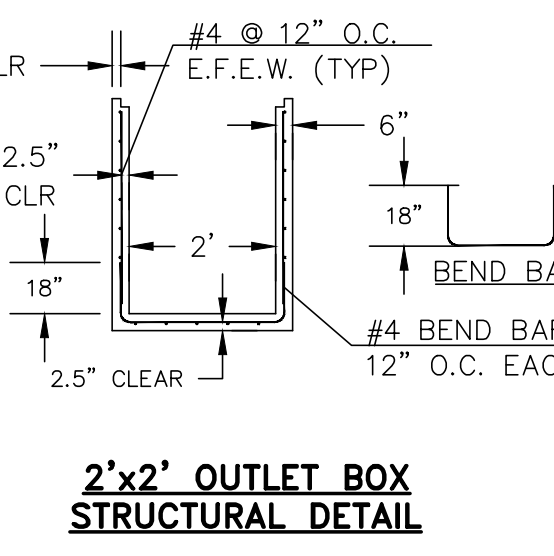
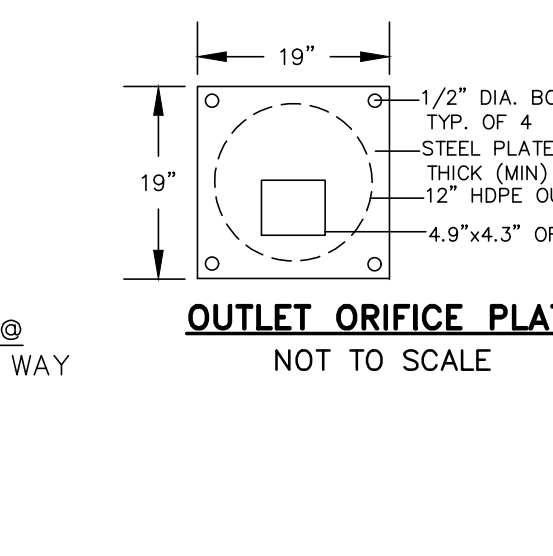
Access must be provided to the outlet structure (via steps per DCMv2 Chap 4.2: "Access to critical elements of the pond (inlet, outlet, spillway, and sediment collection areas) must be provided." And: Either a ladder or steps shall be installed when manhole depth exceeds 30 inches (see ECM Storm Sewer Manhole Detail SD_3-2).
 This is a general safety concern for if someone ends up in the outlet structure, there must be a way for them to exit. And it allows for removing sediment and debris from the outlet structure.

It is not ideal to have the spillway flows concentrated immediately downstream of the grouted spillway. You will need to re-run calcs to show that the riprap installed can withstand the increased velocities from the narrowed conveyance. Or remove this riprap and allow flows to follow the pre-existing contours shown on these original plans.
 Also, as shown in Photo 5 in the SW PA Punchlist, the riprap is placed on top of the grouted spillway. This riprap will badly erode on either side of this riprap instead of being conveyed through it as intended like a swale.
