SOIL AND GEOLOGY STUDY

**Esteban Subdivision
3 parcels totaling 496.25 acres
EL Paso County, Colorado**

JOB NO. 190388

April 27, 2023

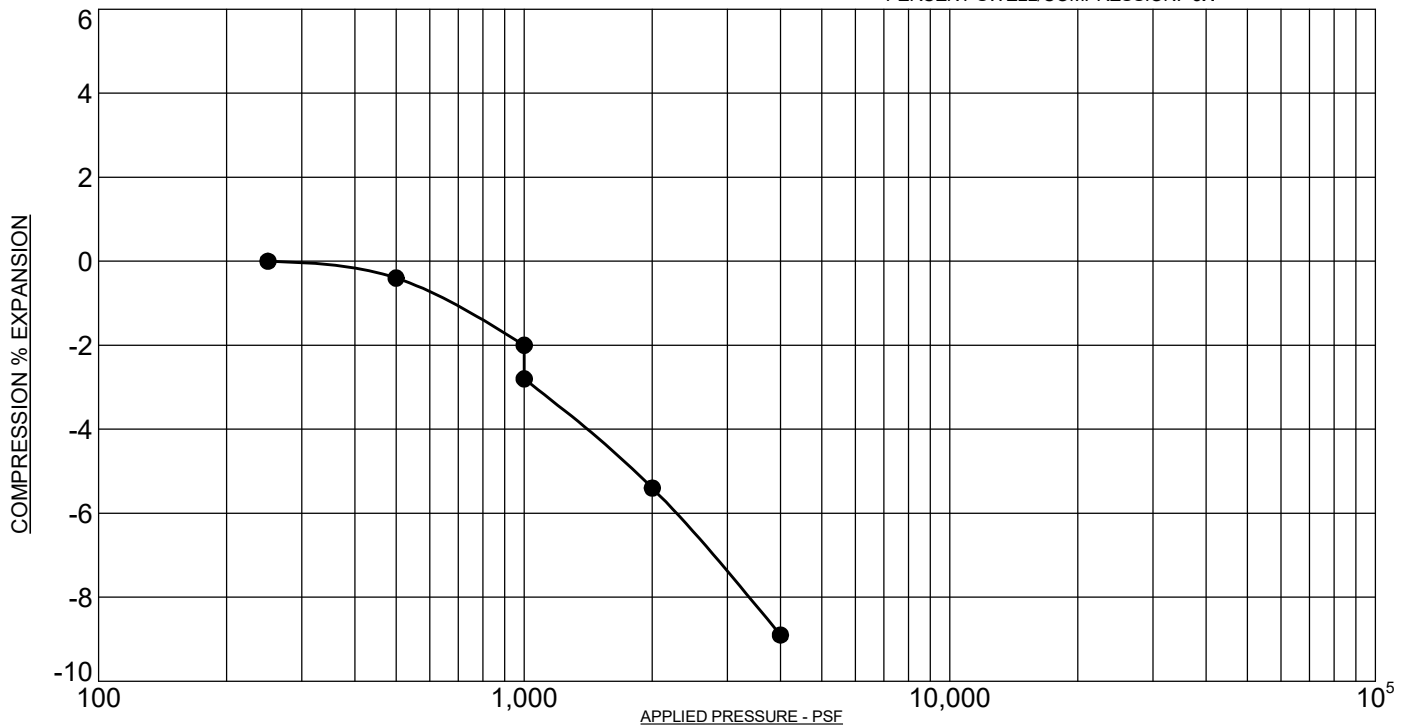
FIGURE No. 25

SAMPLE LOCATION: 5 @ 14 FT
 NATURAL DRY UNIT WEIGHT: 84.7 PCF
 NATURAL MOISTURE CONTENT: 36.3%
 PERCENT SWELL/COMPRESSION: -0.8

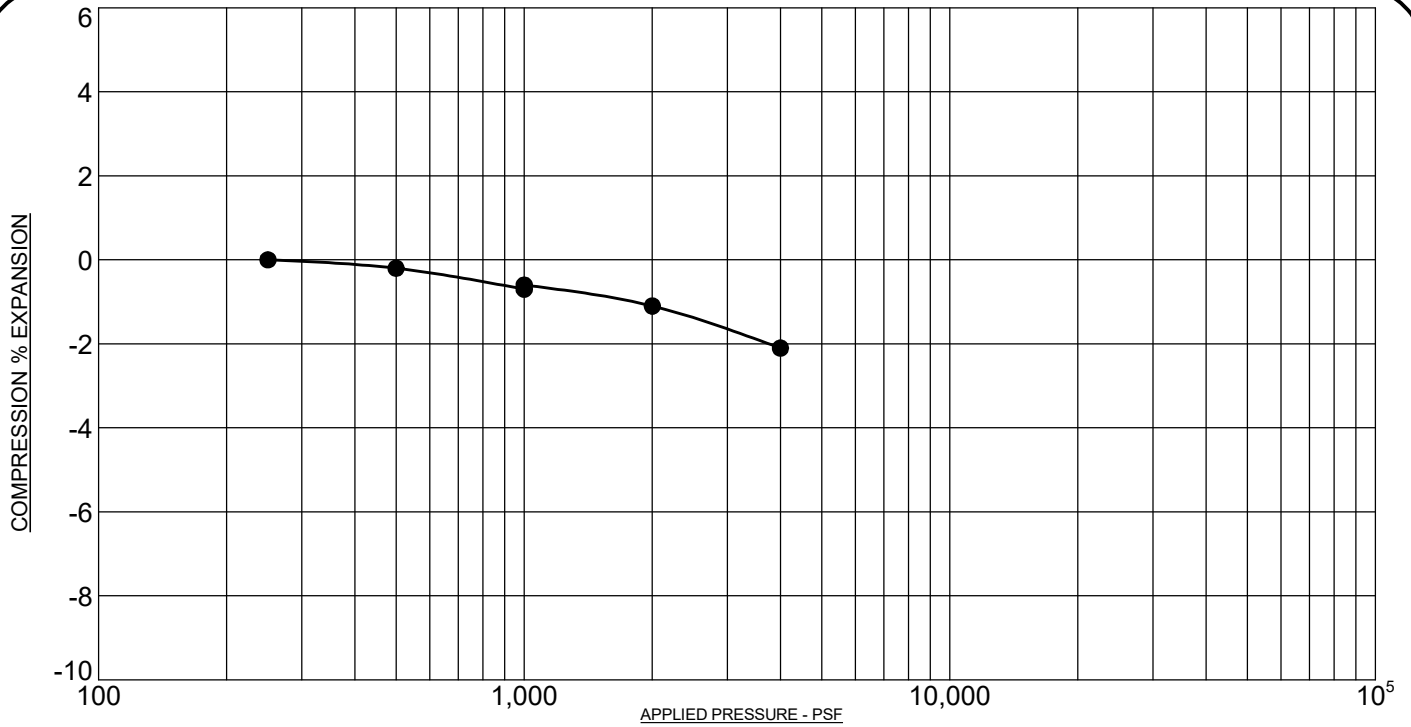
FIGURE No. 26

SAMPLE LOCATION: 9 @ 9 FT
 NATURAL DRY UNIT WEIGHT: 83.9 PCF
 NATURAL MOISTURE CONTENT: 31.4%
 PERCENT SWELL/COMPRESSION: 0.1

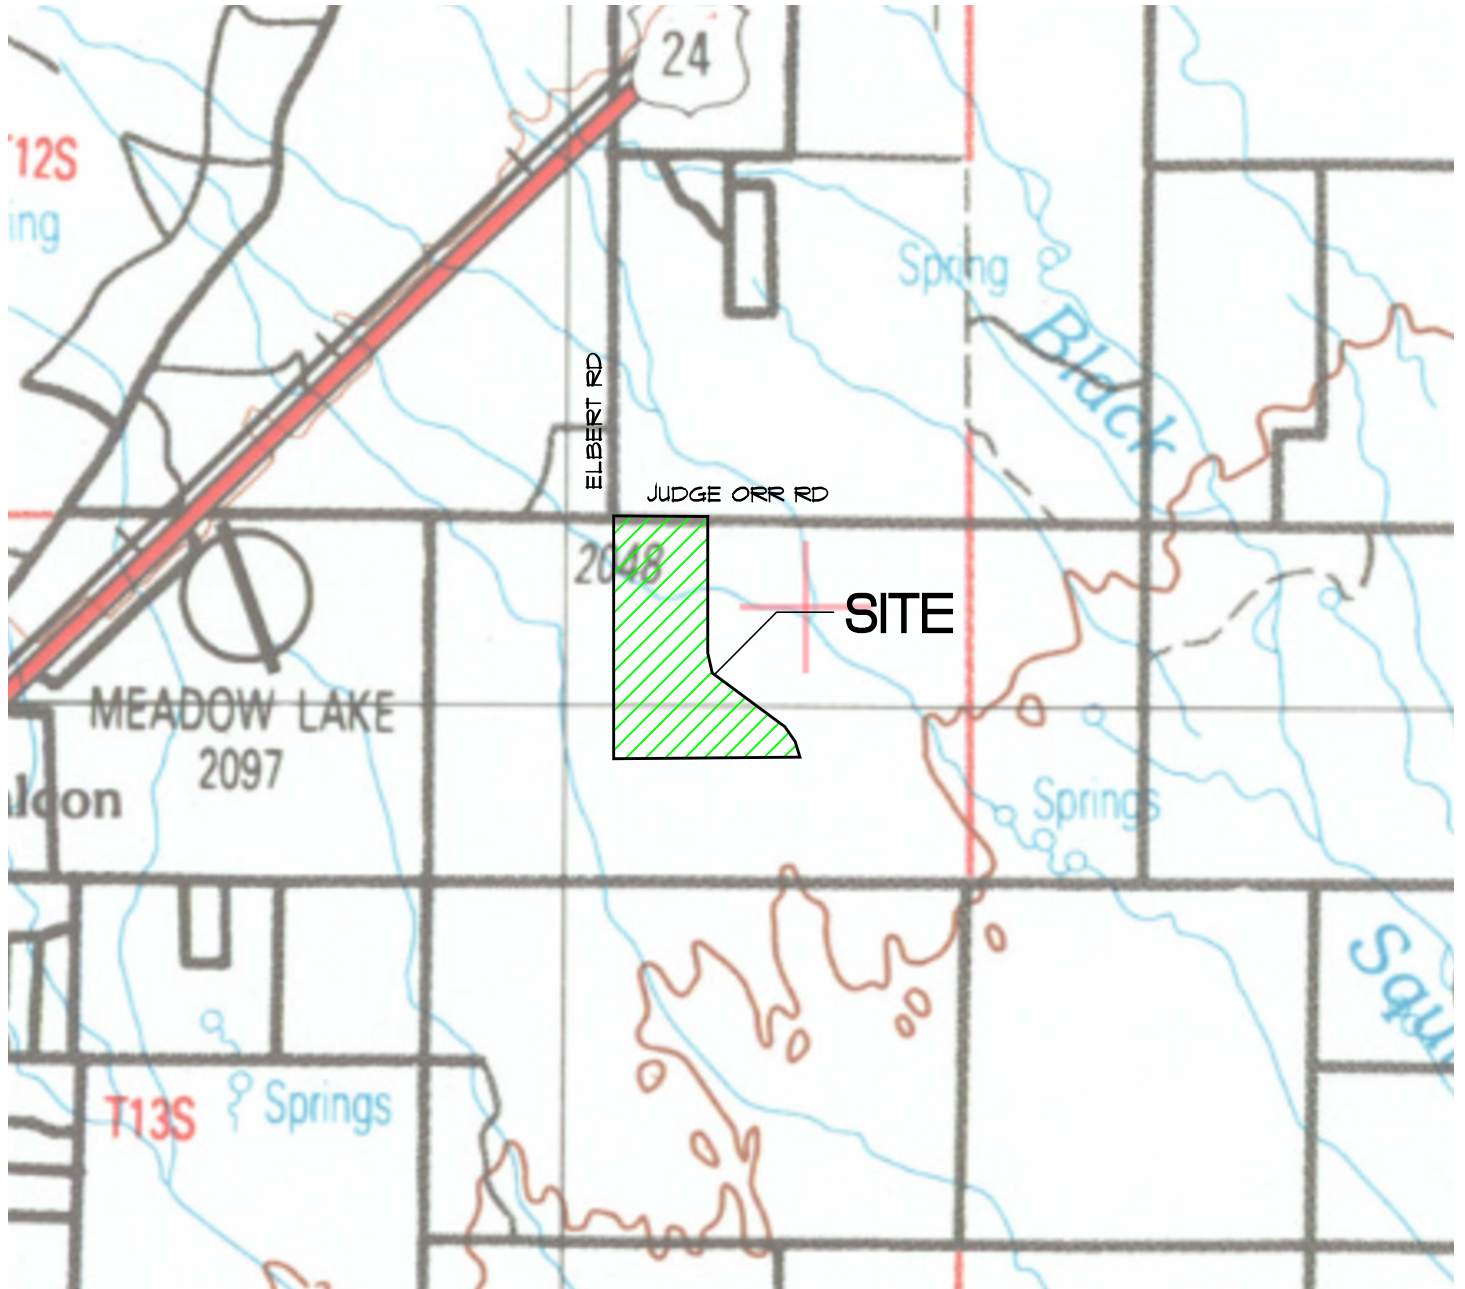
FIG No. 29

A natural drainageway exists near the northern portion of the site running from west to east. The drainageway was dry at the time of the site reconnaissance visits performed by RMG. The USGS Topo Map is presented in Figure 29.

Ponding surface water is likely to be encountered in the low lying drainageway that traverses the northern portion of the site. These areas are denoted as *psw – potential seasonally wet* on the Engineering and Geology Map, Figure 29.

- Each lot shall be designed to insure that a minimum of 2 sites are appropriate for a OWTS and do not fall within the restricted areas, potentially seasonally wet and floodplain, as identified on the Engineering and Geology Map, Figure 29.
