Circle K Retail Store and Shared Access Road

Geologic Hazard Assessment Review Report

February 22, 2023 | Terracon Project No. 23225154

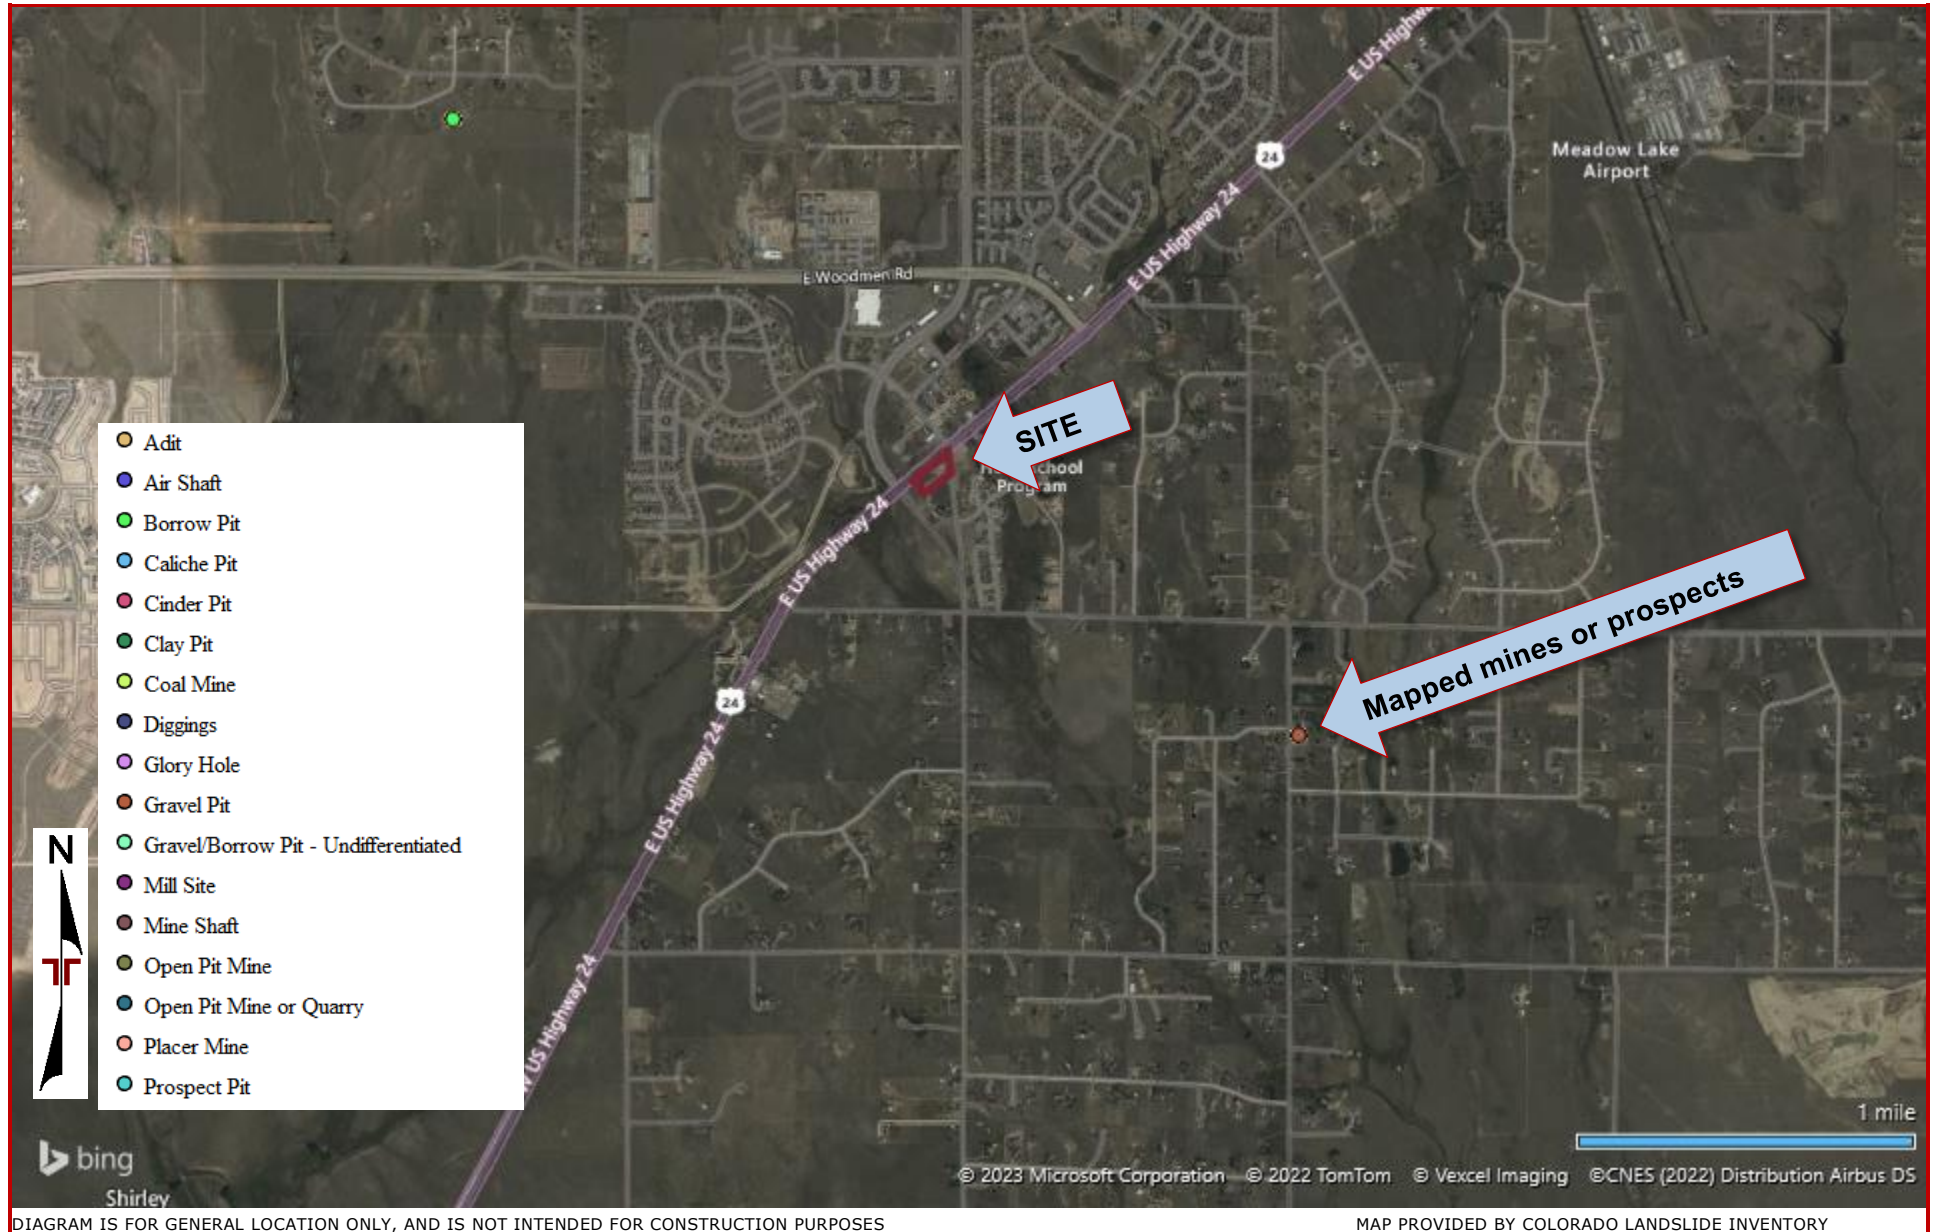
Figure 5 – Mines and Prospects

Hazard	Evaluation	Estimated Risk Level	Proposed Mitigation
Erodible Soils	Soils with a sandy matrix were encountered on the project site. Sandy soils are susceptible to erosion when exposed.	Medium	<ul style="list-style-type: none"> ■ Follow an erosion control (by others) plan during earthwork construction. ■ Long term seeding/landscape/vegetation may be used to help reduce the risk of soils eroding.
Corrosive Soils	Results of corrosivity testing of on-site soils indicate low corrosion potential	Low	<ul style="list-style-type: none"> ■ Concrete should be designed in accordance with ACI Table 19.3.1.1.
Abandoned Mining Activity	<p>The proposed site does not have any abandoned mining activity documented.</p> <p>(Figure 5 – Map of Mines and Prospects)</p>	Low	<ul style="list-style-type: none"> ■ Based on our review of the USGS Prospect-and mine related features of El Paso County, Colorado interactive map of the proposed development site, the area is free of any abandoned mine related features. ■ The nearest mapped mining activity is approximately 1.3 miles southeast.

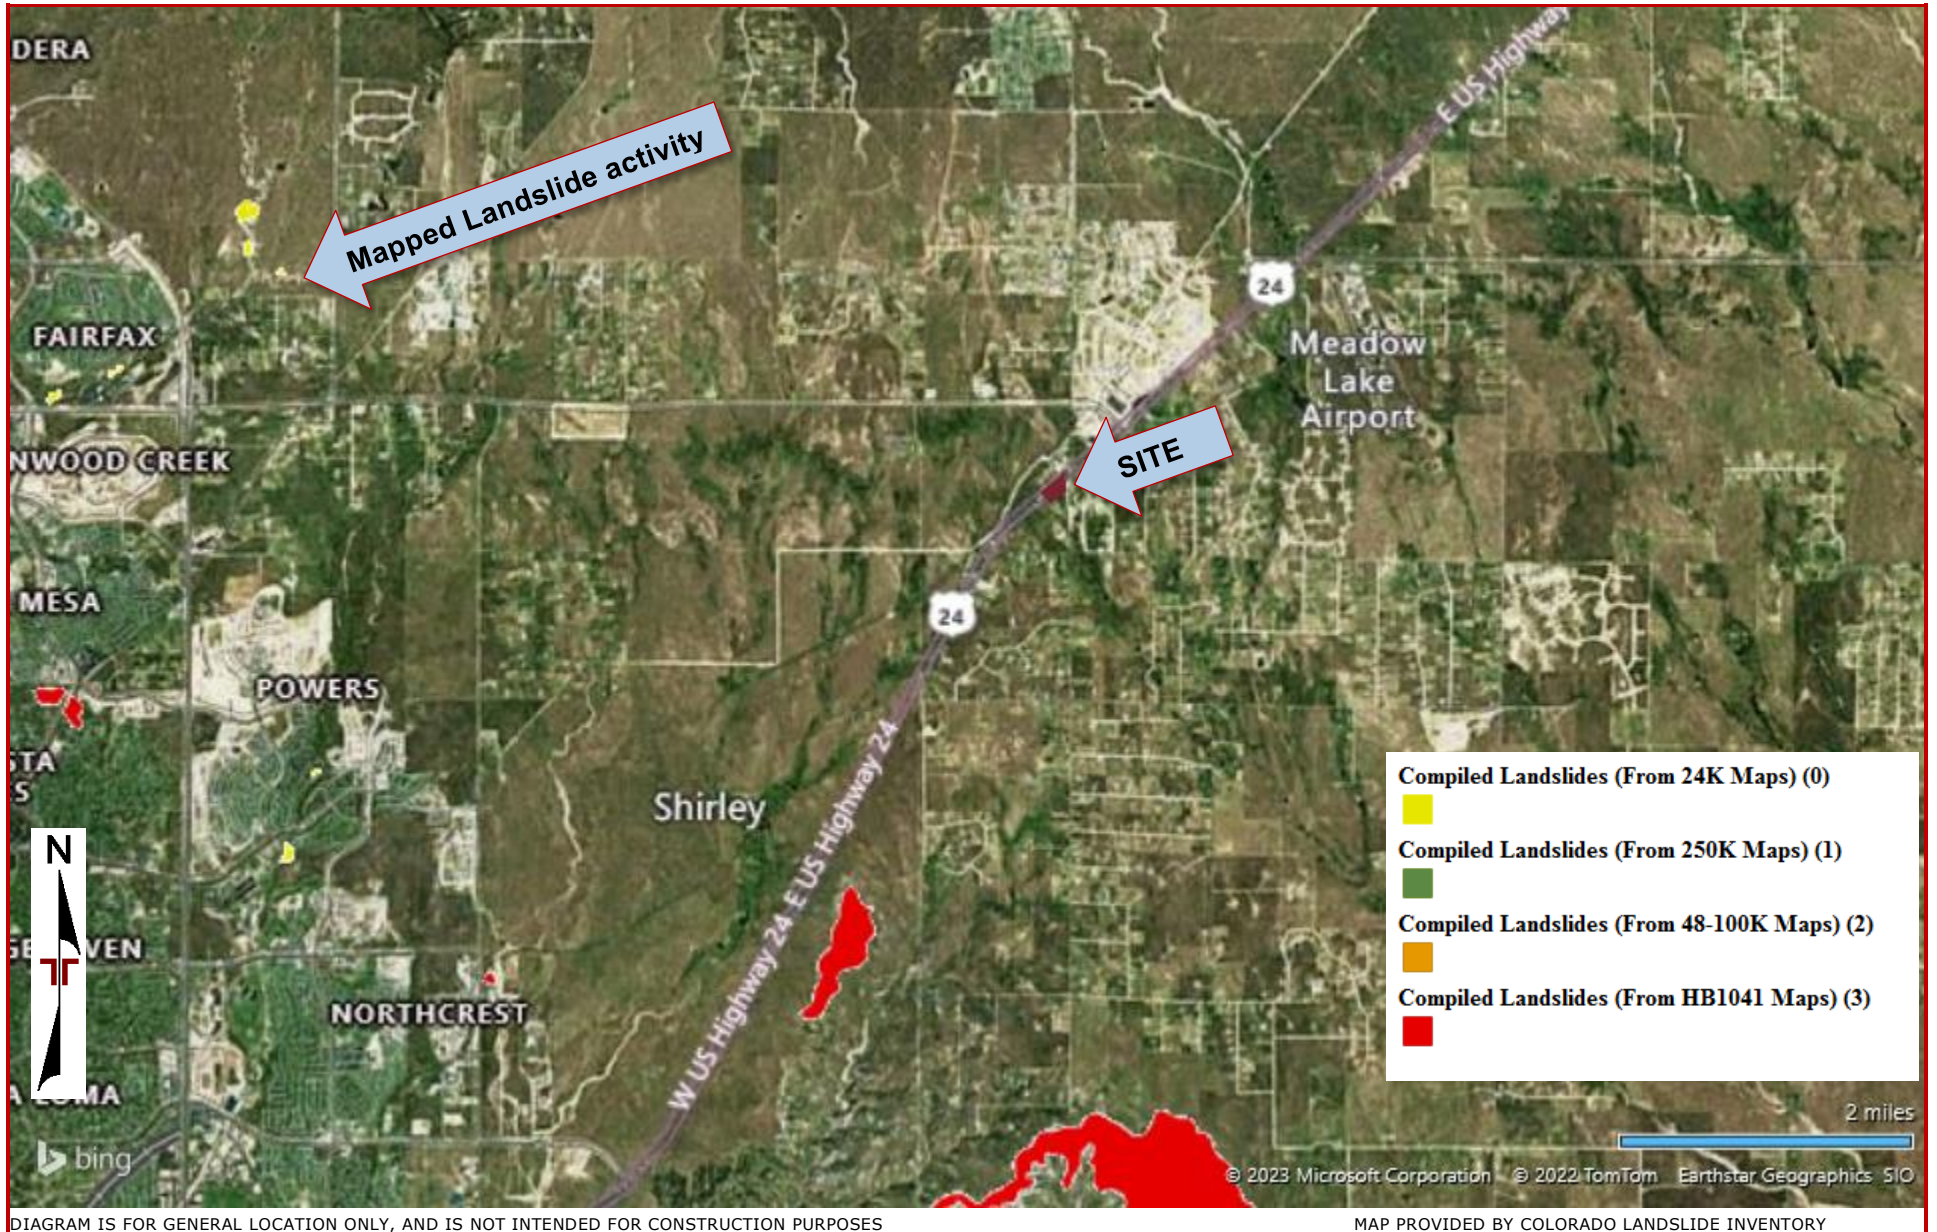
Figure 6 – Landslide Inventory

Hazard	Evaluation	Estimated Risk Level	Proposed Mitigation
	<p>grades generally 5% slopes or flatter. Proposed slopes for the access road are 3H:1V or flatter</p>		
<p>Landfills, Uncontrolled, and or Undocumented Fill Activity</p>	<p>The proposed site does not have any landfill, and minimal uncontrolled and/or undocumented fill activity.</p>	<p>Low</p>	<ul style="list-style-type: none"> ■ Up to 1 foot of existing fill was encountered in Boring No. P-1 in our 2018 exploration. Recommendations in our 2018 geotechnical report call for the overexcavation and re-working of the encountered fill material.
<p>Landslides</p>	<p>The proposed site does not have any landslides in the vicinity. (Figure 6 – Landslide Inventory)</p>	<p>Low</p>	<ul style="list-style-type: none"> ■ Based on our review of the Potential Areas of Landslide Susceptibility in Falcon, El Paso County, Colorado, the proposed site development area is not considered to be within the area of susceptibility. ■ The nearest mapped landslide activity is approximately 5.3 miles northwest.
