Soils and Geology And Wastewater Treatment System Evaluation

For
Wyoming Estates
3050 N. Curtis Road
Final
February 27, 2020

Groundwater Investigations LLC
11590 Black Forest Road Ste 15
Colorado Springs, CO 80908
(719) 338-1805

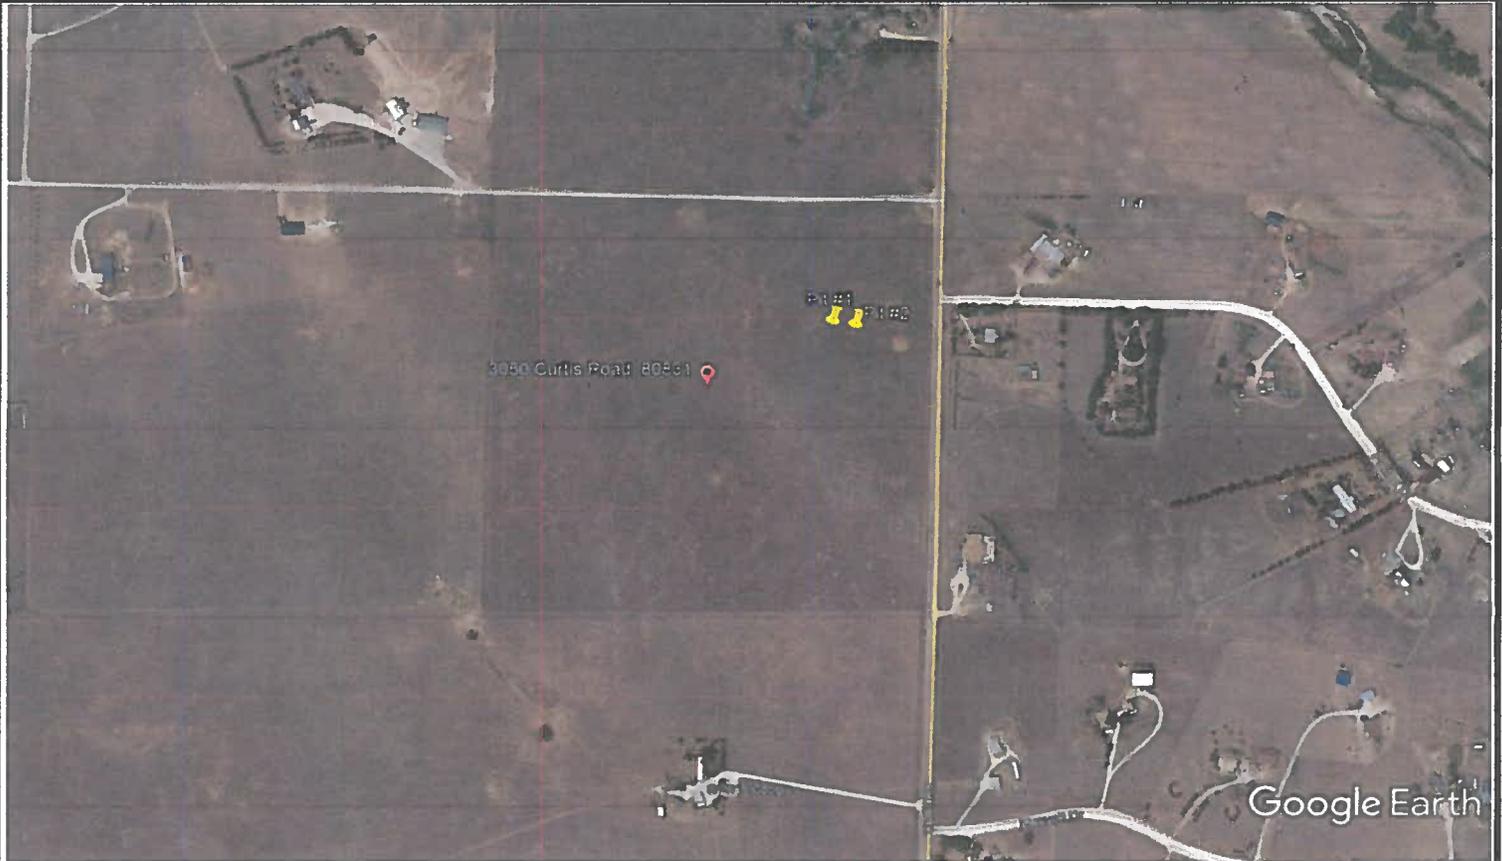
Google Site Map

Recommendations: (1) An Engineered On-Site Wastewater Treatment system (OWTS) is required for this location due to: Soil Type 4 identified in the treatment zone of Profile Pit #1 & Profile Pit #2.
