June 7, 2021

ENTECH
ENGINEERING, INC.

Re: Soil, Geology, and Geologic Hazard Study
Crowe Subdivision
Parcel No. 61280-00-001
15980 Roller Coaster Road
El Paso County, Colorado

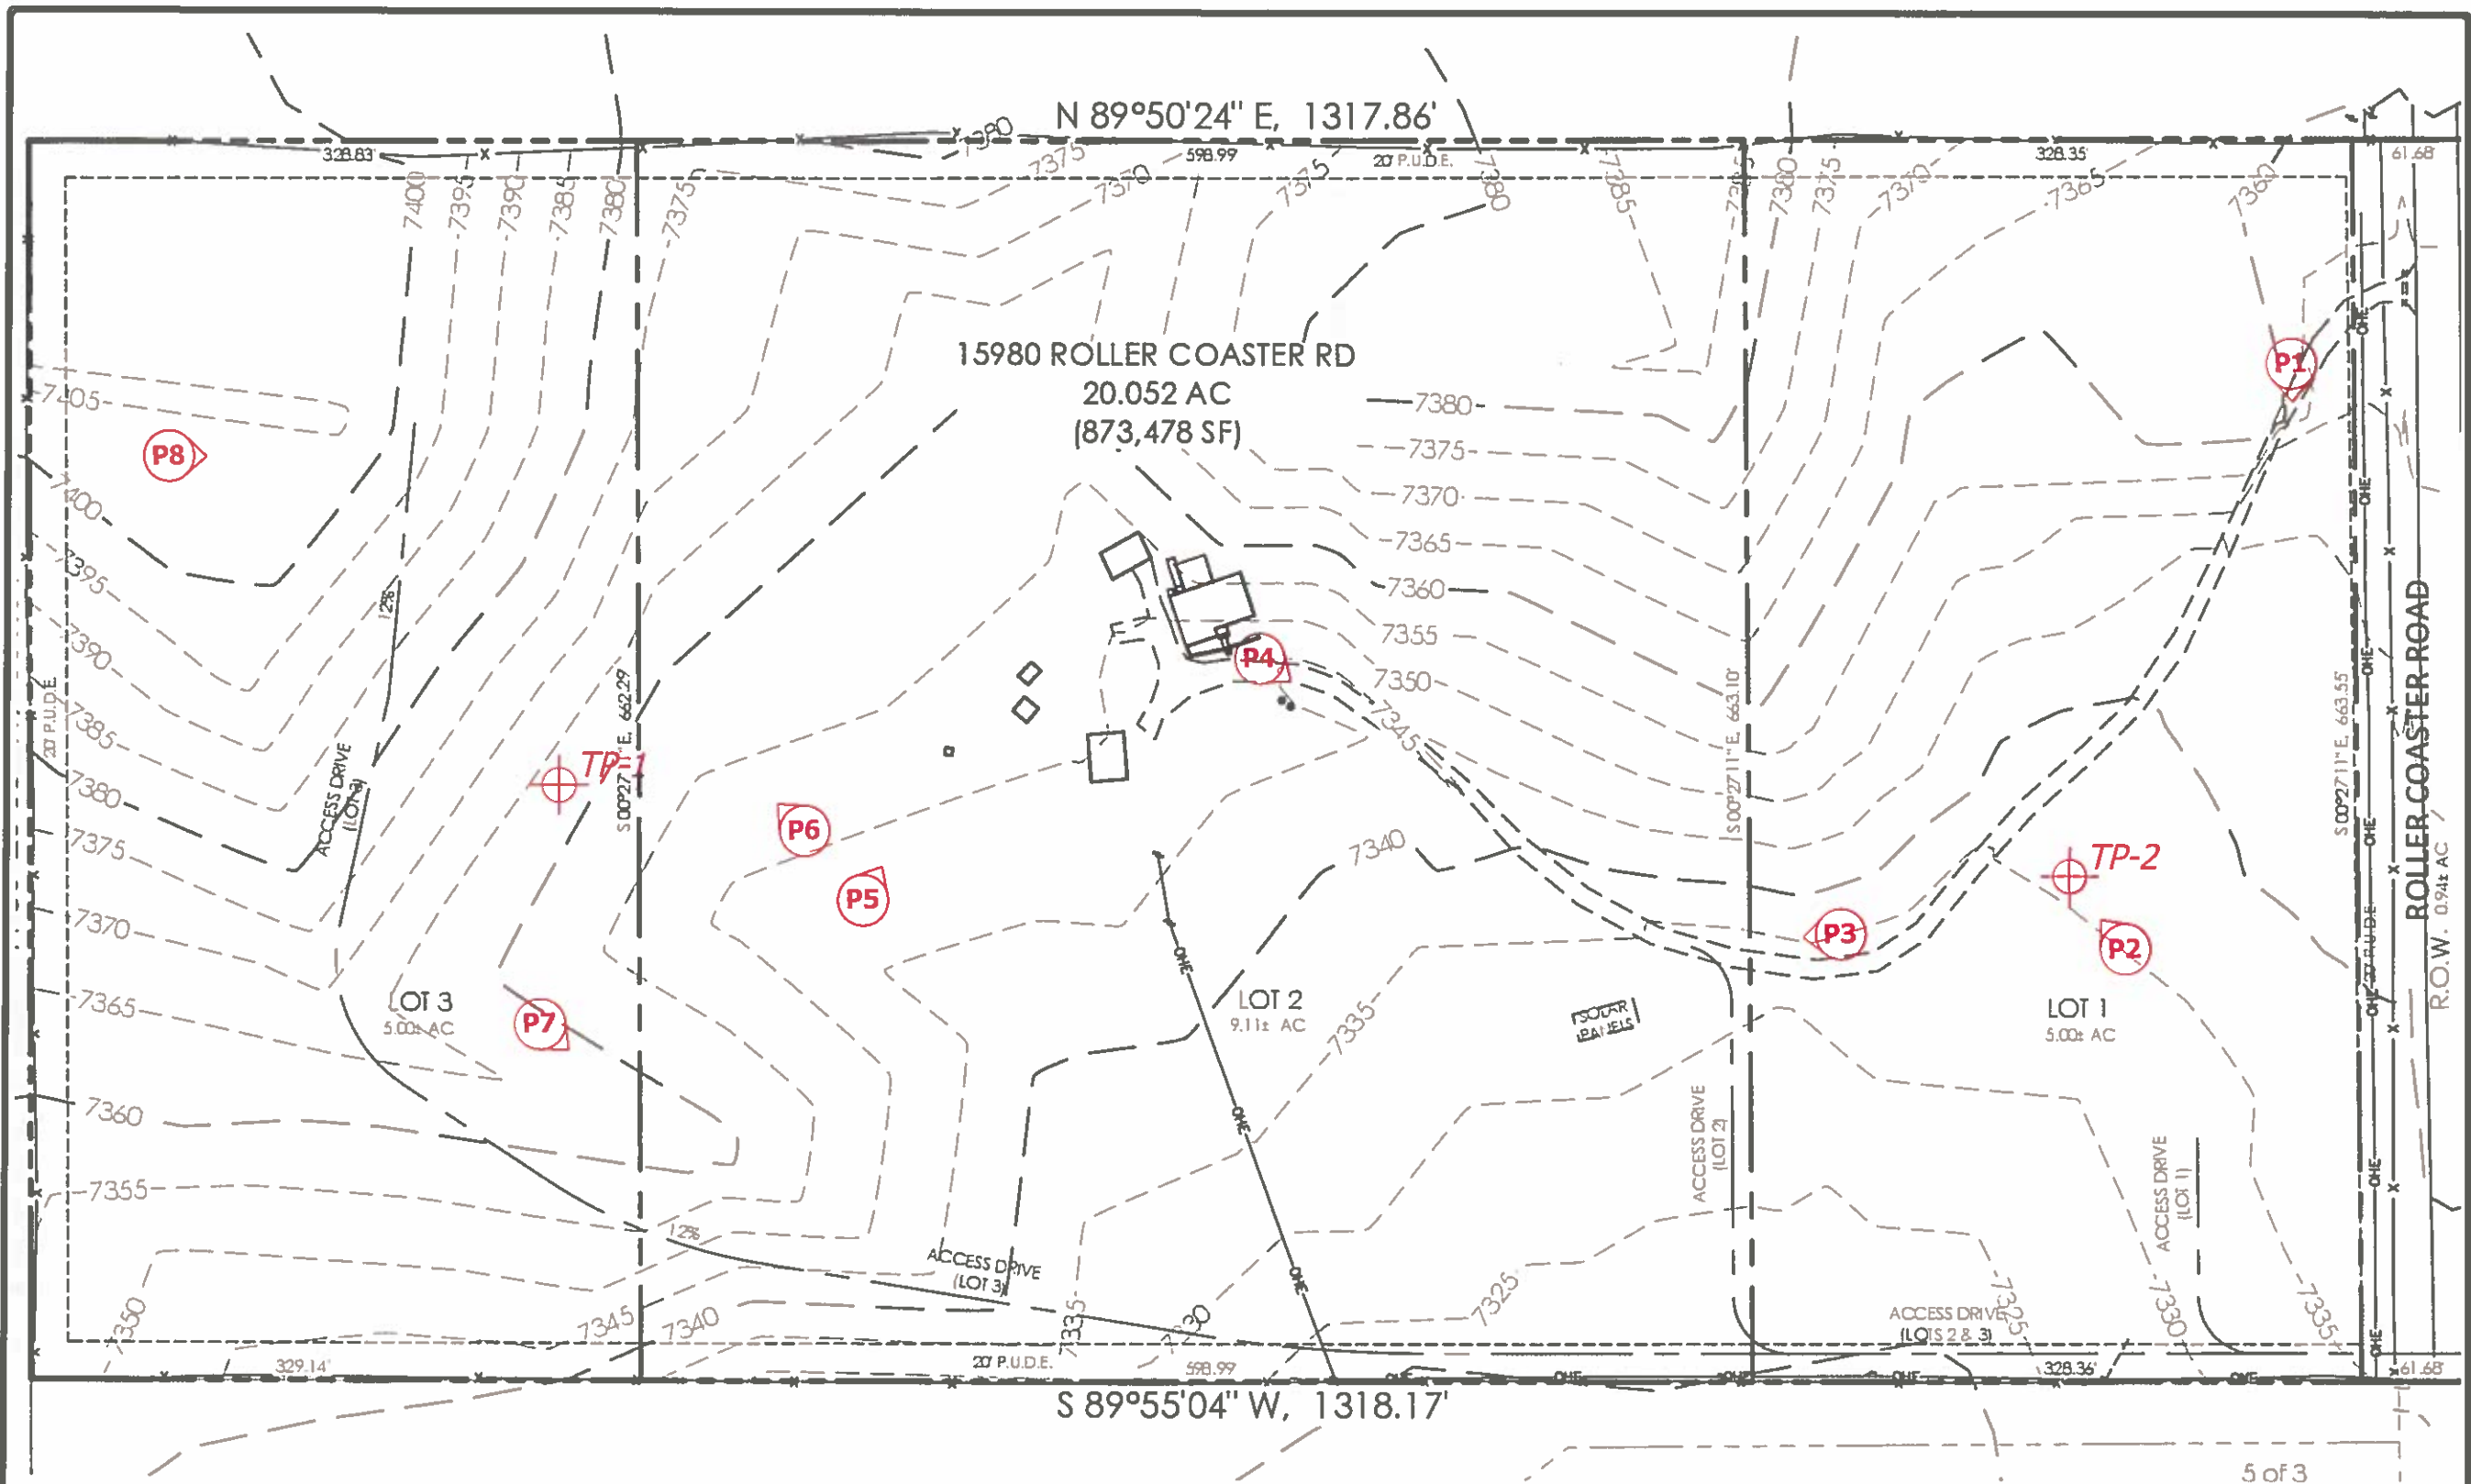
DRAWN LIL CHECKED
DATE 5/22/21
SCALE AS SHOWN
JOB NO. 210825
FIGURE NO. 3

Two test pits were excavated on the two new proposed lots to determine general suitability of the soil characteristics for residential construction and for onsite wastewater treatment. The locations of the test pits are indicated on the Site Plan/Test Pit Location Map, Figure 3. The Test Pit Logs are presented in Appendix B. Results of this testing will be discussed later in this report.

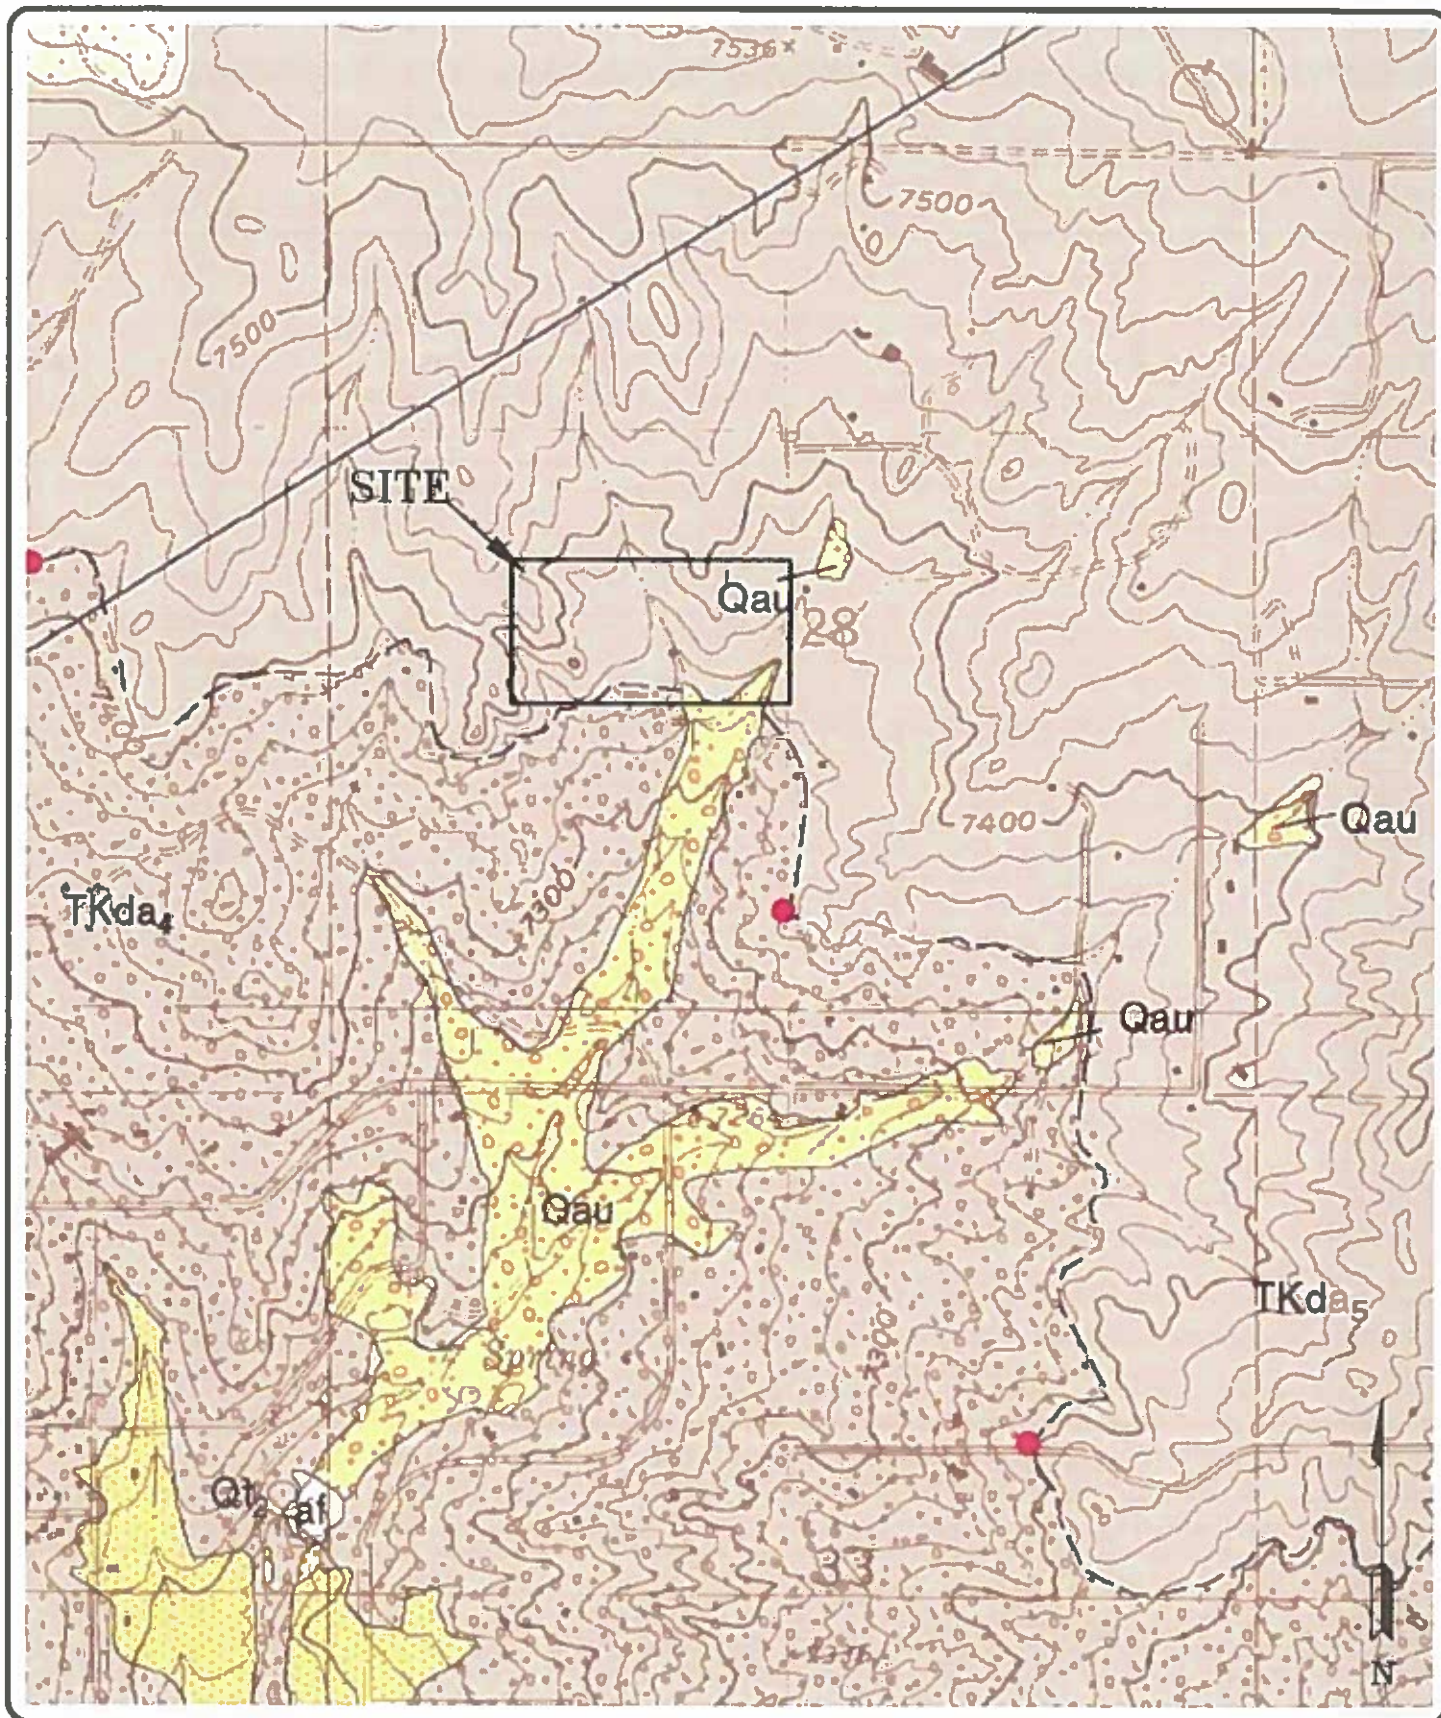
DRAWN LL
CHECKED
DATE 5/22/21
SCALE AS SHOWN
JOB NO. 210825
FIGURE NO. 6

Two minor dry drainages exist in the central and eastern portions of the site. No water was observed flowing in the drainages at the time of the investigation, however, these areas have the potential for seasonal shallow groundwater. These areas are indicated in the Geology/Engineering Geology Map (Figure 6). Due to the size of the proposed lots these areas can either be avoided or redirected around proposed structures or proposed soil treatment areas. The proposed building areas are not affected by these areas. The site does not lie within any floodplain zones according to the FEMA Map Nos. 08041CO285G and 08041CO295G dated December 7, 2018 (Figure 7, Reference 7). The two dry drainages mapped with these hazards have been identified in the National Wetland Inventory as a Freshwater Emergent Wetland habitat classified as Riverine habitat classified as R4SBC (Riverine – R, Intermittent – 4, Streambed – SB, Seasonally Flooded – C) (Figure 8, Reference 8). In this area we would anticipate the potential for surface and near surface groundwater conditions depending on seasonal changes in precipitation and runoff. Exact floodplain locations and drainage studies are beyond the scope of this report. Groundwater areas are discussed as follows:

Areas of downslope creep were observed across the site, and are indicated on Figure 6. The areas identified with this hazard includes the steeper slopes along the ridges across the site. In these areas we would anticipate lateral and vertical movement of the near surface soils in the downslope direction. These areas will be avoided by the proposed structures; however, structures may encroach on these areas. In areas of downslope creep, structures should be
