## SOIL, GEOLOGY, AND WASTEWATER STUDY

**6385 Vessey Road  
El Paso County Schedule No. 5206000065  
El Paso County, Colorado**

**JOB NO. 185099**

**January 11, 2021**

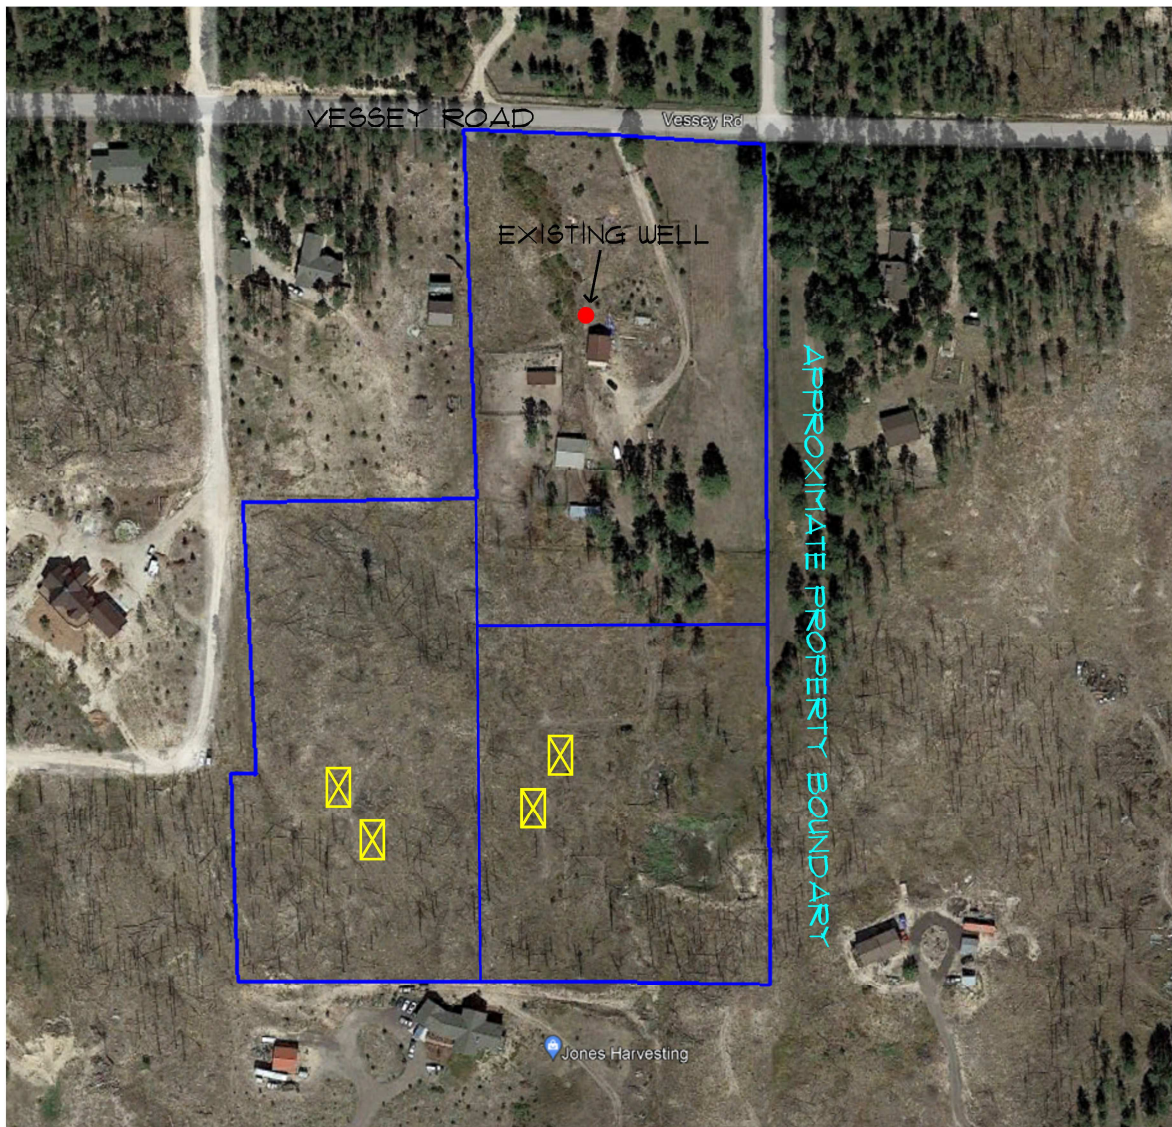
FIG No. 8

The test pits were excavated to 8 feet below the existing ground surface. Additional information is provided in Section 9.0, On-site Disposal of Wastewater. The locations of the test pits are presented on the Site Vicinity Map, Figure 8.
