**SOIL, GEOLOGY, AND GEOLOGIC HAZARD STUDY
STERLING RANCH PHASE 2
AND STERLING RANCH FILING NO. 3
EL PASO COUNTY, COLORADO**

Morley-Bentley Investments, LLC
20 Boulder Crescent Street, Suite 200
Colorado Springs, Colorado 80903

June 25, 2020
Revised March 3, 2021

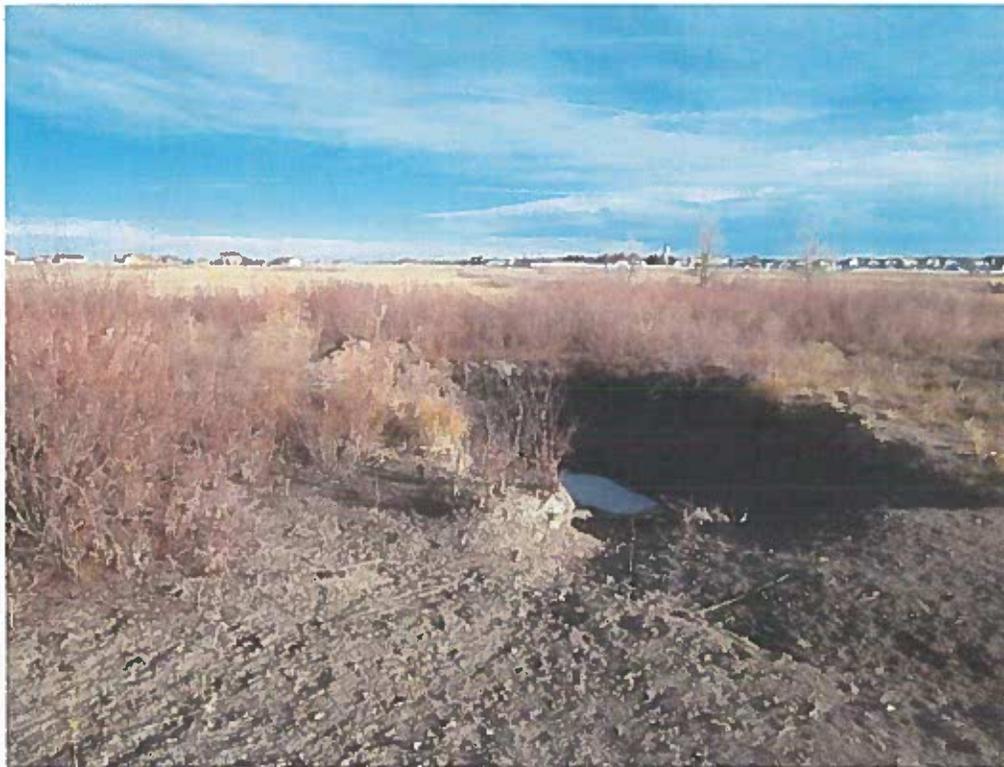
**Looking northeast
from the western
portion of the site.**

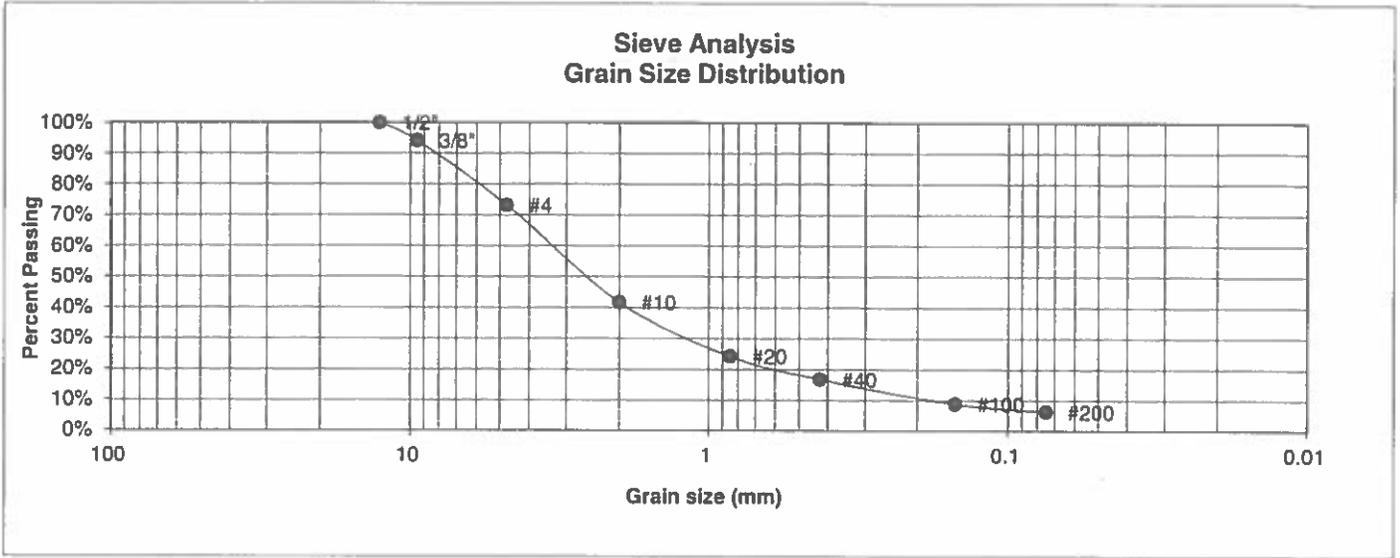
C-1

UNIFIED CLASSIFICATION	SM-SW	CLIENT	MORLEY-BENTLEY INVEST.
SOIL TYPE #	1	PROJECT	STERLING RANCH, P2, F3
TEST BORING #	1	JOB NO.	191089
DEPTH (FT)	2-3	TEST BY	BL

U.S. Sieve #	Percent Finer
3"	
1 1/2"	
3/4"	
1/2"	100.0%
3/8"	94.1%
4	73.2%
10	41.7%
20	24.3%
40	16.8%
100	8.9%
200	6.4%

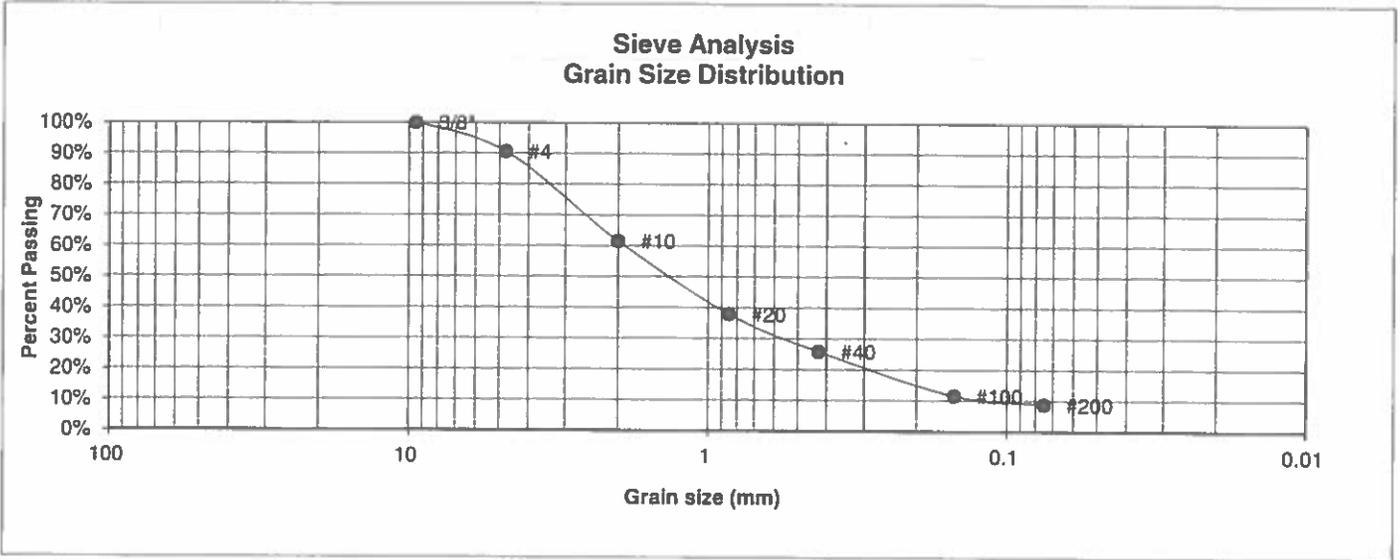
FIG NO:
C-2

UNIFIED CLASSIFICATION	SM-SW	CLIENT	MORLEY-BENTLEY INVEST.
SOIL TYPE #	1	PROJECT	STERLING RANCH, P2, F3
TEST BORING #	2	JOB NO.	191089
DEPTH (FT)	5	TEST BY	BL

U.S. Sieve #	Percent Finer
3"	
1 1/2"	
3/4"	
1/2"	
3/8"	100.0%
4	90.5%
10	61.5%
20	37.8%
40	25.8%
100	11.5%
200	8.7%

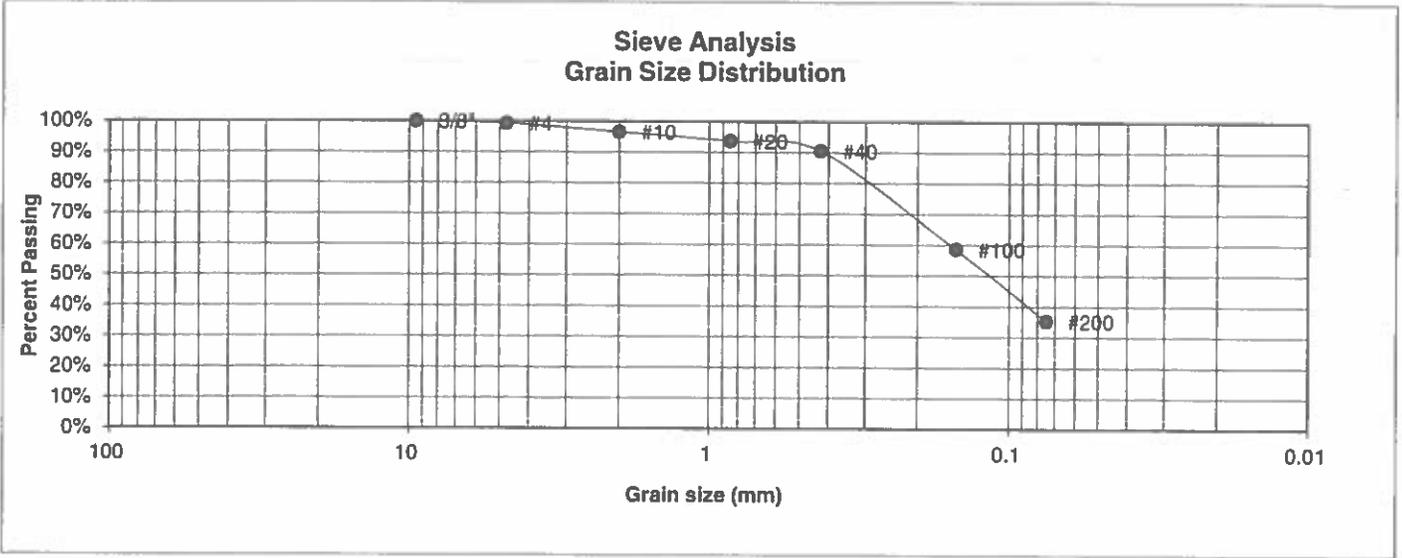
FIG NO:
C-3

<u>UNIFIED CLASSIFICATION</u>	SM	<u>CLIENT</u>	MORLEY-BENTLEY INVEST.
<u>SOIL TYPE #</u>	1	<u>PROJECT</u>	STERLING RANCH, P2, F3
<u>TEST BORING #</u>	3	<u>JOB NO.</u>	191089
<u>DEPTH (FT)</u>	10	<u>TEST BY</u>	BL

U.S. Sieve #	Percent Finer
3"	
1 1/2"	
3/4"	
1/2"	
3/8"	100.0%
4	99.3%
10	96.6%
20	93.6%
40	90.4%
100	58.6%
200	35.3%

Atterberg Limits	
Plastic Limit	NP
Liquid Limit	NV
Plastic Index	NP

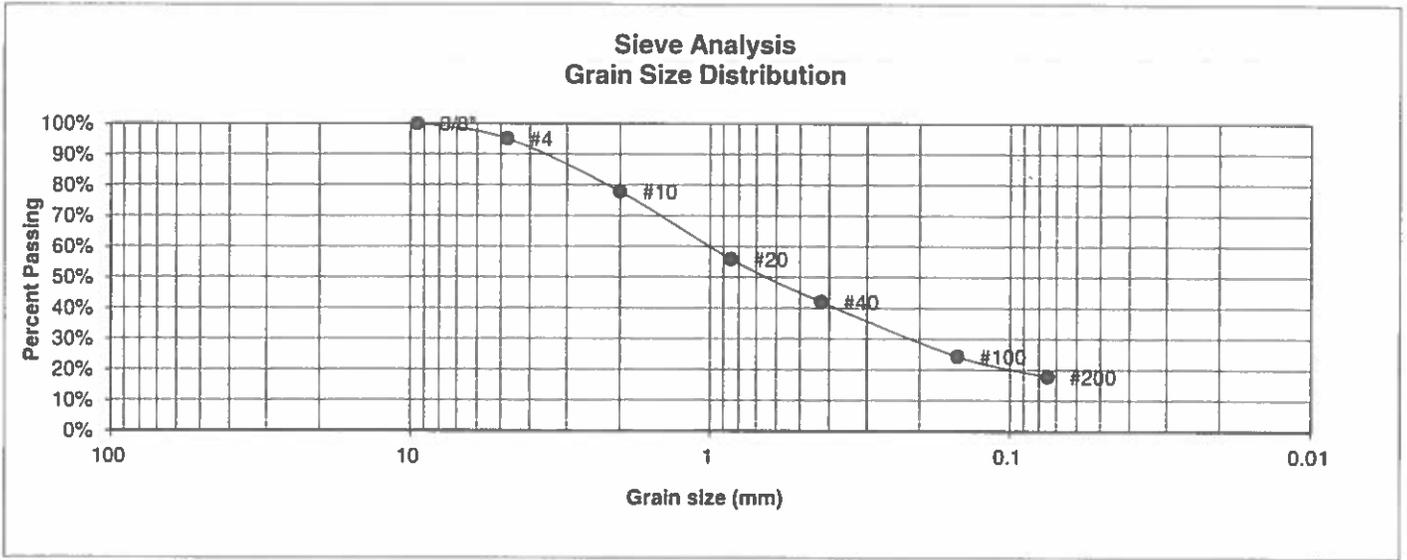
JOB NO.: 191089
 FIG NO.: C-4

UNIFIED CLASSIFICATION	SM	CLIENT	MORLEY-BENTLEY INVEST.
SOIL TYPE #	1	PROJECT	STERLING RANCH, P2, F3
TEST BORING #	4	JOB NO.	191089
DEPTH (FT)	2-3	TEST BY	BL

U.S. Sieve #	Percent Finer
3"	
1 1/2"	
3/4"	
1/2"	
3/8"	100.0%
4	95.0%
10	77.8%
20	55.9%
40	42.0%
100	24.3%
200	17.8%

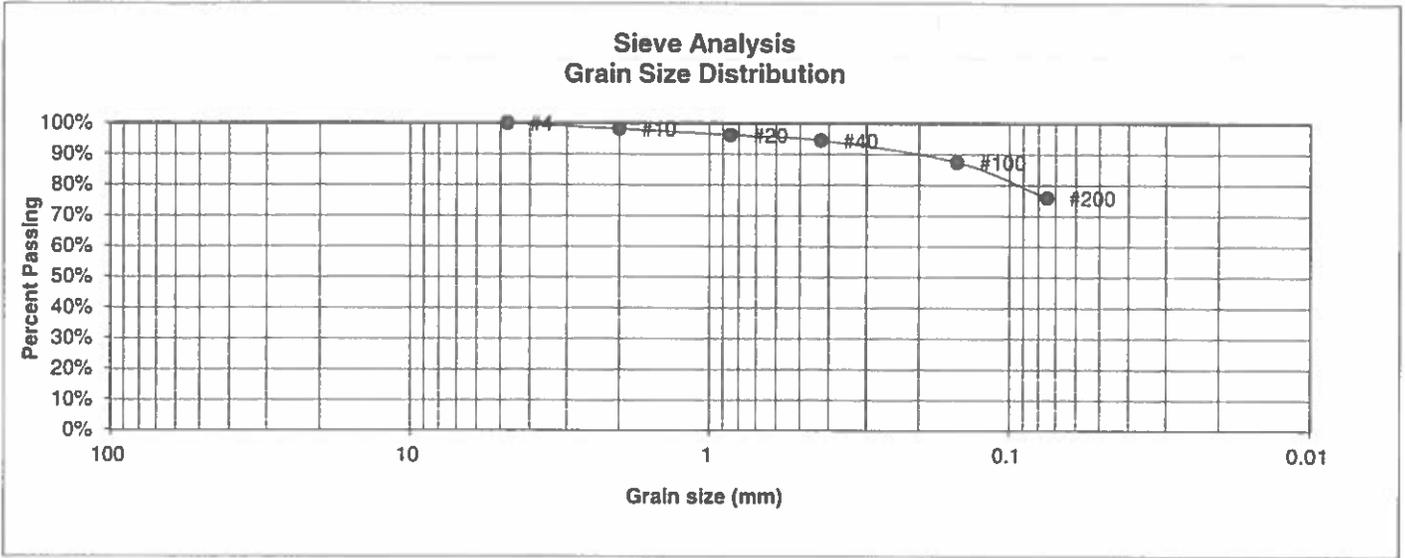
FIG NO:
C-5

<u>UNIFIED CLASSIFICATION</u>	CL	<u>CLIENT</u>	MORLEY-BENTLEY INVEST.
<u>SOIL TYPE #</u>	2	<u>PROJECT</u>	STERLING RANCH, P2, F3
<u>TEST BORING #</u>	4	<u>JOB NO.</u>	191089
<u>DEPTH (FT)</u>	5	<u>TEST BY</u>	BL

<u>U.S. Sieve #</u>	<u>Percent Finer</u>
3"	
1 1/2"	
3/4"	
1/2"	
3/8"	
4	100.0%
10	98.3%
20	96.3%
40	94.5%
100	87.5%
200	75.9%

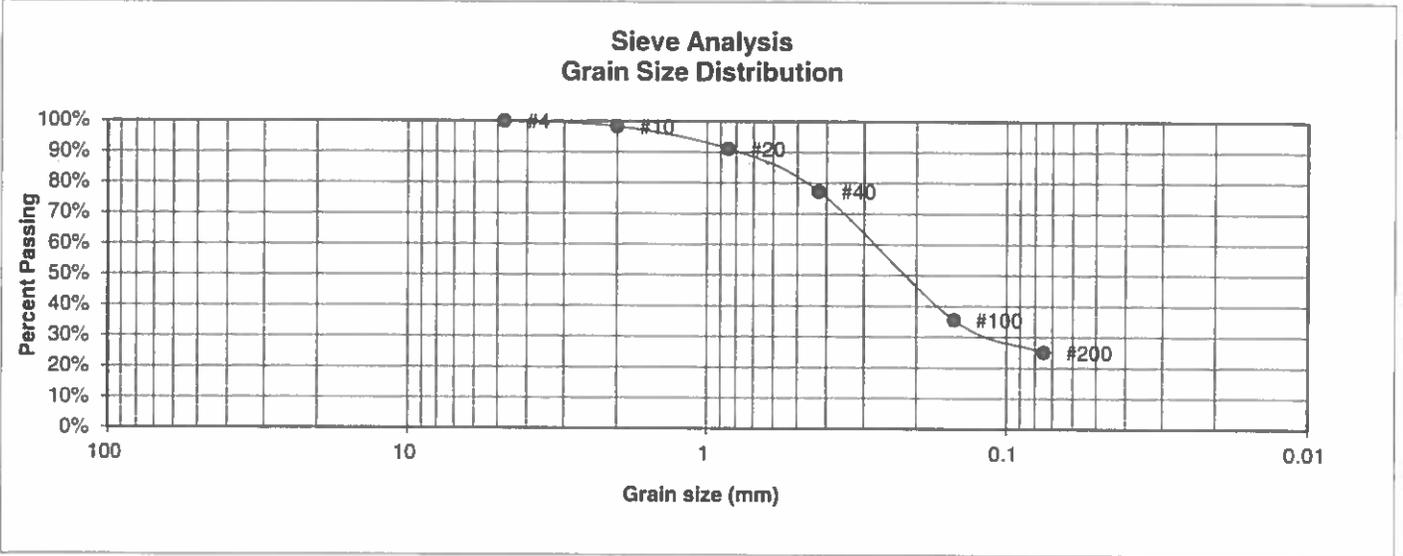
FIG NO.:
C-6

<u>UNIFIED CLASSIFICATION</u>	SM	<u>CLIENT</u>	MORLEY-BENTLEY INVEST.
<u>SOIL TYPE #</u>	3	<u>PROJECT</u>	STERLING RANCH, P2, F3
<u>TEST BORING #</u>	2	<u>JOB NO.</u>	191089
<u>DEPTH (FT)</u>	10	<u>TEST BY</u>	BL

U.S. Sieve #	Percent Finer
3"	
1 1/2"	
3/4"	
1/2"	
3/8"	
4	100.0%
10	98.3%
20	91.1%
40	77.3%
100	35.6%
200	25.1%

Atterberg Limits	
Plastic Limit	NP
Liquid Limit	NV
Plastic Index	NP

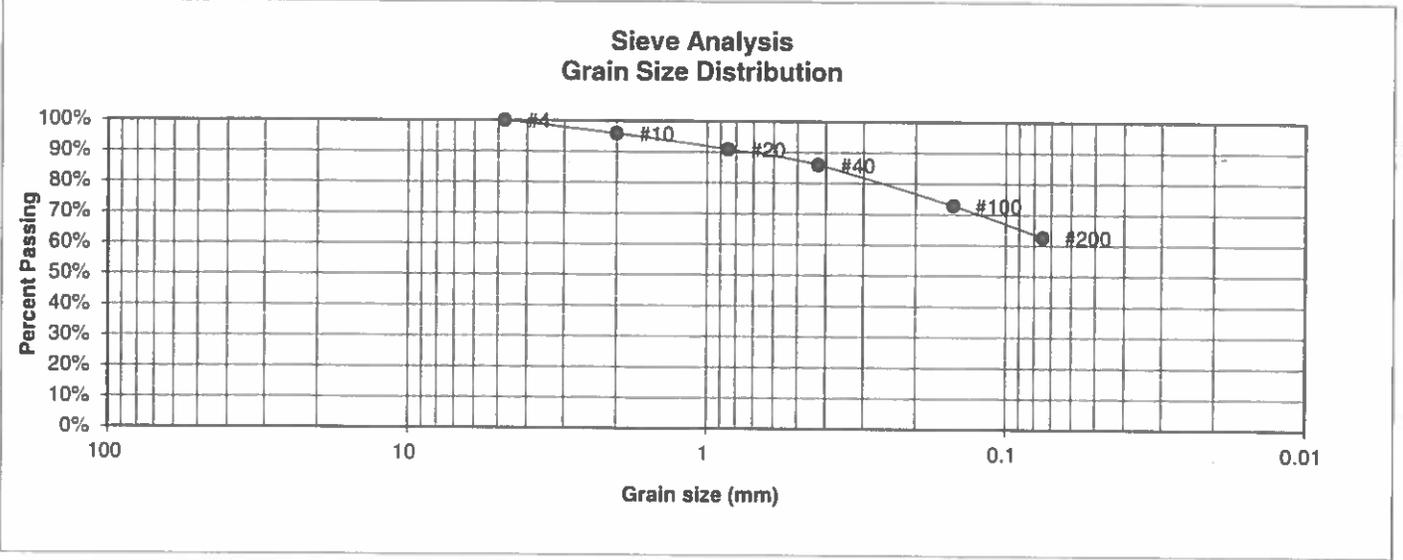
<u>UNIFIED CLASSIFICATION</u>	CL	<u>CLIENT</u>	MORLEY-BENTLEY INVEST.
<u>SOIL TYPE #</u>	4	<u>PROJECT</u>	STERLING RANCH, P2, F3
<u>TEST BORING #</u>	3	<u>JOB NO.</u>	191089
<u>DEPTH (FT)</u>	20	<u>TEST BY</u>	BL

U.S. Sieve #	Percent Finer
3"	
1 1/2"	
3/4"	
1/2"	
3/8"	
4	100.0%
10	95.9%
20	90.9%
40	86.0%
100	72.8%
200	62.7%

Atterberg Limits	
Plastic Limit	20
Liquid Limit	32
Plastic Index	12
