December 23, 2020

Re: Soil, Geology and Geologic Hazard Addendum  
Waterbury, Filings 1 and 2  
PUD Amendment and Preliminary Plan  
El Paso County, Colorado

**SOIL, GEOLOGY,  
GEOLOGIC HAZARD AND  
PRELIMINARY SUBSURFACE SOIL INVESTIGATION  
WATERBURY, PHASE I  
EL PASO COUNTY, COLORADO**

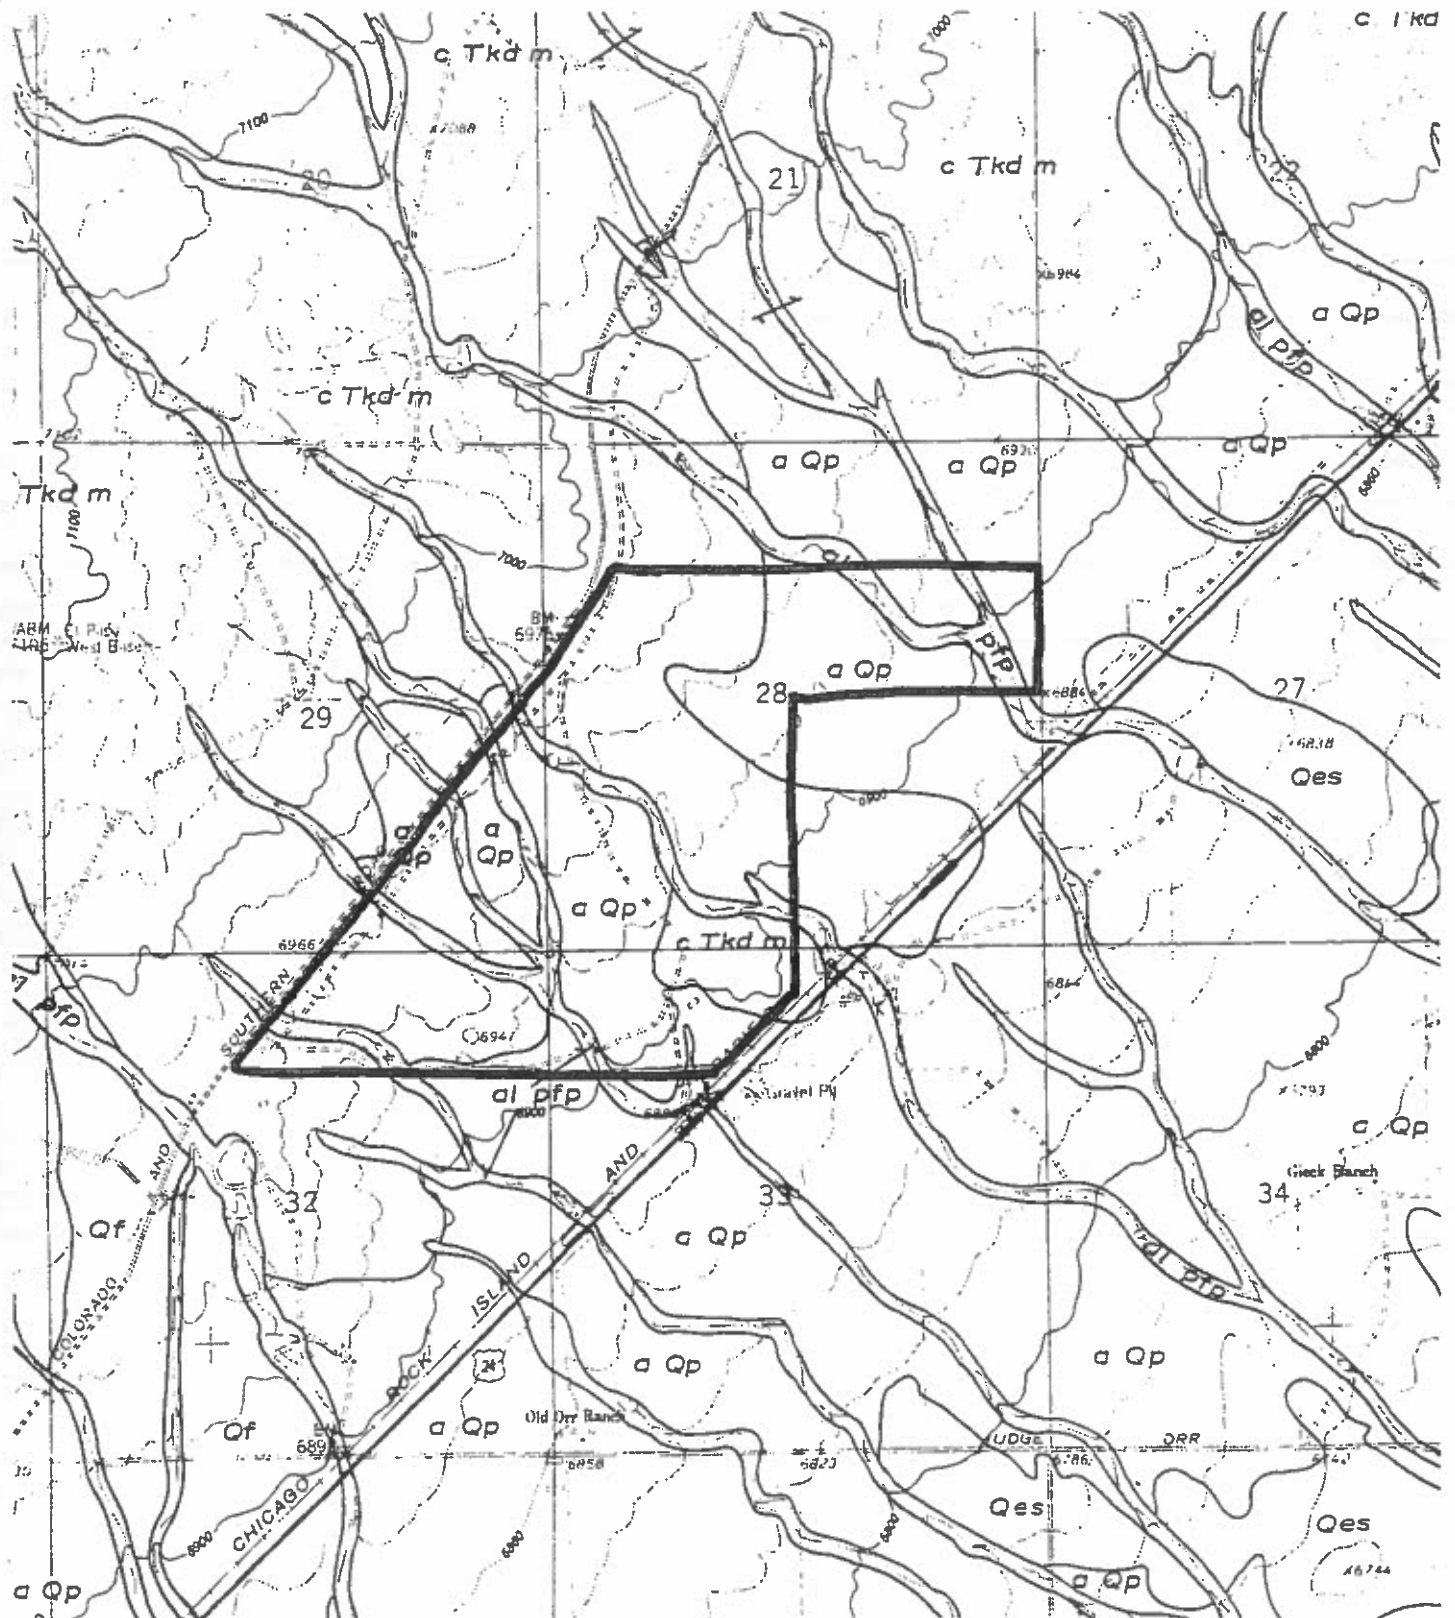
DESIGNED BY	
CHECKED BY	
DATE	03/20/13
SCALE	1" = 300'
FIG. NO.	133377
FIGURE NO.	9

The Engineering Geology Map of the Falcon Quadrangle as mapped by Charles Robinson and Associates, Inc. for El Paso County Planning Department is presented in Figure 10 (Reference 9). The Robinson Study map and site-specific mapping were utilized to produce an Engineering Geology Map, Figure 9. This map shows the location of various geologic conditions of which the developers and planners should be cognizant during the planning, design and construction stages of the project. The hazards identified on this site include floodplains, seasonally shallow groundwater areas, potentially seasonal shallow groundwater areas, areas of seepage or springs, area of ponded water, unstable slopes, artificial fill, loose soils, and expansive soils. These hazards and the recommended mitigation techniques are as follows:

sw - Seasonal shallow groundwater areas: In these areas, we would anticipated the potential for periodically high subsurface moisture conditions, frost heave potential, and highly organic soils. The majority of these areas are to be filled and regraded or designated as open space according to the grading plan, Figure 9. Three to nine feet of fill is proposed in these areas. Construction in these areas, should follow these precautions:

w - Areas of ponded water: These are areas where water could potentially pond behind existing earthen dams. According to the grading plan, Figure 9, this area is to be regraded and the dam removed. All soft and organic soils should be removed prior to fill placement. All uncontrolled fill associated with the dams should be recompacted at a minimum of 92% of its maximum Modified Dry Density ASTM D-1557.

fp - Floodplain: Areas of the site have been mapped as floodplains according to the FEMA Map No. 08041CO575F (Figure 11, Reference 13). The physiographic floodplains on site have been mapped on the Engineering Geology Map (Figure 9). Areas of flowing water, not identified as floodplains on the FEMA map (Figure 11) have been mapped as a physiographic floodplain hazard on Figure 9. It is our understanding a Letter of Map Revision (LOMR) has been submitted for the site and that some drainage improvements and channelization are proposed. A Conditional Letter of Map Revision (CLOMR) is to be

Mitigation: In these locations, foundations are subject to severe frost heave and should penetrate to a sufficient depth so as to discourage the formation of ice lenses beneath foundations. At this location and elevation, a foundation depth for frost protection of 3 feet is recommended. In areas where high subsurface moisture conditions are anticipated periodically, a subsurface perimeter drain will be necessary to help prevent the seepage of water into areas below grade. A typical perimeter drain detail is presented in Figure 12. Any grading in these areas should be done in a manner that directs surface flow around construction to avoid areas of ponded water. Areas of organic material will require removal prior to any fill placement. Unstable soil conditions should be expected in areas of shallow groundwater. Where foundations approach the groundwater level, stabilization of the excavations utilizing shot rock may be necessary. Underslab drains or capillary breaks, and interceptor drains may be necessary to prevent the intrusion of water into areas below grade. Typical drain details are presented in Figures 13 and 14.

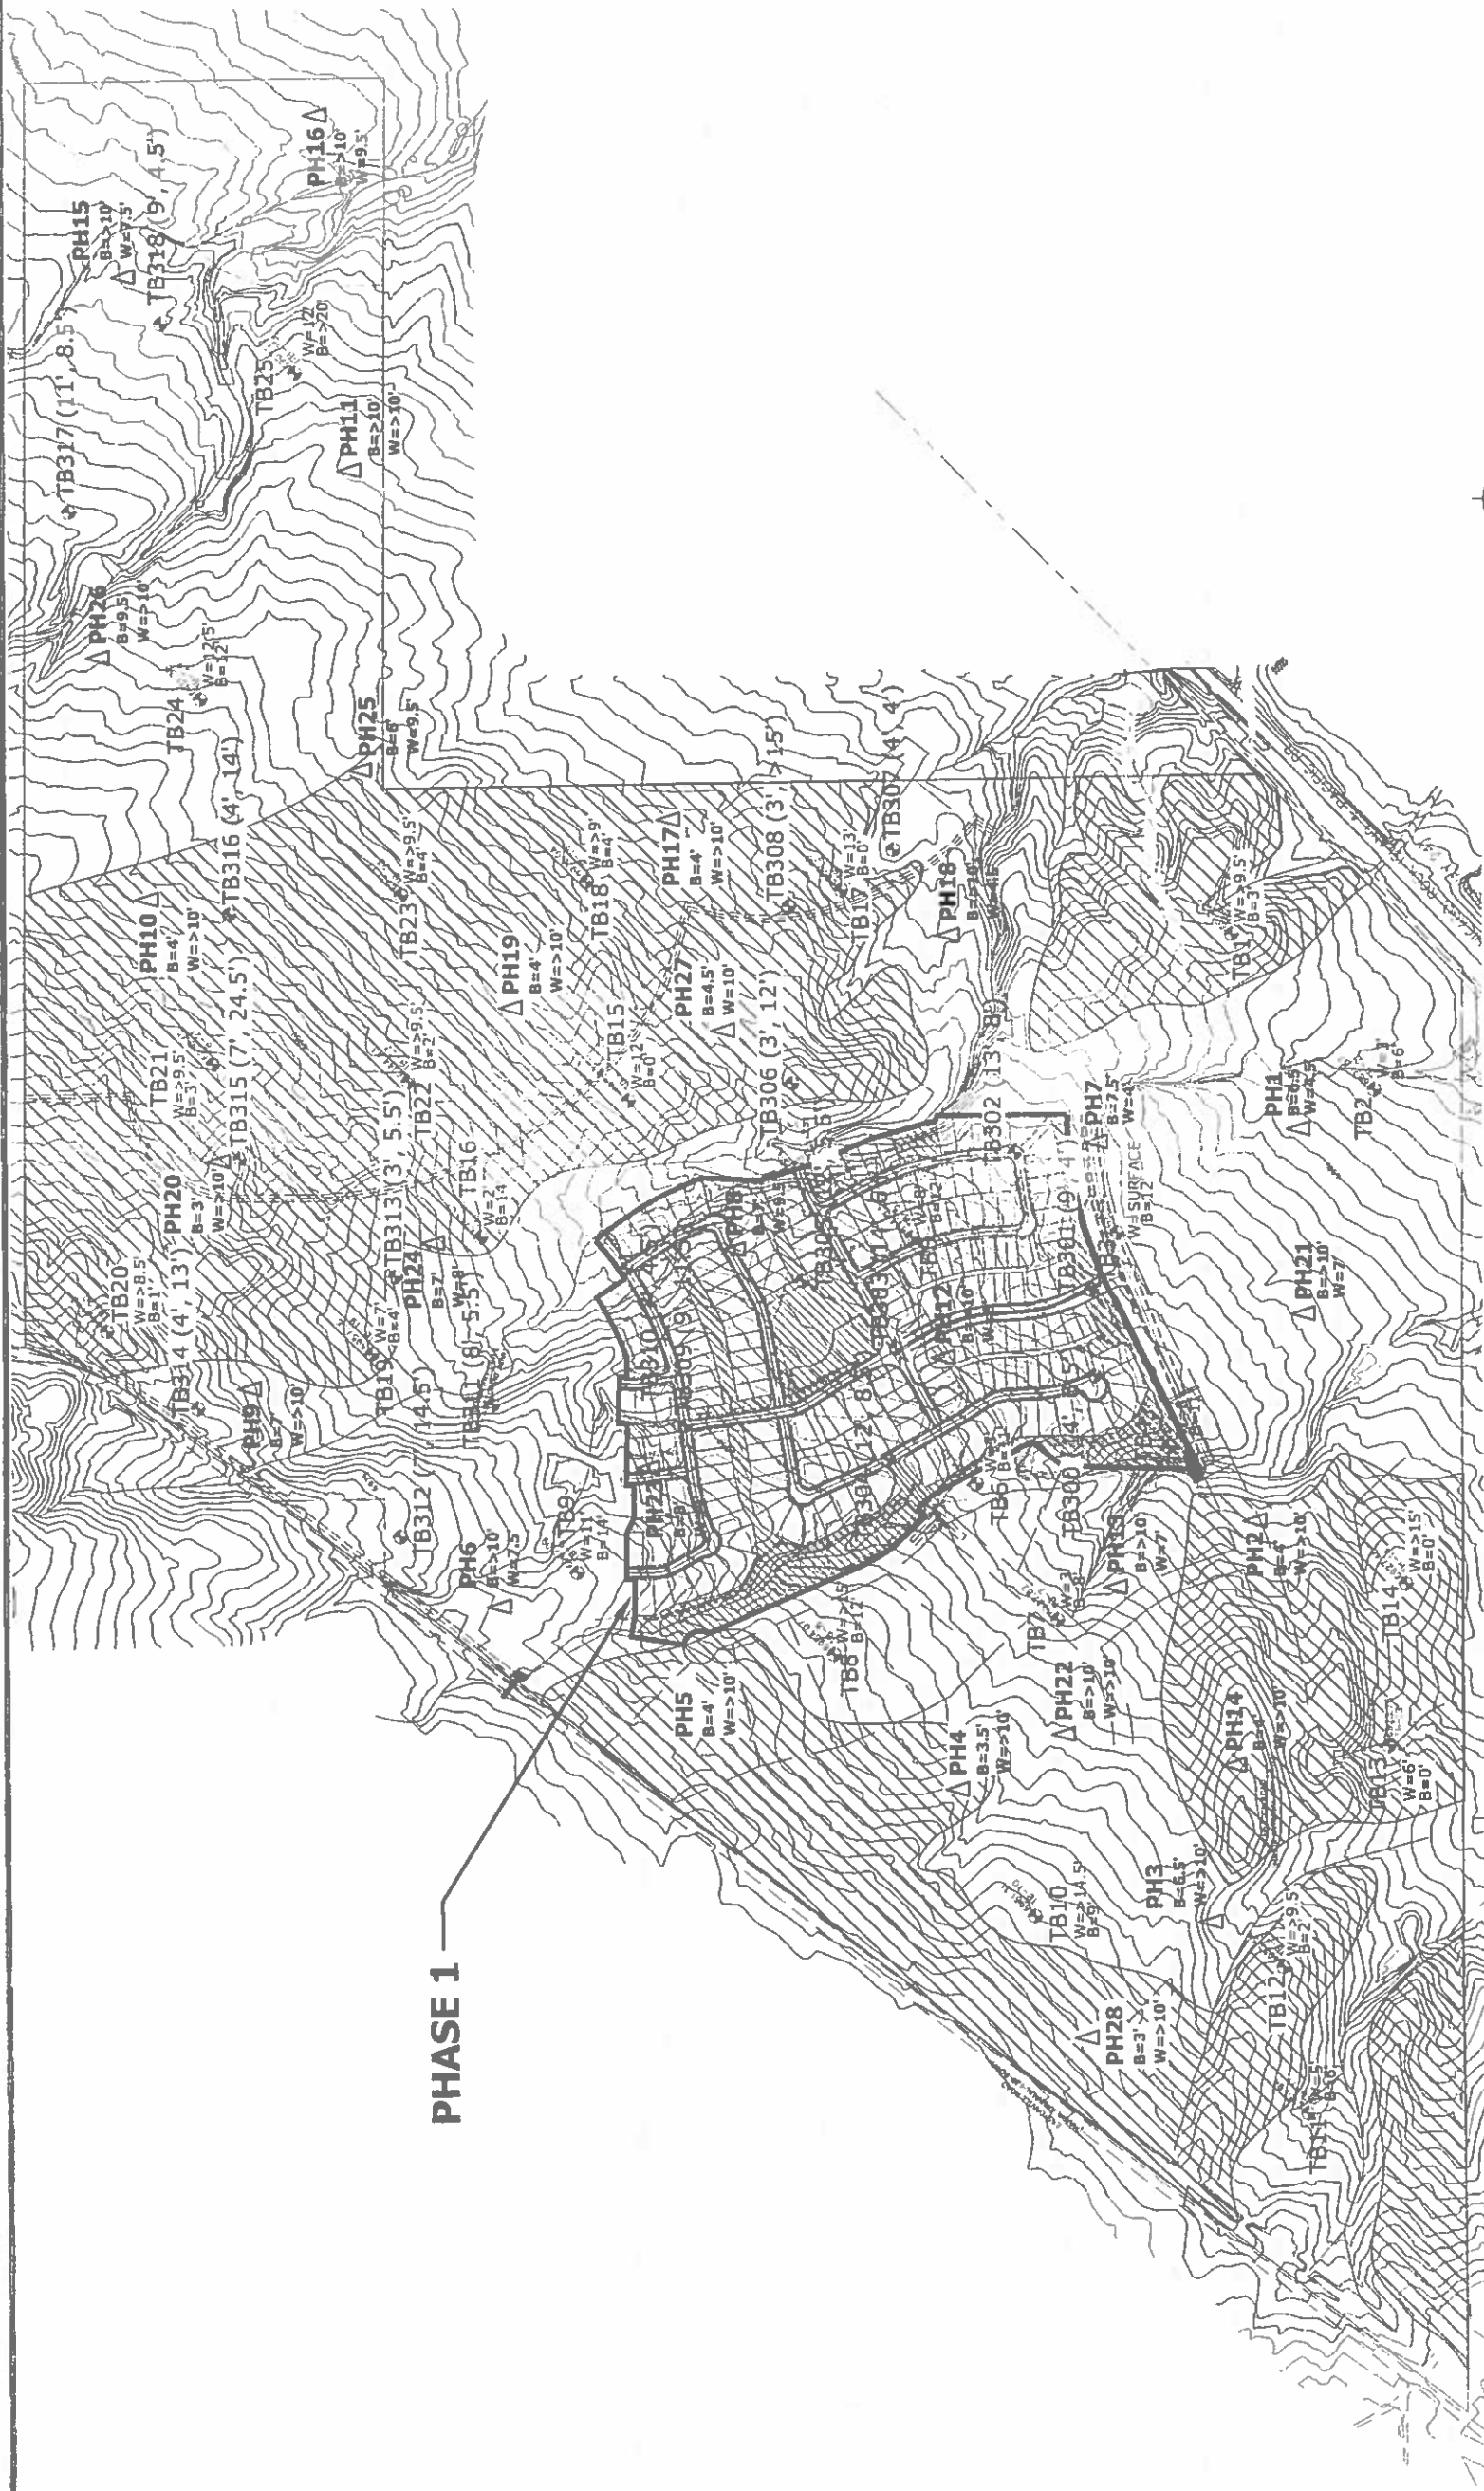
DRAWN BY: R. MCBRIDE	CHECKED BY:	DATE: 03/20/13	SCALE: 1" = 300'	JOB NO. 139377	FIGURE NO. 15
----------------------	-------------	----------------	------------------	----------------	---------------

Shallow bedrock may be encountered on portions of this site where the overlying alluvial materials are thinner. Shallow bedrock areas encountered in the test borings and profile holes are indicated on the Shallow Bedrock Map, Figure 15. Depths of bedrock are indicated on Figure 15. Higher bearing capacities for foundations can be expected in areas of shallow bedrock. Additionally, difficult excavation can be expected in areas of shallow bedrock. The use of track mounted equipment may be necessary in areas of shallow bedrock. Rubber tired equipment can be used where bedrock is not encountered.
