ENTECH
ENGINEERING, INC.

Re: Soil, Geology and Geologic Hazard Addendum
Waterbury, Filings 1 and 2
PUD Amendment and Preliminary Plan
El Paso County, Colorado

**SOIL, GEOLOGY,
GEOLOGIC HAZARD AND
PRELIMINARY SUBSURFACE SOIL INVESTIGATION
WATERBURY, PHASE I
EL PASO COUNTY, COLORADO**

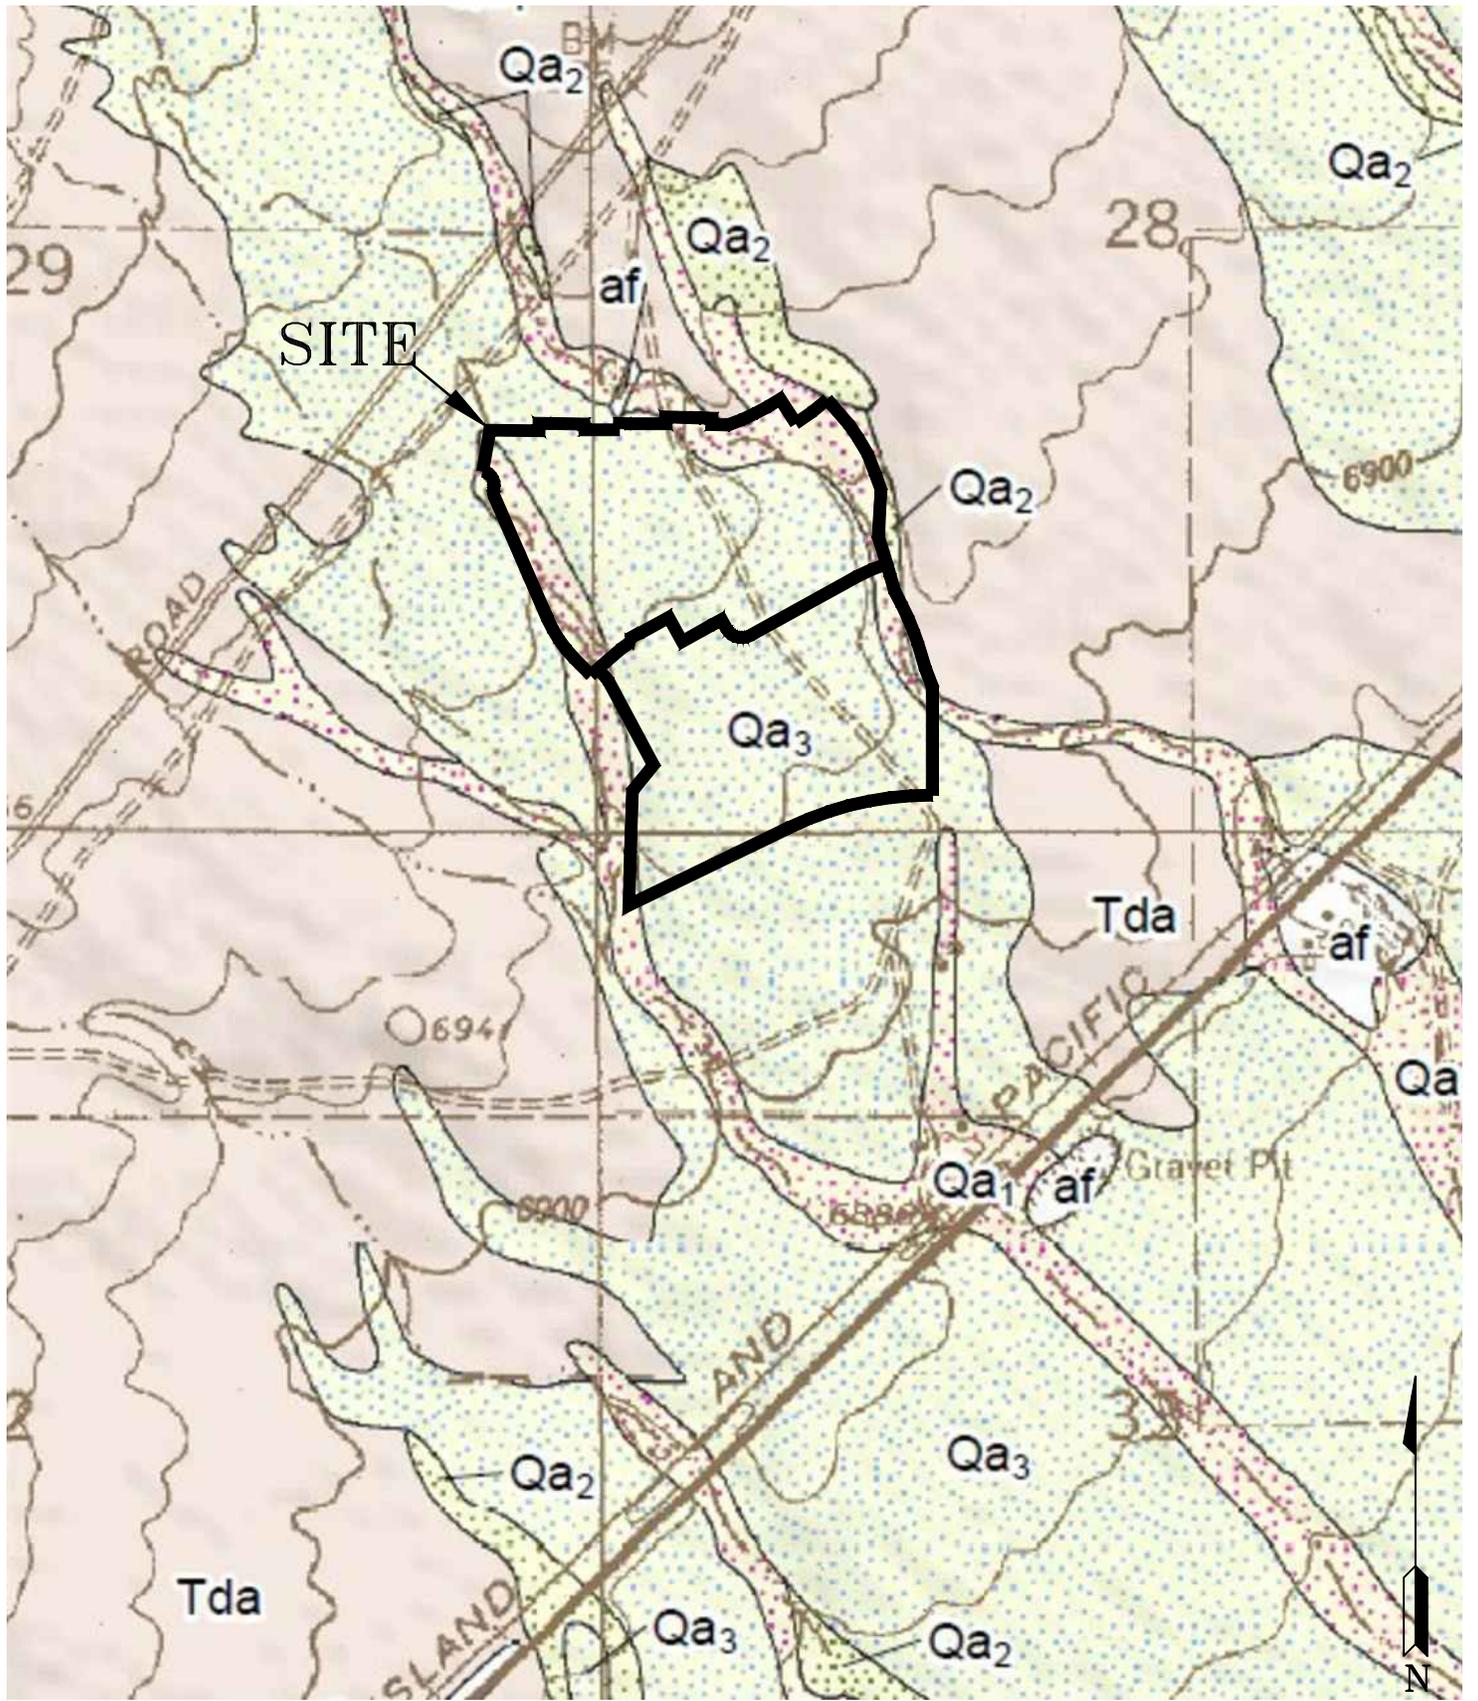
DRAWN L.L.
CHECKED
DATE 1/27/22
SCALE AS SHOWN
JOB NO. 212803
FIGURE No. 3

Current site conditions in the area of the proposed structure are consistent with what is described in the original Geologic Hazard Study by Entech (Reference 1, Appendix B). The grading and topography in the area of the proposed site appears to be relatively unchanged. The *Geologic Map of the Falcon Quadrangle* distributed by the Colorado Geological Survey in 2012, is presented in (Reference 2, Figure 2). Site-specific geologic mapping was performed as a part of the Geologic Hazard Study by Entech (Reference 1) and revised based off recent mapping by the Colorado Geological Survey (Reference 2, Figure 2). The site is mapped as Qal: Recent Alluvium of Quaternary Age along the drainages and Qa₃: Alluvium Three of Quaternary Age which consists of stream terrace deposits. The bedrock underlying the site is the Dawson Formation of Tertiary to Cretaceous Age (References 1 through 3). The updated Geology/Engineering Geology Map is presented in Figure 3.

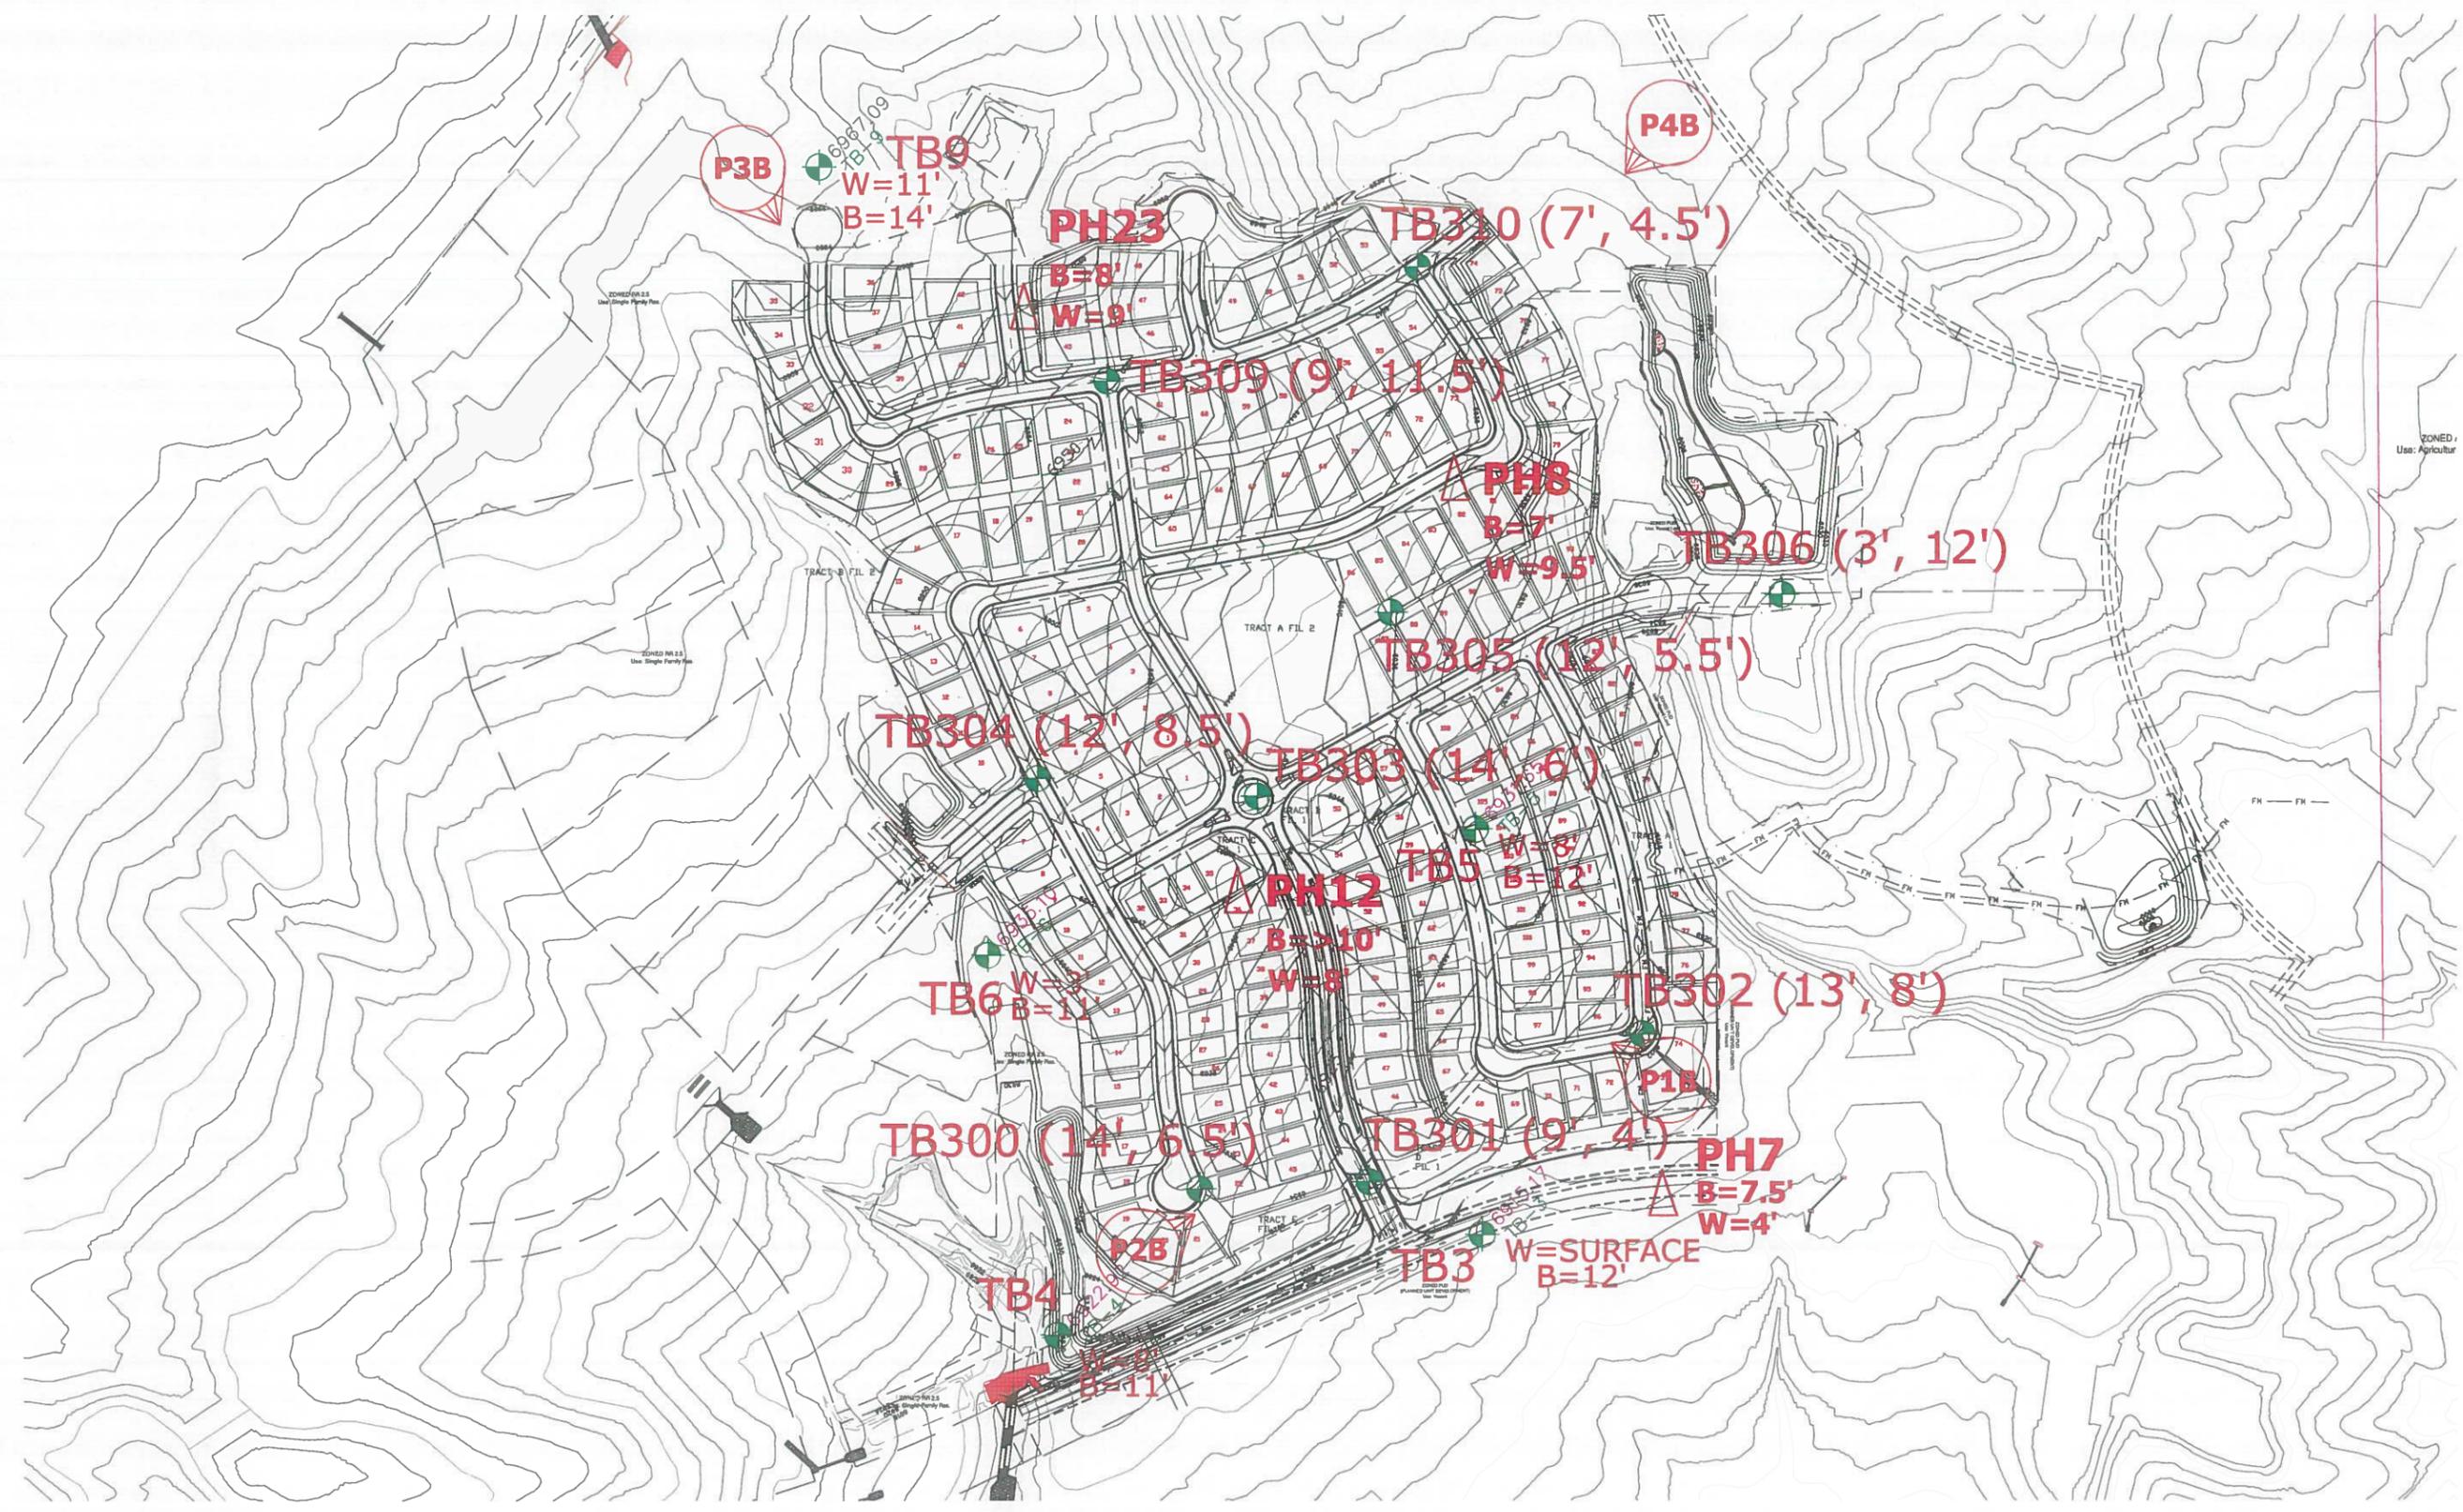
DRAWN BY: R. MCBRIDE
DESIGNED BY: KAH
CHECKED BY:
DATE: 10/19/21
SCALE: AS SHOWN
JOB NO.: 130377
FIGURE NO.: 3

Groundwater was encountered in all of the test borings drilled on or immediately adjacent Phase I of the development, as a part of the Subsurface Soil Investigation/Bedrock/Groundwater Investigation (Figure 3, Reference 6) at depths ranging from 4 to 11.5 feet. A summary of groundwater depths is presented in Table 3 and included in Appendix E.

Groundwater was encountered in all of the test borings drilled on or immediately adjacent Phase I, ranging from the surface to 8 feet below the surface (Figure 3, Reference 1). A summary of groundwater depths for all of the test borings drilled on the entire development is included in Appendix B. Groundwater was also encountered in profile holes drilled on or immediately adjacent to Phase I of the development, at depths ranging from 4 to 9.5 feet below the surface (Figure 3, Reference 1).

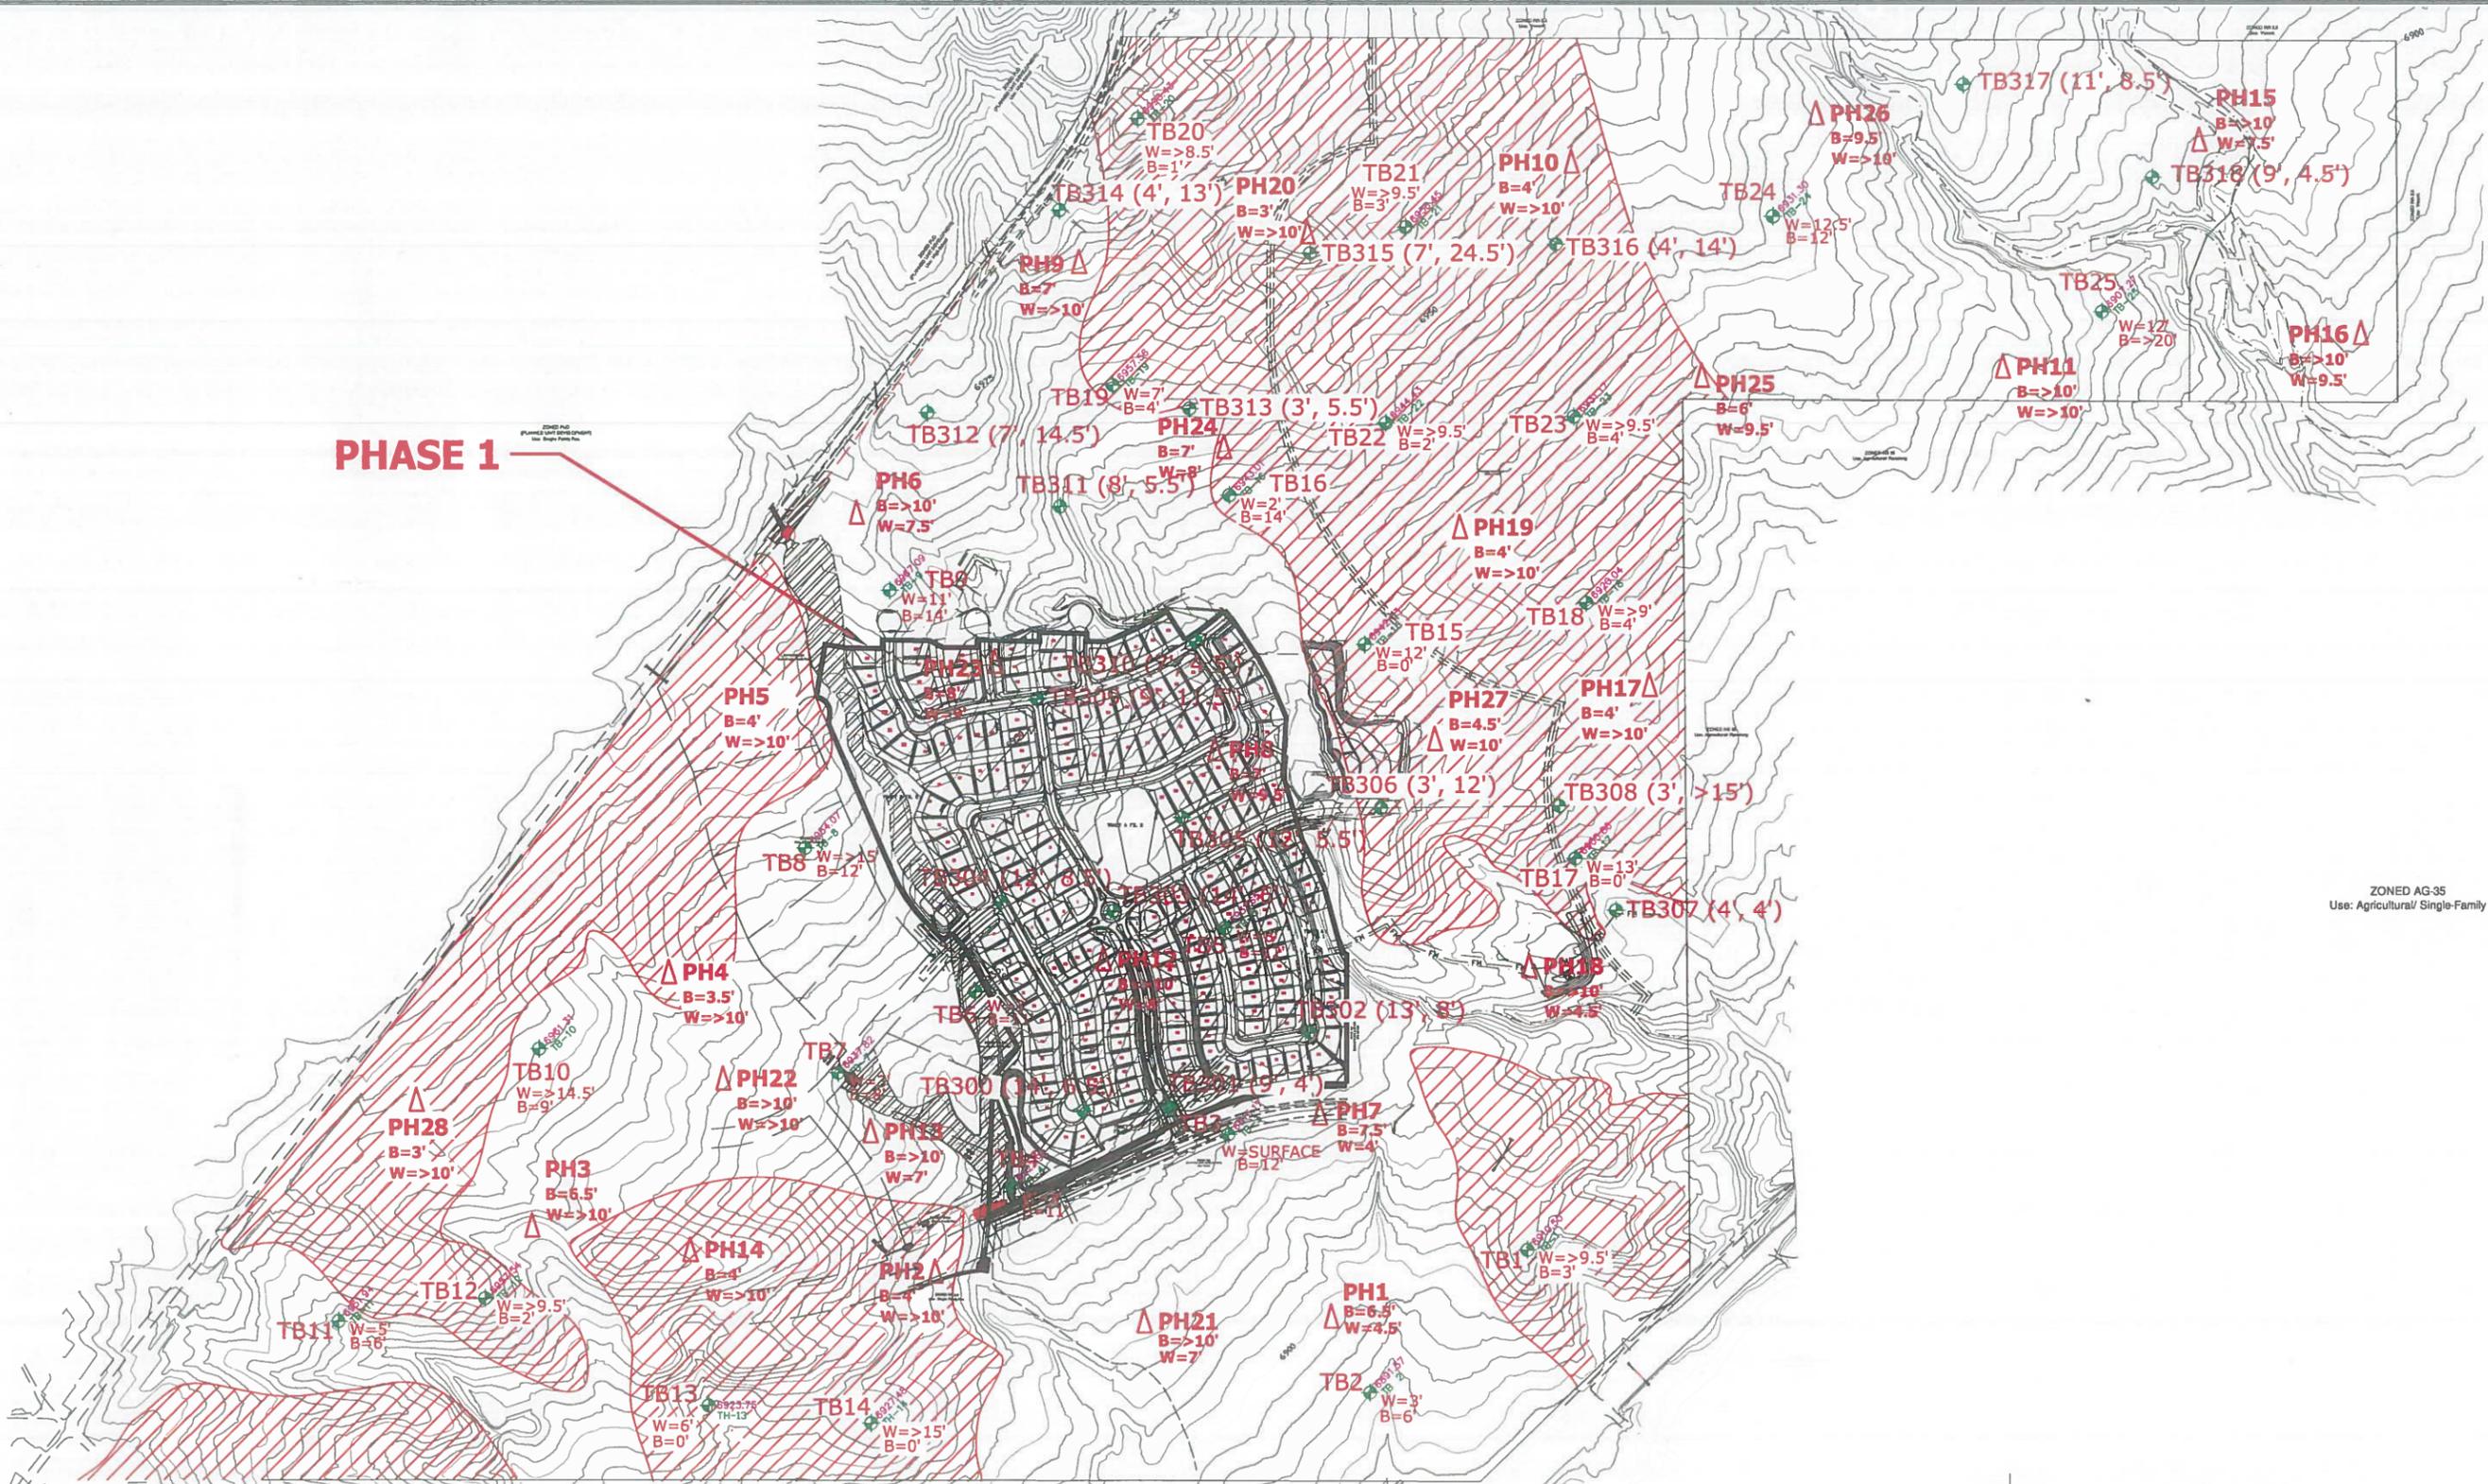
DRAWN BY:	R. MCBRIDE
DESIGNED BY:	KAH
CHECKED BY:	
DATE:	10/19/21
SCALE:	1" - 300'
JOB NO.:	130377
FIGURE NO.:	15

Shallow bedrock will be encountered on portions of this site where the overlying alluvial materials are thinner. Bedrock depths encountered in the test borings and profile holes are indicated on the Bedrock Map, Figure 15. Depths of bedrock are also shown on Figure 3. Higher bearing capacities for foundations can be expected in areas of shallow bedrock. Difficult excavation can be expected in areas of shallow bedrock. The use of track mounted equipment may be necessary in areas of shallow bedrock. Rubber tired equipment can be used where bedrock is not encountered.
