March 15, 2024
Project No. 502907001

Subject: Geologic Hazard Evaluation
Proposed Reagan Ranch Industrial Development
Marksheffel Road & Space Village Avenue
Colorado Springs, Colorado

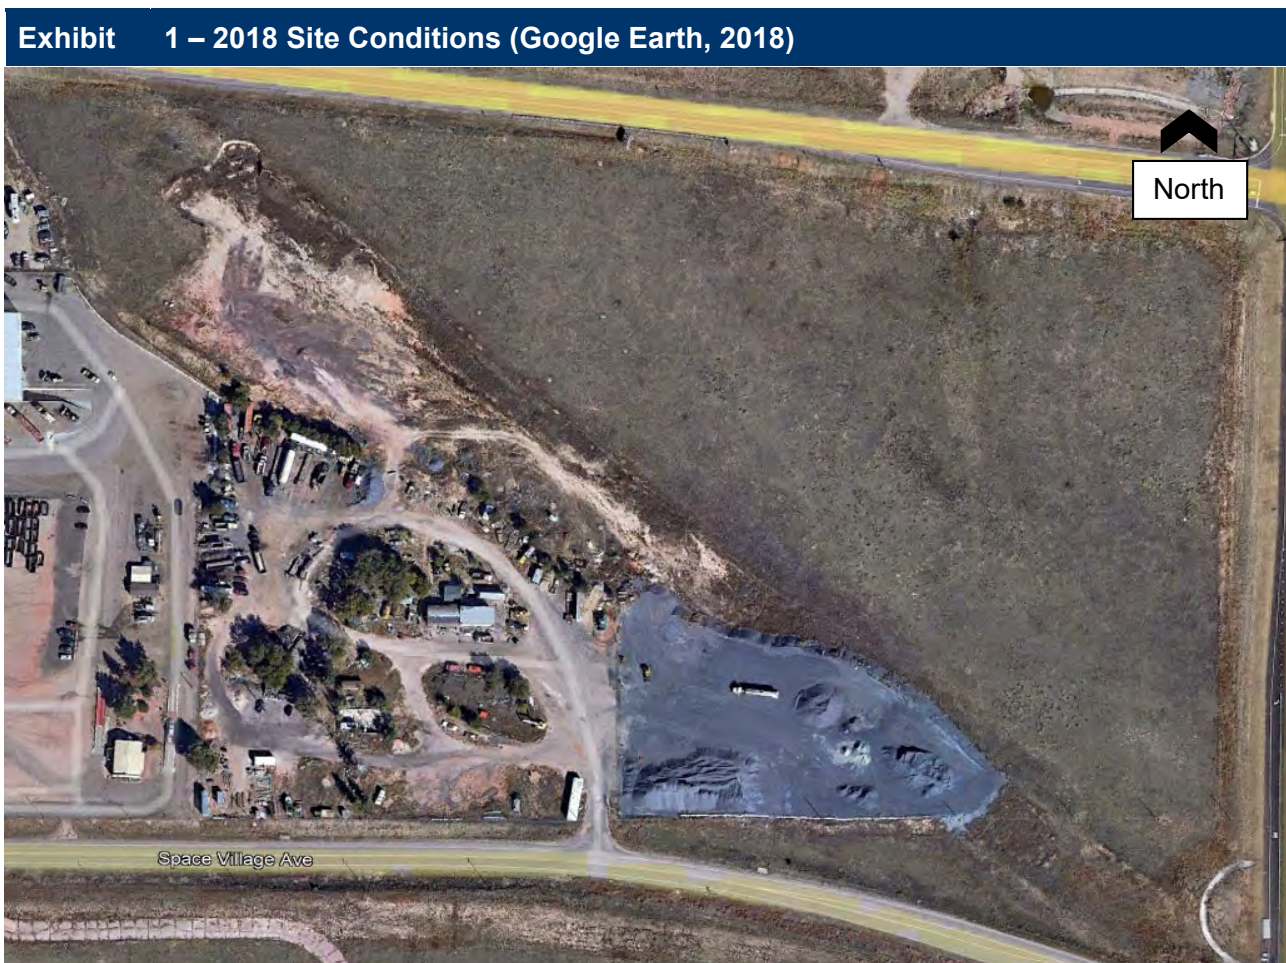
Publicly available historical aerial photographs indicated that between 1999 and 2022, the southwest half of the site was occupied by several structures, stockpiled material, parked vehicles, and apparent refuse. Public aerial photographs prior to 1999 were not available for review. The below exhibit depicts the site in 2018. Ninyo & Moore opines that the dark gray material seen near the southeast corner of the site are asphalt millings.

Aerial photographs between 2020 and 2022 indicate the millings were removed from the site. Since 2022, the project site has maintained a consistent condition.
