ENTECH
ENGINEERING, INC.

September 22, 2021
Revised November 16, 2023

Re: Soil, Geology and Geologic Hazard Evaluation
Joyful View Subdivision
Joyful View & Peyton Highway
Schedule Nos. 33000-00-466 & 33000-00-467
El Paso County, Colorado

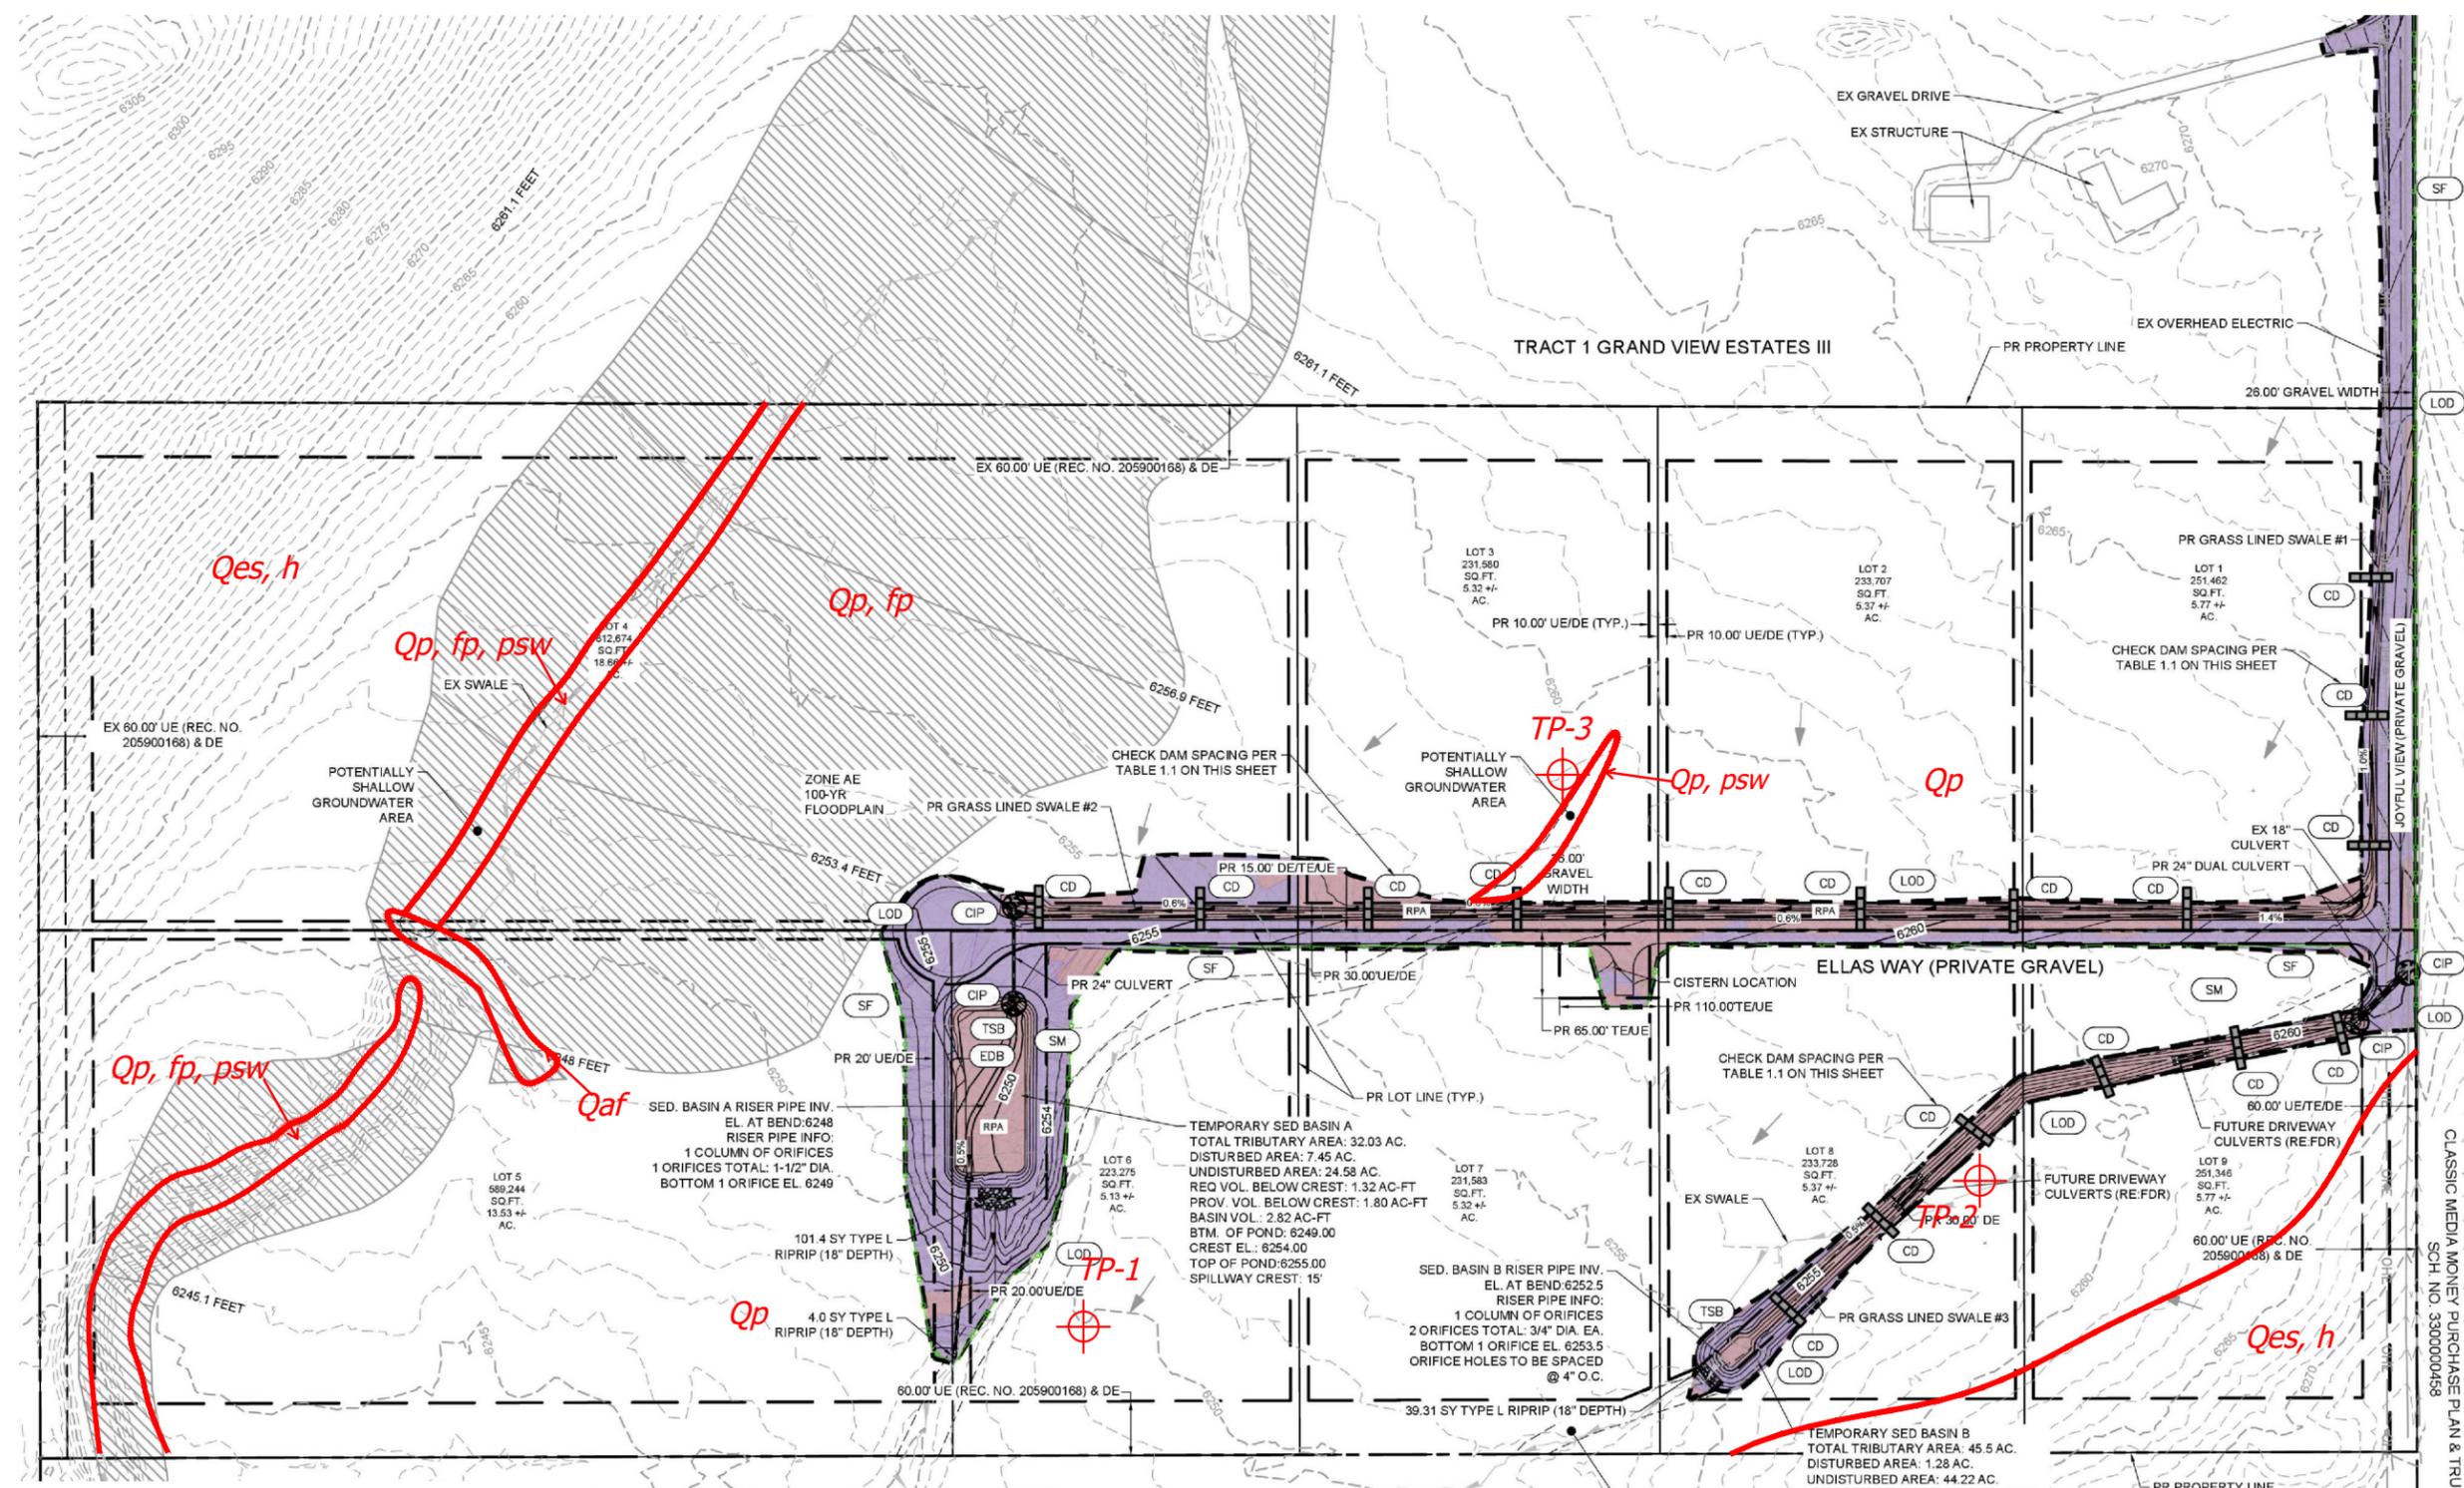
FIG. 6A

Based on the proposed grading and erosion control plan shown on Figure 6A, the majority of the potentially seasonal shallow groundwater areas will be mitigated with the anticipated drainage improvements and grading. However, there is an area in the northeast portion of Lot 3 that will still have the potential for seasonal shallow groundwater.

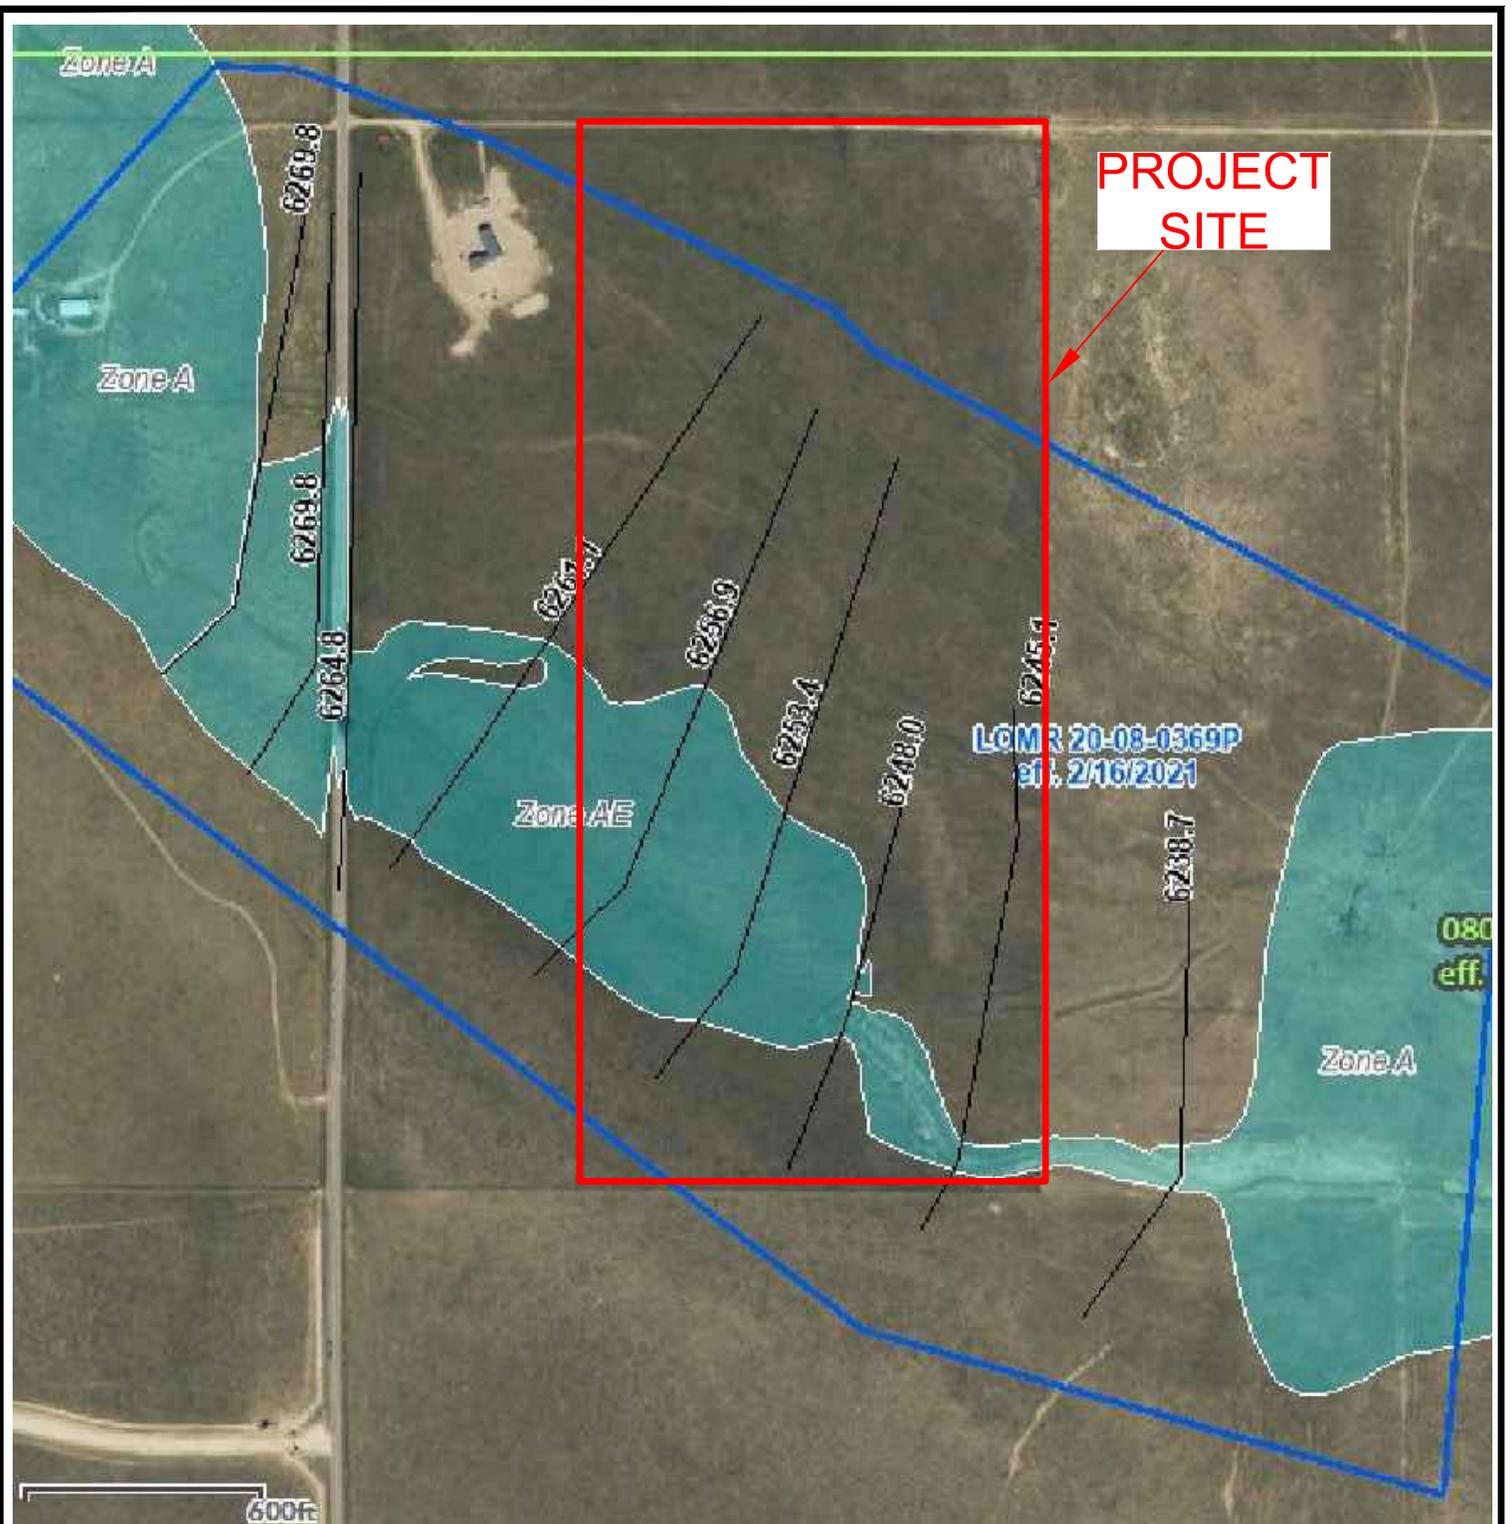
FIG. 7

The southern portion of the site lies within a mapped floodplain zone according to the FEMA Map No. 08041CO805G dated December 7, 2018 (Figure 7, Reference 7). The floodplains area located in no-build area and will be avoided by future development on the lots. Finished floor levels must be a minimum of one foot above the floodplain level. Exact locations of floodplain and specific drainage studies are beyond the scope of this report.
