**Stormwater Management Plan  
for  
Forest Heights Properties  
Didleau Subdivision**

Project Number  
2019.25

EPC Project No MS-206

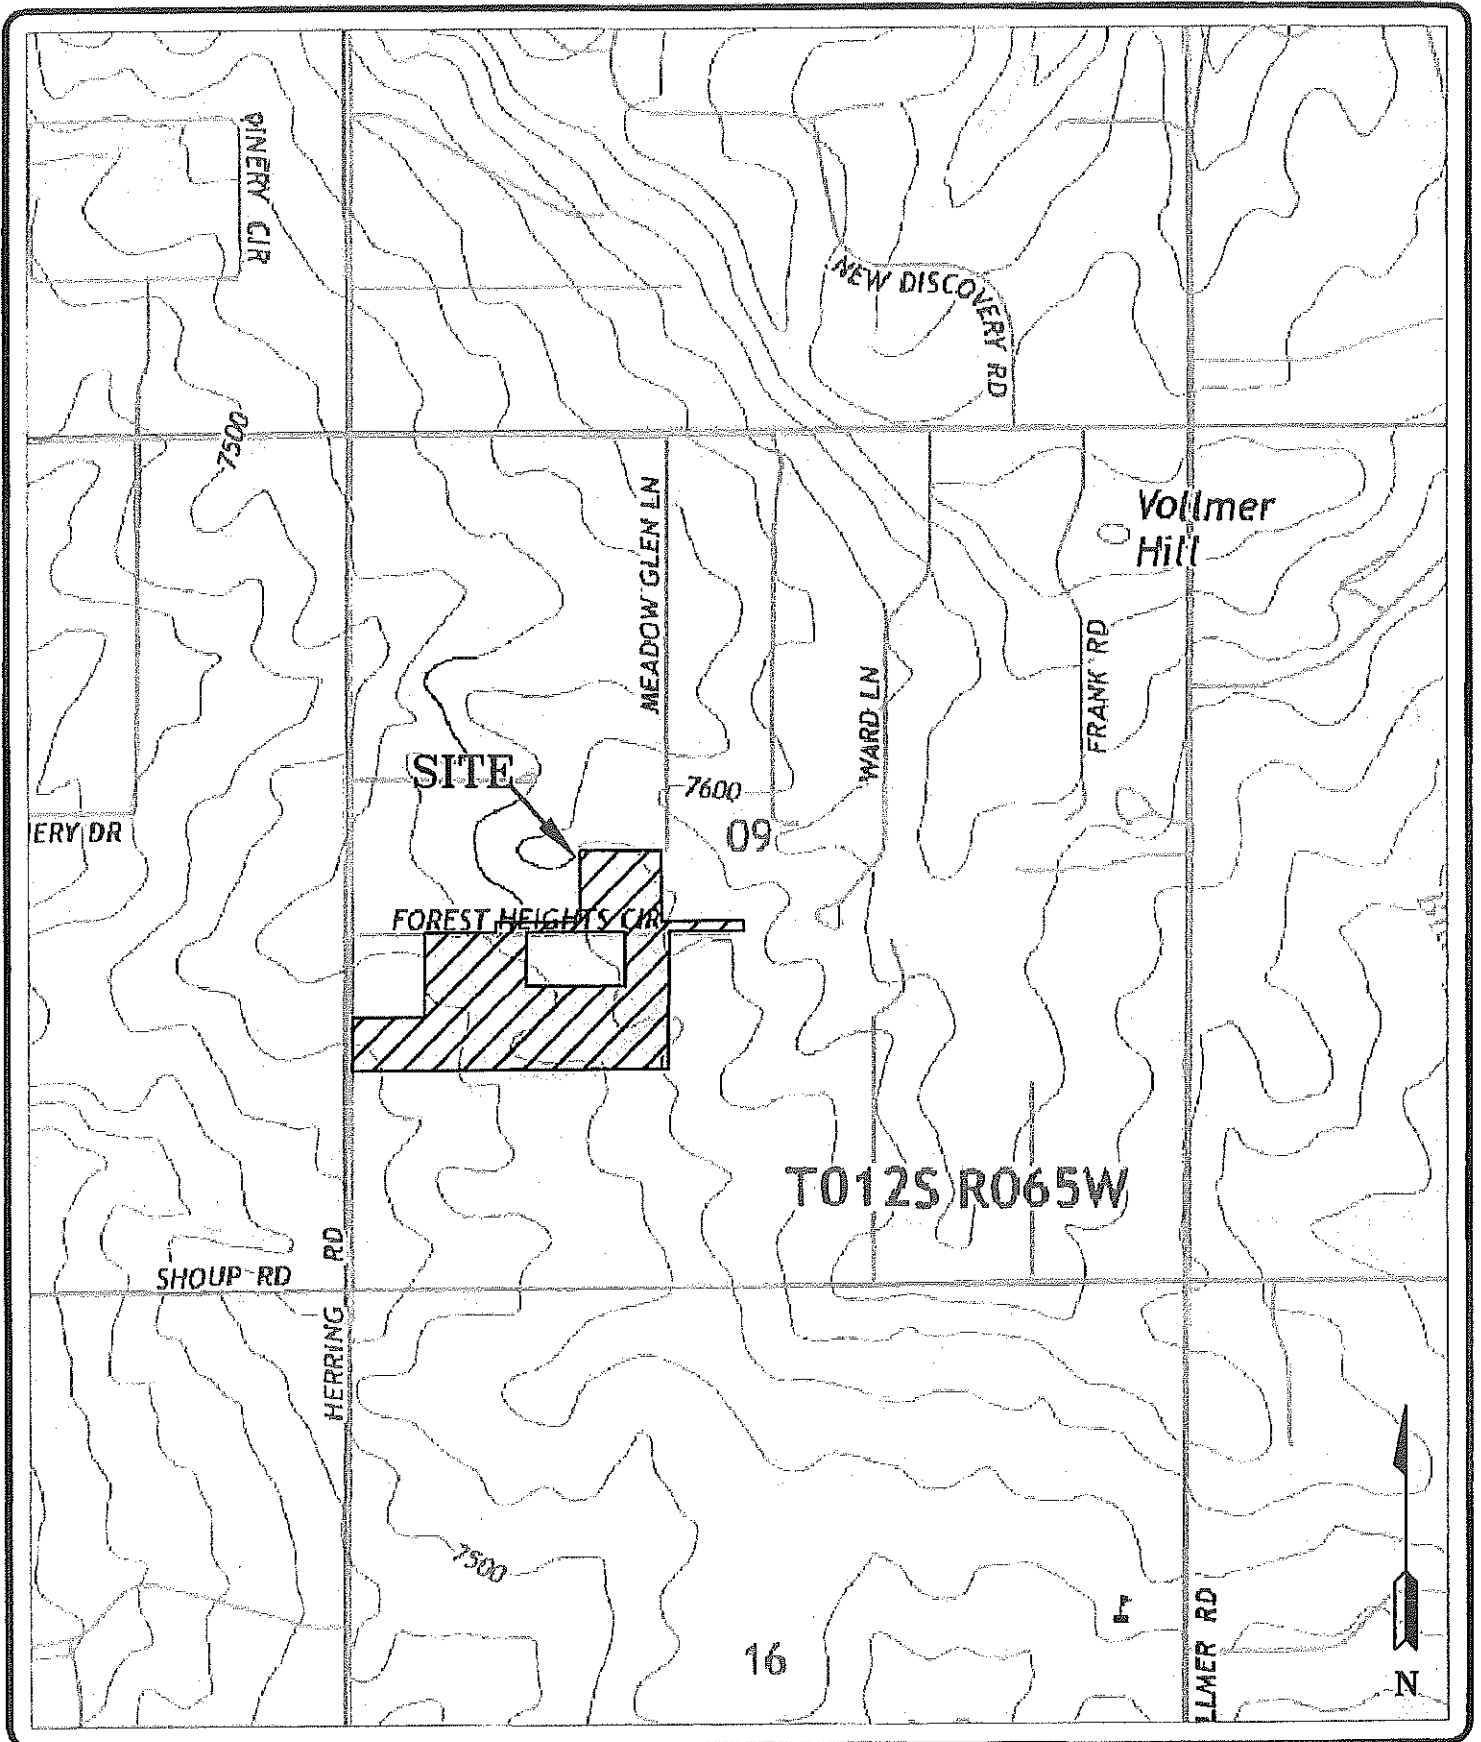
FIG NO.:  
 1

USGS MAP  
 DIDLEAU SUBDIVISION  
 HERRING ROAD & FOREST HEIGHTS CIRCLE  
 PASO COUNTY, CO.  
 FOR: LDC, INC.

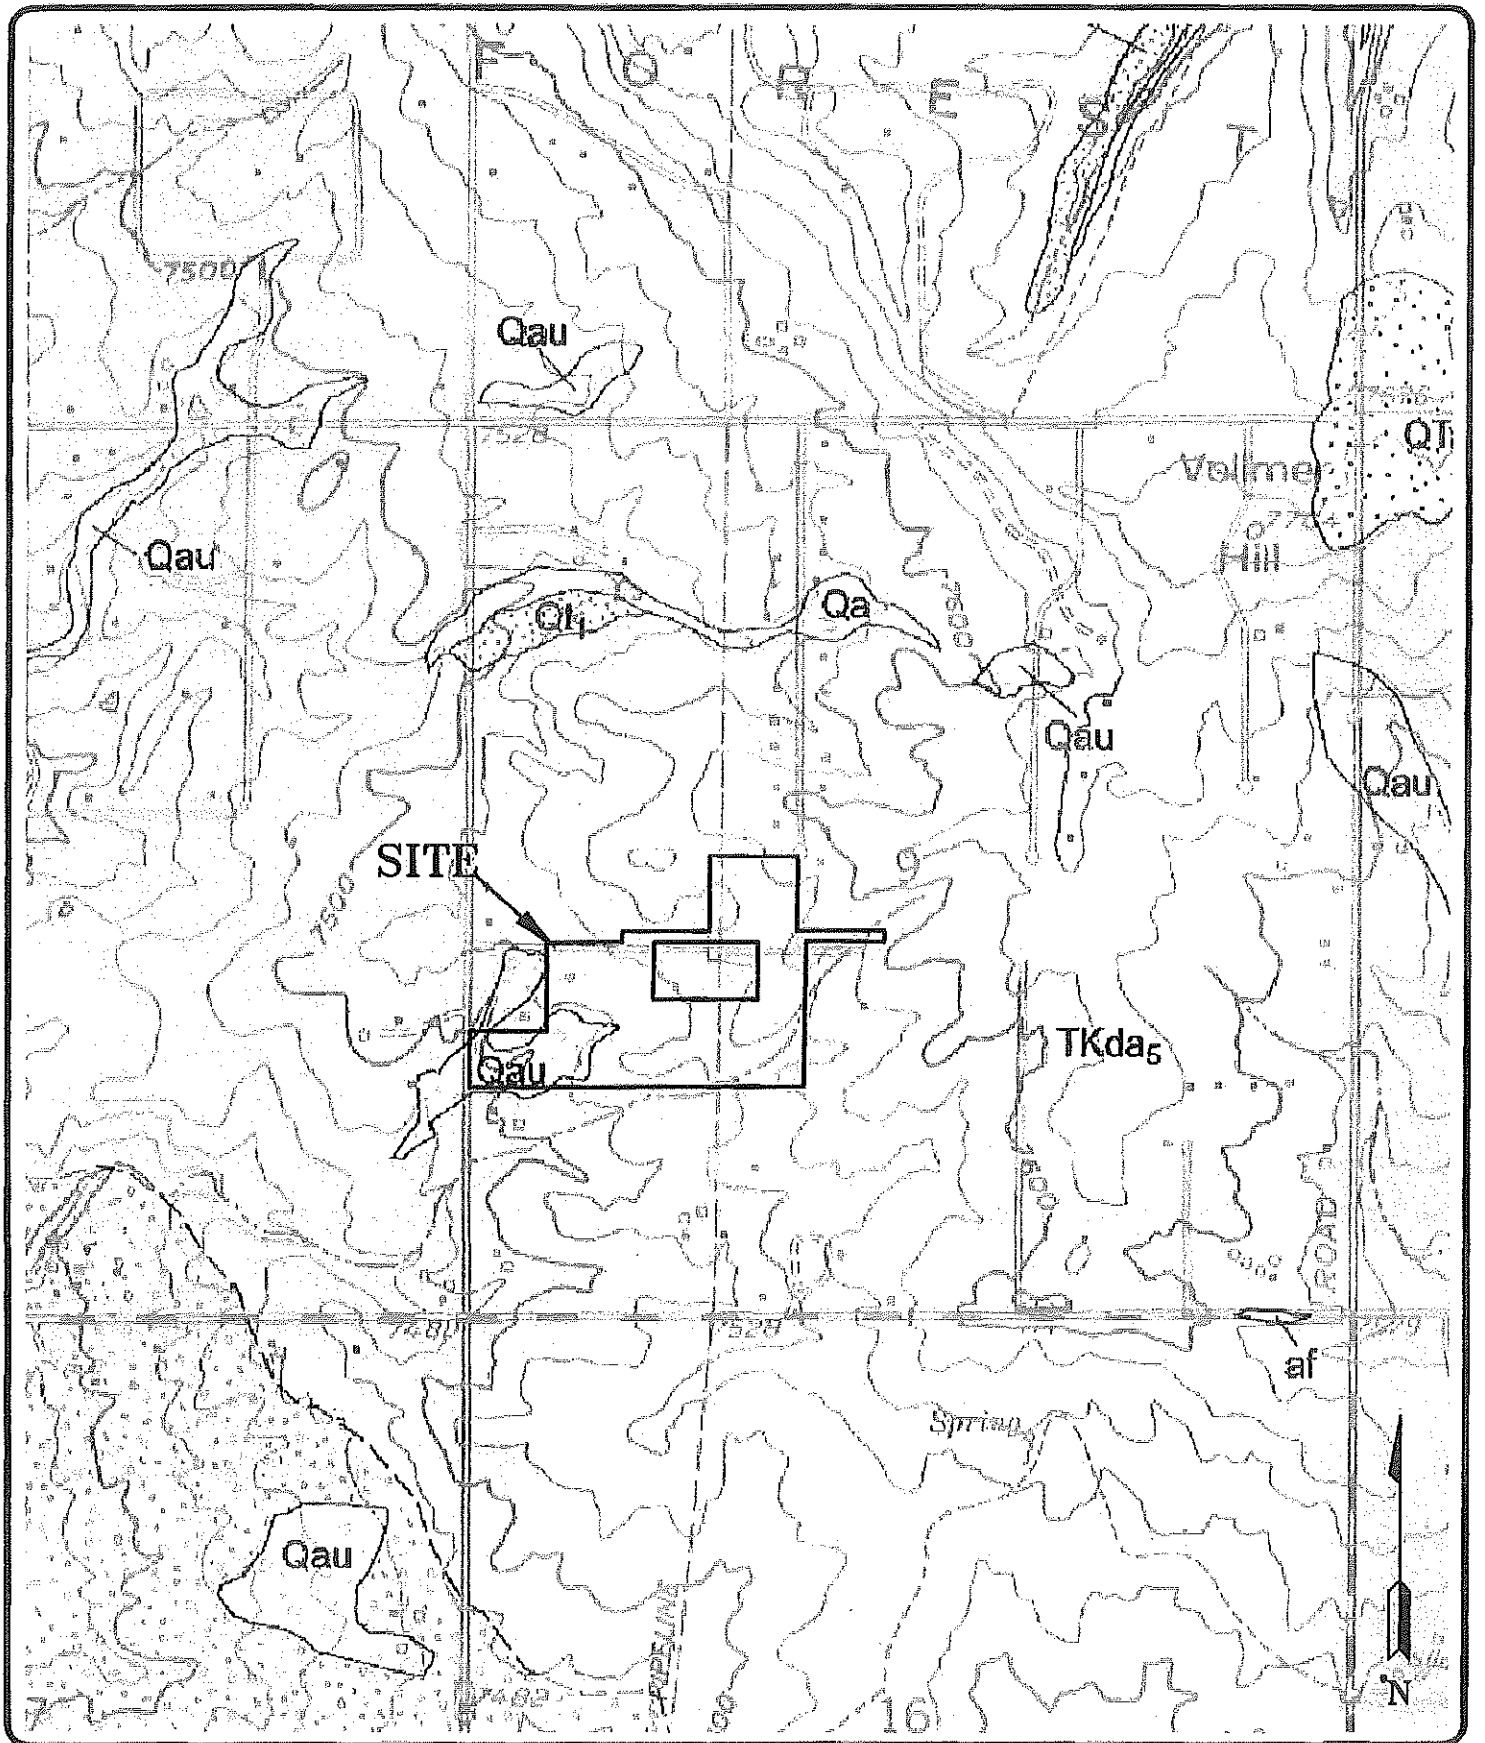
FIG NO.:  
 4

**BLACK FOREST QUADRANGLE GEOLOGIC MAP**  
**DIDLEAU SUBDIVISION**  
**HERRING ROAD & FOREST HEIGHTS CIRCLE**  
**EL PASO COUNTY, CO.**  
**FOR: LDC, INC.**

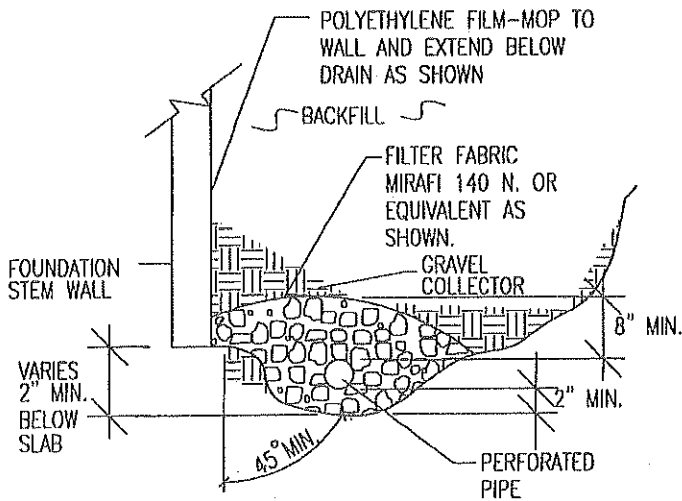
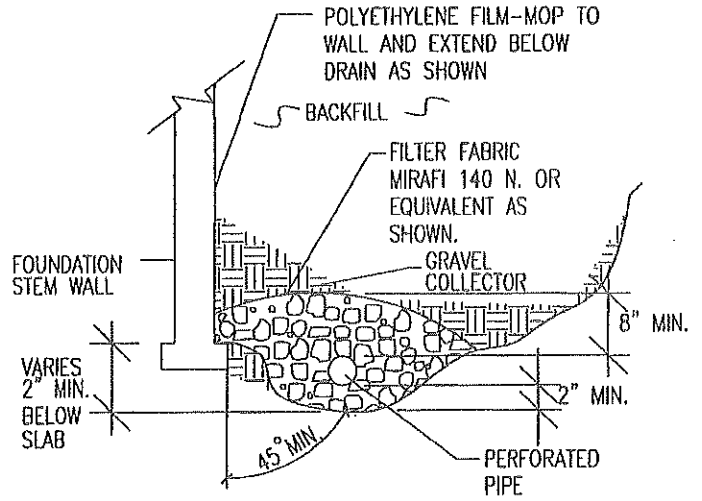
NOTES:

-GRAVEL SIZE IS RELATED TO DIAMETER OF PIPE PERFORATIONS-85% GRAVEL GREATER THAN 2x PERFORATION DIAMETER.

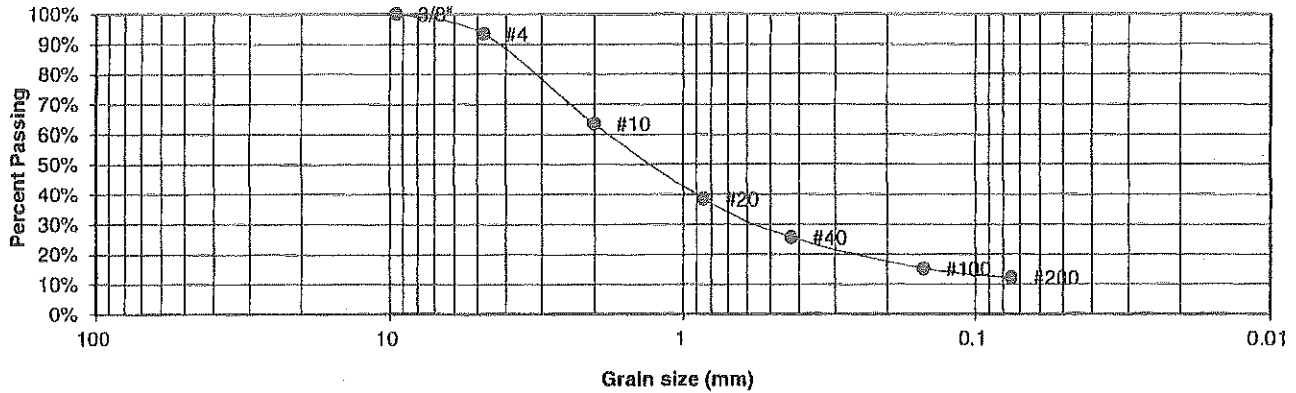
FIG NO.:  
C-1

<b>UNIFIED CLASSIFICATION</b>	SM	<b>CLIENT</b>	LDC, INC.
<b>SOIL TYPE #</b>	1	<b>PROJECT</b>	DIDLEAU SUBDIVISION
<b>TEST BORING #</b>	1	<b>JOB NO.</b>	192115
<b>DEPTH (FT)</b>	2-3	<b>TEST BY</b>	BL

**Sieve Analysis  
Grain Size Distribution**

U.S. Sieve #	Percent Finer
3"	
1 1/2"	
3/4"	
1/2"	
3/8"	100.0%
4	93.4%
10	63.6%
20	38.4%
40	25.6%
100	15.1%
200	12.2%

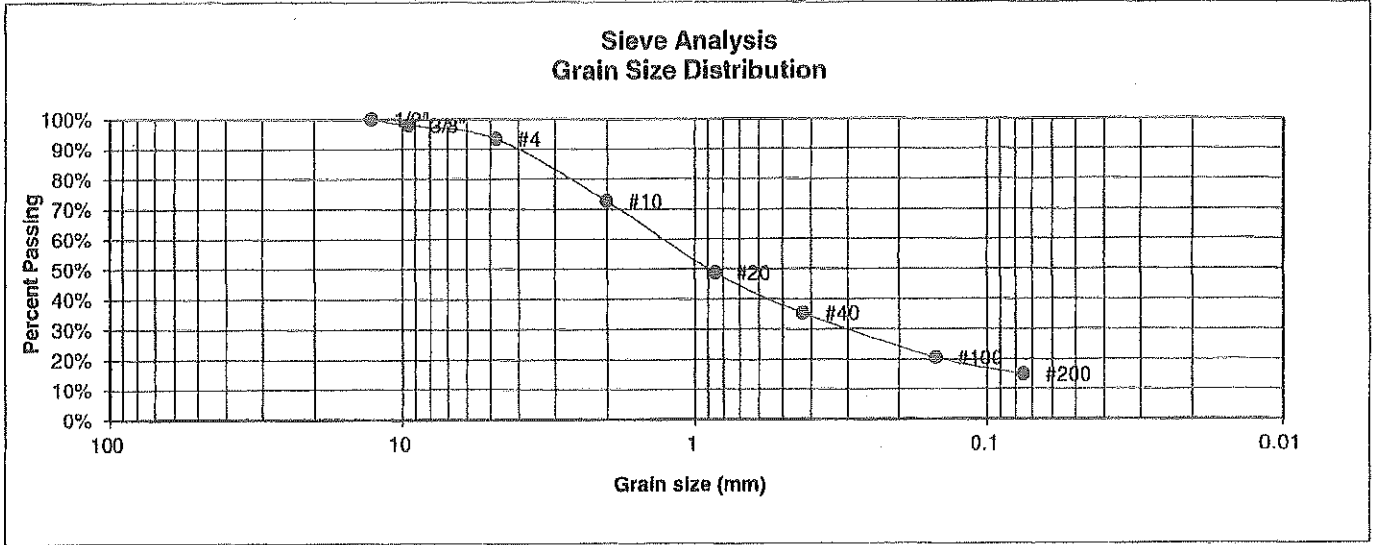
FIG NO.:  
C3

<b>UNIFIED CLASSIFICATION</b>	SM	<b>CLIENT</b>	LDC, INC.
<b>SOIL TYPE #</b>	1	<b>PROJECT</b>	DIDLEAU SUBDIVISION
<b>TEST BORING #</b>	TP-2	<b>JOB NO.</b>	192115
<b>DEPTH (FT)</b>	2-3	<b>TEST BY</b>	BL

U.S. Sieve #	Percent Finer	Atterberg Limits
3"		Plastic Limit
1 1/2"		Liquid Limit
3/4"		Plastic Index
1/2"	100.0%	
3/8"	97.9%	
#4	93.3%	
#10	72.7%	
#20	48.7%	
#40	35.2%	
#100	20.5%	
#200	14.9%

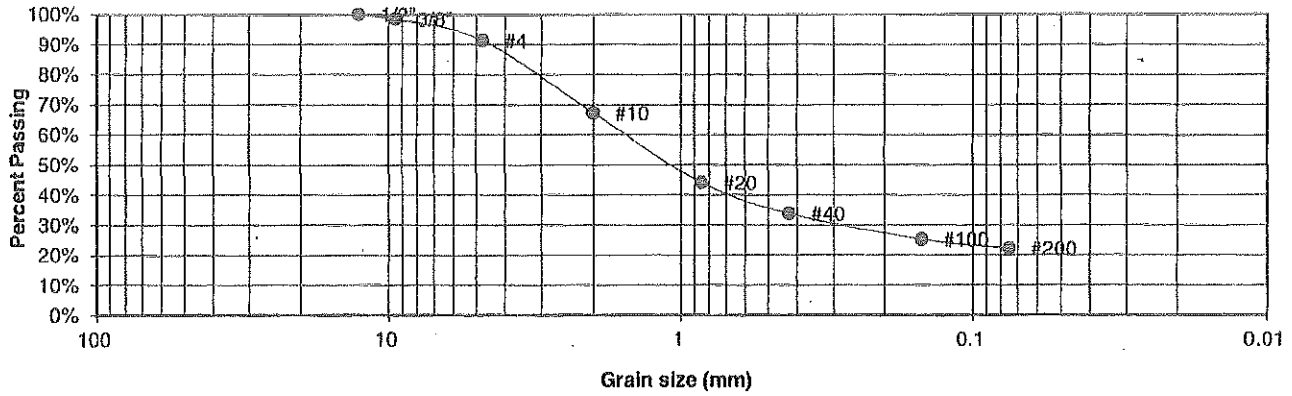
FIG NO.:  
C-5

<b>UNIFIED CLASSIFICATION</b>	SM	<b>CLIENT</b>	LDC, INC.
<b>SOIL TYPE #</b>	2	<b>PROJECT</b>	DIDLEAU SUBDIVISION
<b>TEST BORING #</b>	1	<b>JOB NO.</b>	192115
<b>DEPTH (FT)</b>	15	<b>TEST BY</b>	BL

**Sieve Analysis  
Grain Size Distribution**

U.S. Sieve #	Percent Finer
3"	
1 1/2"	
3/4"	
1/2"	100.0%
3/8"	98.4%
4	91.4%
10	67.2%
20	44.1%
40	33.8%
100	25.2%
200	22.2%

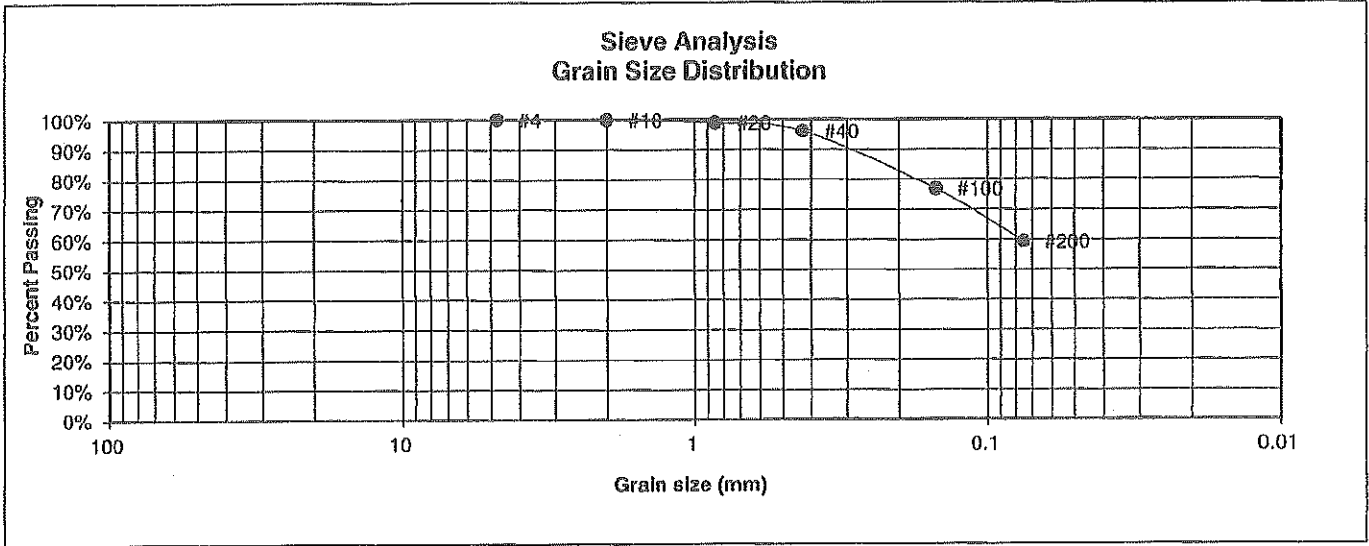
FIG NO.:  
*C-6*

<b>UNIFIED CLASSIFICATION</b>	CL	<b>CLIENT</b>	LDC, INC.
<b>SOIL TYPE #</b>	3	<b>PROJECT</b>	DIDLEAU SUBDIVISION
<b>TEST BORING #</b>	2	<b>JOB NO.</b>	192115
<b>DEPTH (FT)</b>	10	<b>TEST BY</b>	BL

U.S. Sieve #	Percent Finer
3"	
1 1/2"	
3/4"	
1/2"	
3/8"	
4	100.0%
10	99.8%
20	98.9%
40	96.1%
100	76.9%
200	59.3%

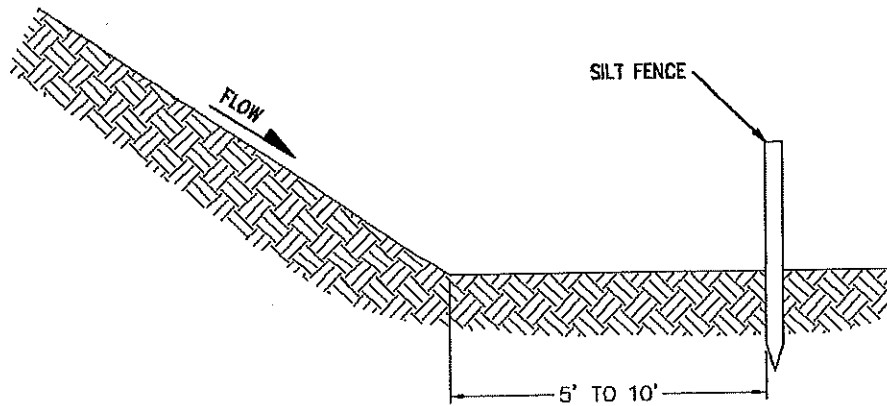
SECTION A-A

## TOE OF SLOPE PROTECTION

1. SILT FENCE SHALL HAVE A MAXIMUM DRAINAGE AREA OF ONE-QUARTER ACRE PER 100 FEET OF SILT FENCE LENGTH; MAXIMUM SLOPE LENGTH BEHIND BARRIER IS 100 FEET; MAXIMUM GRADIENT BEHIND THE BARRIER IS 2:1.
2. SILT FENCE USED AT TOE OF SLOPE SHALL BE PLACED 5 TO 10 FEET BEYOND TOE OF SLOPE TO PROVIDE STORAGE CAPACITY.
3. SILT FENCE SHALL BE PLACED ON THE CONTOUR, WITH ENDS FLARED UP SLOPE.

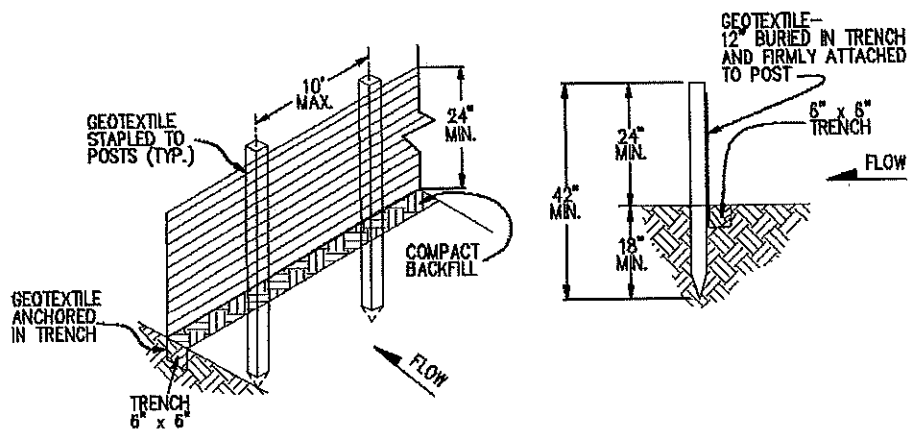
## SILT FENCE

GEOTEXTILE SHALL BE ATTACHED TO WOOD POSTS WITH THREE OR MORE STAPLES PER POST.  
 STAPLES SHALL BE 1/2"  
 WOOD POST SHALL BE 1 1/2" x 1 1/2" NOMINAL

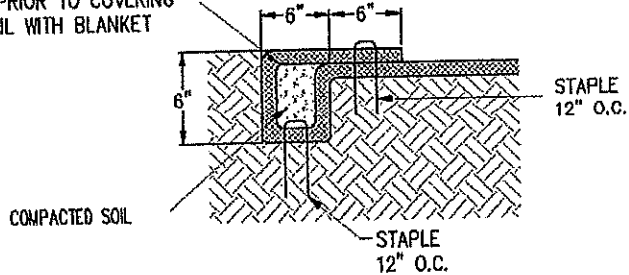
**ANCHOR TRENCH  
SECTION A**

TO BE USED AT THE BEGINNING AND END  
OF THE CHANNEL ACROSS IT'S ENTIRE WIDTH.

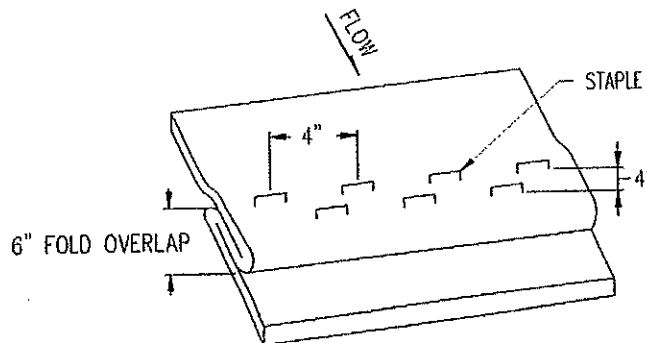
**STAPLE CHECK  
SECTION C**

TO BE USED ON SLOPE EVERY 35 FEET.

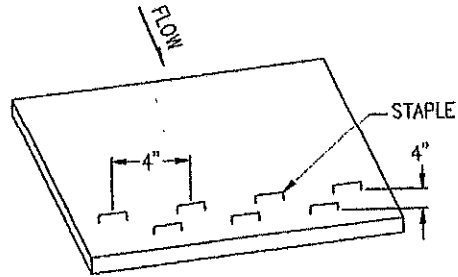
DOWNSLOPE END STAPLE CHECK  
TO BE USED WHEN SLOPE RUNS INTO A RECEIVING WATER  
AND CANNOT BE EXTENDED 3 FEET BEYOND SLOPE.

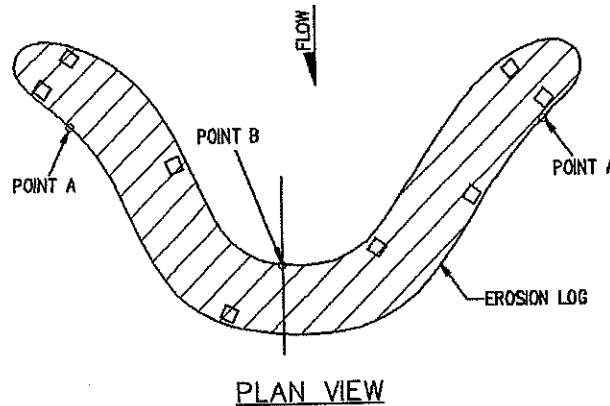
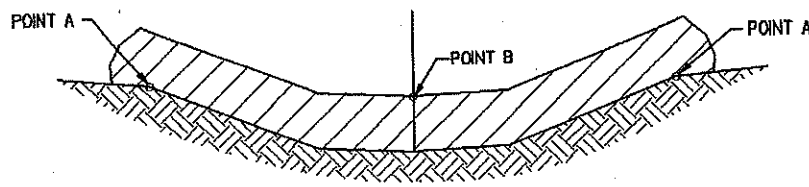
1. EROSION LOGS SHALL BE EMBEDDED 2 INCHES INTO THE SOIL.
2. STAKES SHALL BE EMBEDDED TO A MINIMUM DEPTH OF 12 INCHES.
3. EROSION LOGS SHALL BE TIGHTLY ABUTTED WITH NO GAPS.

### ELEVATION

### EROSION LOG DITCH INSTALLATION

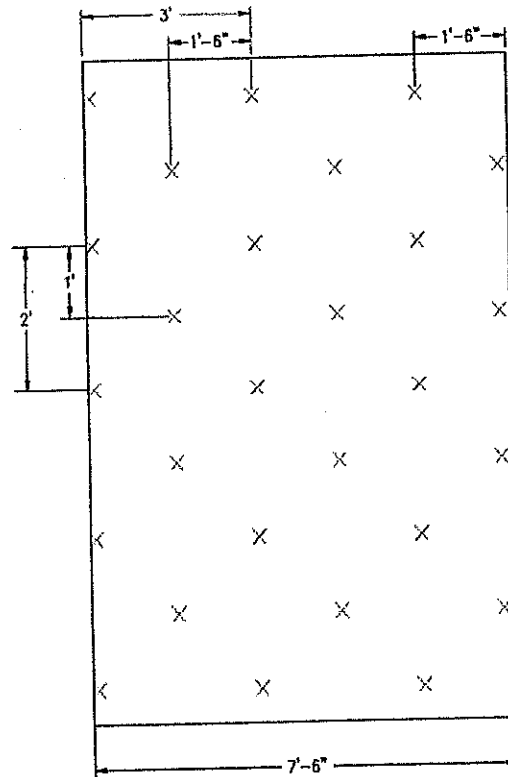
TYPICAL STAPLE PATTERN  
FOR CHANNEL APPLICATION

SEE SUBSECTION 216.05.

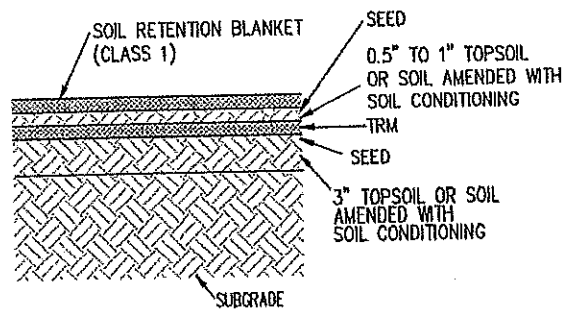
SOIL FILLED TRM APPLICATION

1. PLACE 3" TOPSOIL OR SOIL AMENDED WITH SOIL CONDITIONING.
2. APPLY SEED AND RAKE INTO SOIL.
3. INSTALL TRM.
4. PLACE 0.5" TO 1" TOPSOIL OR SOIL AMENDED WITH SOIL CONDITIONING.
5. APPLY SEED AND RAKE INTO SOIL.
6. INSTALL SOIL RETENTION BLANKET (CLASS 1).

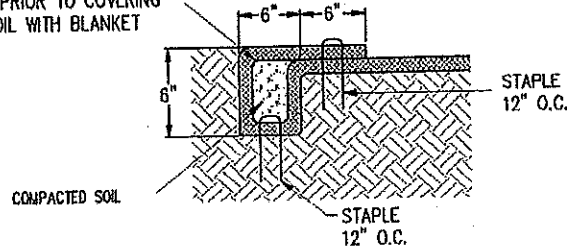
**ANCHOR TRENCH  
SECTION A**

TO BE USED AT THE BEGINNING AND END OF THE CHANNEL ACROSS IT'S ENTIRE WIDTH.

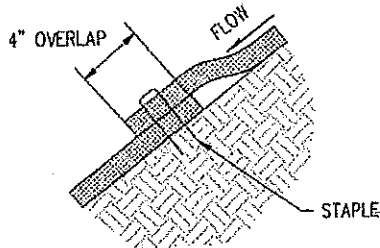
**CONSECUTIVE ROLL OVERLAP  
SECTION B**

TO BE USED WHEREVER ONE ROLL OF BLANKET ENDS AND ANOTHER BEGINS WITH UPSTREAM BLANKET PLACED ON TOP OF THE BLANKET ON THE DOWNSTREAM SIDE.

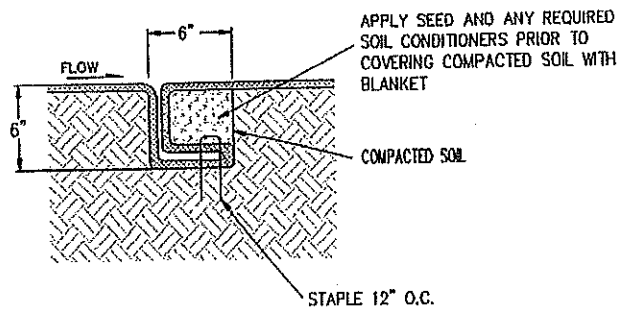
**SIDE SEAM OVERLAP  
SECTION C**

TO BE USED FOR OVERLAP WHEN 2 WIDTHS OF BLANKET ARE APPLIED SIDE BY SIDE WITH THE UPHILL BLANKET PLACED ON TOP OF THE BLANKET ON THE DOWNHILL SIDE.

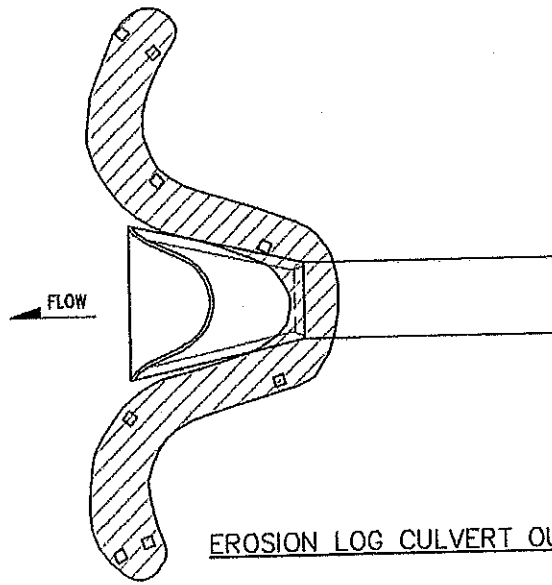
## Outlet Protection

Outlet protection prevents scour and erosion at the outlet of a channel or conduit by reducing the speed of stormwater. Outlet protection is comprised of geotextile fabric and riprap placed at the outlet.

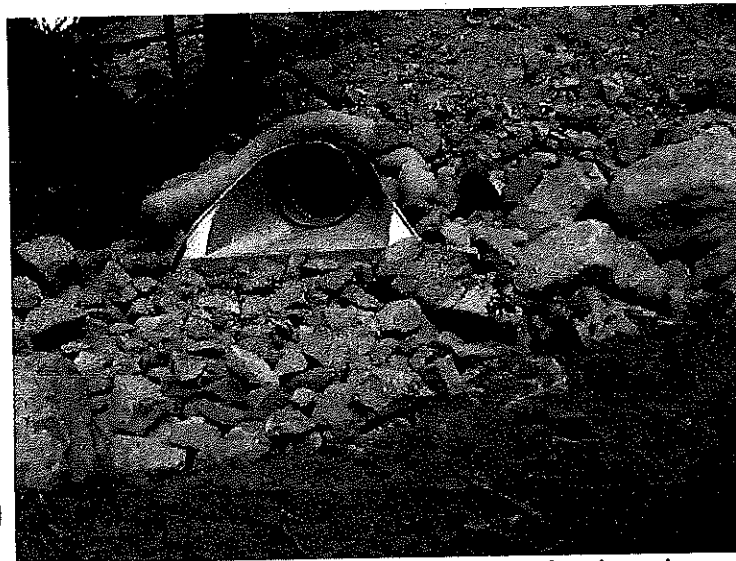
EROSION LOG CULVERT OUTLET PROTECTION

*Good use of rock as outlet protection. The erosion log above the culvert helps prevent debris and dirt from falling into the outlet.*

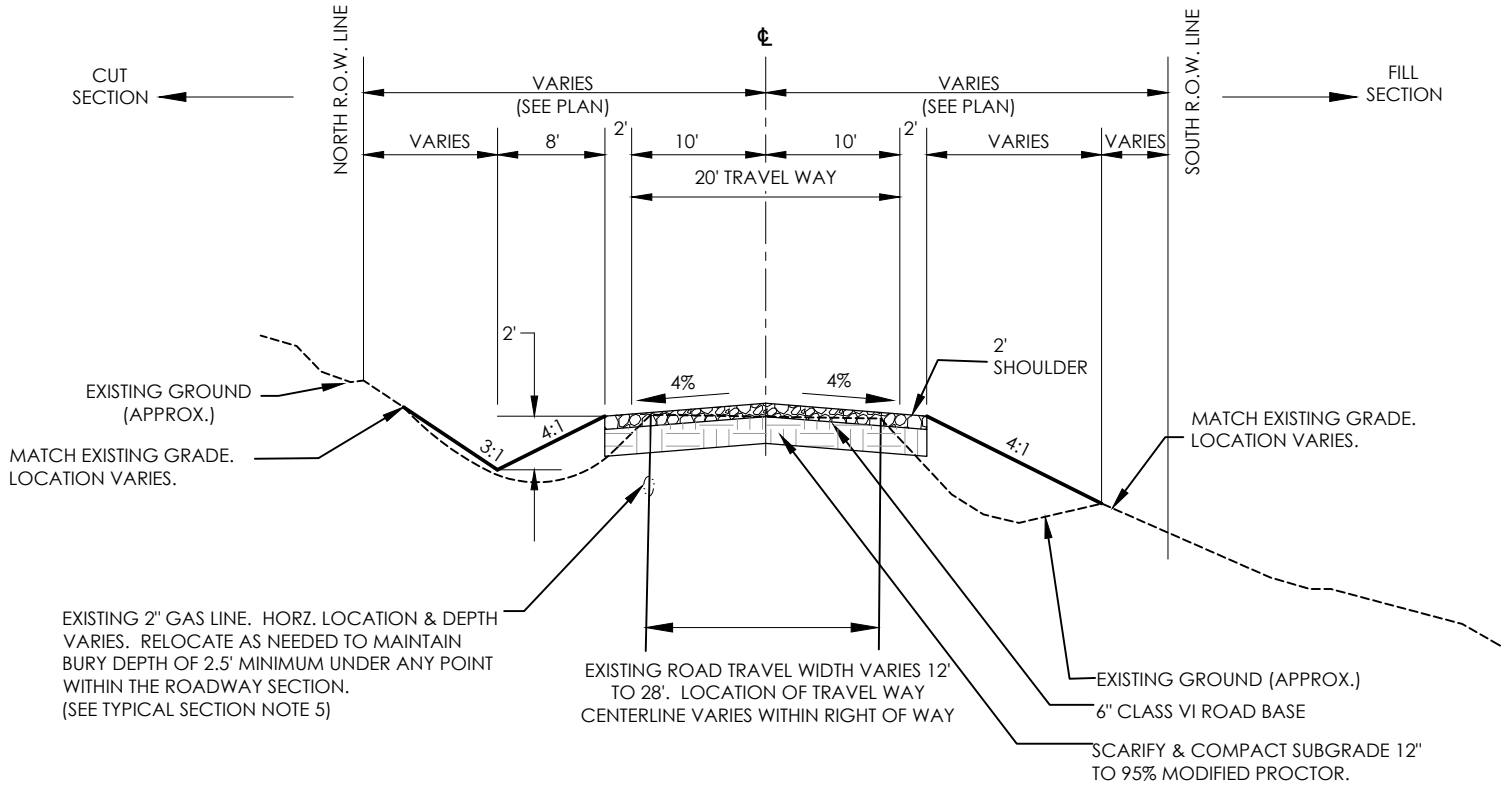
PROPOSED CENTERLINE GRADE PER PROFILE.  
USE EXCAVATED MATERIAL FOR ROAD  
SUBGRADE AS NEEDED.

## TYPICAL PRIVATE RURAL ROADWAY SECTION RURAL GRAVEL LOCAL ROADWAY WITH A DESIGN AND POSTED SPEED OF 20 MPH

SCALE:  
HORIZONTAL SCALE: 1" = 10'  
VERTICAL SCALE: 1" = 5'

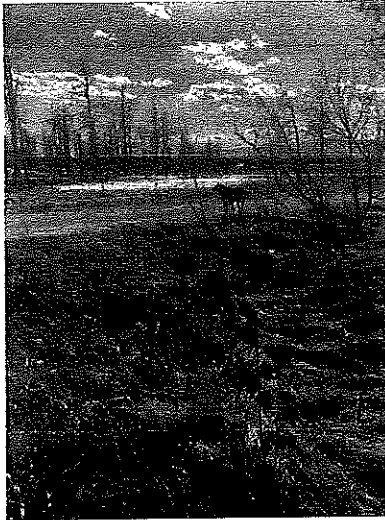
Figure 2: Facing Downstream of Culvert #1

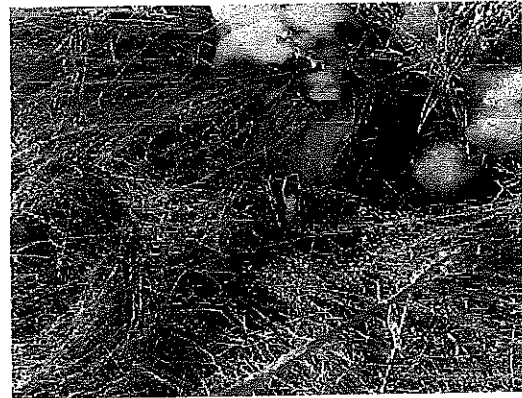
Figure 21: Upstream end of Culvert 2

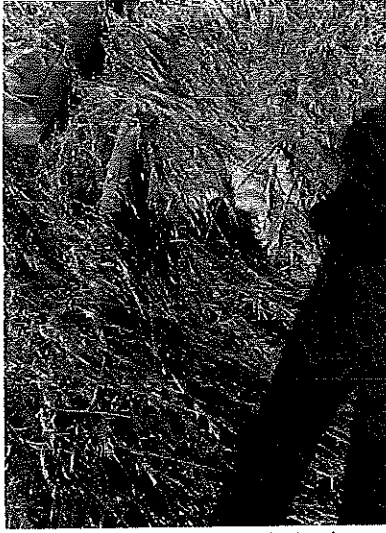
Figure 24: Downstream end of Culvert 2

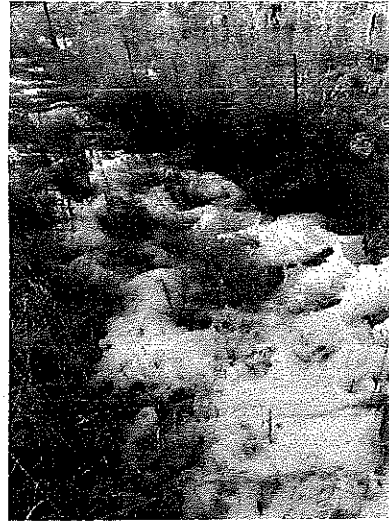
Figure 32: Water routed in northern borrow ditch

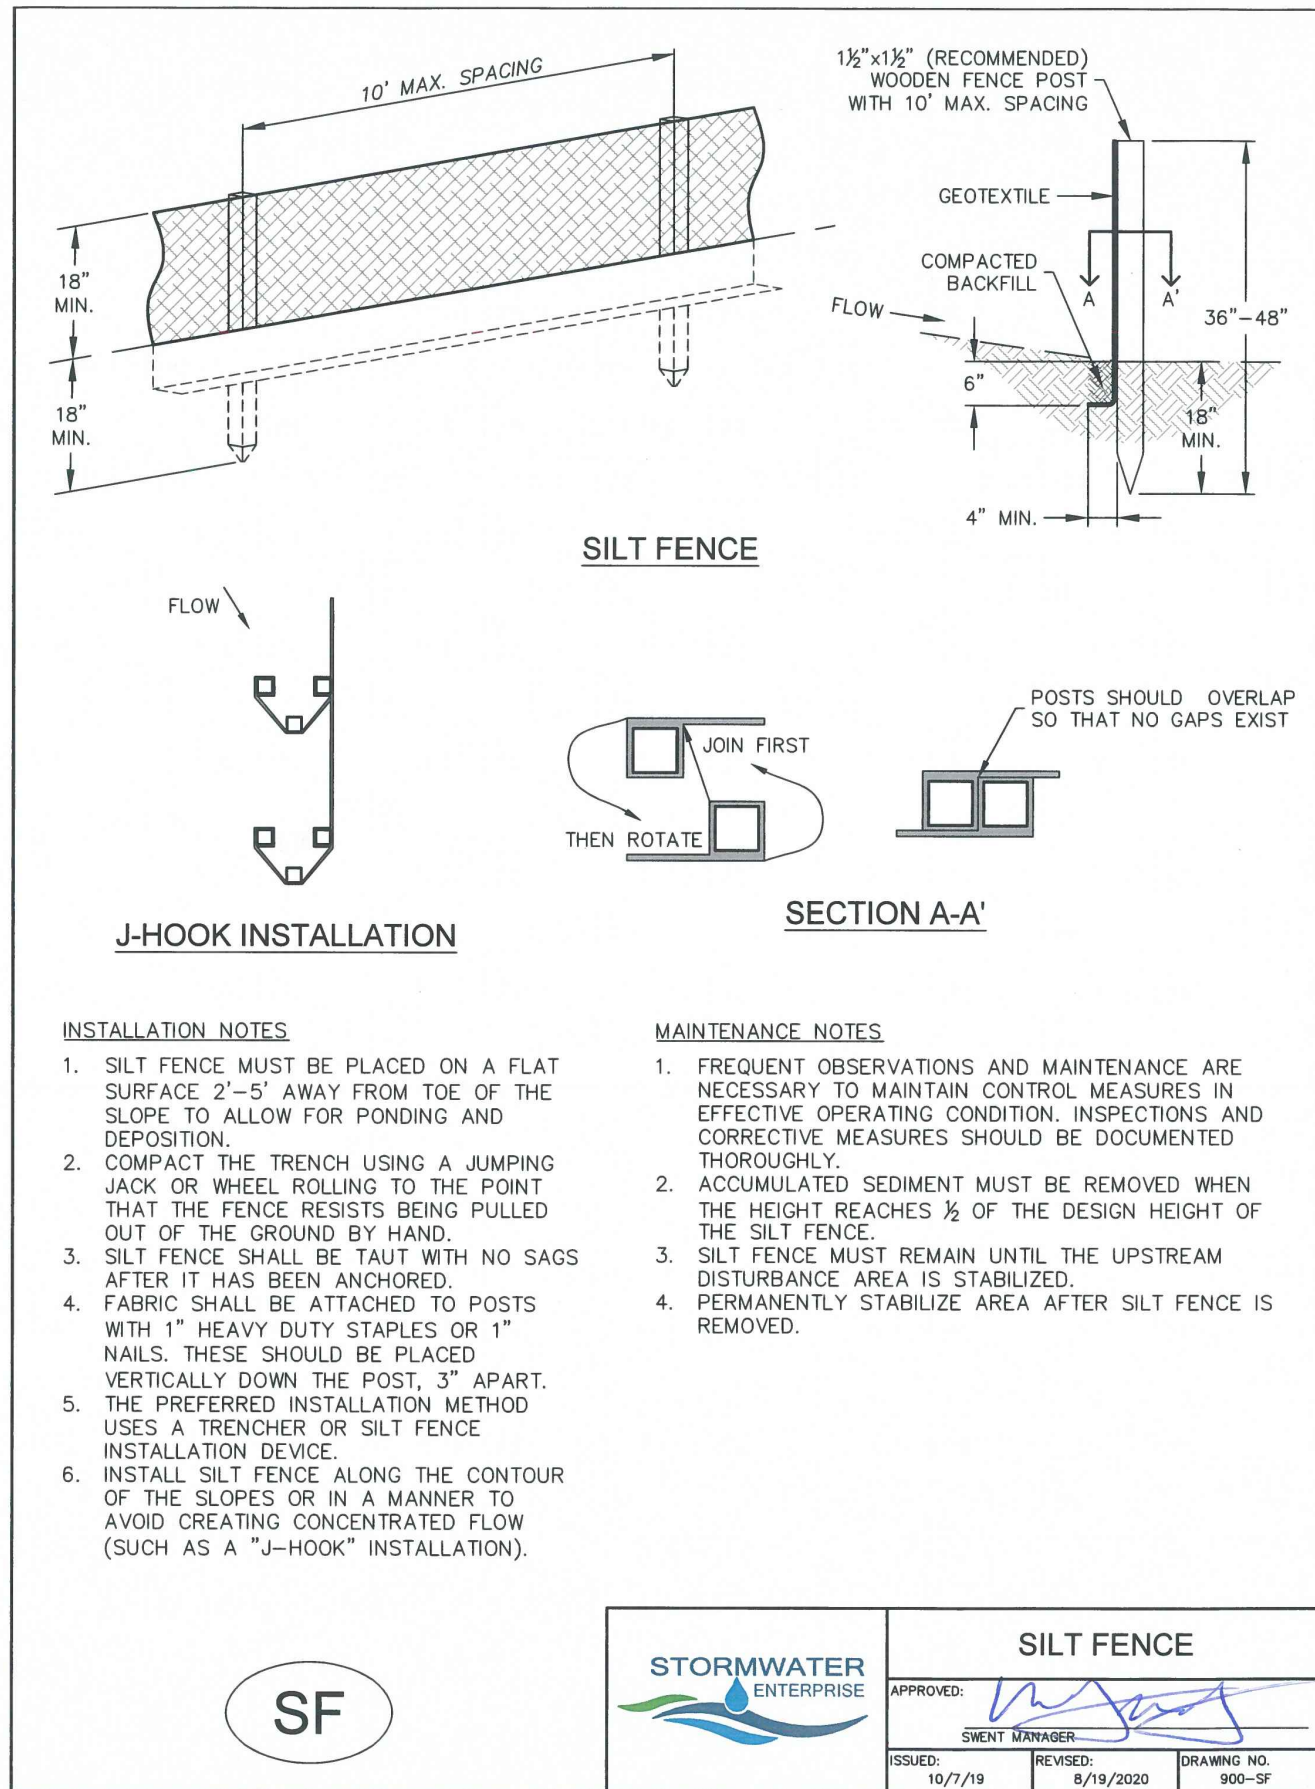
STORMWATER ENTERPRISE		SILT FENCE	
ISSUED: 10/7/19	REVISED: 8/19/2020	DRAWING NO: 900-SF

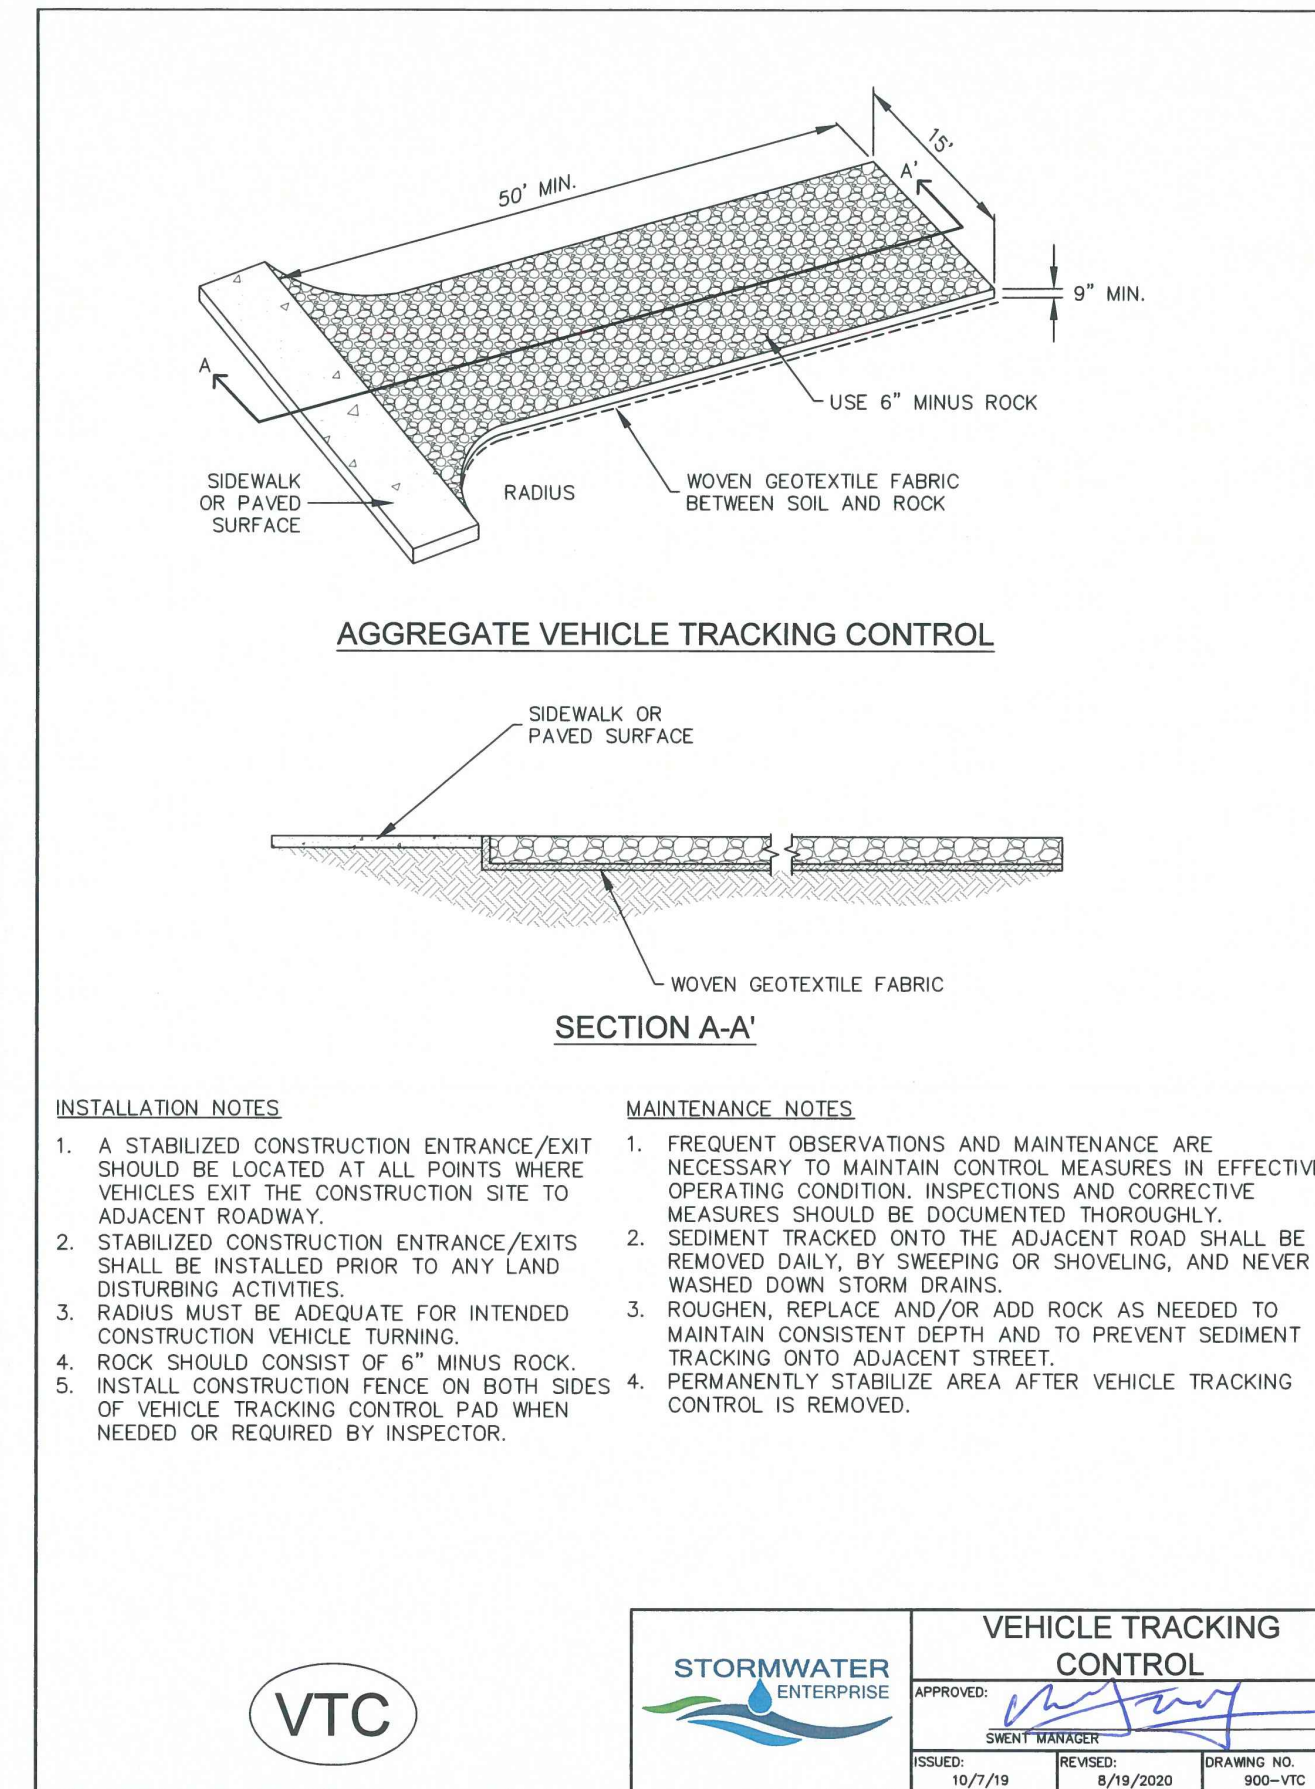
STORMWATER ENTERPRISE		VEHICLE TRACKING CONTROL	
ISSUED: 10/7/19	REVISED: 8/19/2020	DRAWING NO: 900-VTC

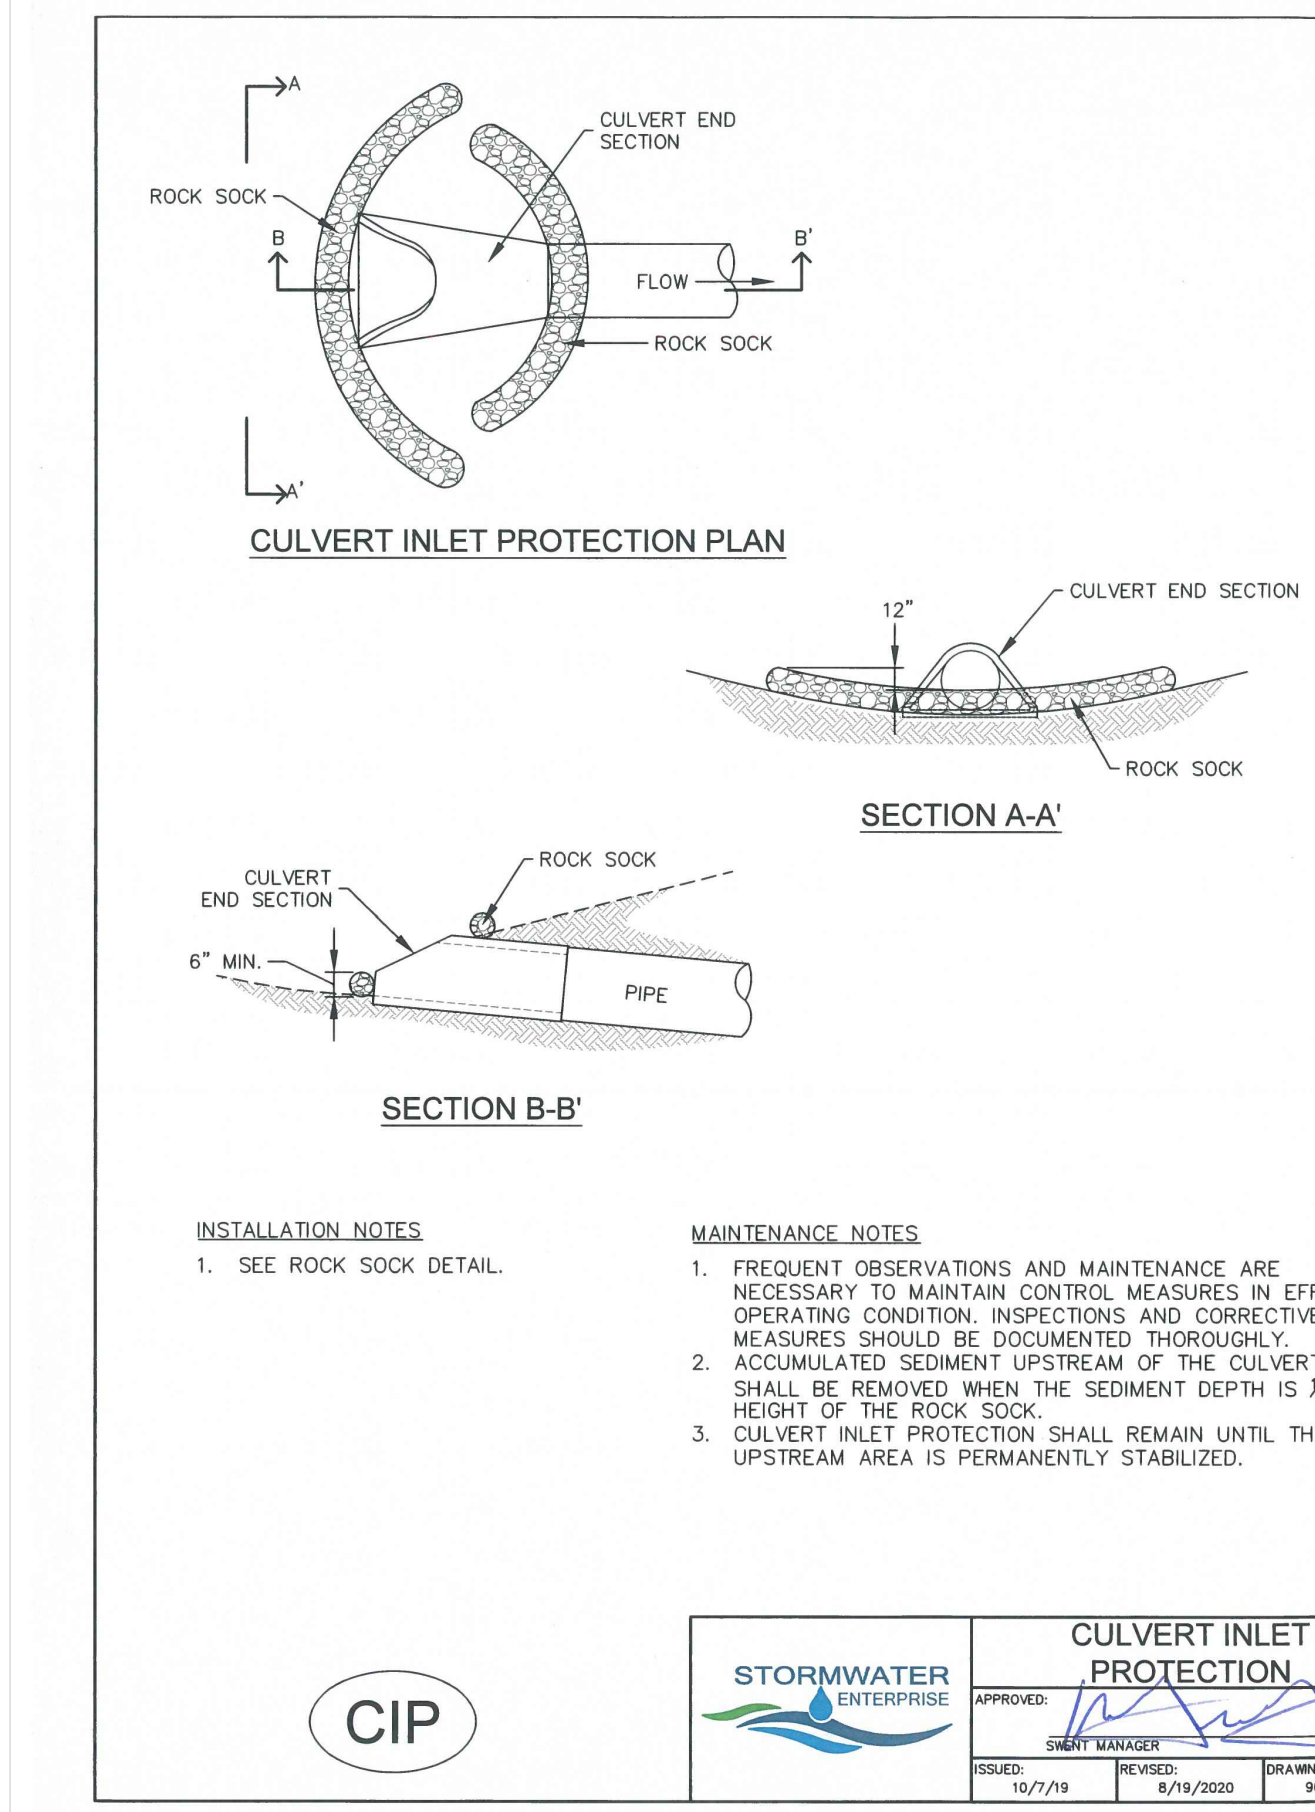
STORMWATER ENTERPRISE		CULVERT INLET PROTECTION	
ISSUED: 10/7/19	REVISED: 8/19/2020	DRAWING NO: 900-CIP
