**Stormwater Management Plan  
for  
Forest Heights Properties  
Didleau Subdivision**

Project Number  
2019.25

EPC Project No MS-206

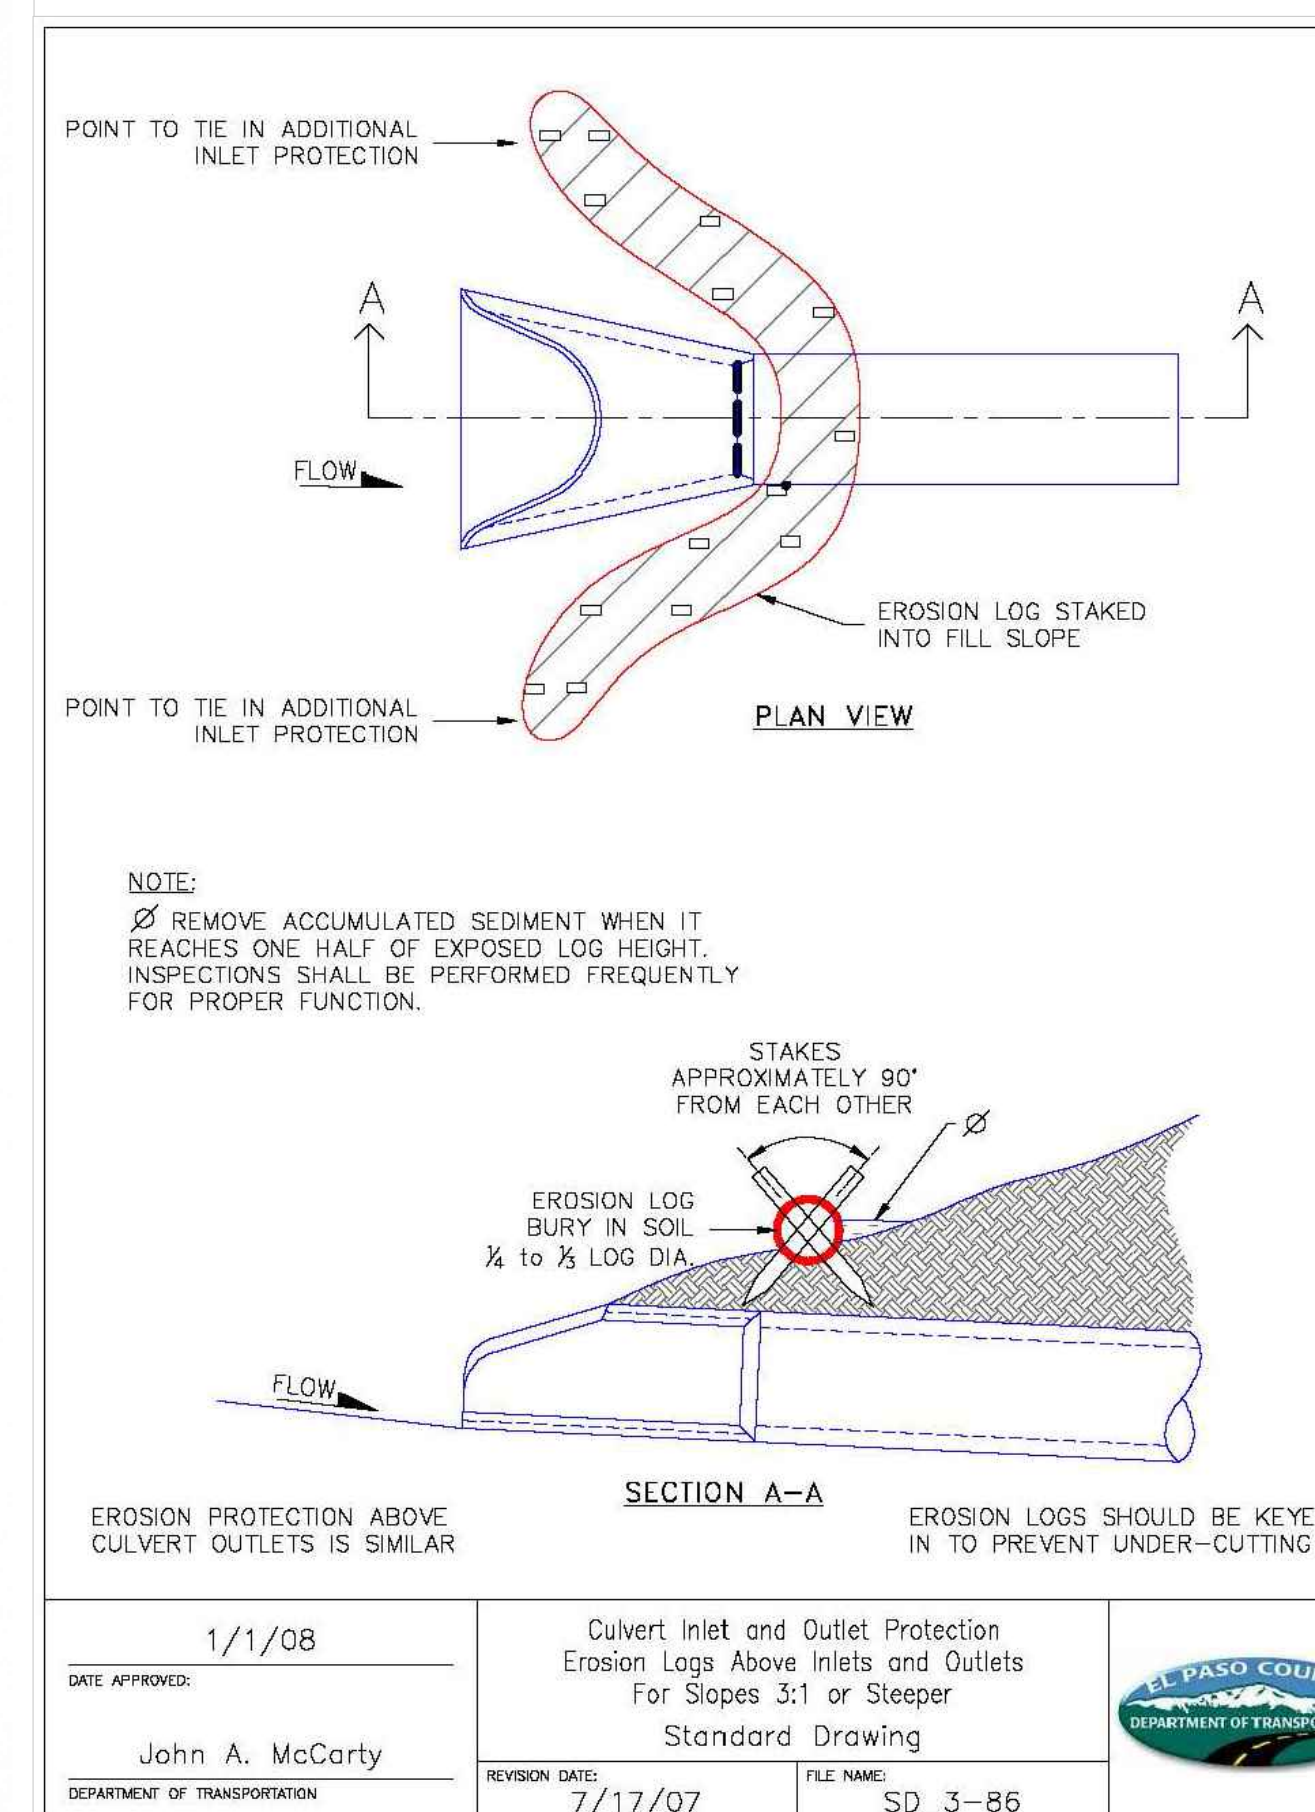
STORMWATER ENTERPRISE		EROSION PROTECTION ABOVE CULVERT OUTLETS	
ISSUED: 10/7/19	REVISED: 8/19/2020	DRAWING NO: 900-EPC

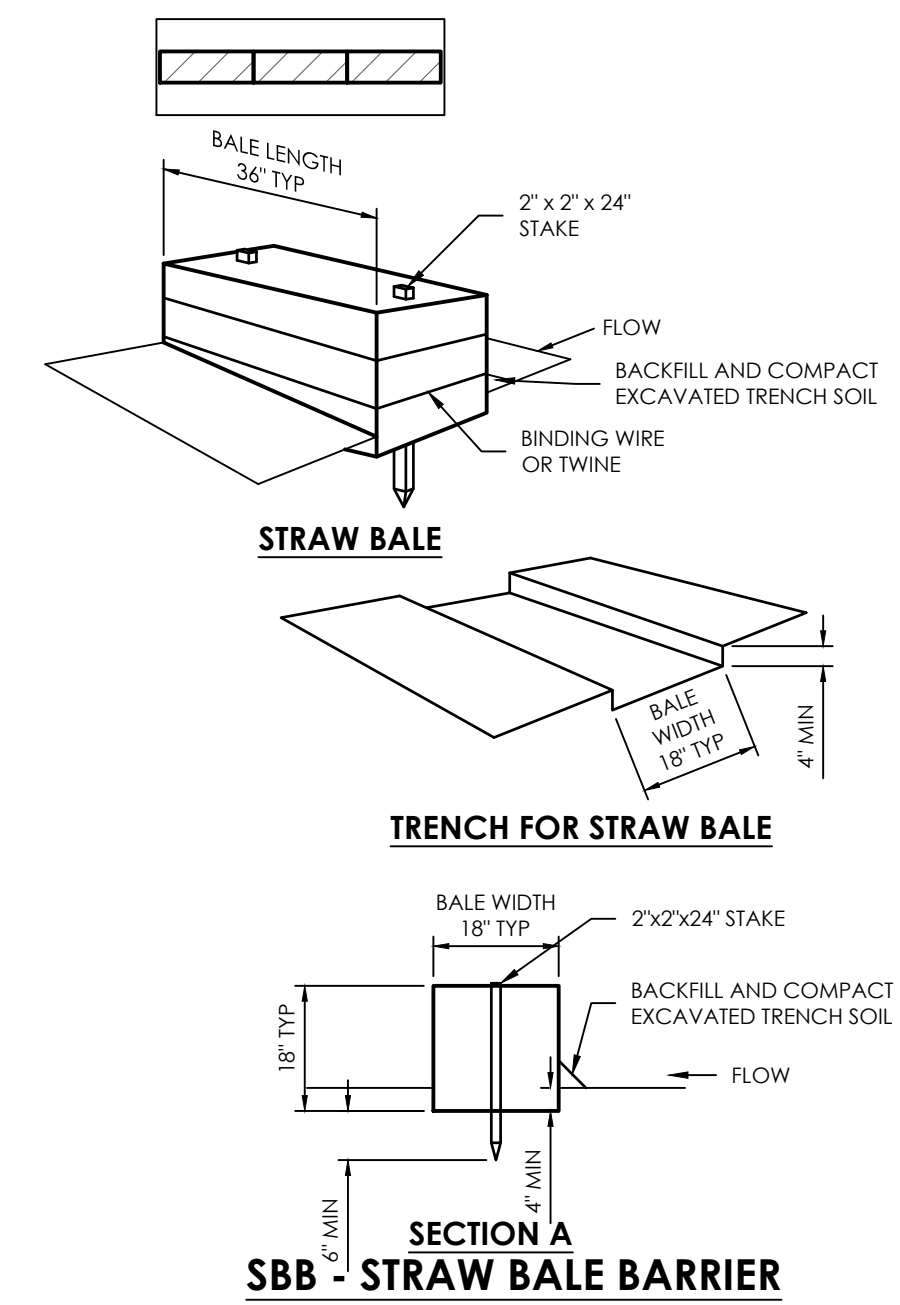
- STRAW BALE INSTALLATION NOTES:**
- SEE PLAN VIEW FOR:
    - LOCATIONS OF STRAW BALES.
  - STRAW BALES SHALL CONSIST OF CERTIFIED WEED FREE STRAW OR HAY. LOCAL JURISDICTIONS MAY REQUIRE PROOF THAT BALES ARE WEED FREE.

- STRAW BALES SHALL CONSIST OF APPROXIMATELY 5 CUBIC FEET OF STRAW OR HAY AND WEIGH NOT LESS THAN 55 POUNDS.
  - WHEN STRAW BALES ARE USED IN SERIES AS A BARRIER, THE END OF EACH BALE SHALL BE TIGHTLY ABUTTING ONE ANOTHER.

- STRAW BALE MAINTENANCE NOTES:**
- INSPECT BMPs EACH WORKDAY, AND MAINTAIN THEM IN EFFECTIVE OPERATING CONDITION. MAINTENANCE OF BMPs SHOULD BE PROACTIVE, NOT REACTIVE. INSPECT BMPs AS SOON AS POSSIBLE (AND ALWAYS WITHIN 24 HOURS) FOLLOWING A STORM THAT CAUSES SURFACE EROSION, AND PERFORM NECESSARY MAINTENANCE.

- SEDIMENT ACCUMULATED UPSTREAM OF STRAW BALE BARRIER SHALL BE REMOVED AS NEEDED TO MAINTAIN FUNCTIONALITY OF THE BMP. TYPICALLY WHEN DEPTH OF ACCUMULATED SEDIMENTS IS APPROXIMATELY 1/2 OF THE HEIGHT OF THE STRAW BALE BARRIER.

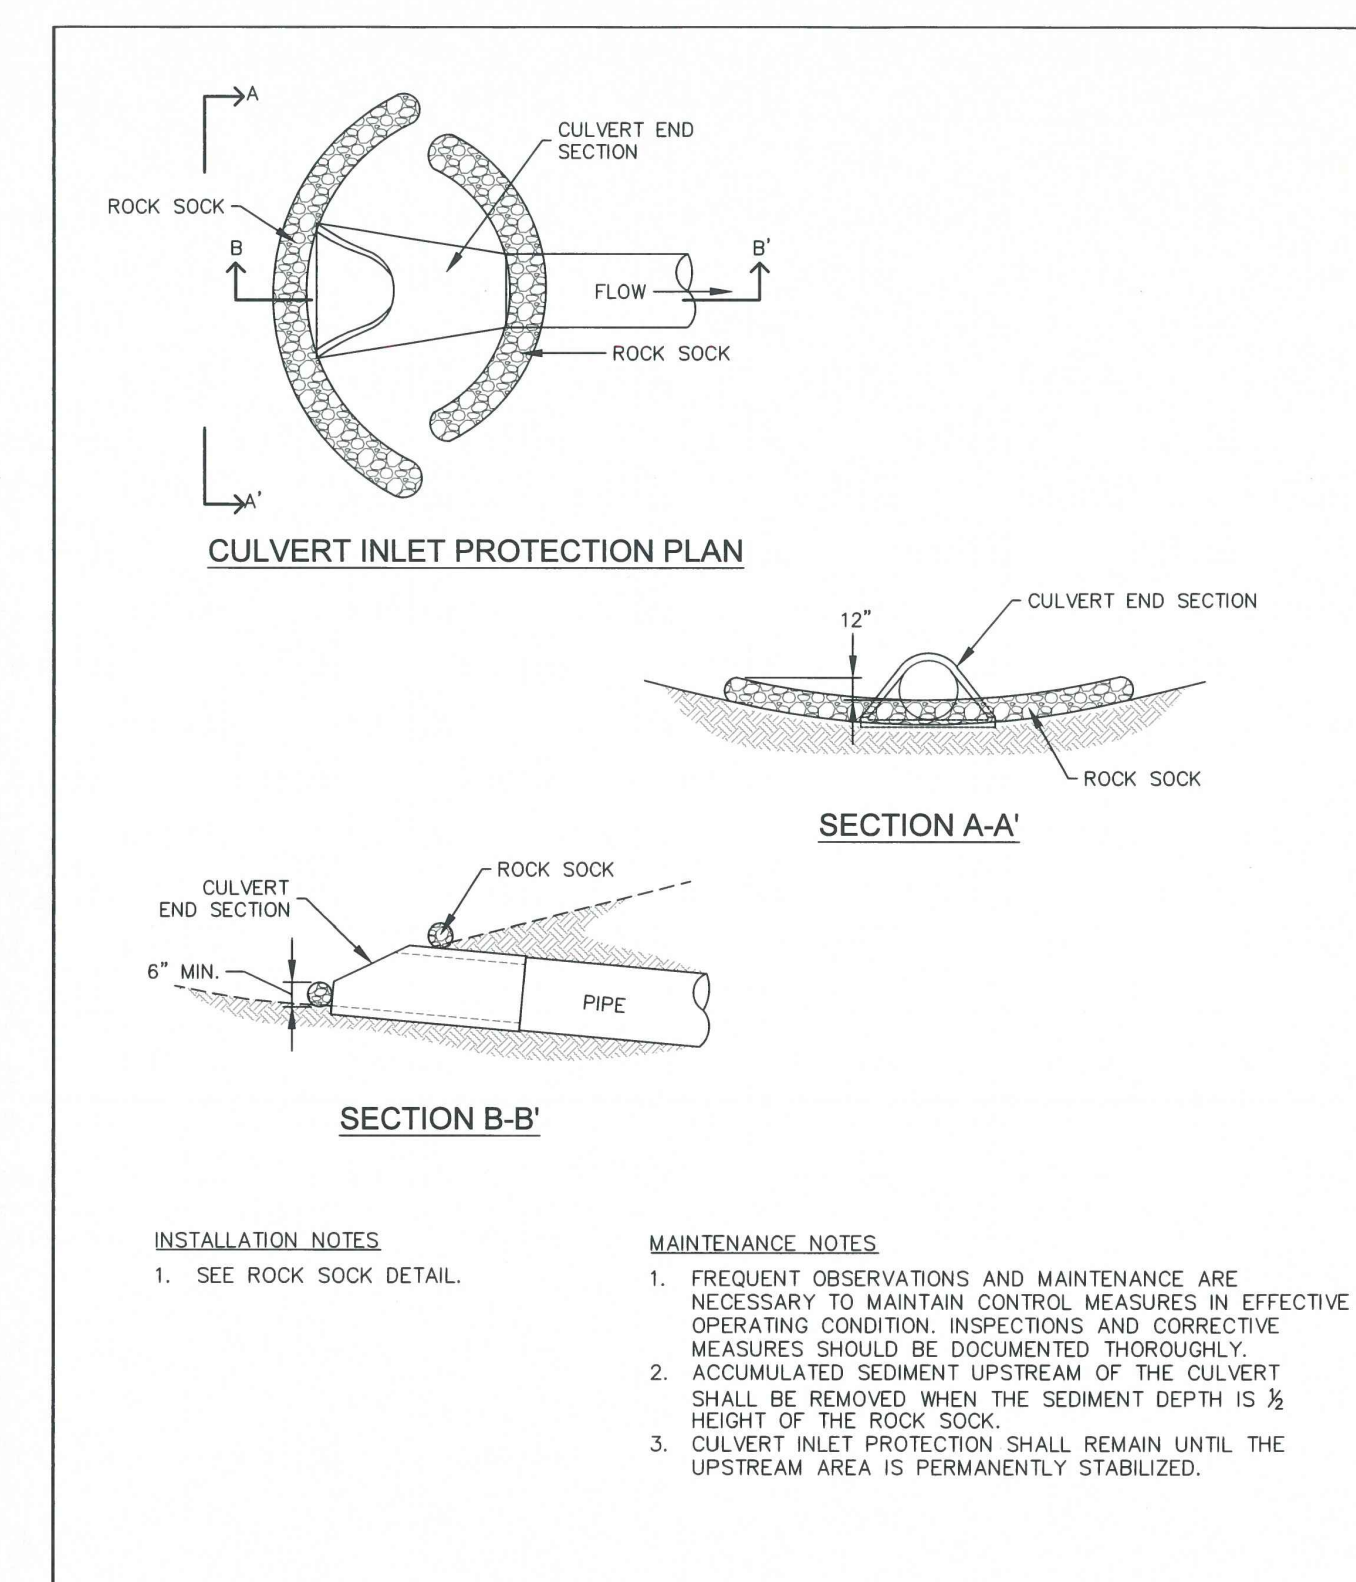
CIP  
STORMWATER ENTERPRISE  
CULVERT INLET PROTECTION  
APPROVED: [Signature]  
DESIGNED BY: [Signature]  
CHECKED BY: [Signature]  
DATE: 10/7/19  
REVISION: 8/13/2020  
DRAWING NO. 900-0P

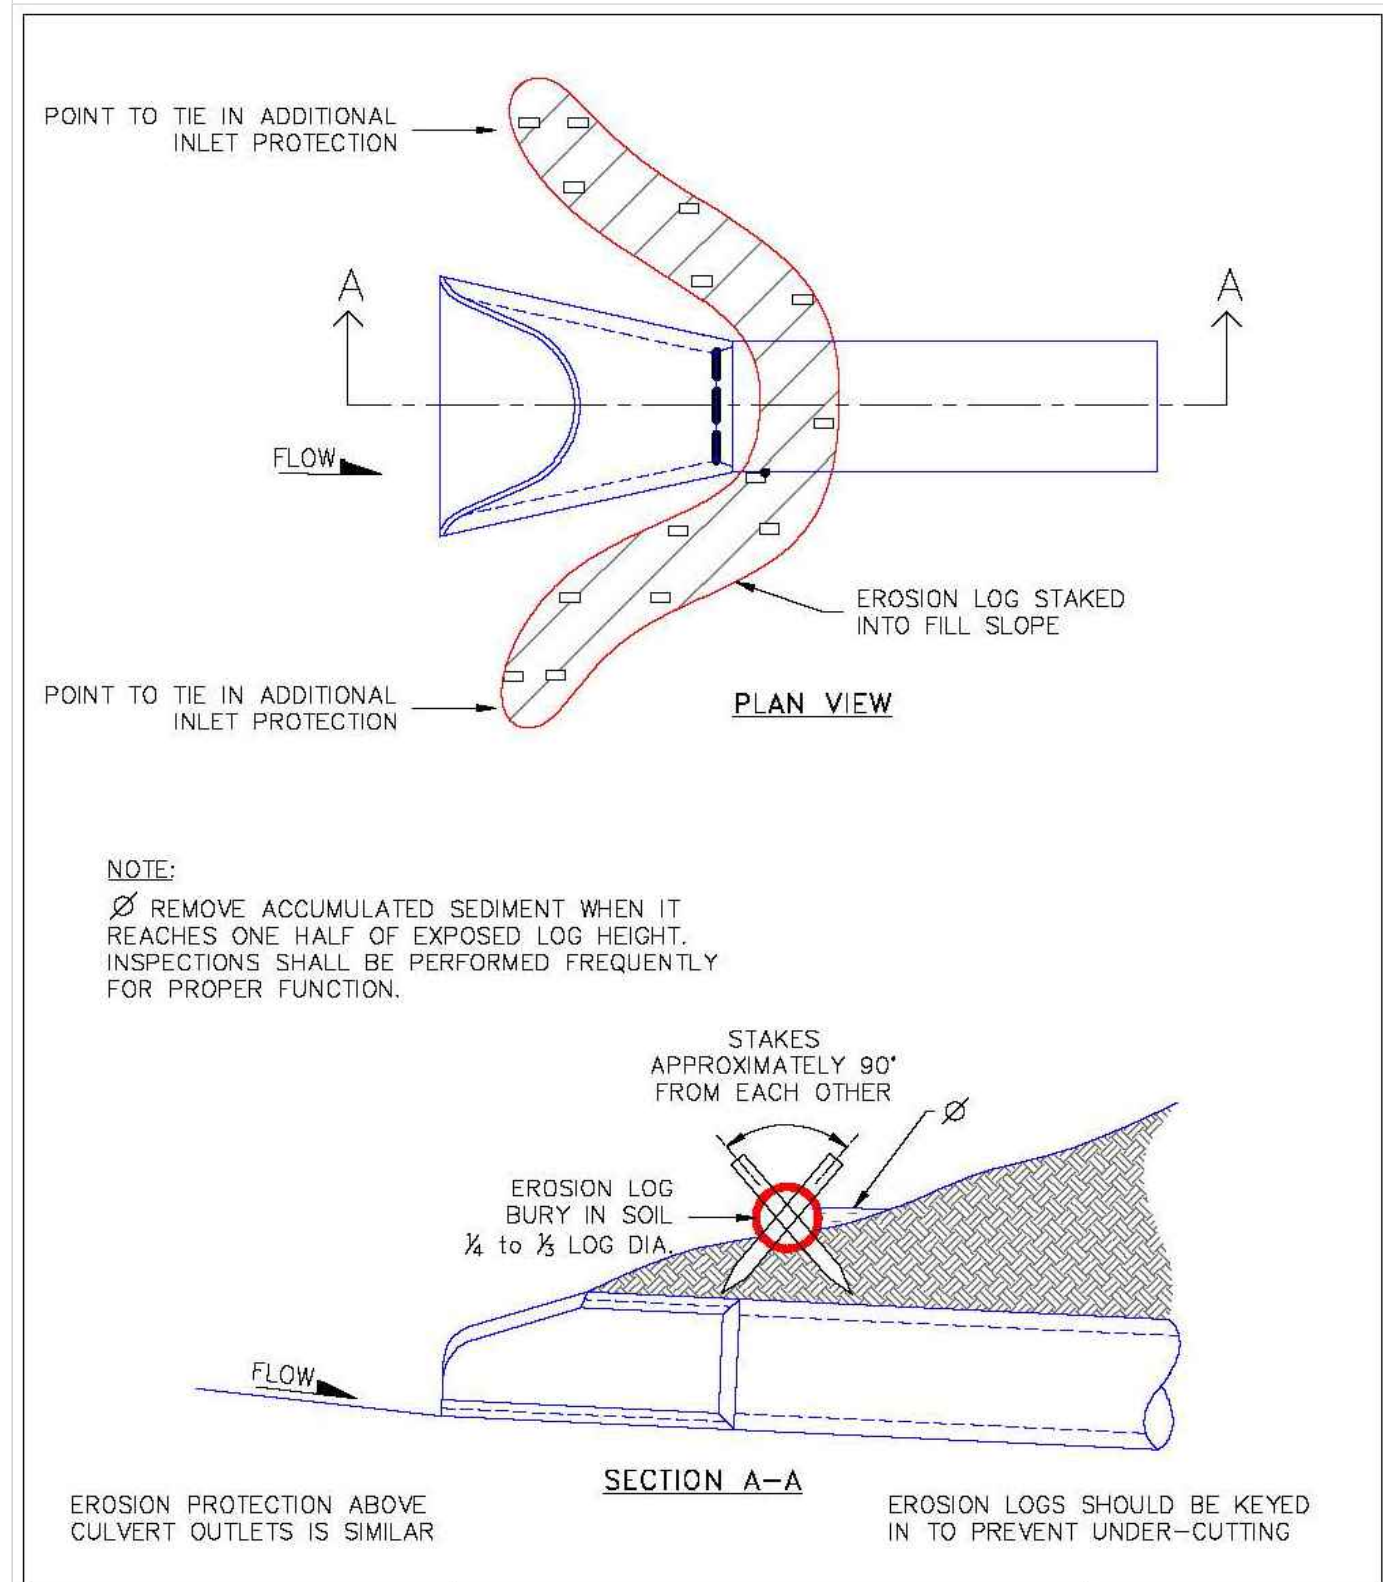
1/1/08  
DATE APPROVED: John A. McCarty  
DEPARTMENT OF TRANSPORTATION  
Culvert Inlet and Outlet Protection  
Erosion Logs Above Inlets and Outlets  
For Slopes 3:1 or Steeper  
Standard Drawing  
REVISION DATE: 7/17/07  
FILE NAME: SD\_3-86  
EL PASO COUNTY DEPARTMENT OF TRANSPORTATION

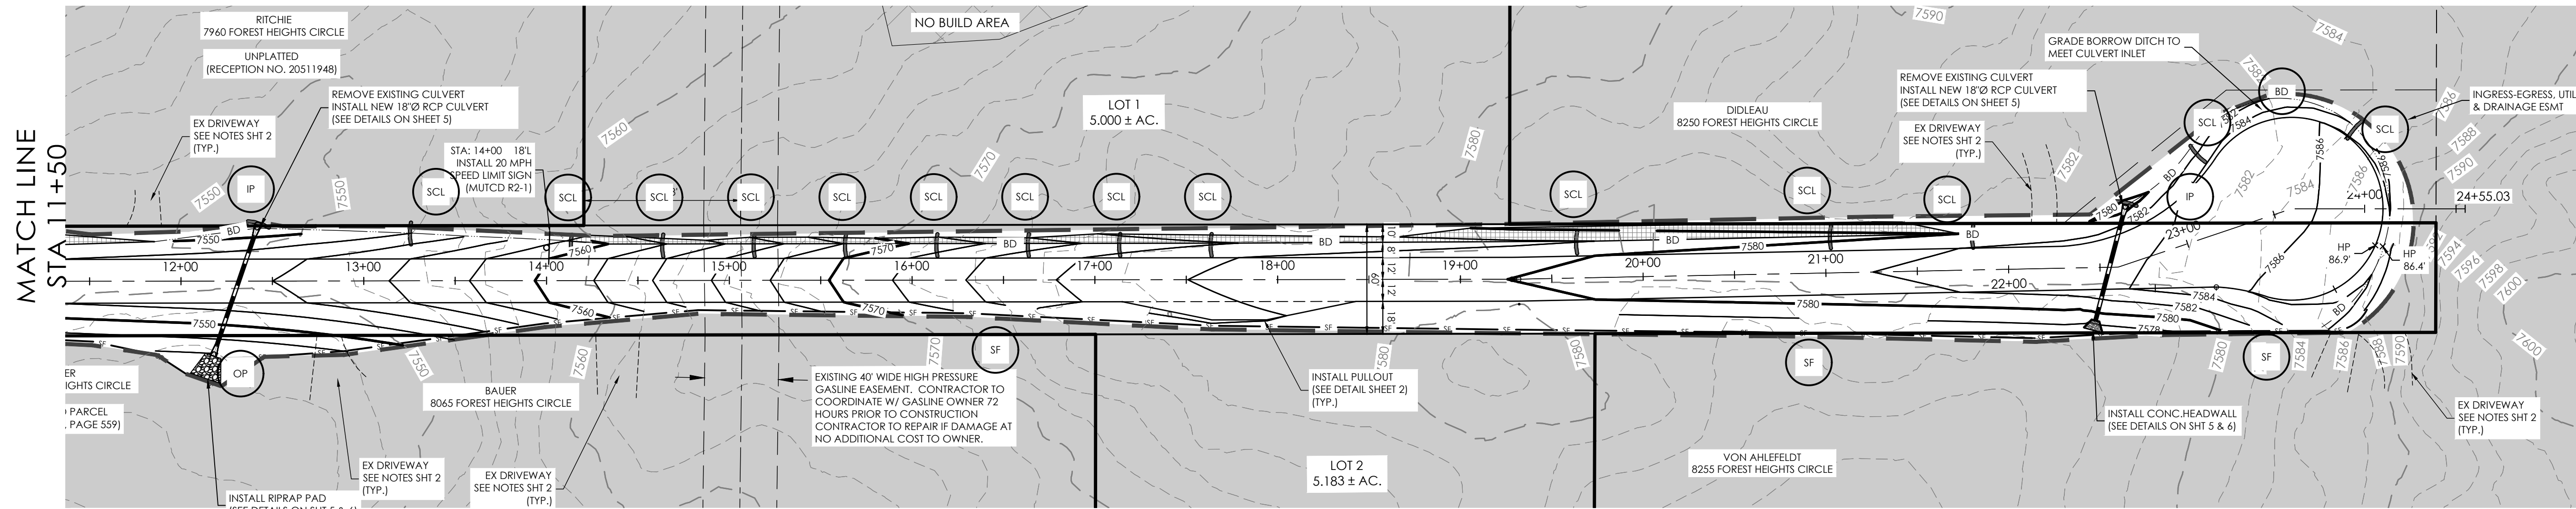
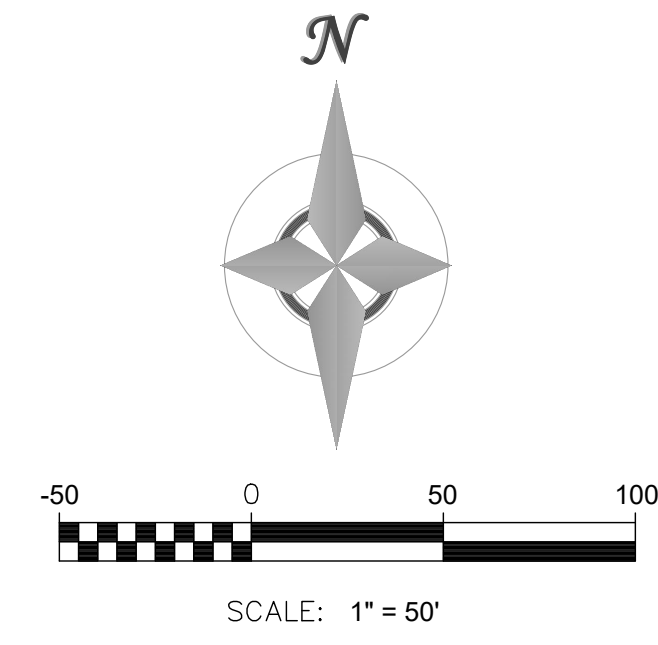
**FOREST HEIGHTS CIRCLE  
GRADING & EROSION CONTROL PLAN**  
EROSION CONTROL
