March 10, 2020
Revised March 17, 2022

ENTECH
ENGINEERING, INC.

Re: Wastewater Study
Didleau Subdivison
Herring Road & Forest Heights Circle
Parcel Nos. 52090-00-050 & 52090-00-120
El Paso County, Colorado

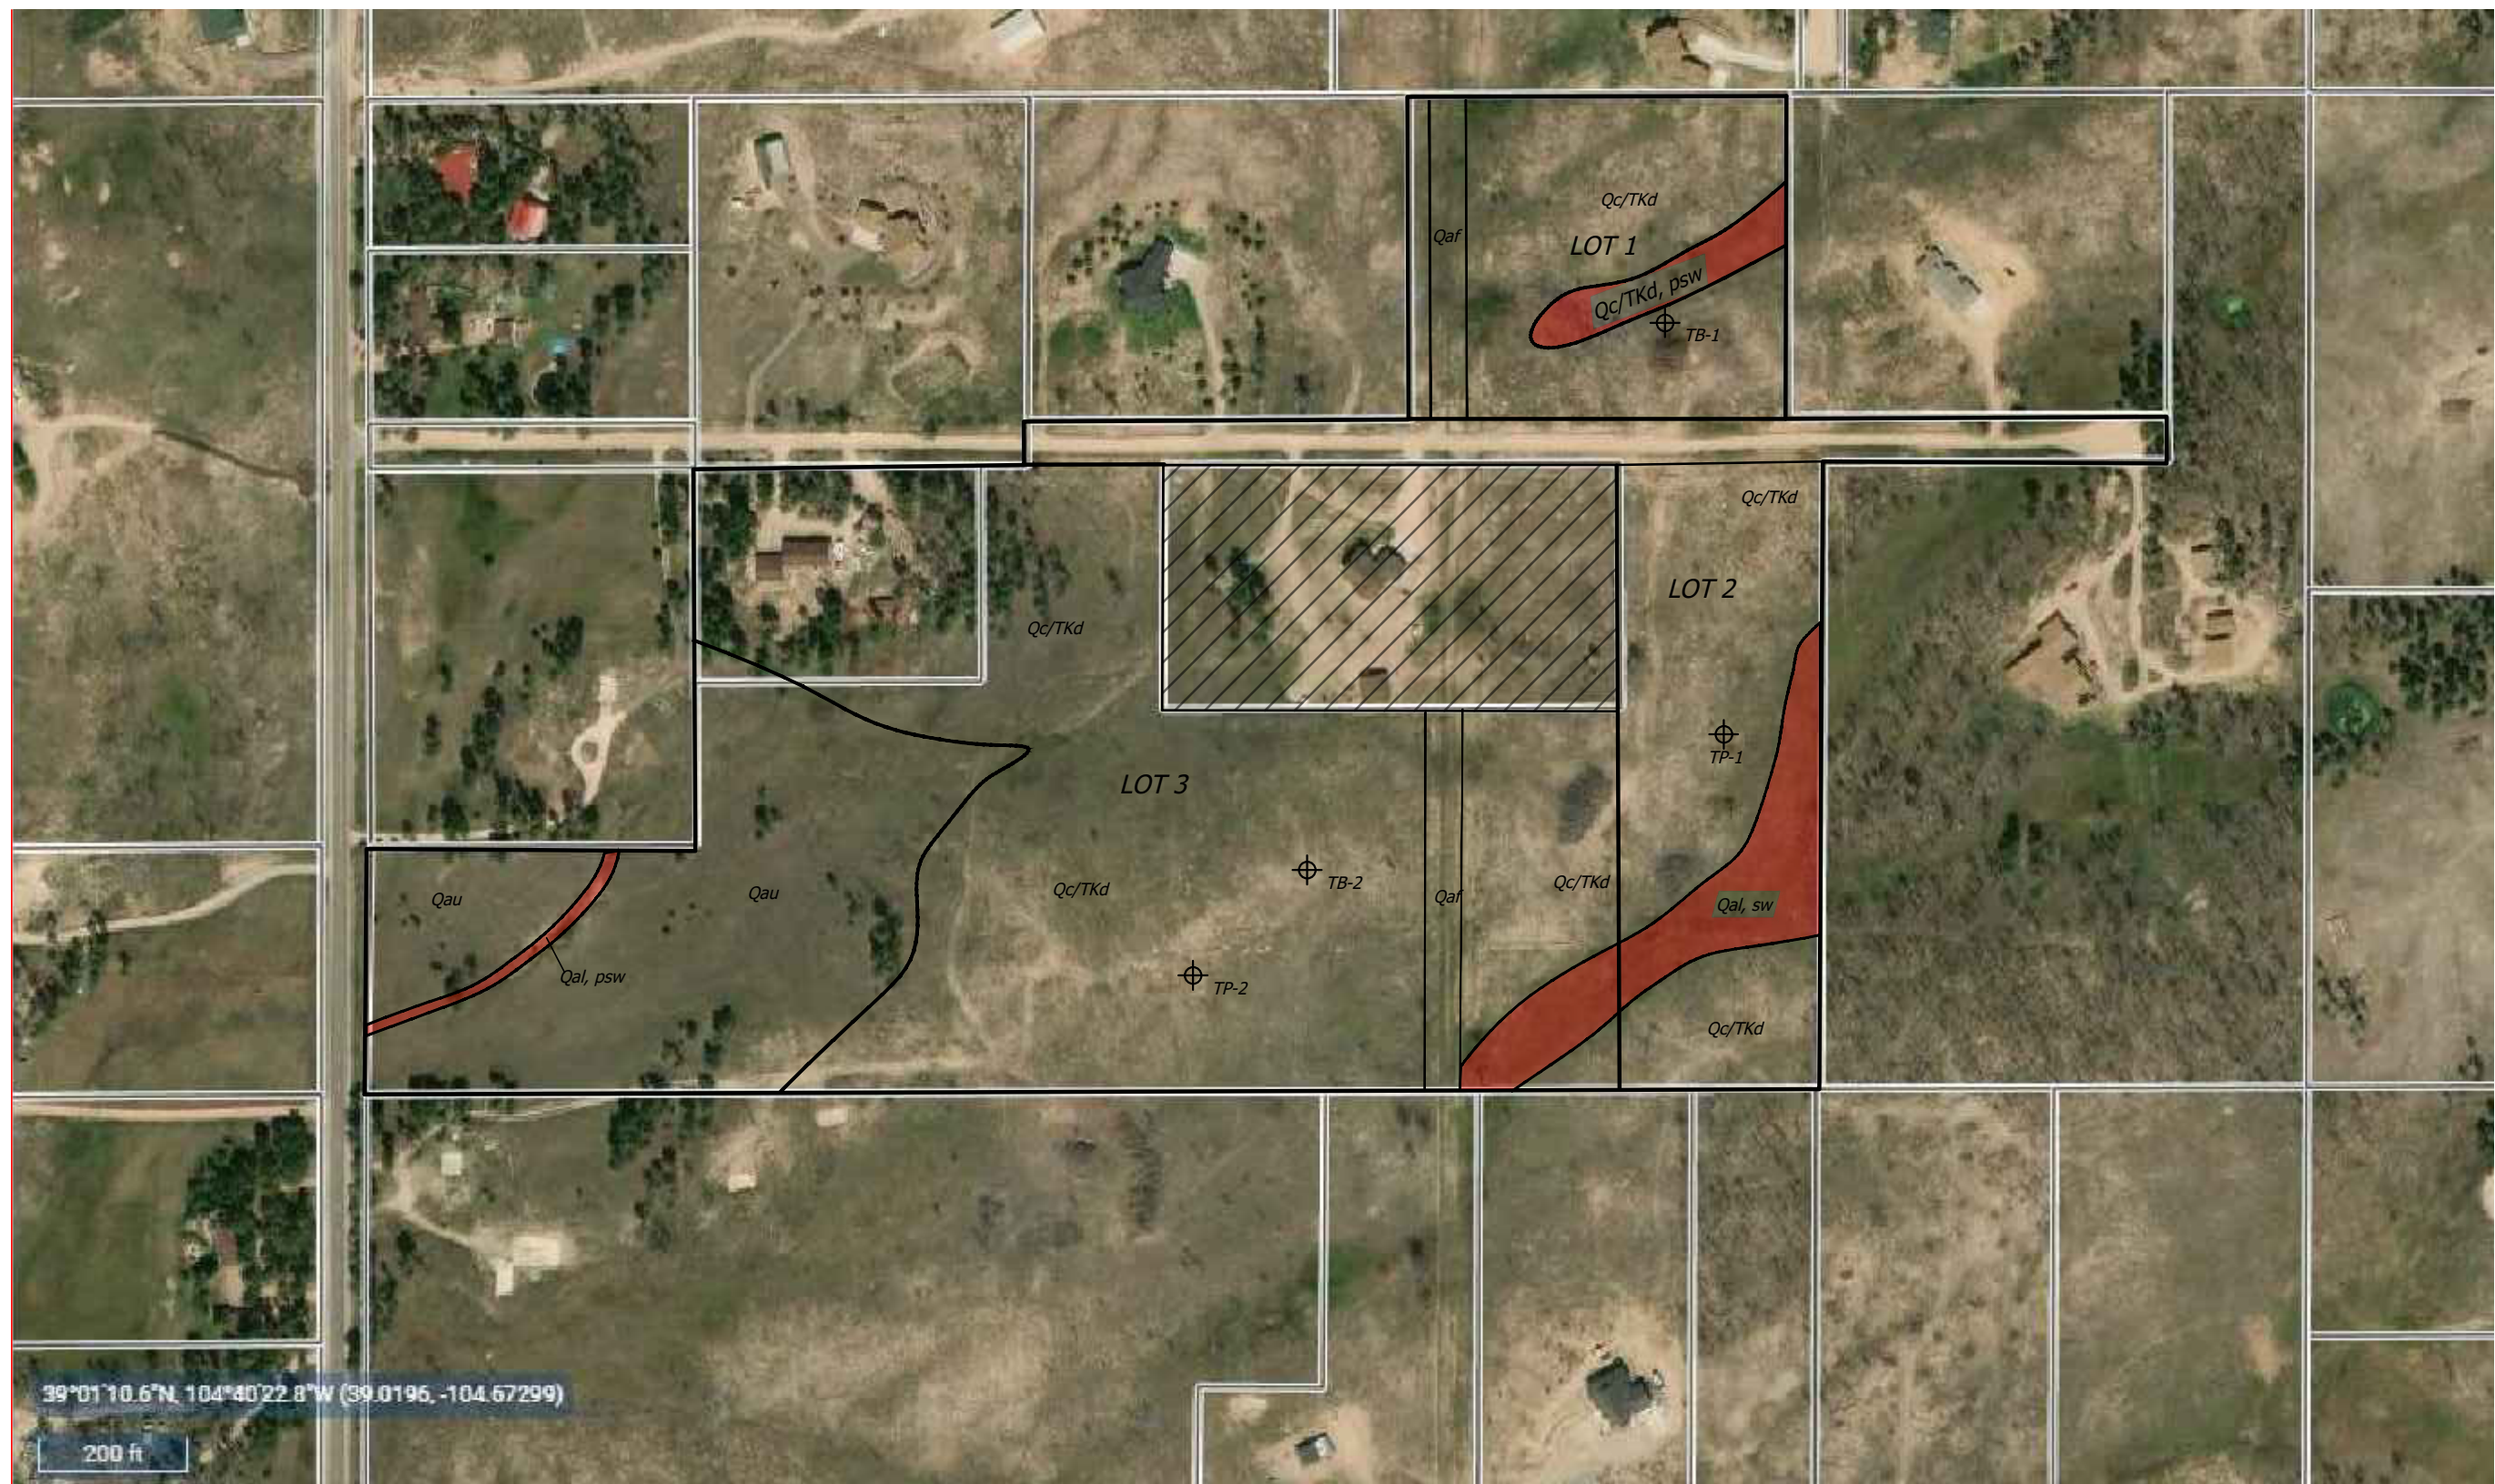
DRAWN	L.L.
CHECKED	
DATE	3/17/22
SCALE	AS SHOWN
JOB NO.	192115
FIGURE No.	6

- Legend:**
- Qaf - Artificial Fill of Holocene Age:
man-made fill deposits
 - Qal - Recent Alluvium of Holocene Age:
recent water deposited materials
 - Qau - Alluvium Undivided of Holocene and Pleistocene Age:
sheetwash and stream deposited alluvium associated with alluvial-filled valley heads
 - QcTKd - Colluvium of Quaternary Age overlying Dawson Formation of Tertiary to Cretaceous Age:
colluvial and residual soils overlying arkosic sandstone with interbedded fine-grained sandstone, siltstone and claystone
 - sw - shallow groundwater area
 - psw - potentially shallow groundwater area

GEOLOGY/ENGINEERING GEOLOGY MAP
DIDLEAU SUBDIVISION
HERRING ROAD & FOREST HEIGHTS CIRCLE
EL PASO COUNTY, CO.
FOR: LDC, INC.

The geology of the site was evaluated using the *Geologic Map of the Black Forest*, by Thorson in 2003, (Reference 4, Figure 5). The Geology Map for the site is presented in Figure 6. Four mappable units were identified on this site which is described as follows:

The soils listed above were mapped from site-specific mapping, the *Geologic Map of the Black Forest Quadrangle* distributed by the Colorado Geologic Survey in 2003 (Reference 4, Figure 5), The *Geologic Map of the Colorado Springs-Castle Rock Area*, distributed by the US Geological Survey in 1979 (Reference 5), and the *Geologic Map of the Pueblo 1° x 2° Quadrangle*, distributed by the US Geological Survey in 1978 (Reference 6). The test borings and test pits were used in evaluating the site and is included in Appendix B. The Geology Map prepared for the site is presented in Figure 6.

Minor drainages exist on-site that flow in southwesterly directions. Burgess Creek exists in the eastern portion of the site and a minor drainage exists in the western portion of the site. No water was observed flowing in these drainages at the time of the investigation. Areas of seasonal and potentially seasonal shallow groundwater have been mapped in the drainages on the site (Figure 6).
