**Stormwater Management Plan
for
Forest Heights Properties
Didleau Subdivision**

September 29, 2023

2019.25

EPC Project NO MS-206

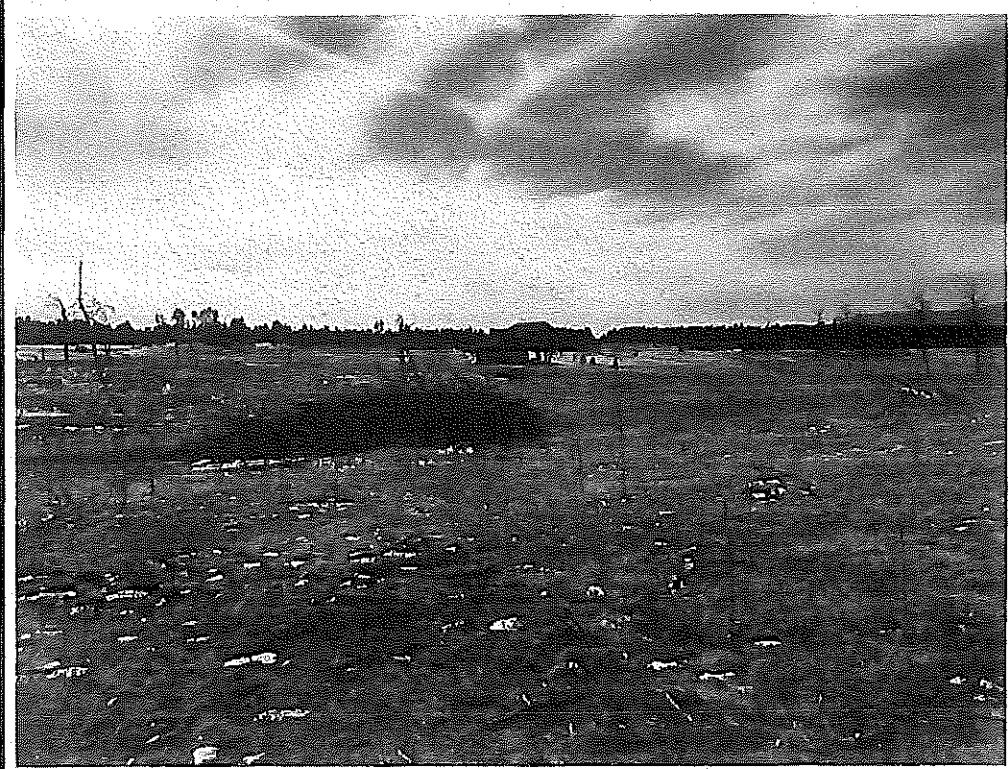
**Looking south towards
one of the stockpiles
of cut trees.**

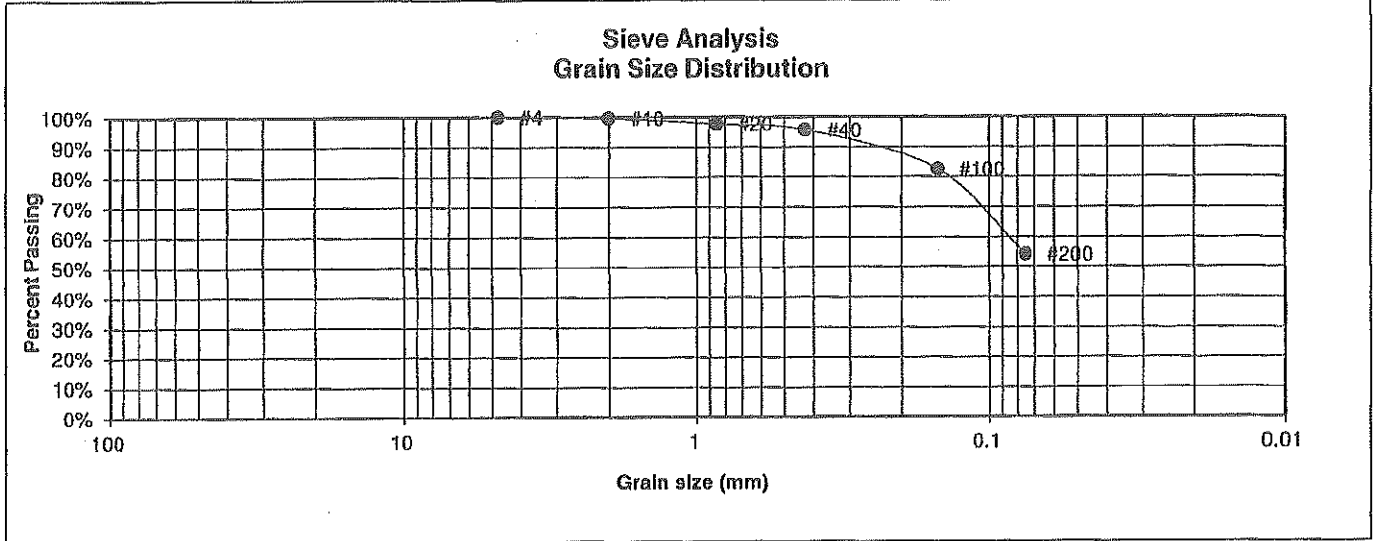
<u>UNIFIED CLASSIFICATION</u>	CL	<u>CLIENT</u>	LDC, INC.
<u>SOIL TYPE #</u>	3	<u>PROJECT</u>	DIDLEAU SUBDIVISION
<u>TEST BORING #</u>	2	<u>JOB NO.</u>	192115
<u>DEPTH (FT)</u>	5	<u>TEST BY</u>	BL

U.S. Sieve #	Percent Finer
3"	
1 1/2"	
3/4"	
1/2"	
3/8"	
4	100.0%
10	99.6%
20	97.7%
40	95.7%
100	82.6%
200	54.2%

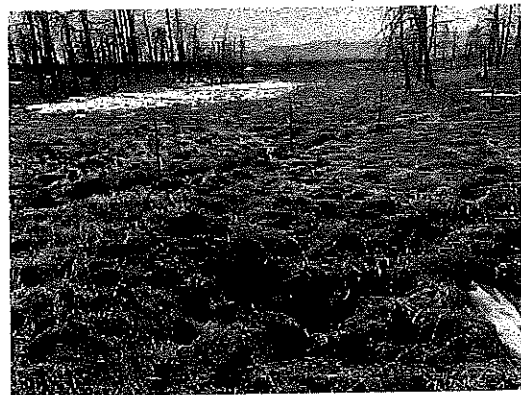
Figure 6: Facing downstream of Culvert 1

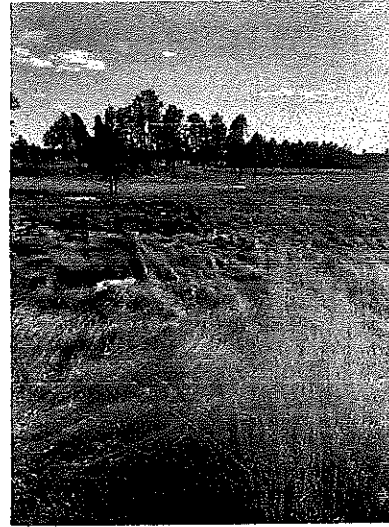
Figure 41: Upstream end Culvert 3

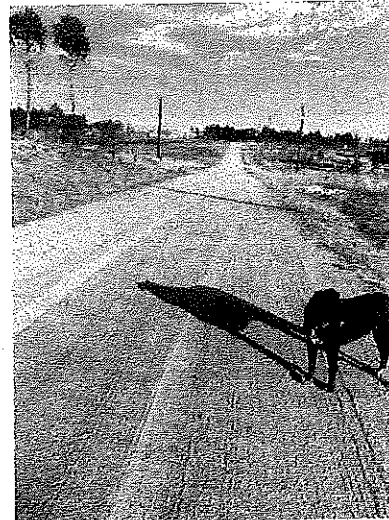
Figure 48: 18" CMP under Drive

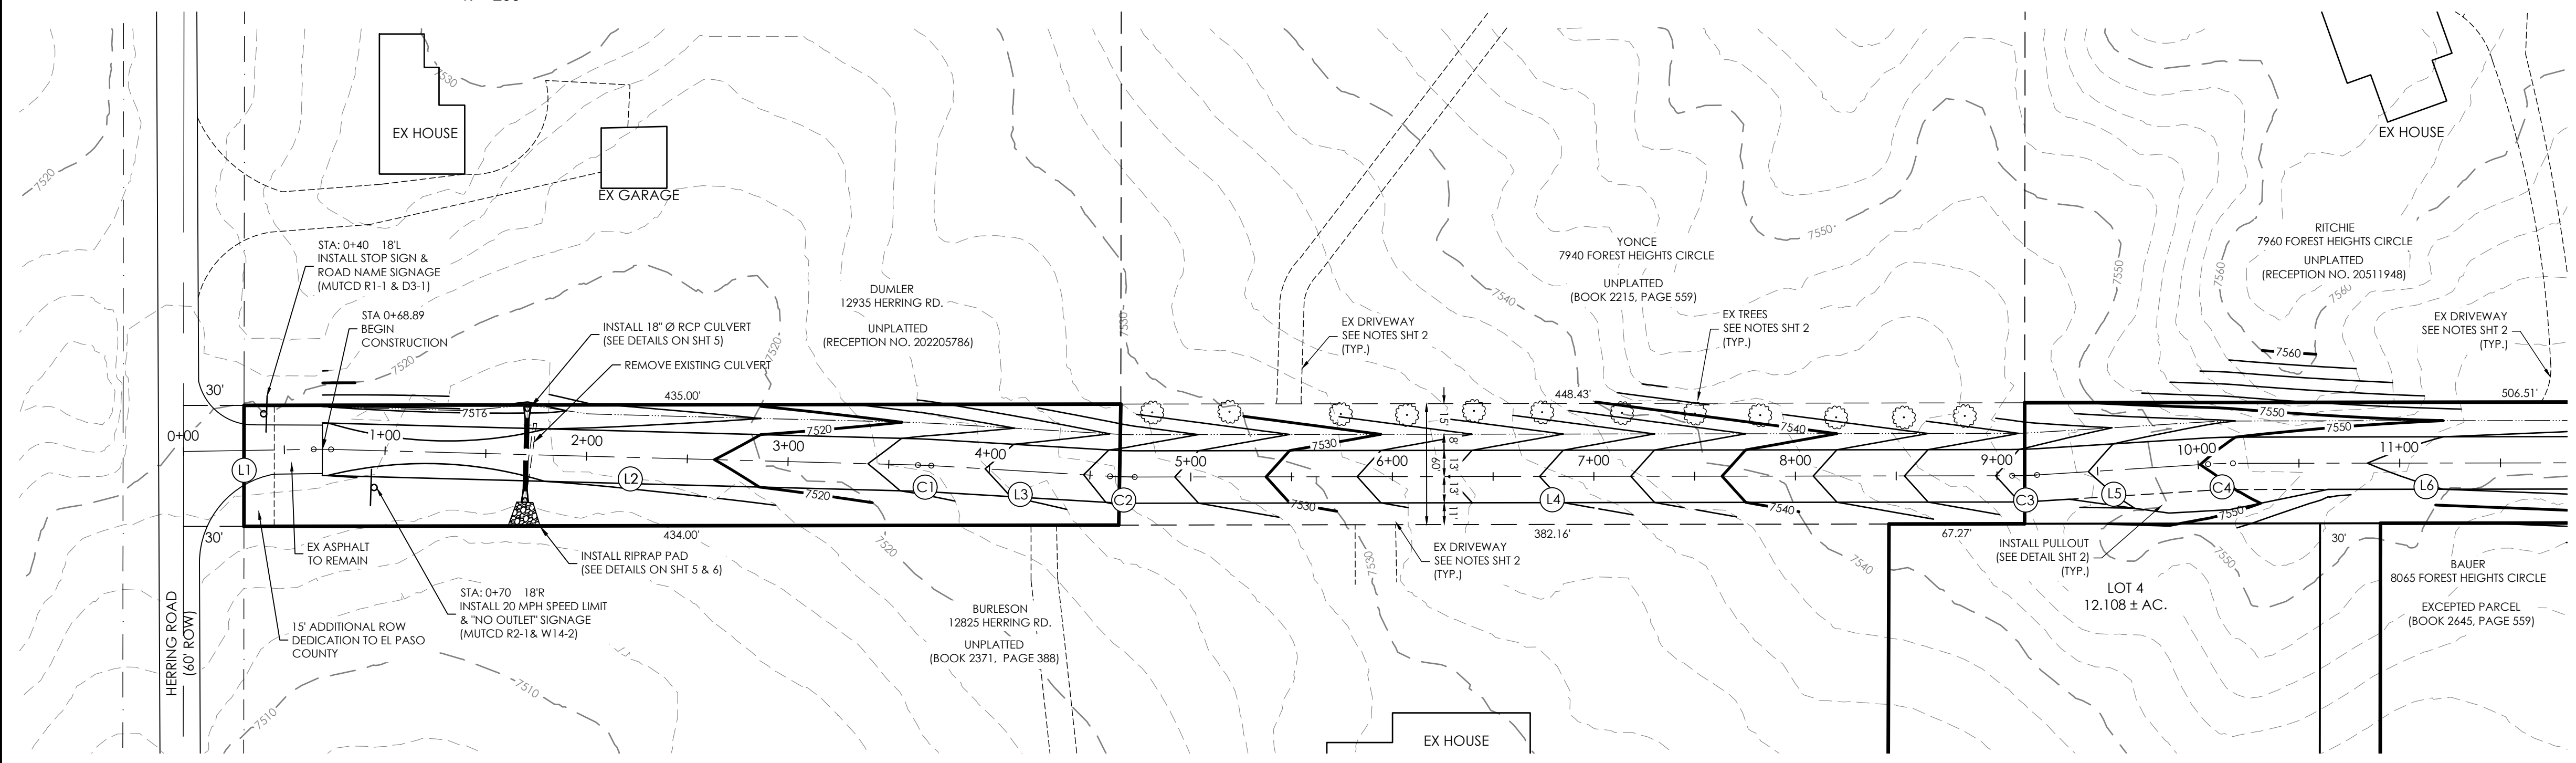
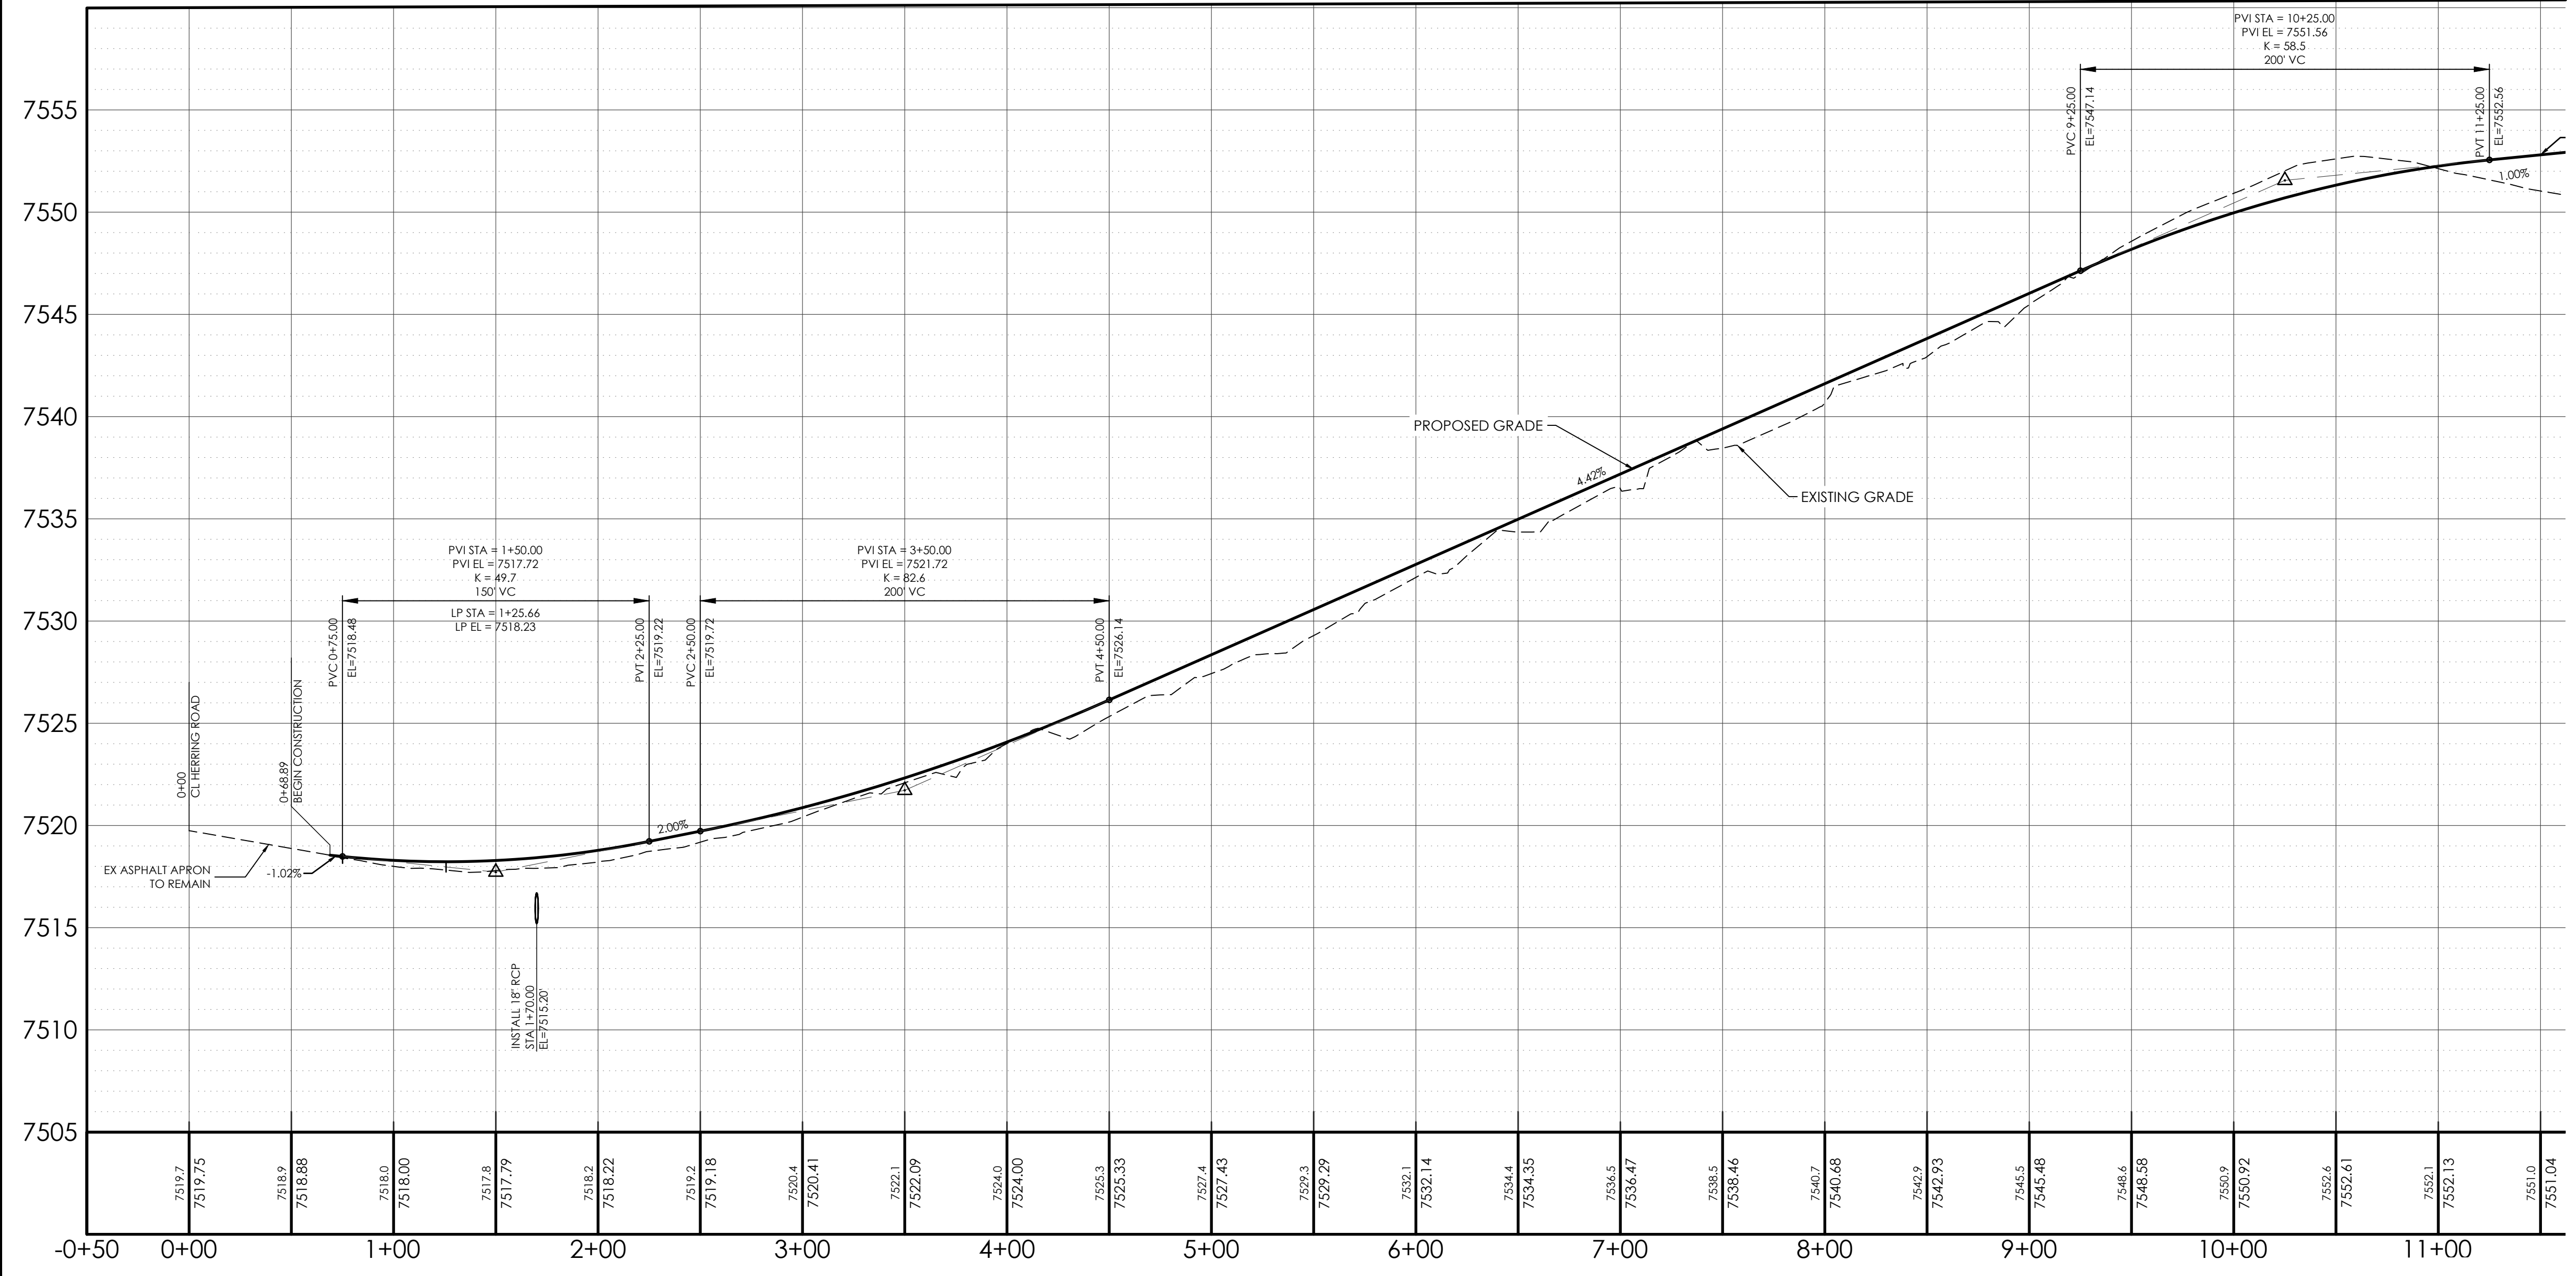
FOREST HEIGHTS CIRCLE
STA 0+00 TO 11+50

CL HERRING RD	L1 LINE DATA	BEGIN CONSTRUCTION	L2 LINE DATA	C1 CURVE DATA	L3 LINE DATA	C2 CURVE DATA	L4 LINE DATA	C3 CURVE DATA	L5 LINE DATA	C4 CURVE DATA	L6 LINE DATA
STA: 0+00 N: 1,432,828 E: 3,232,502	N89°02'56"E 64.57'	PI STA: 0+68.89 PC: 0+64.57 PT: 0+73.21 L = 8.64' Δ = 02°28'30" R = 200'	S88°28'34"E 291.28'	PC = 3+64.49 PT = 3+71.10 L = 6.61' Δ = 1°53'37" R = 200'	S86°34'57"E 88.87'	PC = 4+59.97 PT = 4+72.18 L = 12.22 Δ = 3°30'00" R = 200'	N89°55'03"E 435.34'	PC = 9+07.53 PT = 9+19.86 L = 12.33' Δ = 3°31'57" R = 200'	N86°23'06"E 85.05'	PC = 10+04.90 PT = 10+17.23 L = 12.33' Δ = 3°31'57" R = 200'	N89°55'03"E 910.92'

MATCH LINE
STA 11+50
SEE SHEET 4

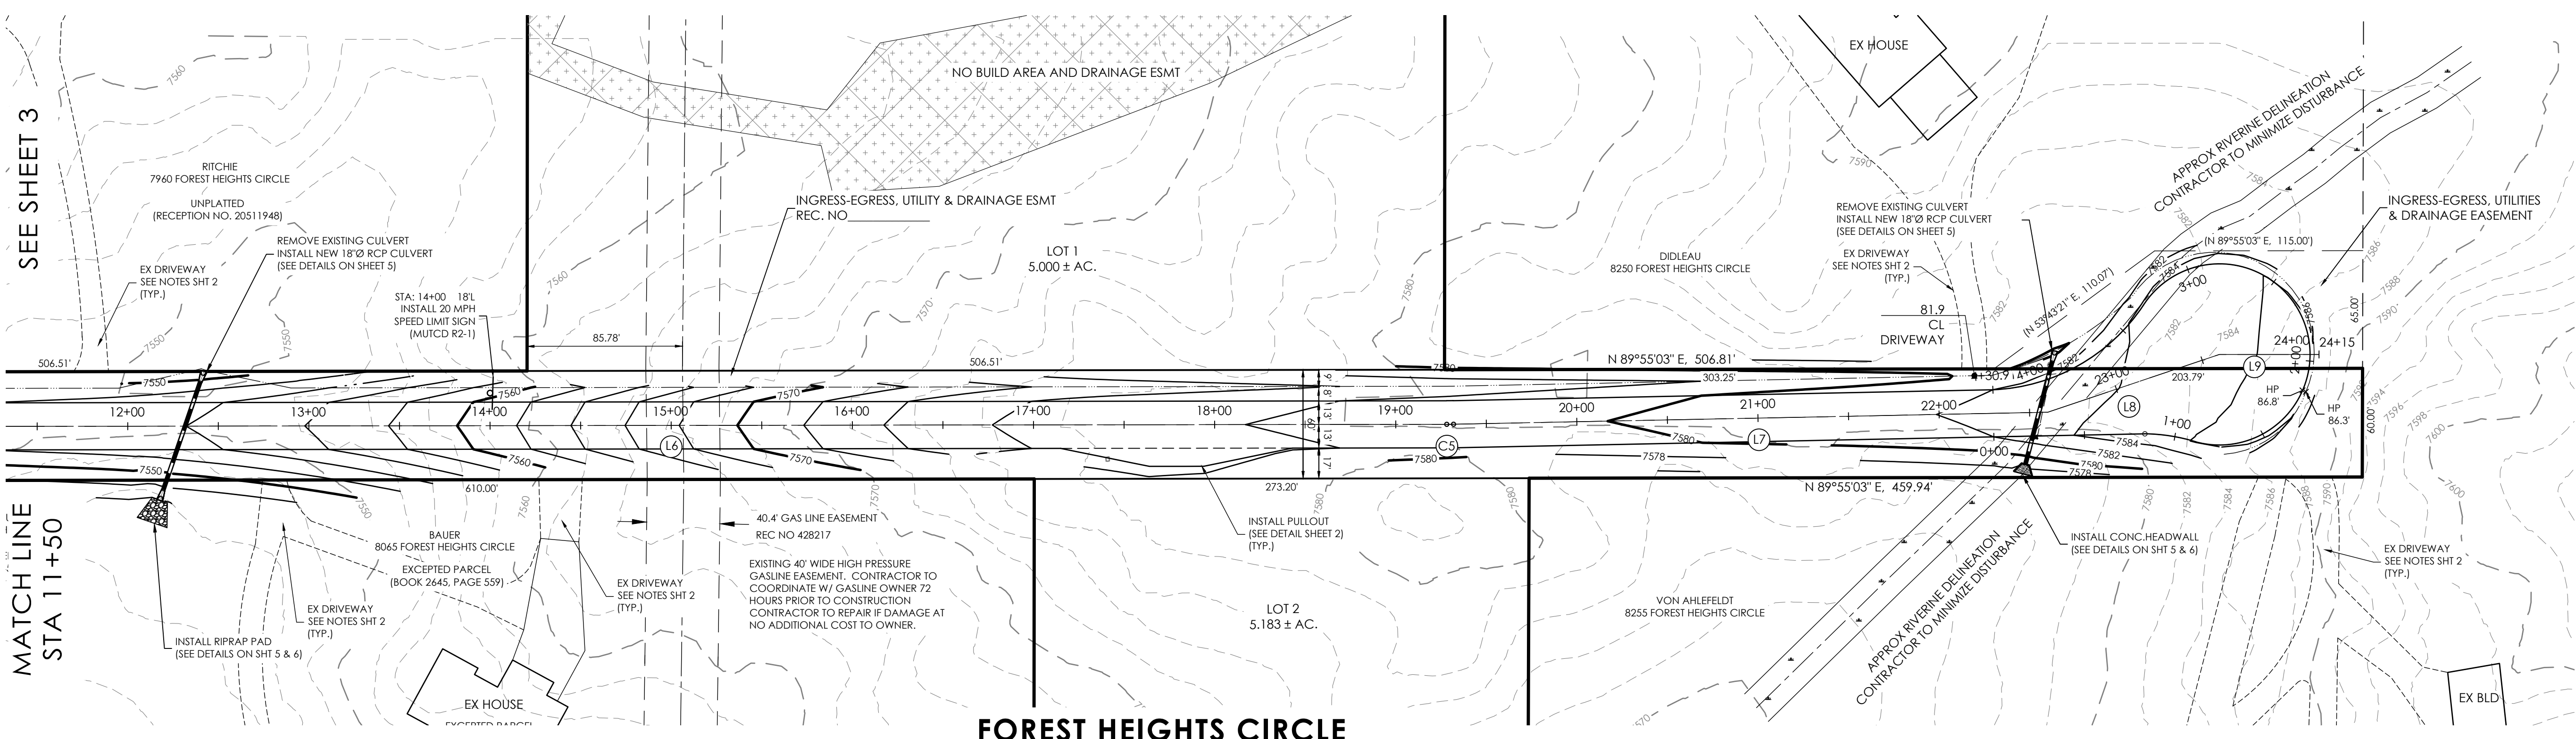
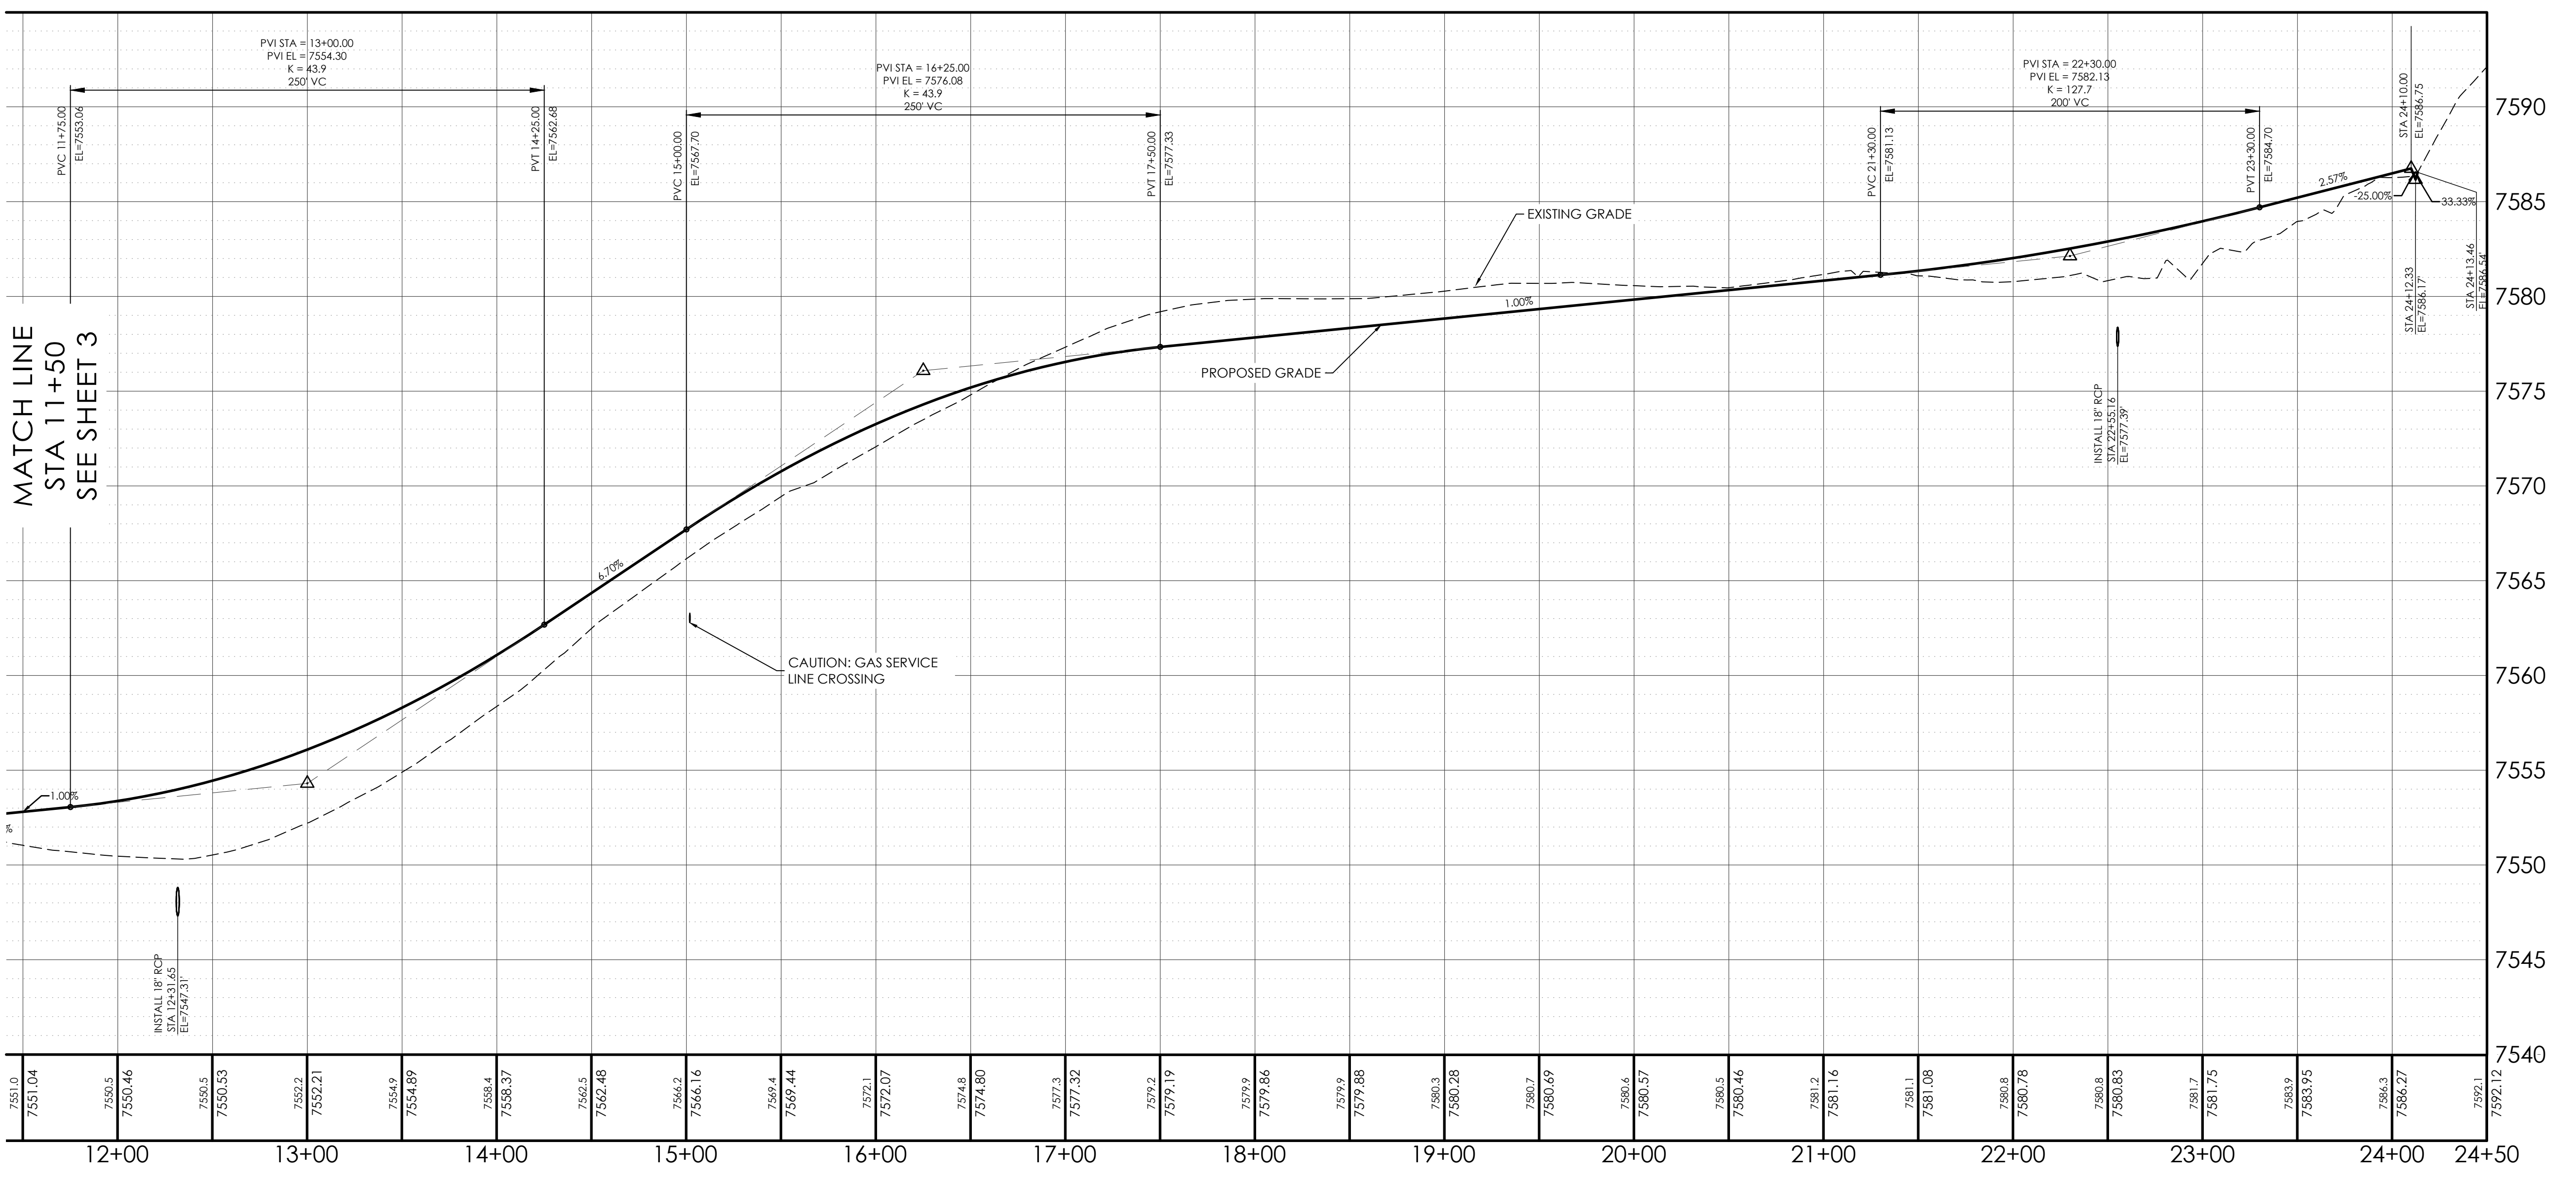
FOREST HEIGHTS CIRCLE
STA 11+50 TO 24+19

FOREST HEIGHTS CIRCLE
CONSTRUCTION DRAWINGS
PLAN & PROFILE
11+50 TO 24+19
