Re: Wastewater Study  
Didleau Subdivision  
Herring Road & Forest Heights Circle  
Parcel Nos. 52090-00-050 & 52090-00-120  
El Paso County, Colorado

### **GENERAL SITE CONDITIONS AND PROJECT DESCRIPTION**

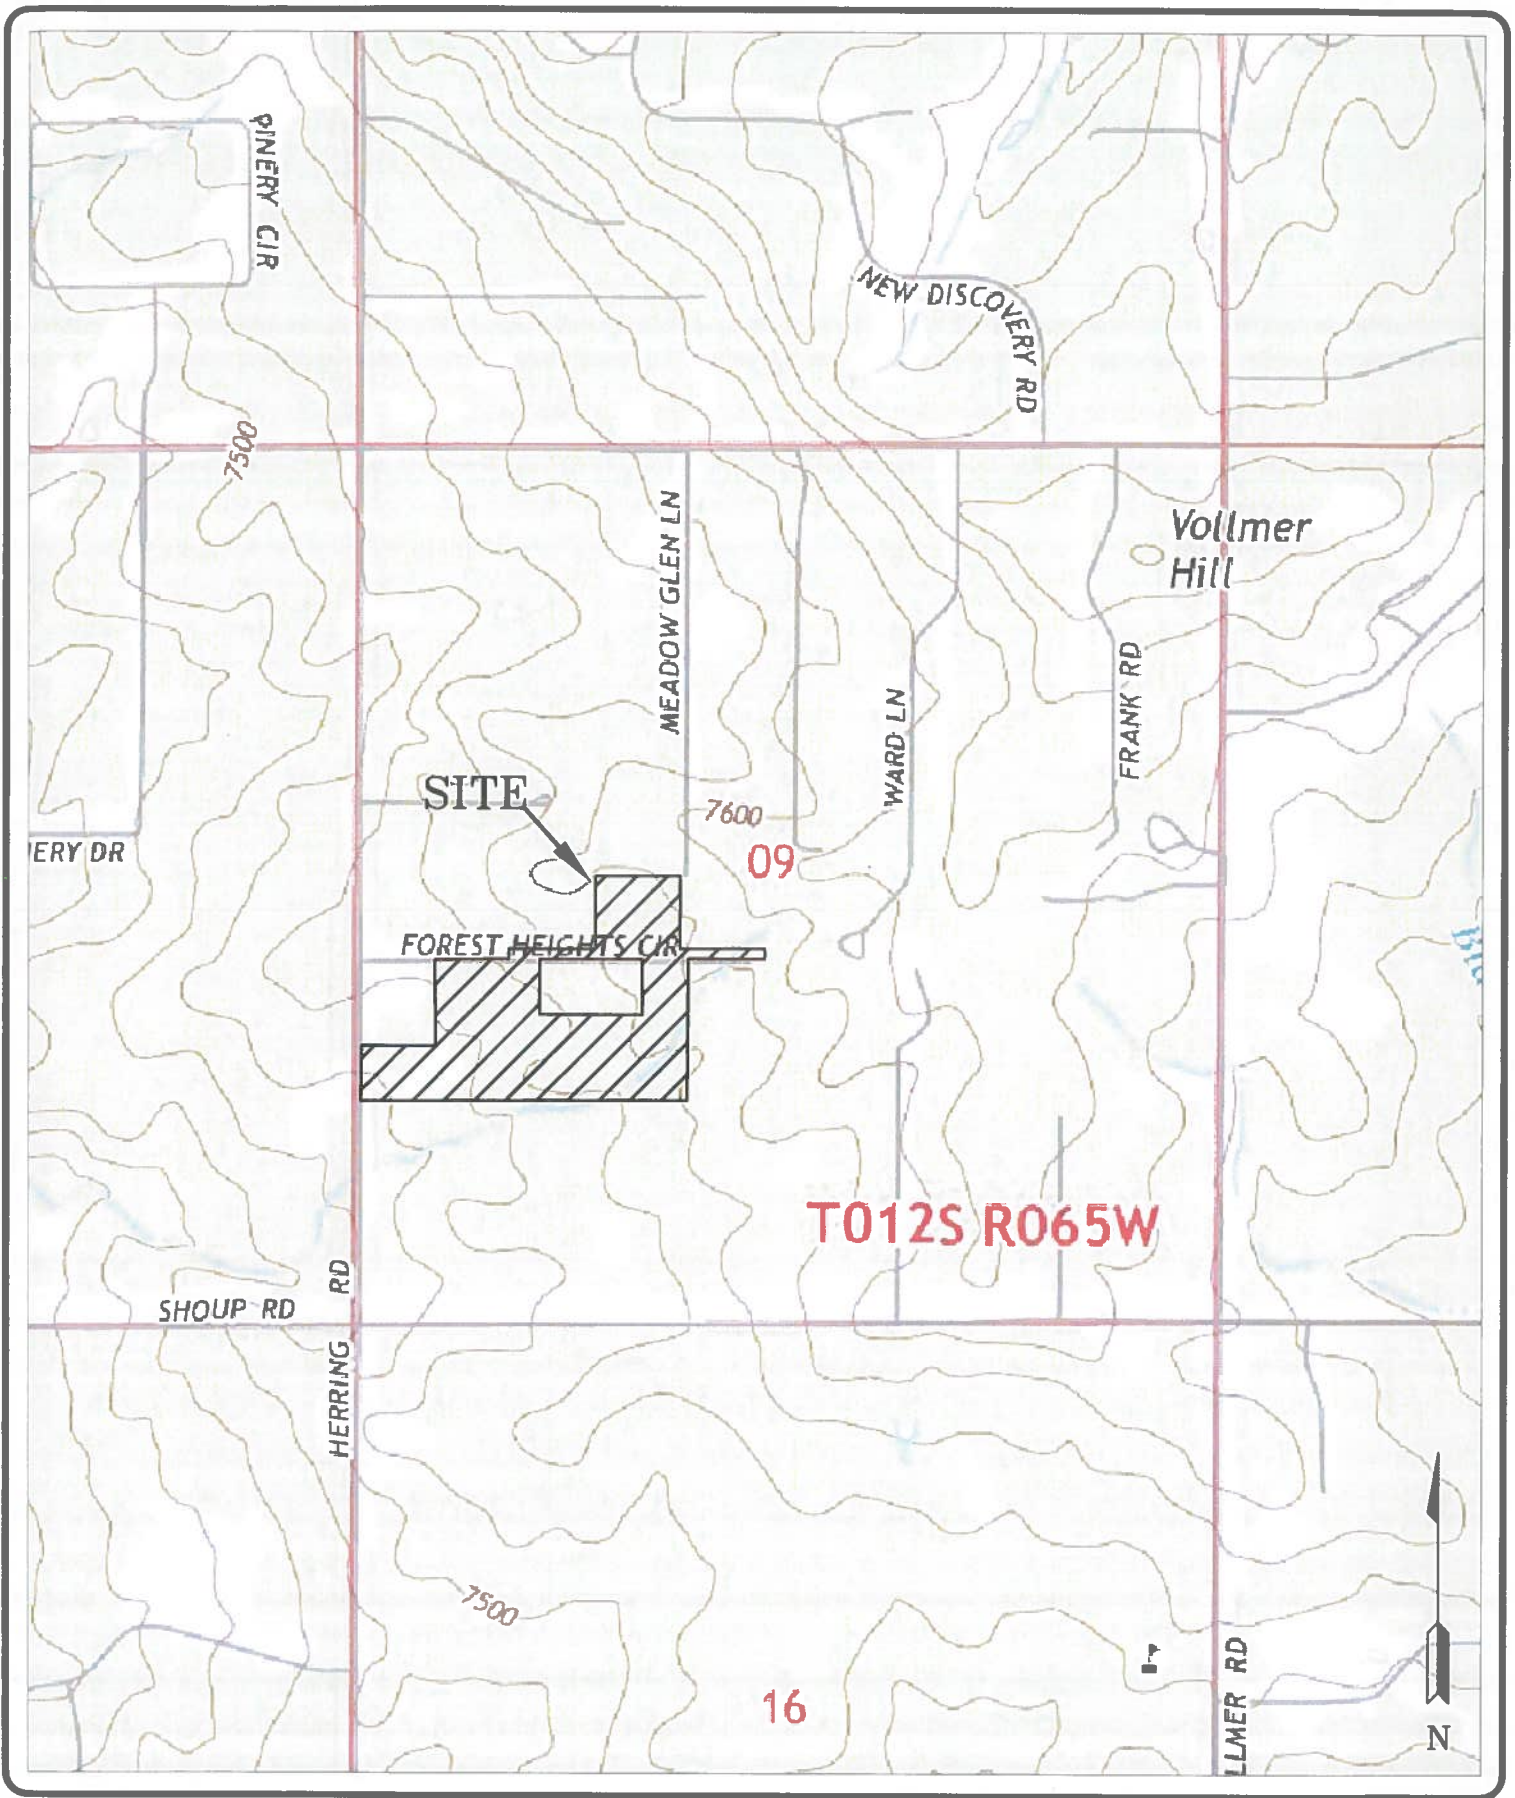
FIG NO.:  
2

USGS MAP  
DIDLEAU SUBDIVISION  
HERRING ROAD & FOREST HEIGHTS CIRCLE  
PASO COUNTY, CO.  
FOR: LDC, INC.

The topography of the site is gradually sloping generally to the southwest with moderate slopes along the ridge that bisects the site. Burgess Creek is located in the eastern portion of the site and flows in a southwesterly direction. A minor drainage is located in the western portion of the property. Water was not observed in the drainages at the time of this investigation. The site boundaries are indicated on the USGS Map, Figure 2. Previous land uses have included undeveloped and a rural residential development. The site is located within the Black Forest burn scar. The site contains primarily field grasses and weeds with scattered areas of ponderosa pines in the western portion of the site and around the existing house located on Lot 2. Site photographs, taken January 30, 2020, are included in Appendix A.

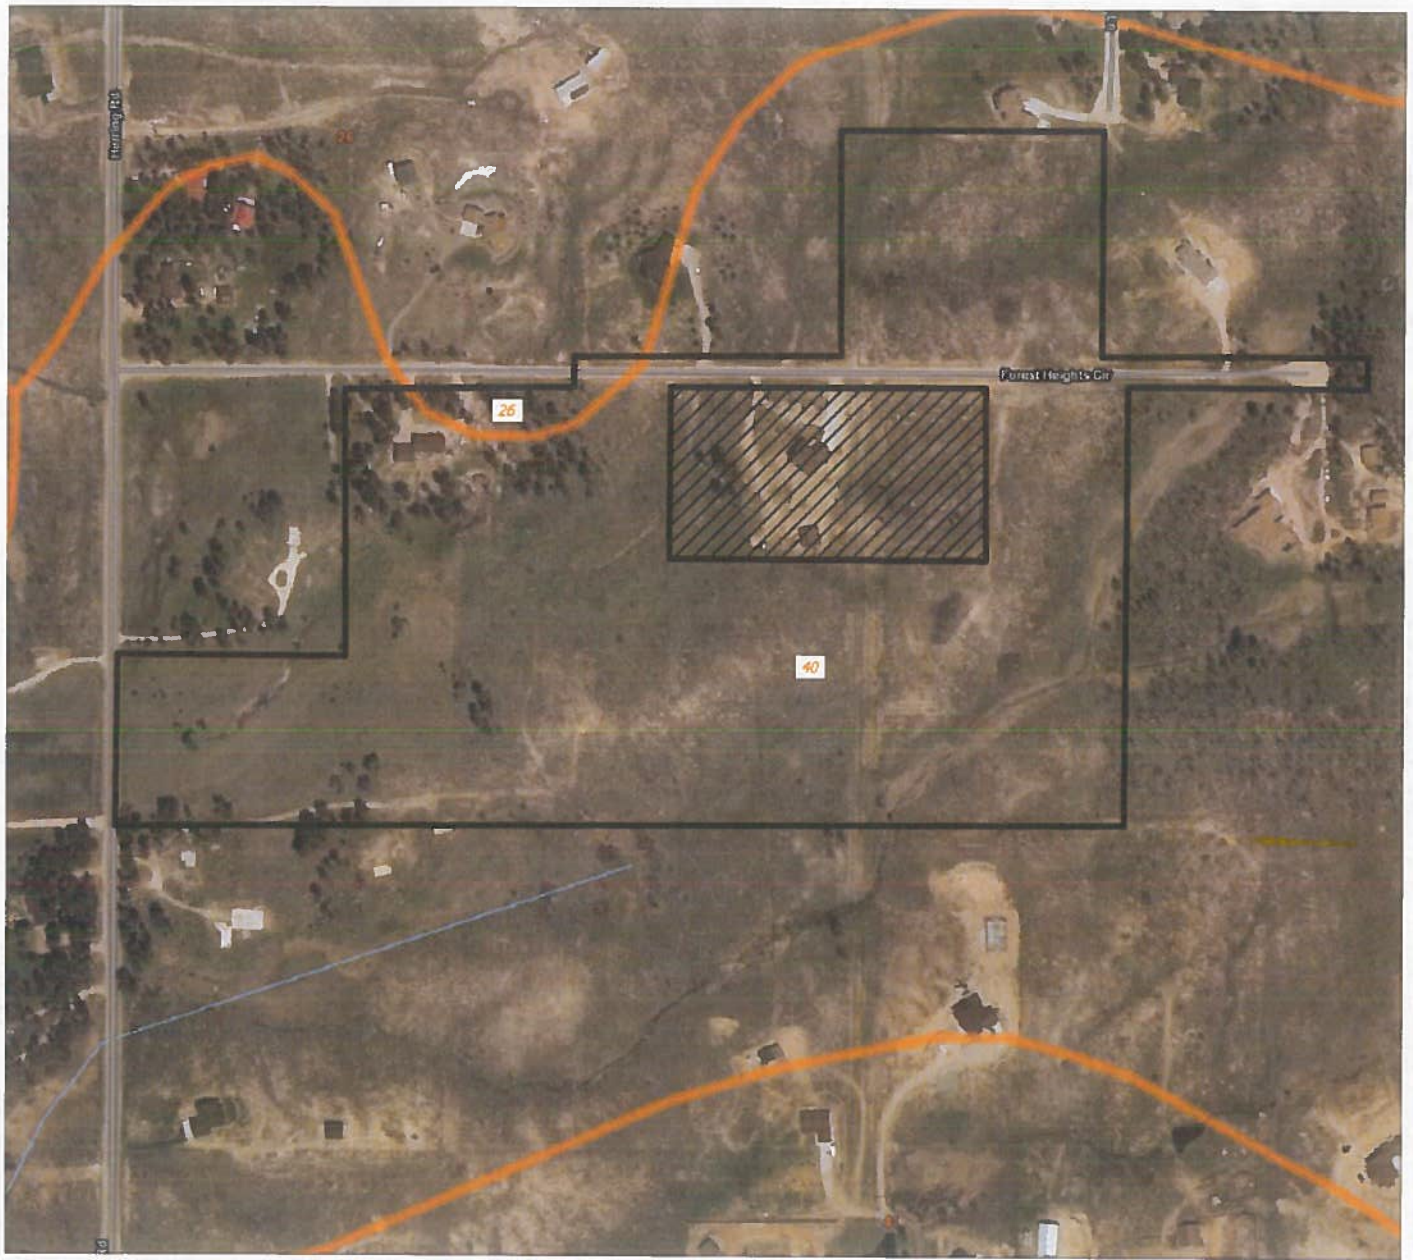
FIG NO.:  
4

SOIL SURVEY MAP  
DIDLEAU SUBDIVISION  
HERRING ROAD & FOREST HEIGHTS CIRCLE  
EL PASO COUNTY, CO.  
FOR: LDC, INC.

The soils have been described to have moderate to rapid permeabilities. The soils are described as well suited for use as homesites. Possible hazards with soils erosion are present on the site. The erosion potential can be controlled with vegetation. The soils have been described to have moderate erosion hazards (Reference 2).

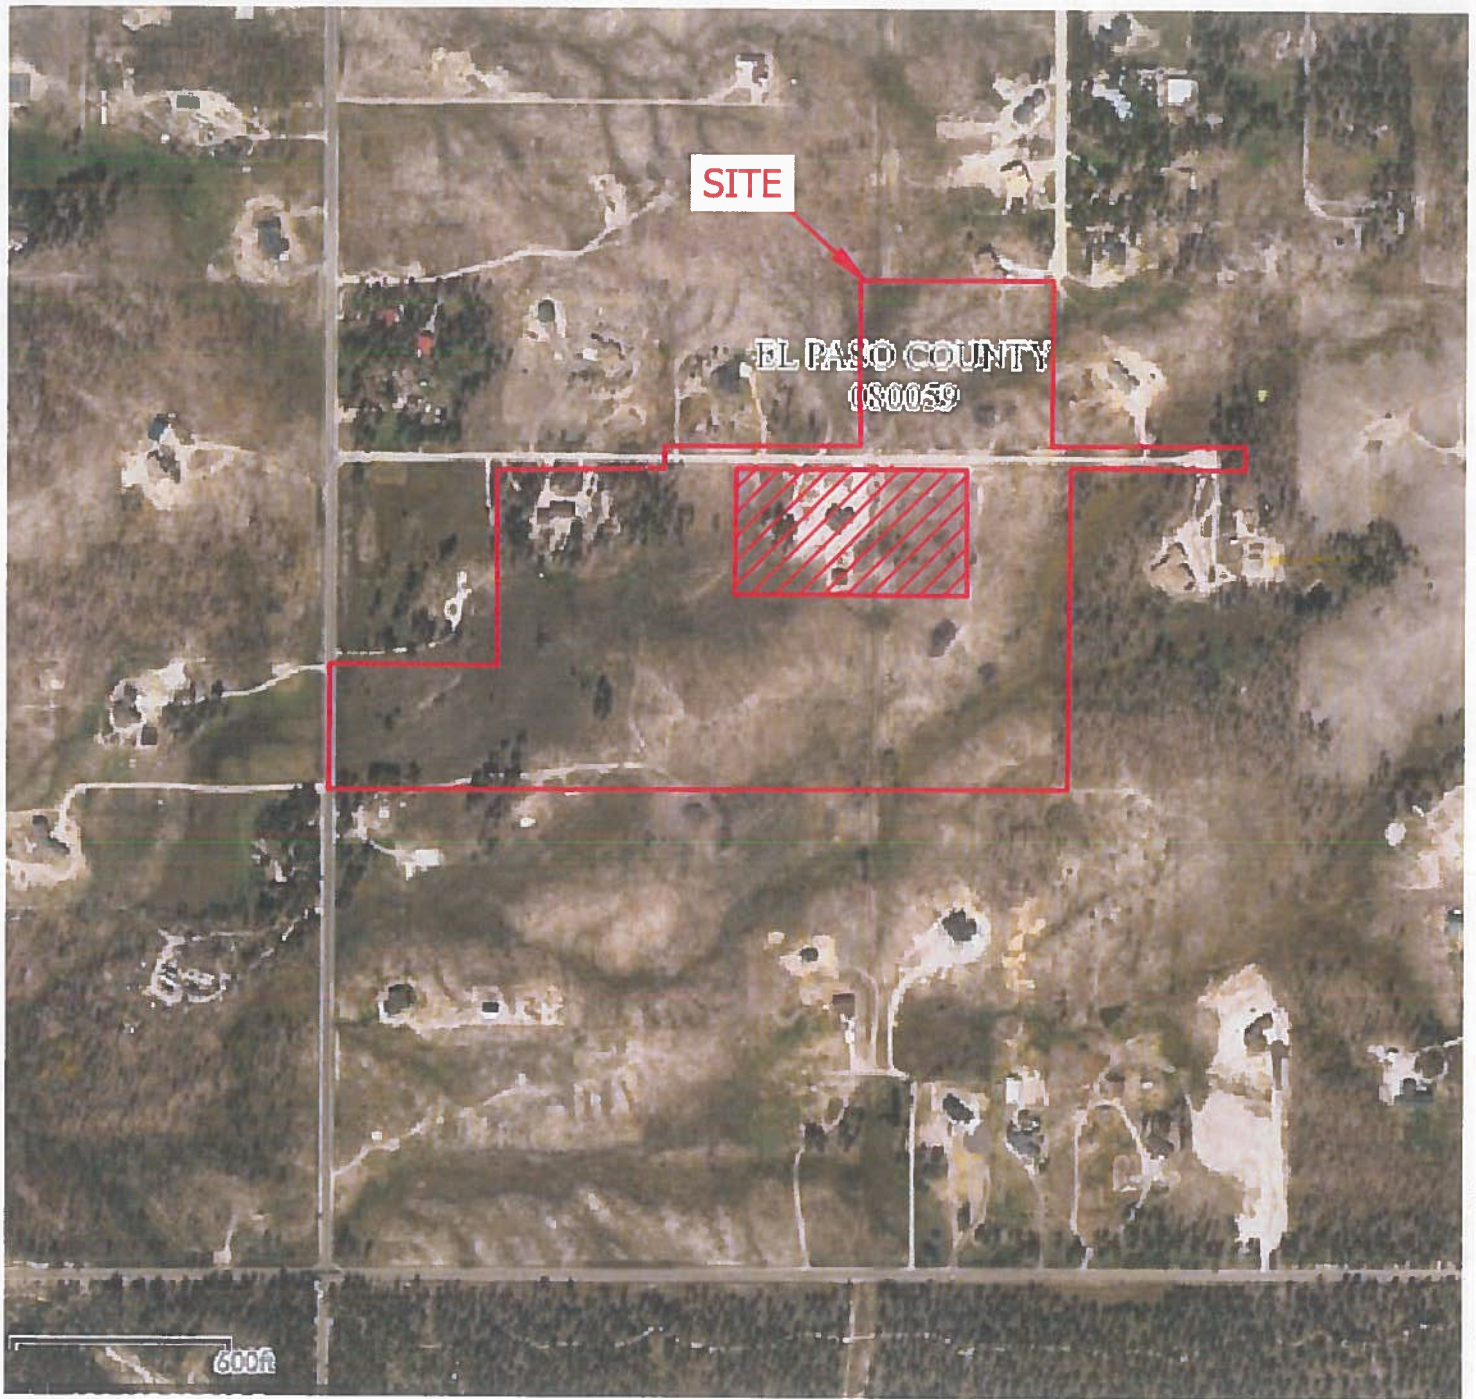
SEPERATE PARCEL NOT INCLUDED IN THE SUBDIVISION

Minor drainages exist on-site that flow in southwesterly directions. Burgess Creek exists in the eastern portion of the site and a minor drainage exists in the western portion of the site. No water was observed flowing in these drainages at the time of the investigation. Areas of seasonal and potentially seasonal shallow groundwater have been mapped in the drainages on the site (Figure 6).

In these areas, we would anticipate the potential for periodically high subsurface moisture conditions, frost heave potential and highly organic soils. These areas lie within minor drainage areas which can be avoided by the proposed development. Due to the potential for seasonal high groundwater conditions, on-site wastewater treatment systems are not recommended in these areas. Due to lot sizes, it is anticipated these areas can be avoided by systems. The site does not lie within any floodplain zones according to the FEMA Map No. 08041CO320 dated December 7, 2018 (Figure 7, Reference 7). Exact locations of floodplain and specific drainage studies are beyond the scope of this report. Individual wastewater treatment systems must be located a minimum of 25 feet from dry gulches and 50 feet from water courses or floodplains.

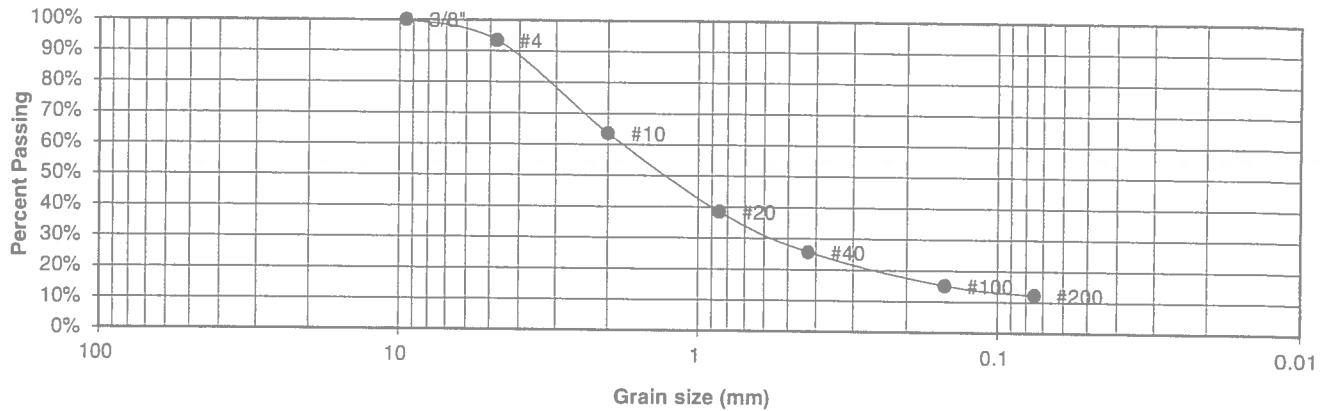
### Sieve Analysis Grain Size Distribution

UNIFIED CLASSIFICATION	SM	CLIENT	LDC, INC.
SOIL TYPE #	1	PROJECT	DIDLEAU SUBDIVISION
TEST BORING #	1	JOB NO.	192115
DEPTH (FT)	2-3	TEST BY	BL

U.S. Sieve #	Percent Finer
3"	
1 1/2"	
3/4"	
1/2"	
3/8"	100.0%
4	93.4%
10	63.6%
20	38.4%
40	25.6%
100	15.1%
200	12.2%

The soils encountered in the test borings and test pits consisted of silty sand to very clayey sand overlying weathered to formational silty sandstone and very sandy claystone. Bedrock was encountered at depths ranging from 2 to 6 feet. The upper sands were encountered at loose to dense states and moderate moisture conditions, and the sandstone was encountered at very dense states and moderate moisture conditions. The claystone was encountered at hard consistencies and moderate moisture conditions. The samples of sand tested had approximately 12 to 38 percent of the soil size particles passing the No. 200 sieve. FHA Swell Testing on a sample of the very clayey sand resulted in an expansion pressure of 1640 psf, which indicates a moderate expansion potential. The samples of sandstone tested had 10 to 22 percent of the soil

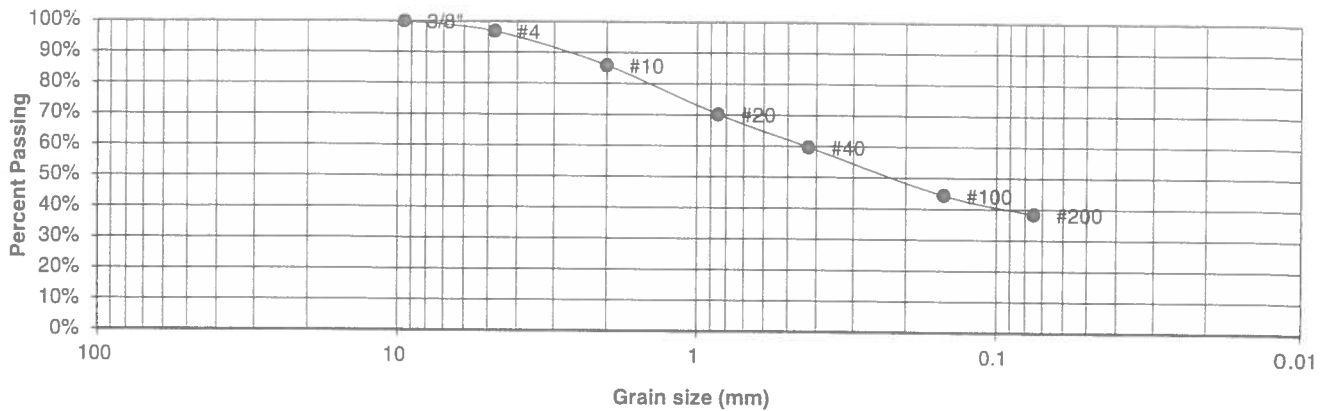
### Sieve Analysis Grain Size Distribution

CLIENT	LDC, INC.
PROJECT	DIDLEAU SUBDIVISION
JOB NO.	192115
TEST BY	BL

U.S. Sieve #	Percent Finer
3"	
1 1/2"	
3/4"	
1/2"	
3/8"	100.0%
4	96.8%
10	85.8%
20	70.2%
40	59.7%
100	44.3%
200	38.4%

<u>Swell</u>	
Moisture at start	13.8%
Moisture at finish	25.6%
Moisture increase	11.8%
Initial dry density (pcf)	95
Swell (psf)	1640

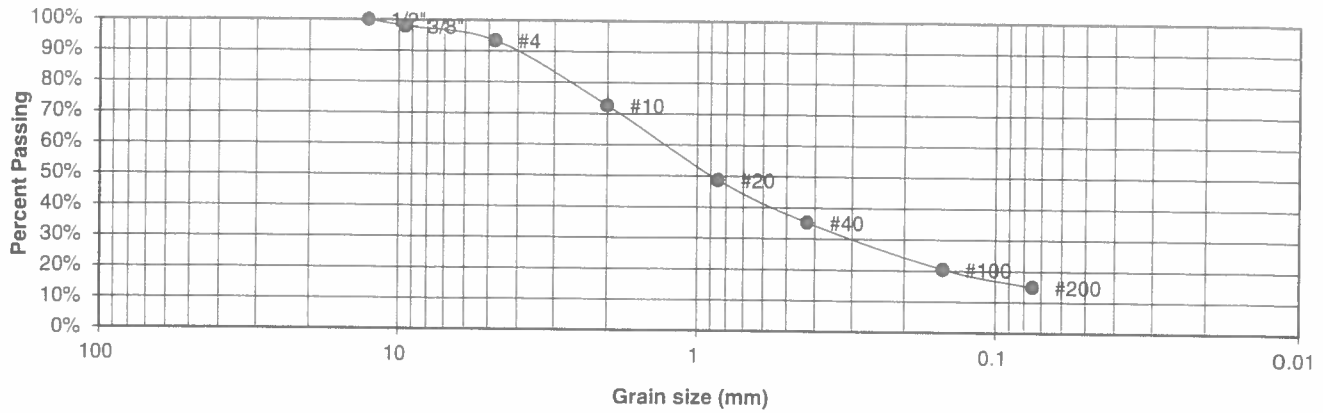
### Sieve Analysis Grain Size Distribution

<u>UNIFIED CLASSIFICATION</u>	SM	<u>CLIENT</u>	LDC, INC.
<u>SOIL TYPE #</u>	1	<u>PROJECT</u>	DIDLEAU SUBDIVISION
<u>TEST BORING #</u>	TP-2	<u>JOB NO.</u>	192115
<u>DEPTH (FT)</u>	2-3	<u>TEST BY</u>	BL

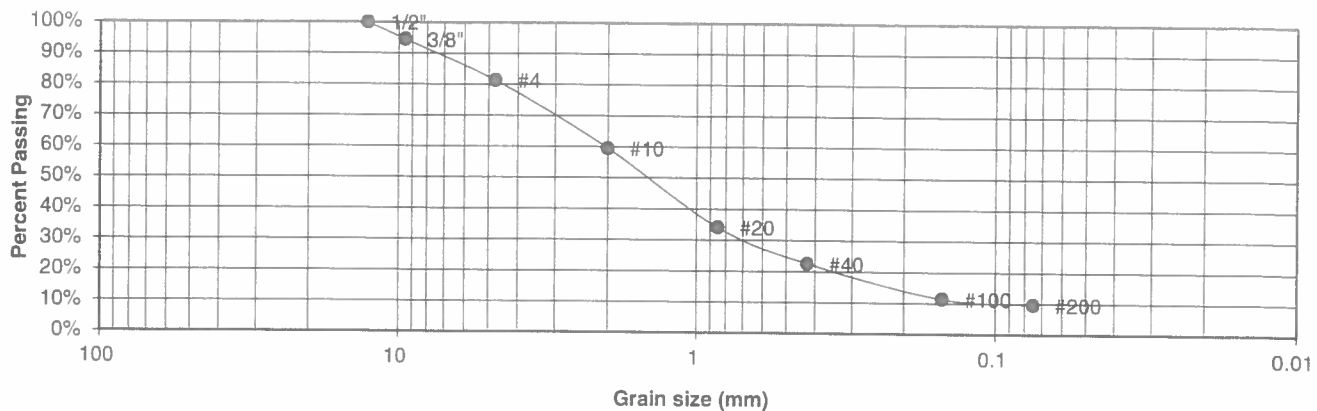
### Sieve Analysis Grain Size Distribution

UNIFIED CLASSIFICATION	SM	CLIENT	LDC, INC.
SOIL TYPE #	2	PROJECT	DIDLEAU SUBDIVISION
TEST BORING #	TP-1	JOB NO.	192115
DEPTH (FT)	5-6	TEST BY	BL

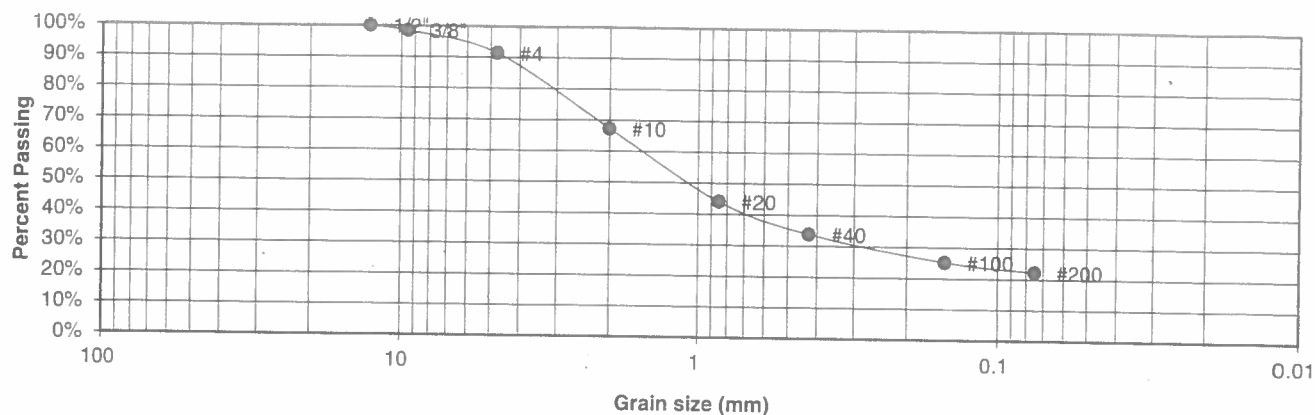
### Sieve Analysis Grain Size Distribution

UNIFIED CLASSIFICATION	SM	CLIENT	LDC, INC.
SOIL TYPE #	2	PROJECT	DIDLEAU SUBDIVISION
TEST BORING #	1	JOB NO.	192115
DEPTH (FT)	15	TEST BY	BL

U.S. Sieve #	Percent Finer
3"	
1 1/2"	
3/4"	
1/2"	100.0%
3/8"	98.4%
#4	91.4%
#10	67.2%
#20	44.1%
#40	33.8%
#100	25.2%
#200	22.2%

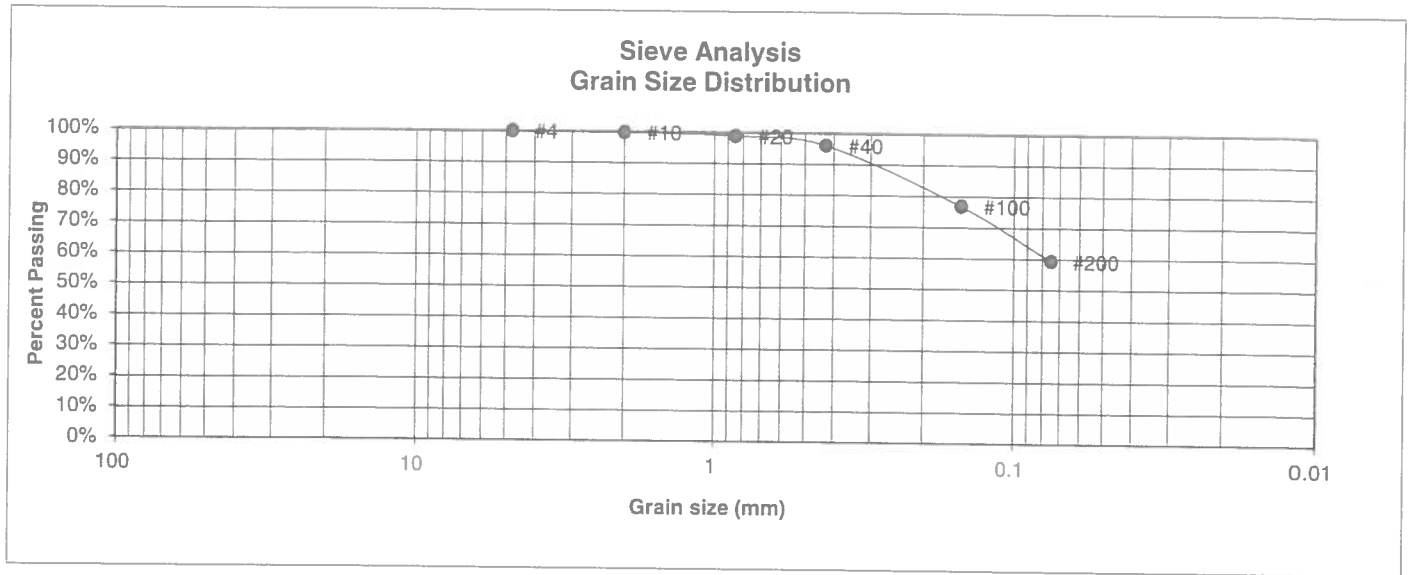
UNIFIED CLASSIFICATION	CL	CLIENT	LDC, INC.
SOIL TYPE #	3	PROJECT	DIDLEAU SUBDIVISION
TEST BORING #	2	JOB NO.	192115
DEPTH (FT)	10	TEST BY	BL

<u>Swell</u>	
Moisture at start	16.1%
Moisture at finish	20.4%
Moisture increase	4.3%
Initial dry density (pcf)	104
Swell (psf)	730

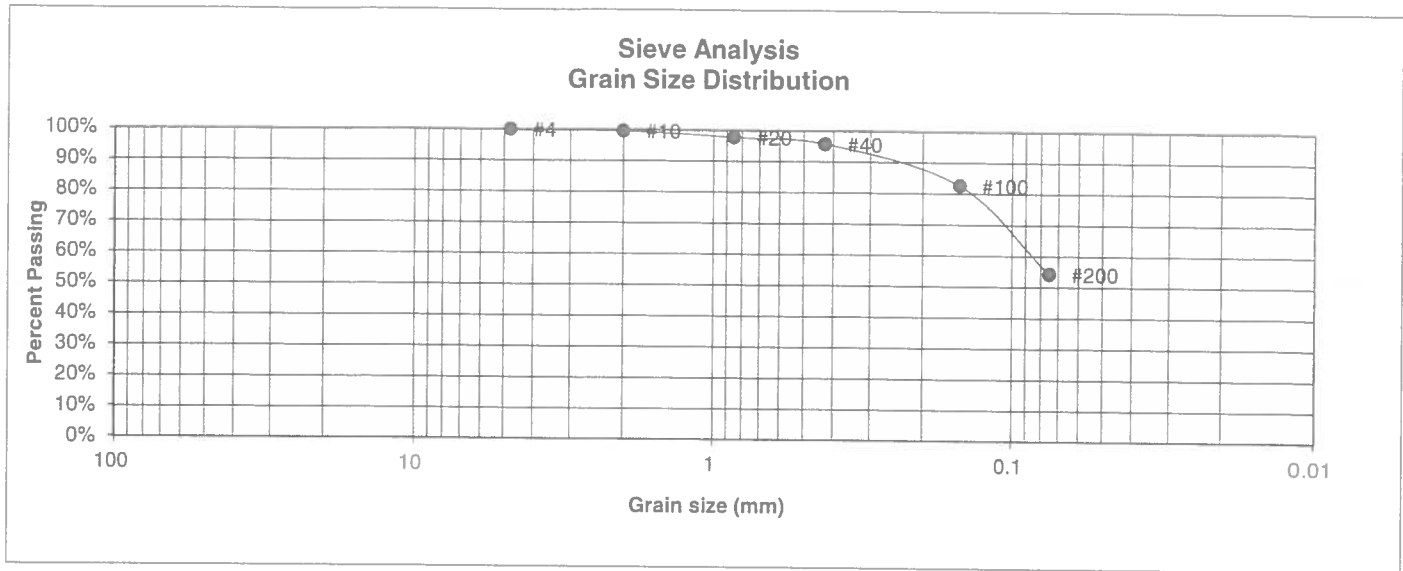
FIG NO  
C-6

UNIFIED CLASSIFICATION	CL	CLIENT	LDC, INC.
SOIL TYPE #	3	PROJECT	DIDLEAU SUBDIVISION
TEST BORING #	2	JOB NO.	192115
DEPTH (FT)	5	TEST BY	BL
