SOIL AND GEOLOGY STUDY

**9660 Towner Avenue
Foundation Lutheran Church
Tract C, Paint Brush Hills, Filing No. 13A
Falcon, Colorado**

**Colorado Commercial Construction
12325 Oracle Blvd, Suite 120
Colorado Springs, CO 80921**

JOB NO. 191726

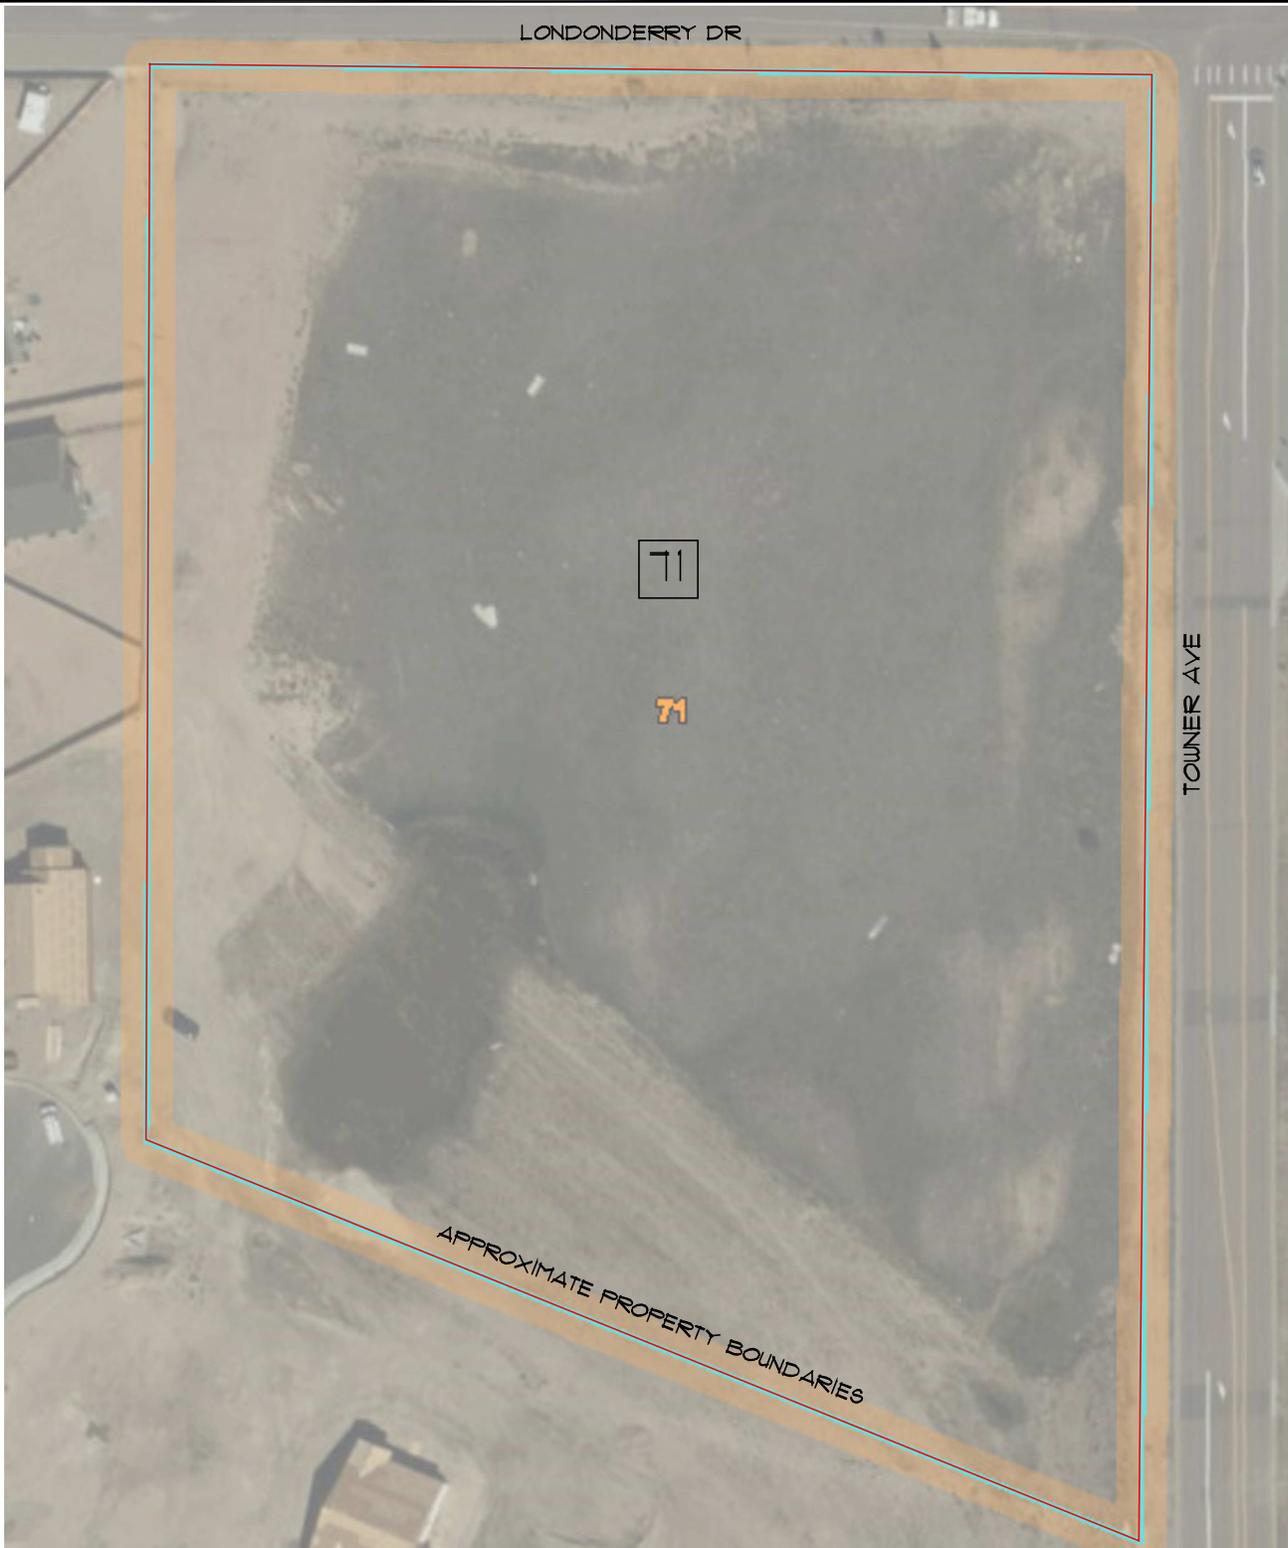
FIG No. 3

71 - Fine coarse sandy loam, 3 to 8 percent slopes

The USDA Soil Survey Map is presented in Figure 3.

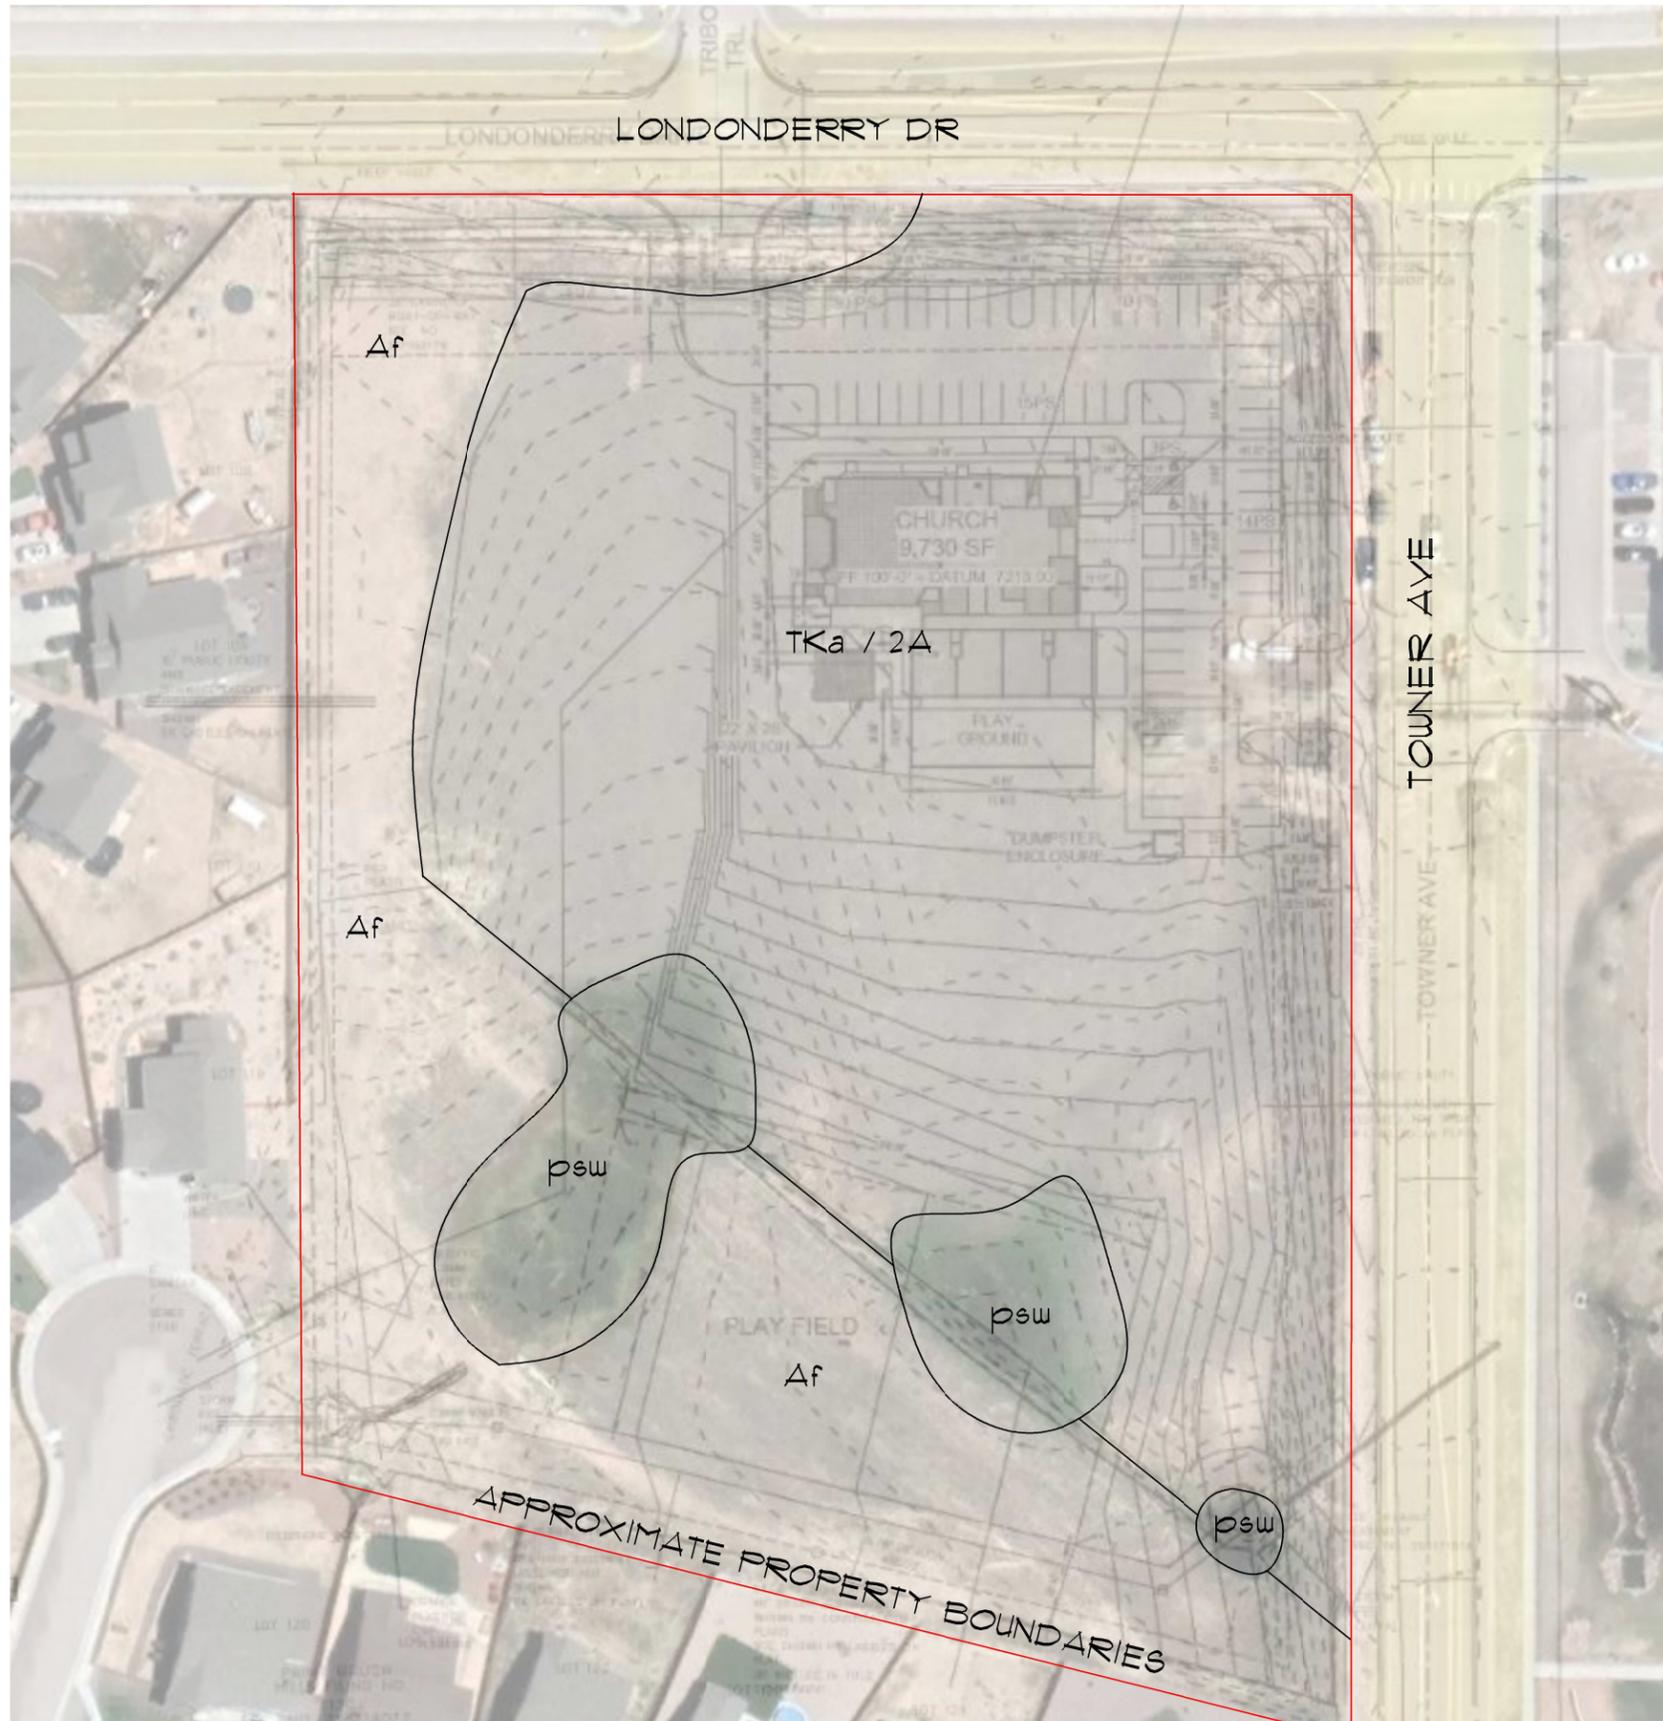
FIG-4

General Geologic Conditions

- *Tkd* - Dawson Arkose Formation - sandstone bedrock with interbedded claystone seams underlies the entire site
- *p sw* - potentially seasonally wet - areas that have historically retained surface water runoff.
- *Af* - Artificial fill - areas that have been built up around the site due to the neighboring development.

Based on our review of relevant geologic maps, we identified the geologic conditions (listed below) affecting the development, as shown on the Engineering and Geology Map, Figure 4.

One engineering geology unit was mapped at the site and is shown on the Engineering and Geology Map, Figure 4.

Currently, the surface drainage on-site is uncontrolled. Chromatic Terrace, a cul-de-sac near the southwest corner of the property, sheetwashes water from the paved surface down onto the site. Over time, this surface water has created ponding water at the surface. Proposed drainage improvements are to include new storm inlet that is to reroute the surface water from Chromatic Terrace to an off-site drainage facility, located southeast of the property. The areas of surface water are currently indicated as potentially seasonally wet (*psw*) on the Engineering and Geology Map, Figure 4. These areas are anticipated to slowly dissipate once the proposed drainage improvements are installed.

Proposed drainage improvements are to include a new storm inlet that is to reroute the surface water from the west to the east. The areas of surface water are currently indicated as potentially seasonally wet (*psw*) on the Engineering and Geology Map, Figure 4.
