## **SOILS AND GEOLOGY STUDY**

**Currently Addressed: 11525 Howells Road  
Schedule No. 6214000071  
El Paso County, Colorado**

**JOB NO. 198665**

**May 27, 2026**

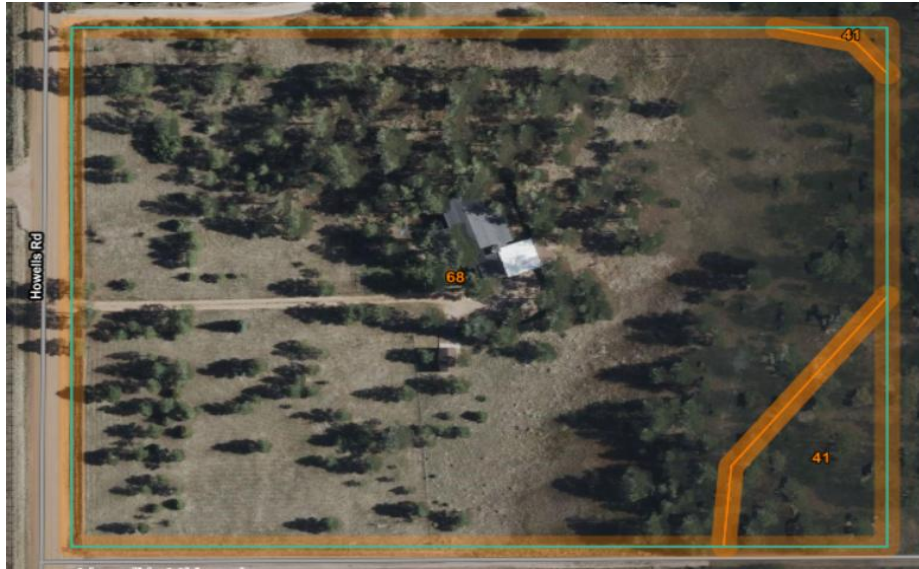
- **41 – Kettle Gravelly Loamy Sand**, 8 to 40 percent slopes. The Kettle Gravelly Loamy Sand was mapped by the USDA to encompass a small portion of the southeast corner of the property. Properties of the loamy sand include somewhat excessively drained soils, depth of the water table is anticipated to be greater than 80 inches, runoff is anticipated to be medium, frequency of flooding and/or ponding is none, and landforms include hills.
- **68 – Peyton-Pring complex**, 3 to 8 percent slopes. The Peyton-Pring complex was mapped by the USDA to encompass the majority of the property. Properties of the Peyton-Pring complex include, well-drained soils, depth of the water table is anticipated to be greater than 6.5 feet, runoff is anticipated to be low, frequency of flooding and ponding is none, and landforms include hills.

The USDA Soil Survey Map is presented below.

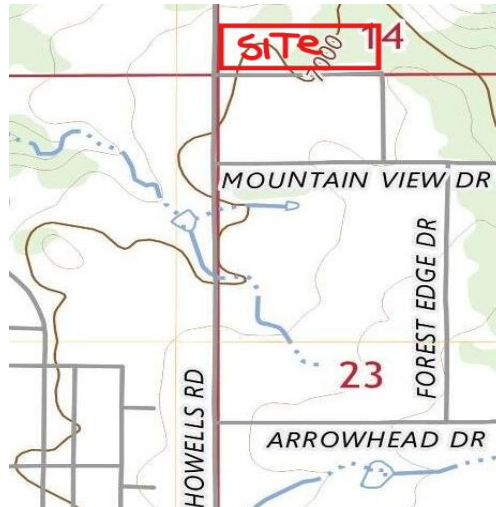
The overall topography of the site slopes down to the north, northeast. Generally, the direction of surface water and groundwater flows in the same direction. Groundwater was not encountered at the time of drilling and is not expected to affect basement foundation, if selected. Groundwater is known to fluctuate depending on the season, variations in rainfall, new development, proximity to drainages, etc. Groundwater measurements in test borings are limited to the time of year measured (a snapshot) and are inherently inaccurate in predicting depth to groundwater during the engineering life of a structure/development. At this time, there is not enough conclusive evidence to preclude basement construction (e.g. elevated moisture conditions, redoximorphic features) or recommend a groundwater-monitoring program to observe seasonal fluctuations. However, if construction is not to occur within a few years, a follow up test boring to verify the groundwater conditions would be prudent for the future homeowners.

Multiple natural drainage/ravine features are located north of the site. Kettle Creek had a trickle of water at the time of site reconnaissance performed by RMG in December 2025. The USGS Topo Map is presented below.

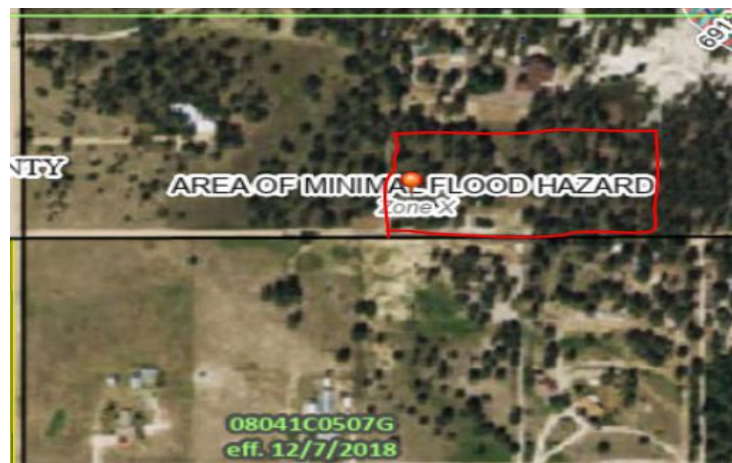
Based on our review of the Federal Emergency Management Agency (FEMA) Community Panel Nos. 08041C0507G and the online ArcGIS El Paso County Risk Map, the entire site lies outside the 100-year floodplain and regulatory floodway. FEMA Map is presented below. The site is outlined in red.

Zone X is defined by FEMA as an area of minimal flood hazard that is determined to be outside the floodway and floodplain.

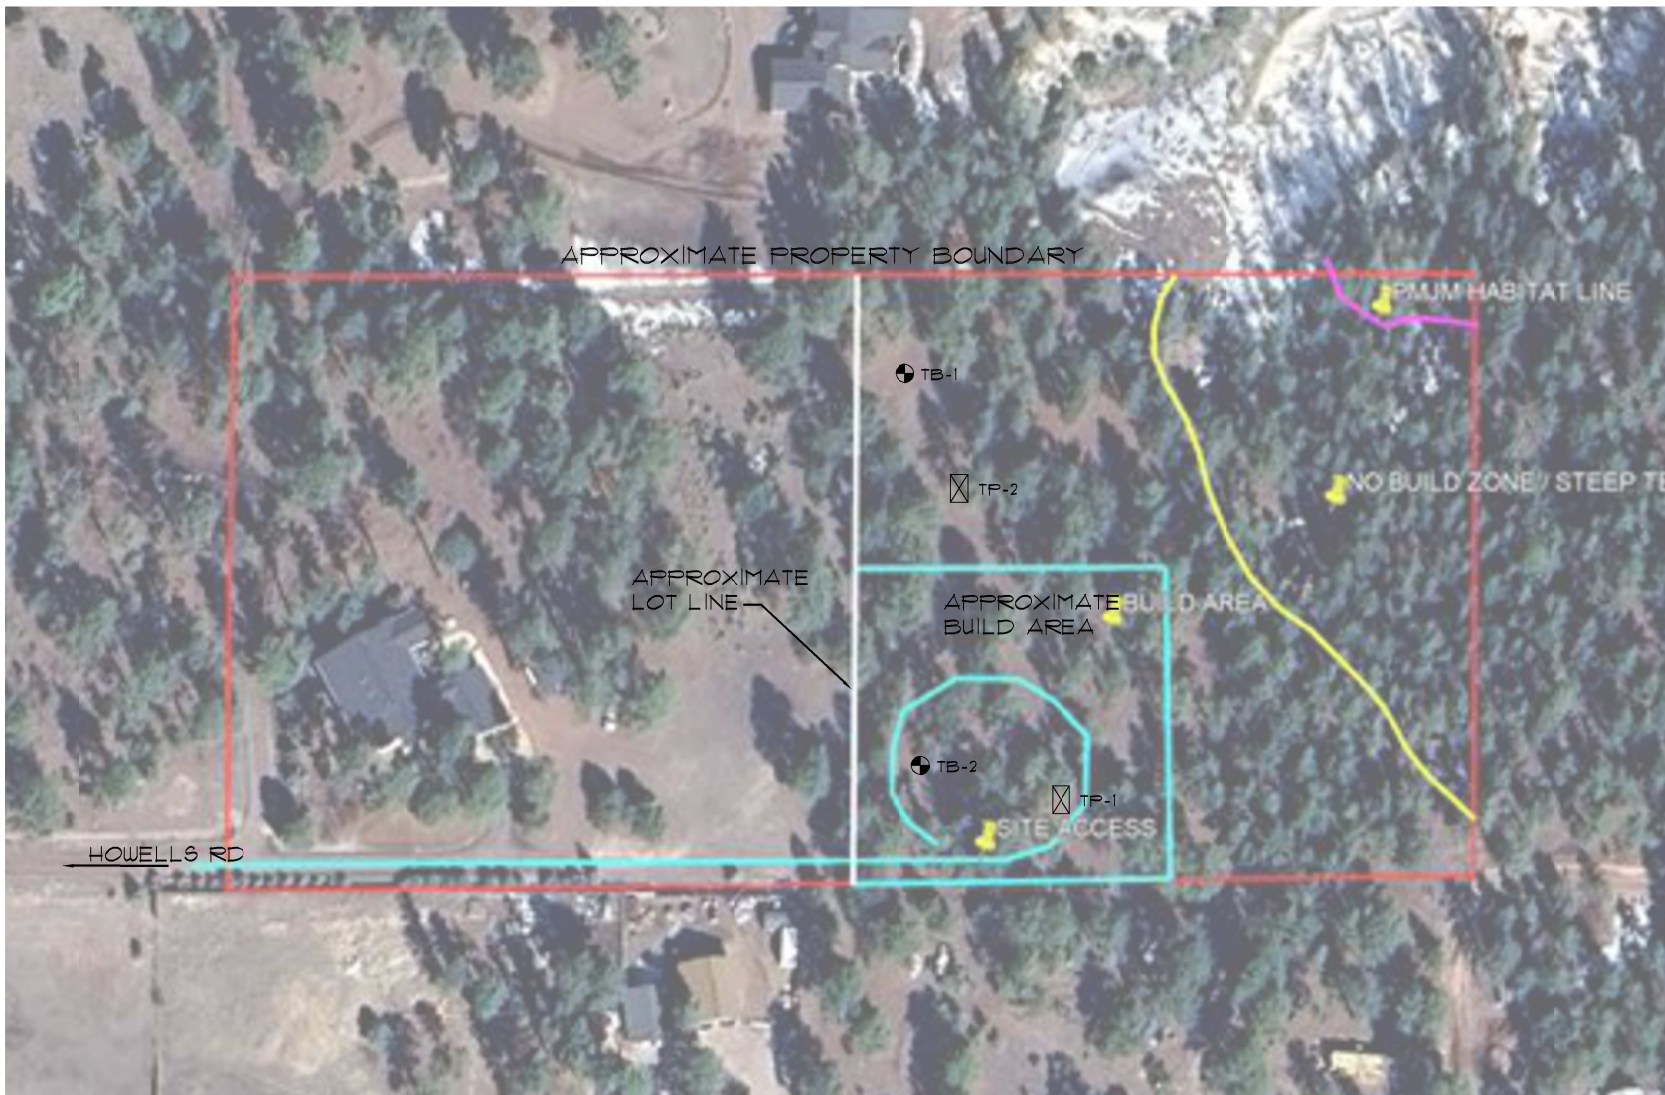
FIG No. 3

● DENOTES APPROXIMATE  
LOCATION OF TEST BORINGS

The subsurface conditions were explored by RMG by drilling two (2) test borings. The test borings were performed on December 2, 2025 and extended to 20 and 30 feet below the existing ground surface. Additionally, two (2) test pits were observed on December 12, 2025. The approximate location of the test borings and test pits are presented on the Test Boring/Pit Location Plan, Figure 3.

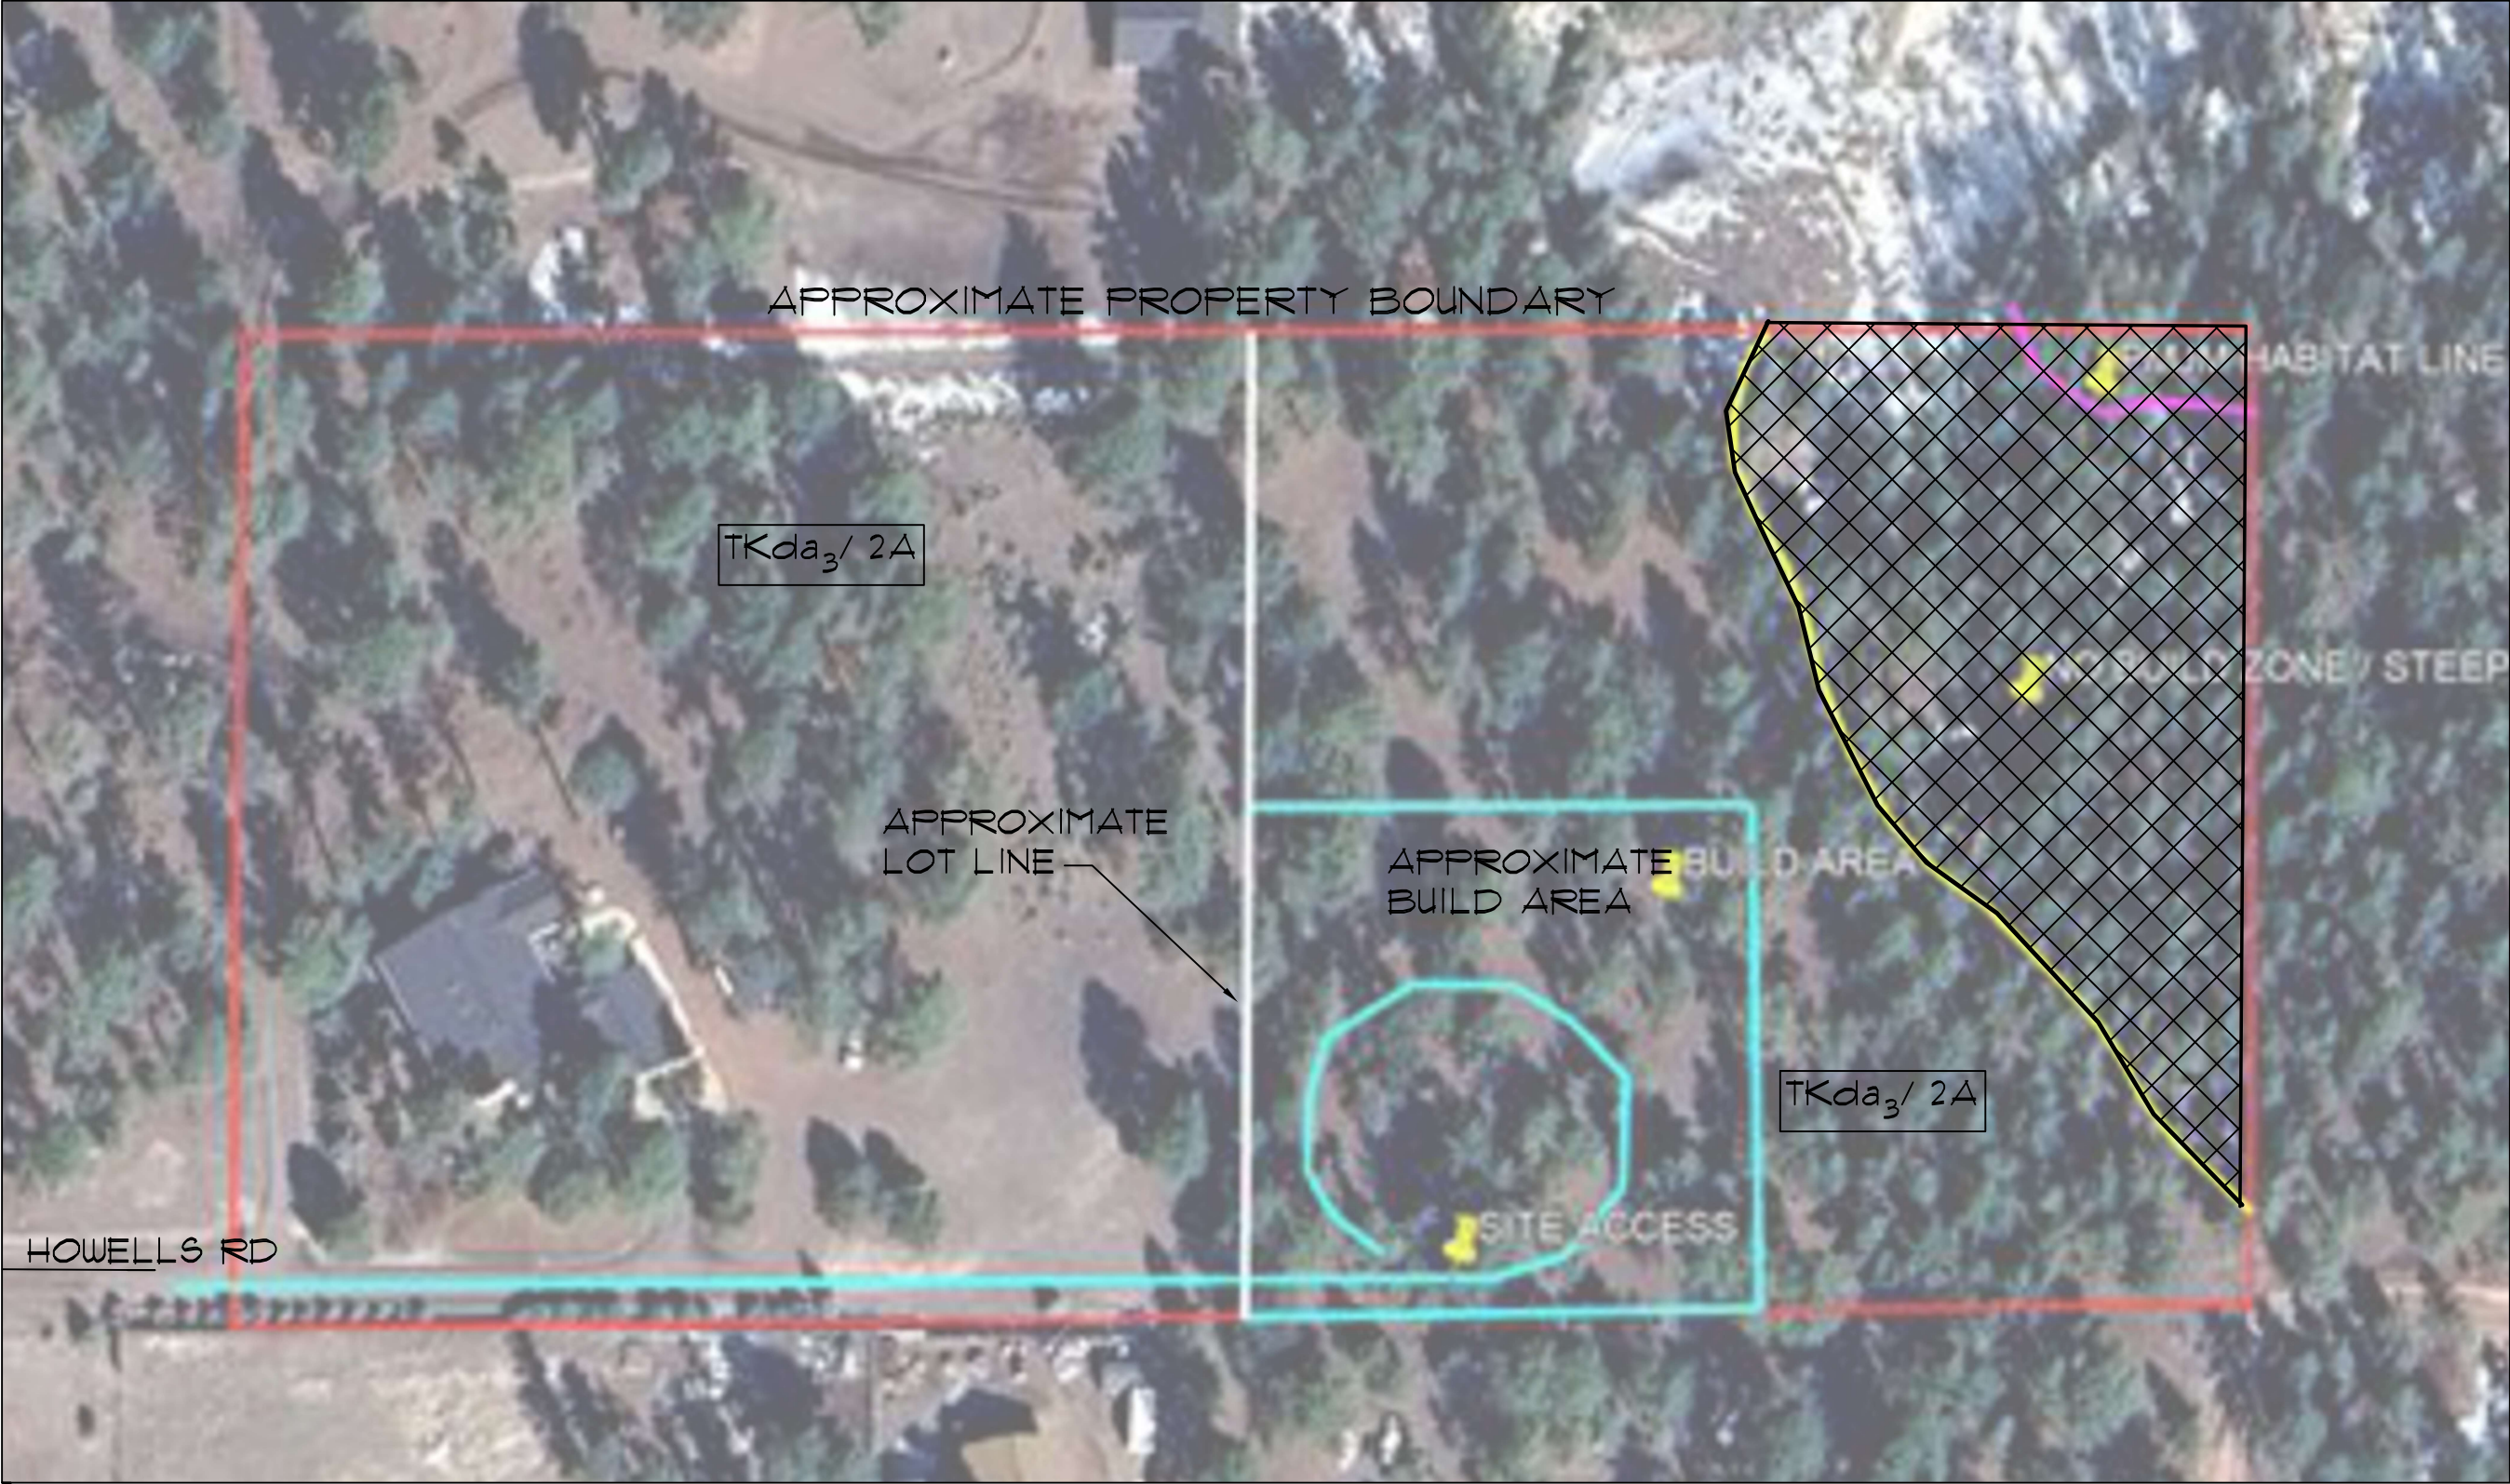
FIG-8

**GEOLOGIC UNITS**

**Tkda3 - Dawson Formation Facies Unit Three (Paleocene)** - this unit is generally light-gray to greenish-gray, contains interbedded sandy claystone that is known to be expansive in the area, and underlies the entire site. This unit was encountered in the borings. Residually weathered claystone, claystone and sandstone were encountered at approximately 12-foot below the surface.

Based on our field observations and review of relevant geologic maps, we identified the geologic conditions (listed below) affecting the development, as shown on the Engineering and Geology Map, Figure 8.

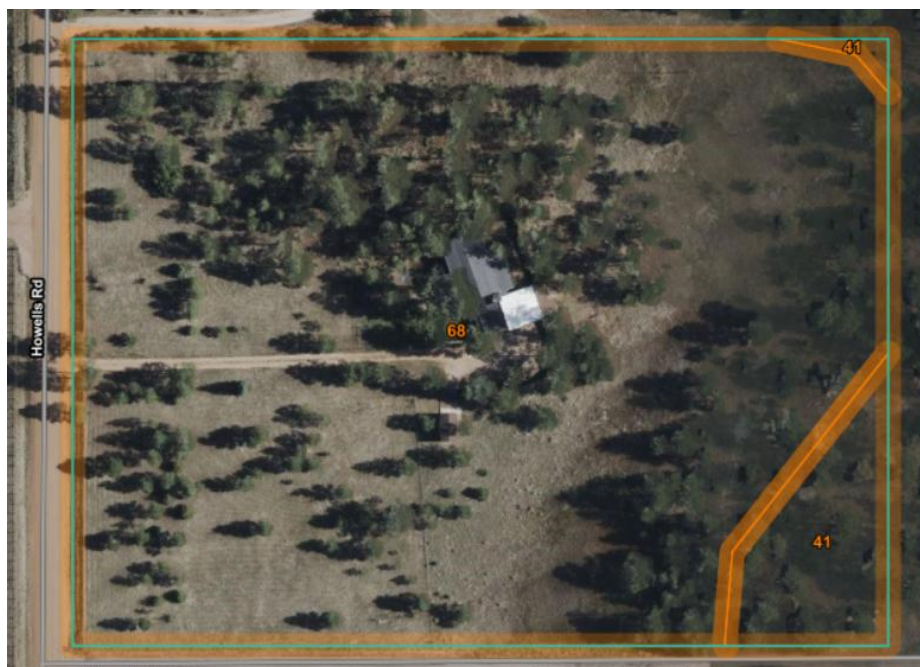
- **41 – Kettle Gravelly Loamy Sand**, 8 to 40 percent slopes. The Kettle Gravelly Loamy Sand was mapped by the USDA to encompass a small portion of the southeast corner of the property. Properties of the loamy sand include somewhat excessively drained soils, depth of the water table is anticipated to be greater than 80 inches, runoff is anticipated to be medium, frequency of flooding and/or ponding is none, and landforms include hills.
- **68 – Peyton-Pring complex**, 3 to 8 percent slopes. The Peyton-Pring complex was mapped by the USDA to encompass the majority of the property. Properties of the Peyton-

Pring complex include, well-drained soils, depth of the water table is anticipated to be greater than 6.5 feet, runoff is anticipated to be low, frequency of flooding and ponding is none, and landforms include hills. A USDA Soil Survey Map is presented below.

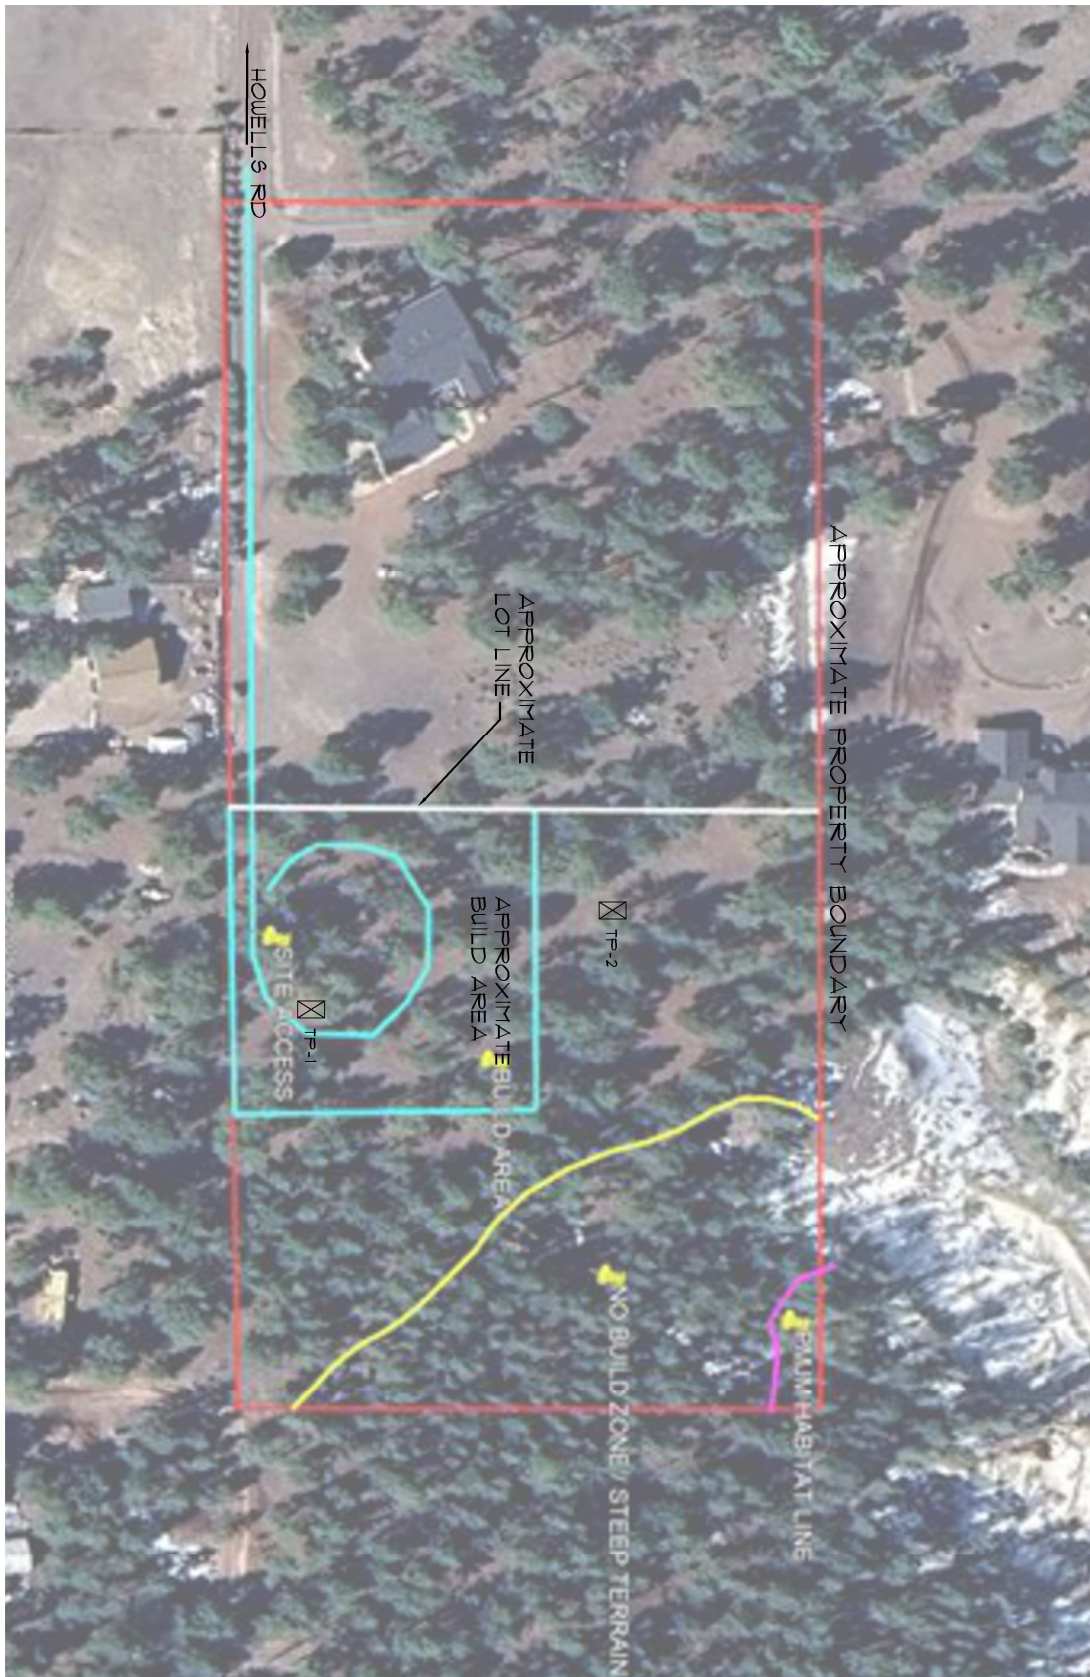
FIG No. 2

☒ DENOTES APPROXIMATE  
LOCATION OF TEST PITS

Personnel of RMG performed a reconnaissance visit on December 12, 2025. The purpose of the reconnaissance visit was to evaluate the site surface characteristics including landscape position, topography, vegetation, natural and cultural features, and current and historic land uses. Two test pits (6 and 7 feet deep) were performed on the new proposed (eastern) lot, during our reconnaissance visit. A Test Pit Location Plan is presented in Figure 2.
