**GEOLOGIC HAZARDS EVALUATION AND  
PRELIMINARY GEOTECHNICAL INVESTIGATION  
MAYBERRY – 540 ACRE SITE  
STATE HIGHWAY 94 AND LOG ROAD  
EL PASO COUNTY, COLORADO**

CTL|T Project No. CS18969.004-105

March 13, 2023

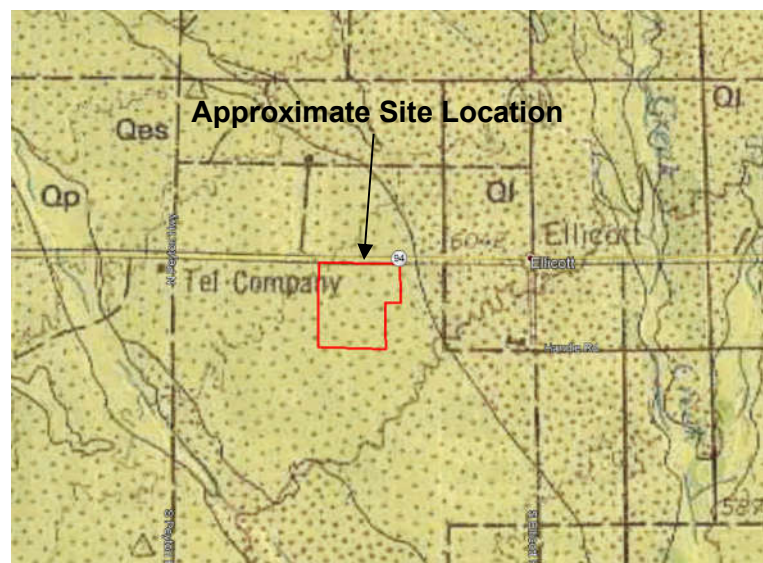
**Geologic Map**

The site is mapped as Holocene and Pinedale Glaciation of the Pleistocene age eolian sand (wind-deposited sediment), overlying the Dawson Formation. The Dawson Formation typically consists of sandstone interbedded with claystone in this area. Our subsurface investigation and observations generally confirm the mapping, although no bedrock was encountered to depths of up to 30-feet. Some areas in the northeast portion of the site have been disturbed by previous development activities.

The surficial geology at the site was evaluated by re-viewing published geologic maps and our site visits. The Geologic Map of the Pueblo 1° x 2° degrees Quadrangle<sup>1</sup>, published by the US Geological Survey in Miscellaneous Field Studies Map MF-775, 1978 covers the project site.

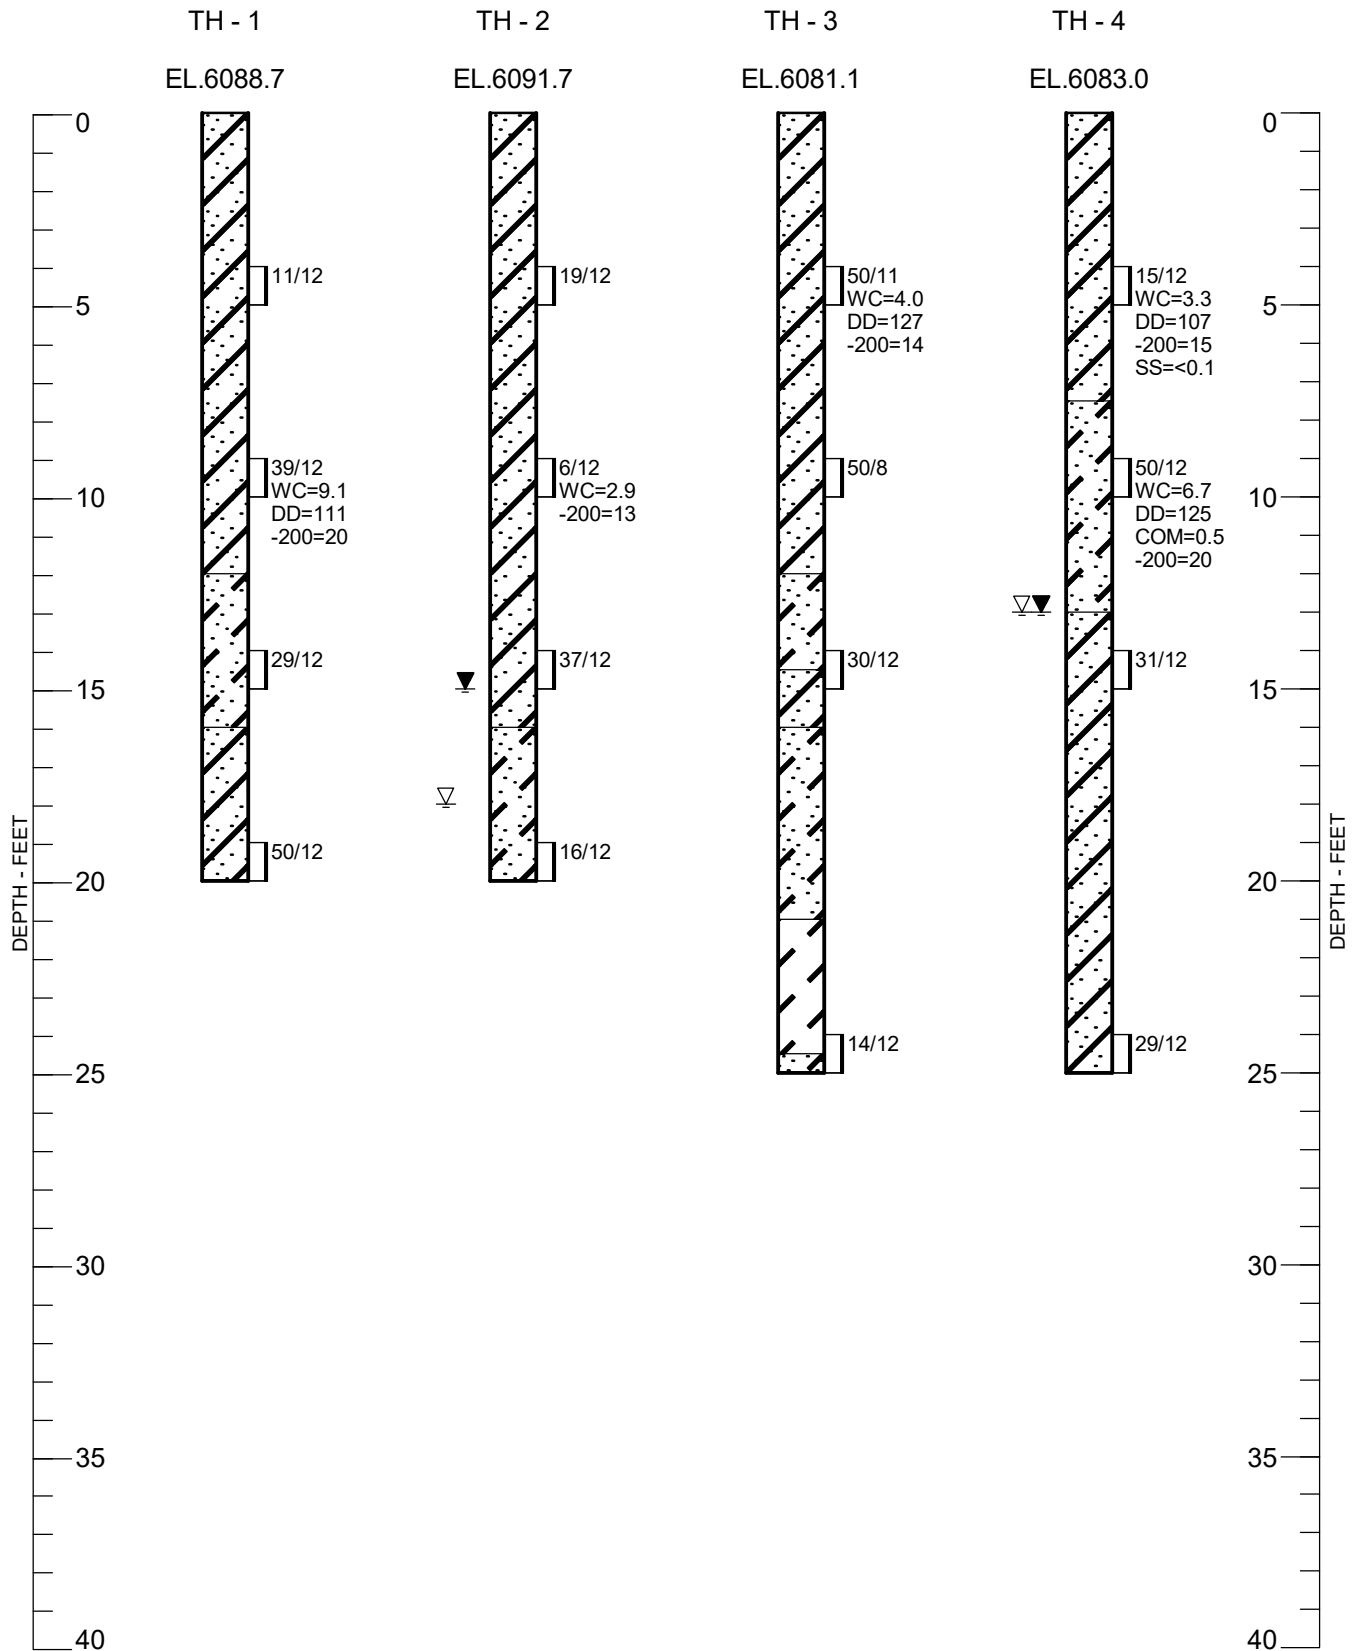
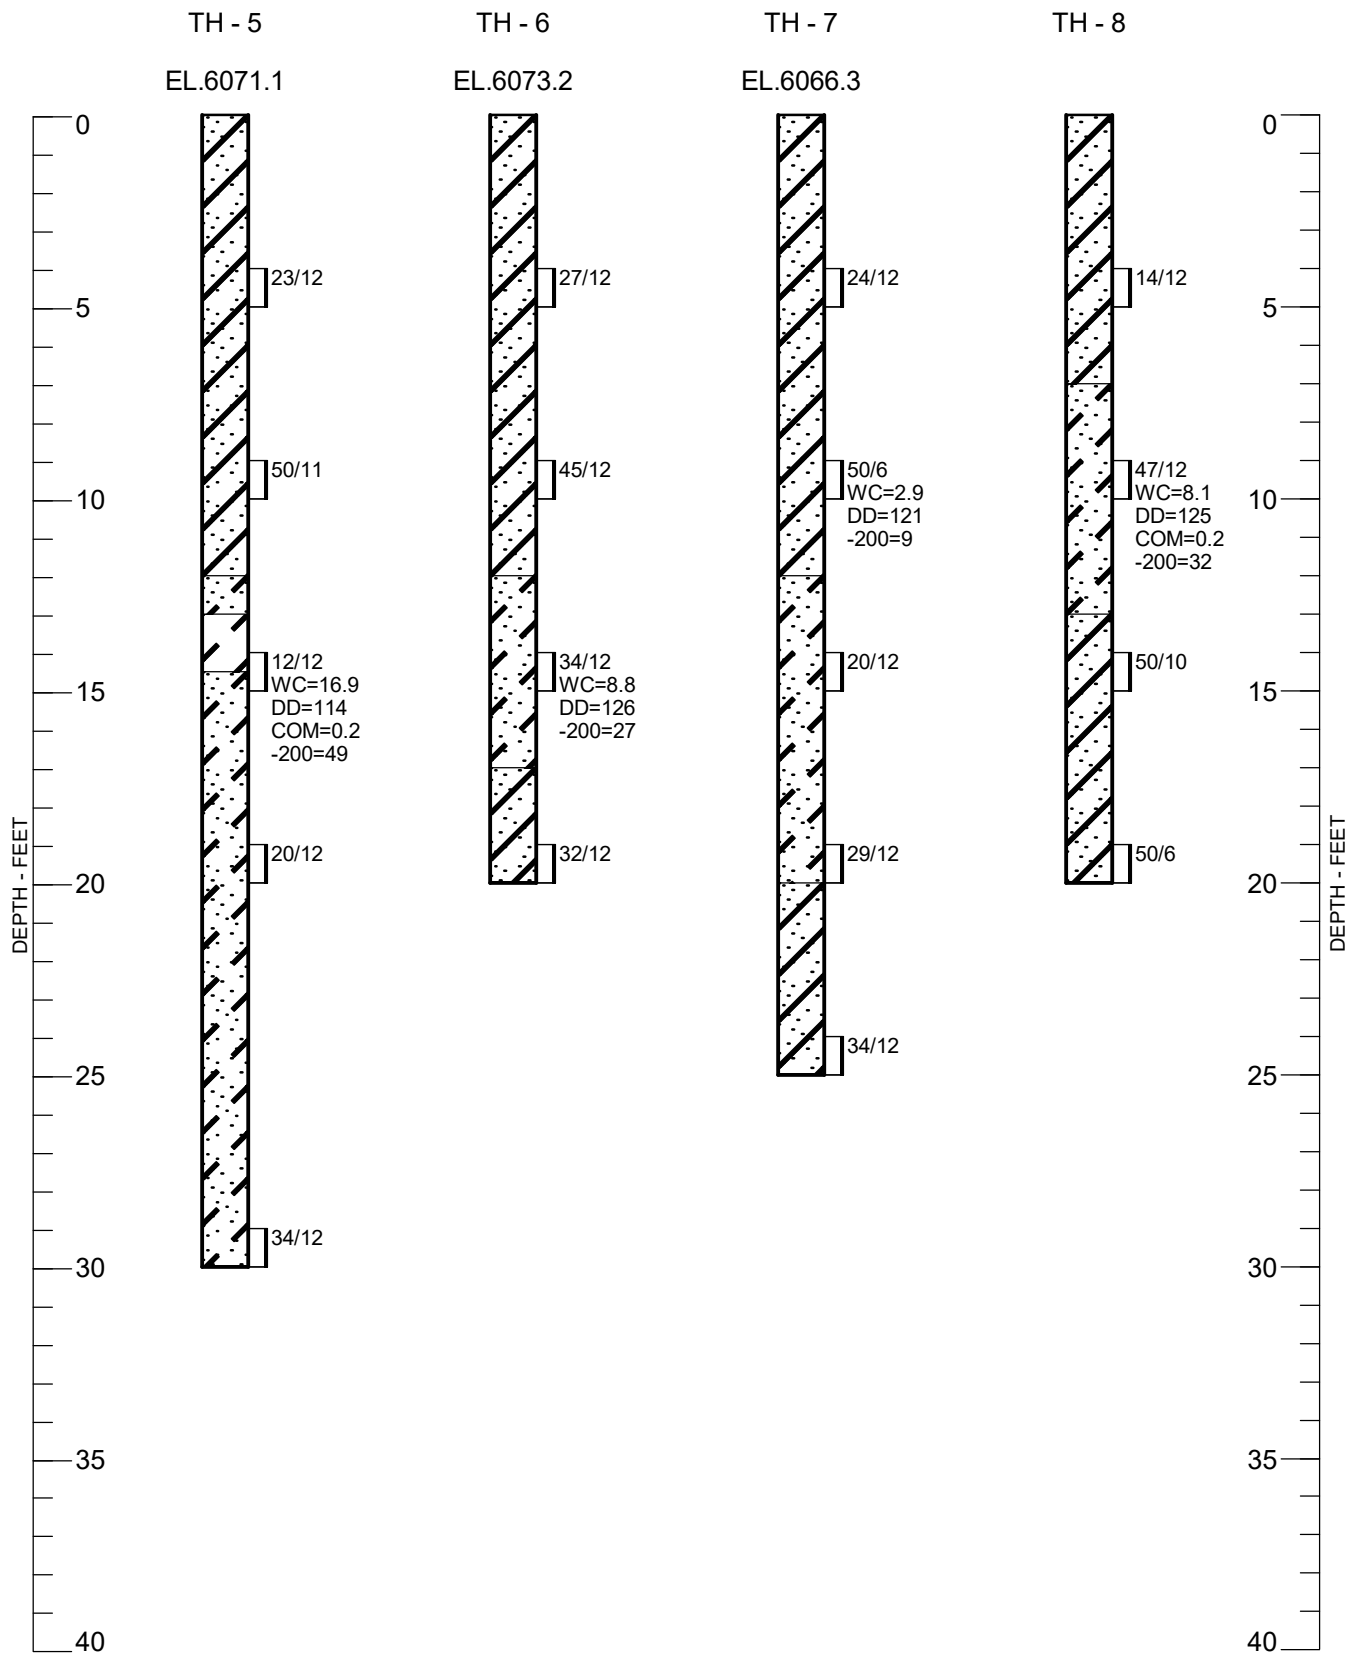
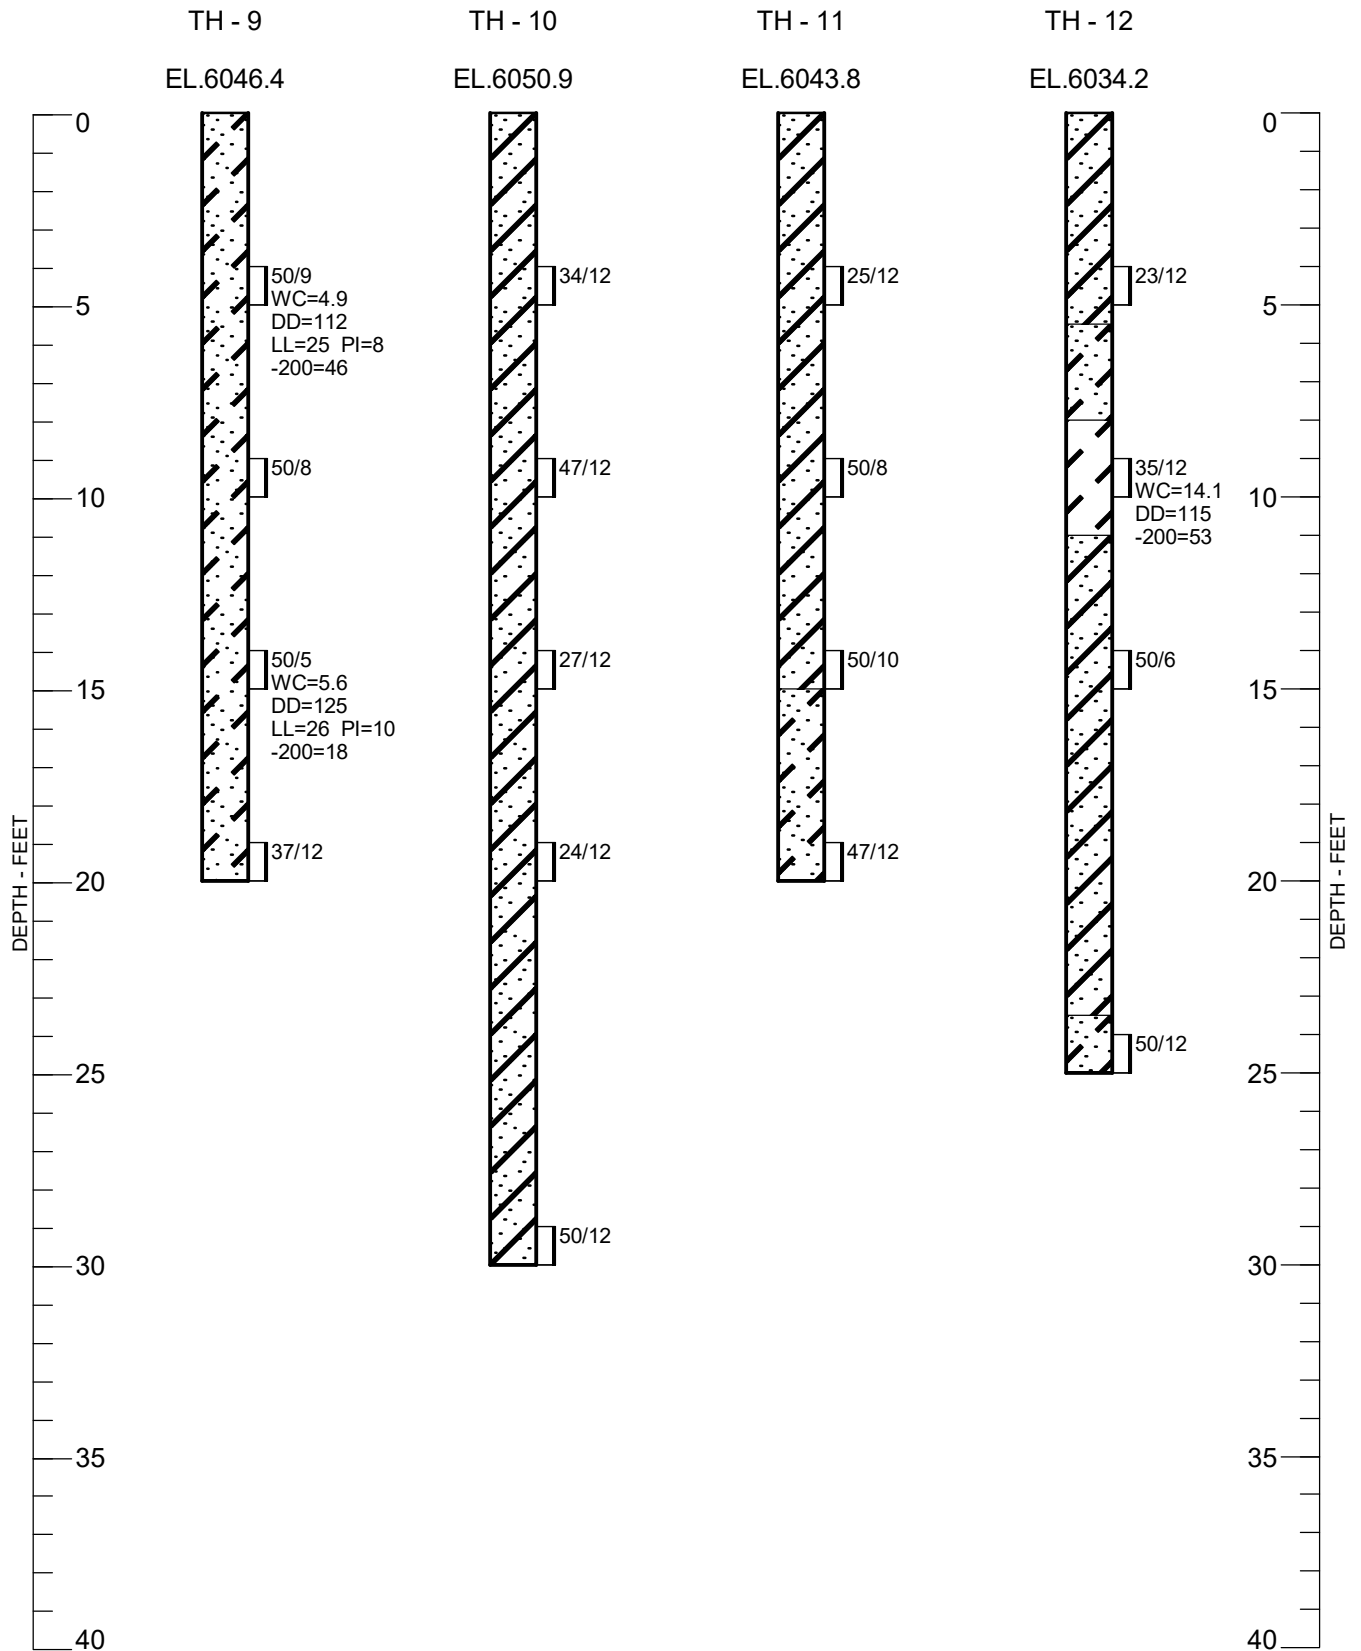
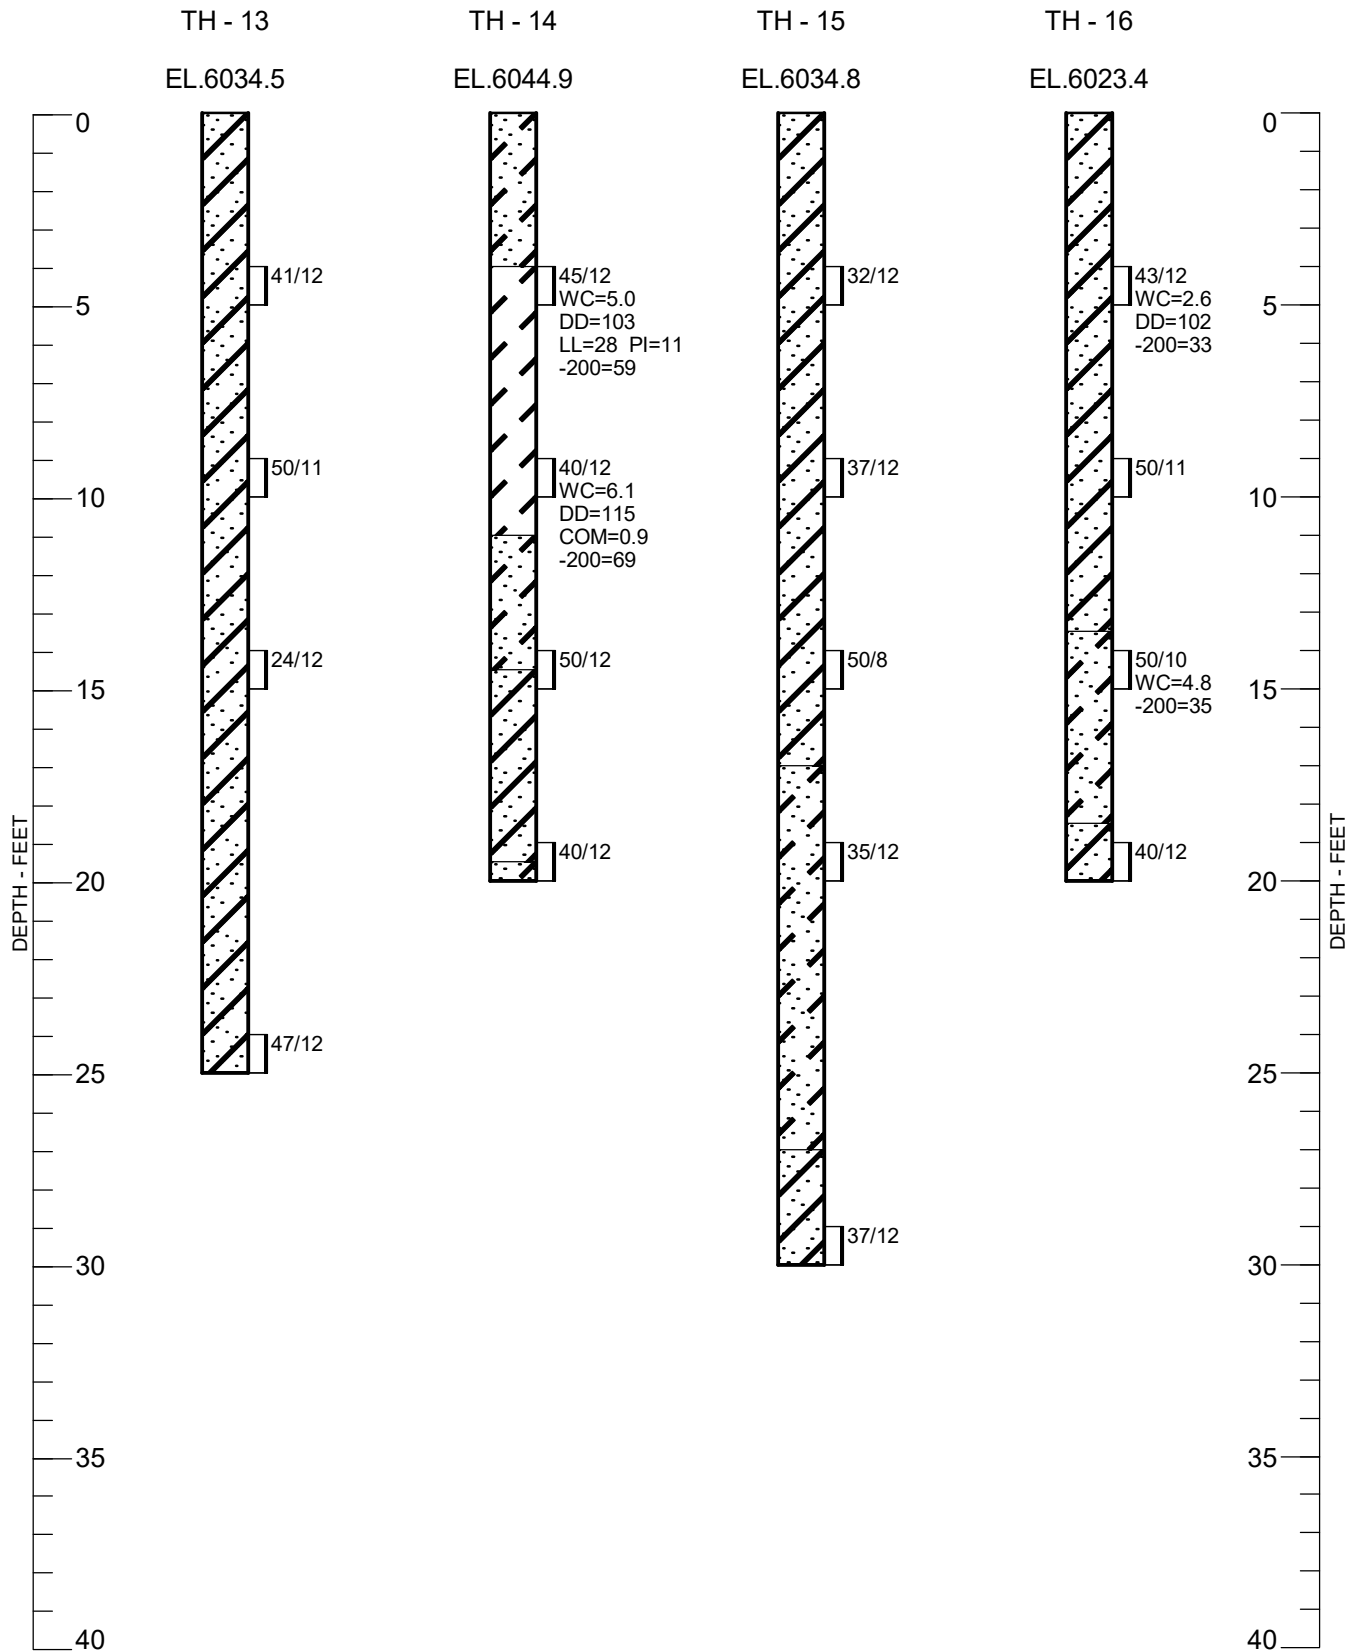
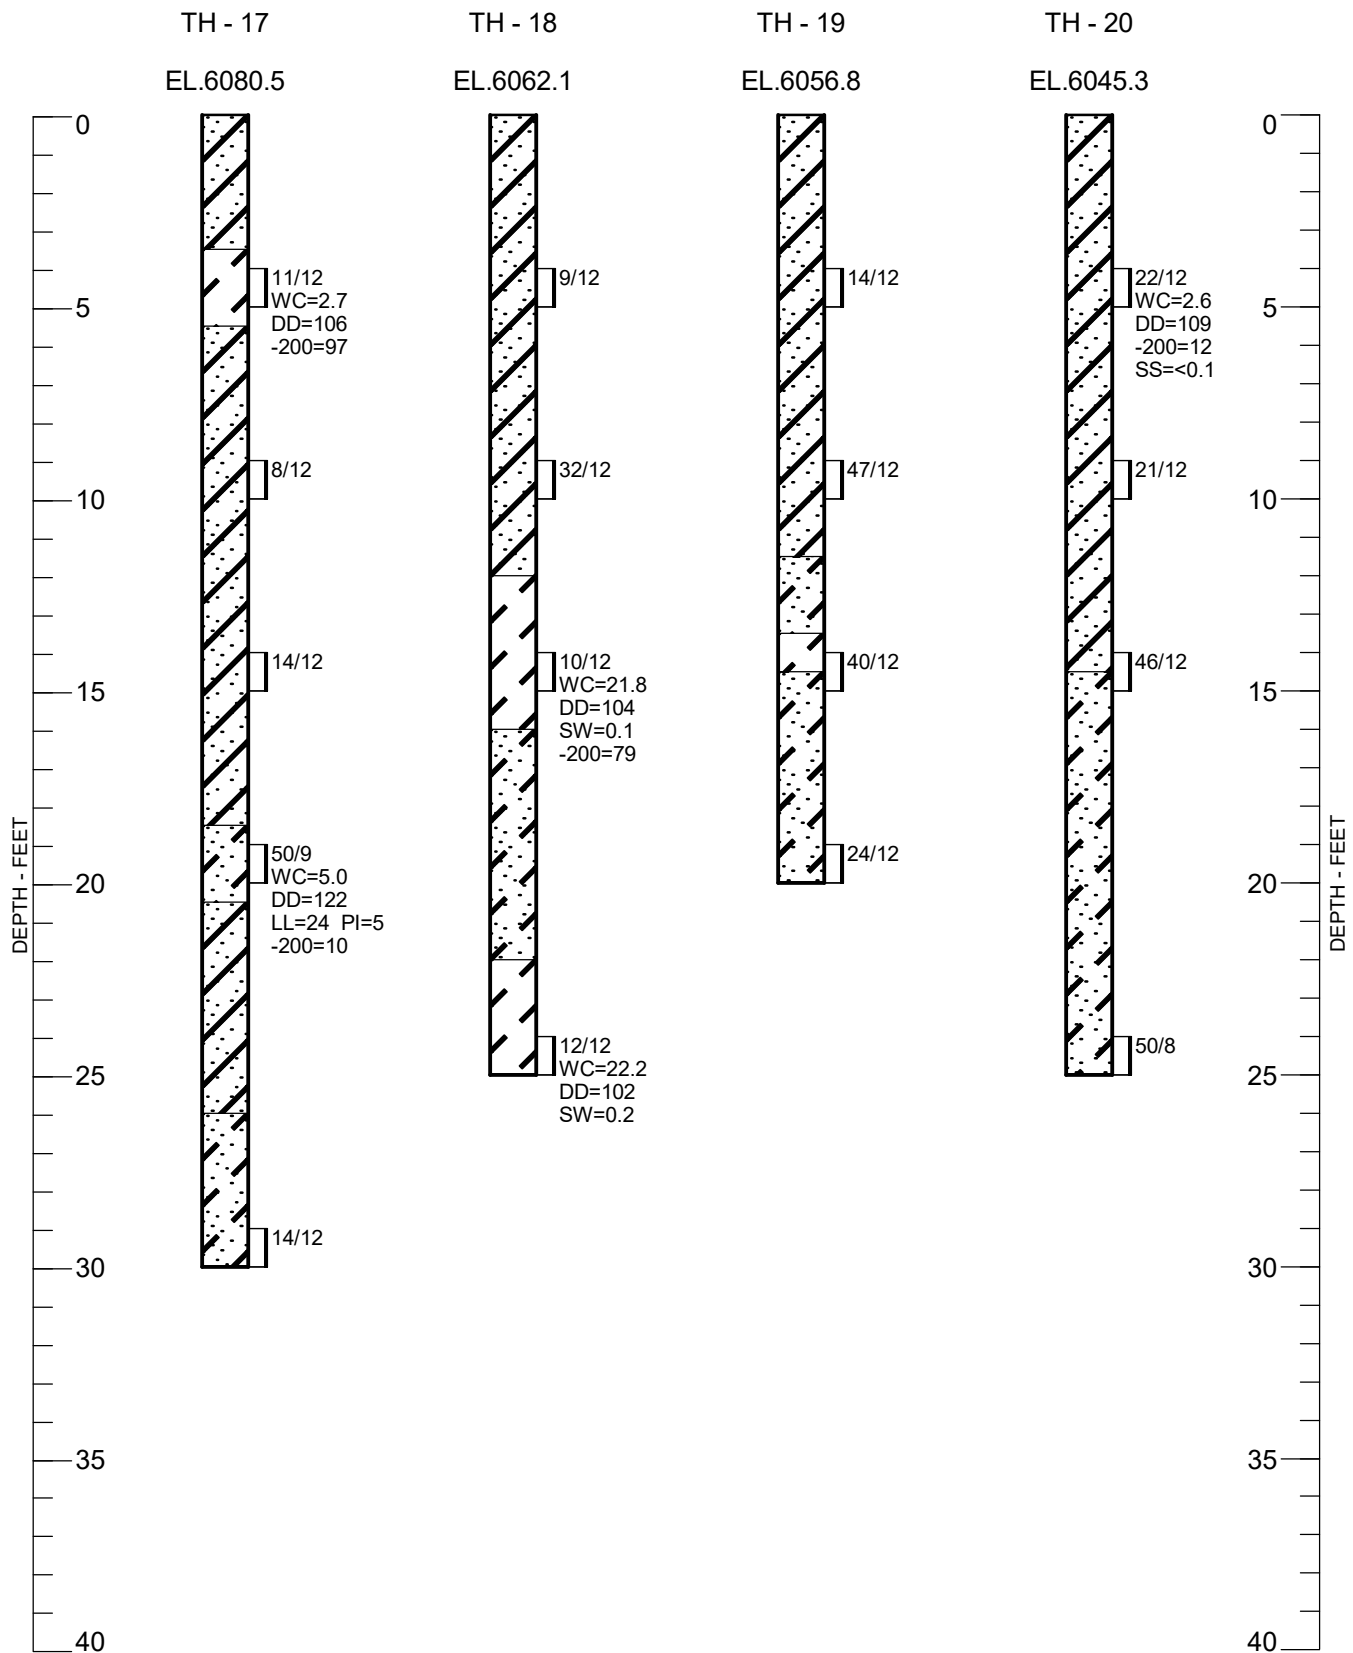
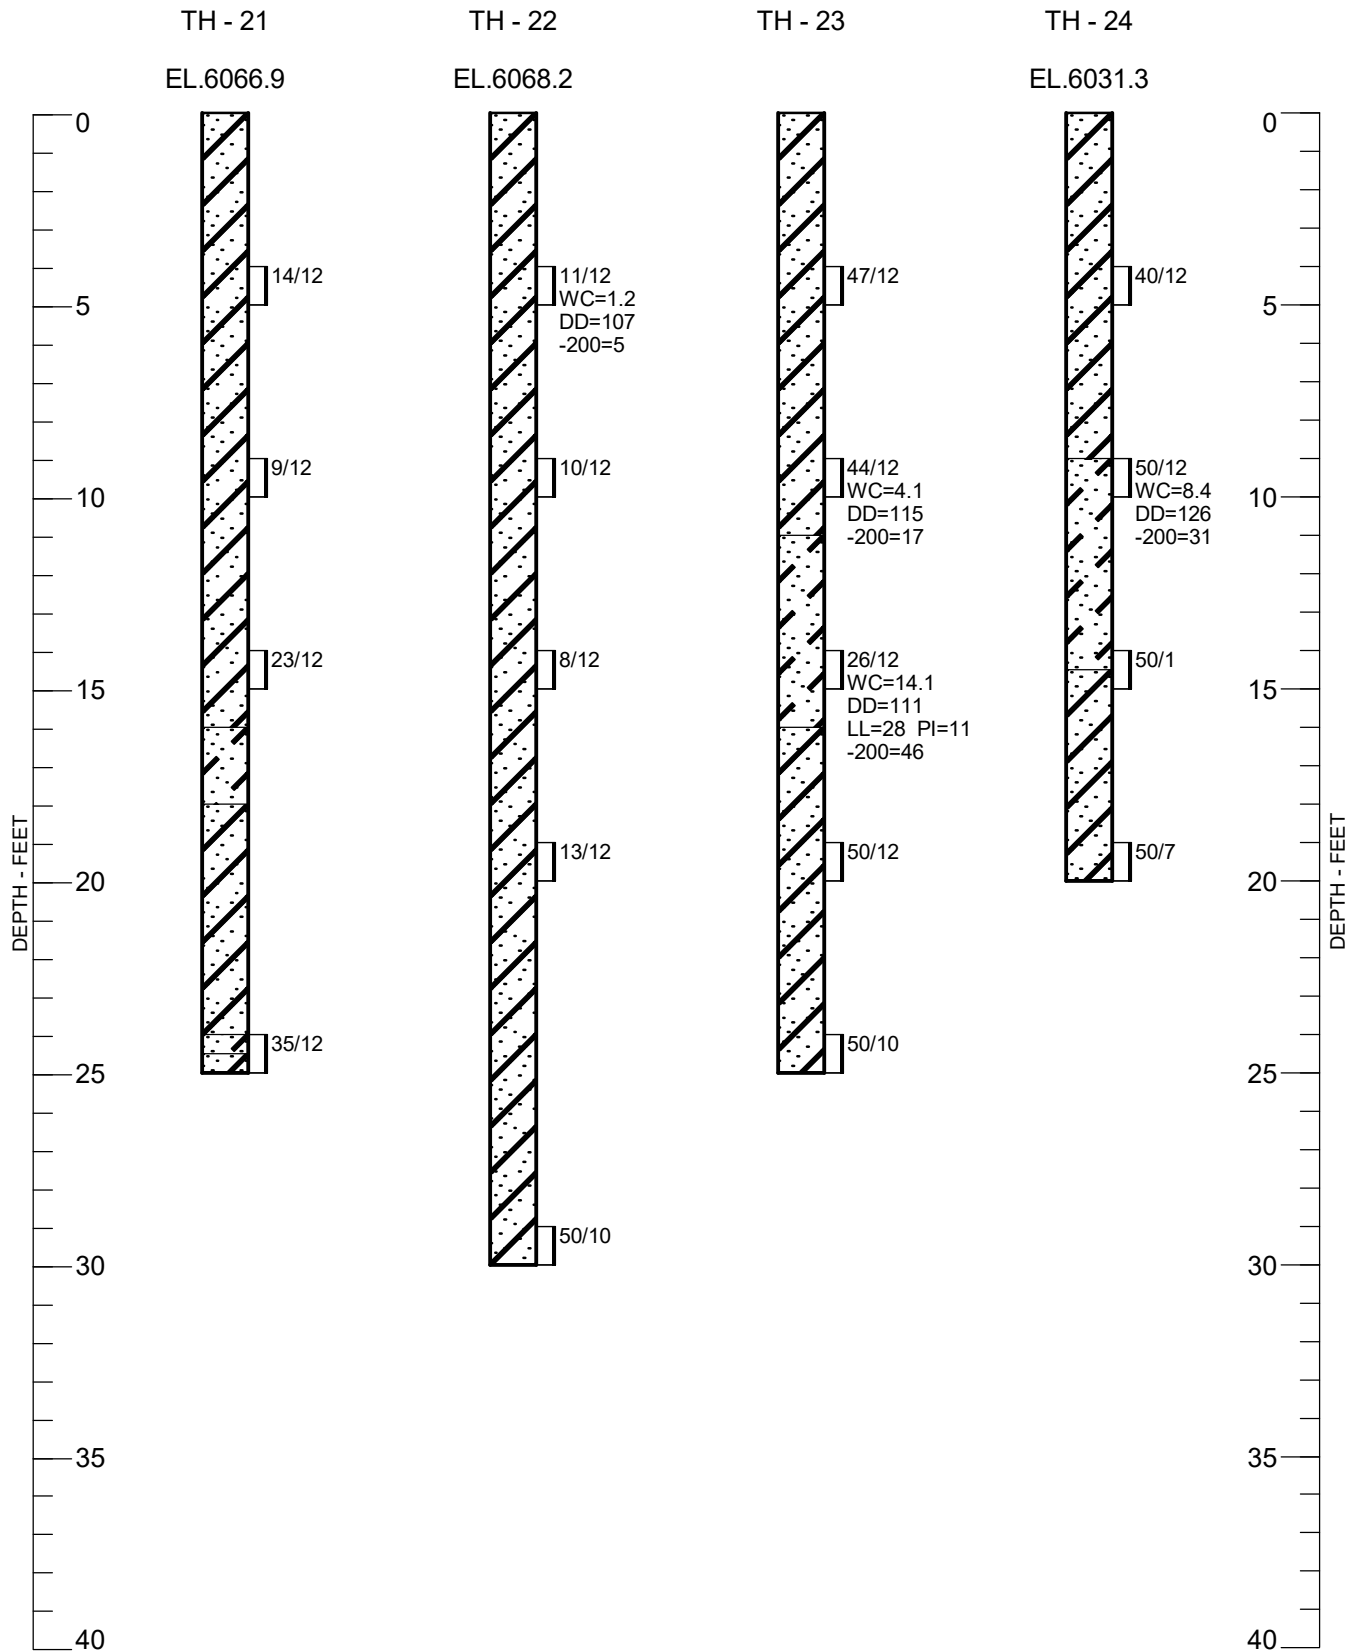
### **SUMMARY LOGS OF EXPLORATORY BORINGS**

CLAY, SLIGHTLY SANDY TO VERY SANDY, STIFF TO VERY STIFF, SLIGHTLY MOIST, MEDIUM BROWN (CL).
-

SAND, CLAYEY TO VERY CLAYEY, MEDIUM DENSE TO VERY DENSE, SLIGHTLY MOIST, MEDIUM BROWN (SC).
-

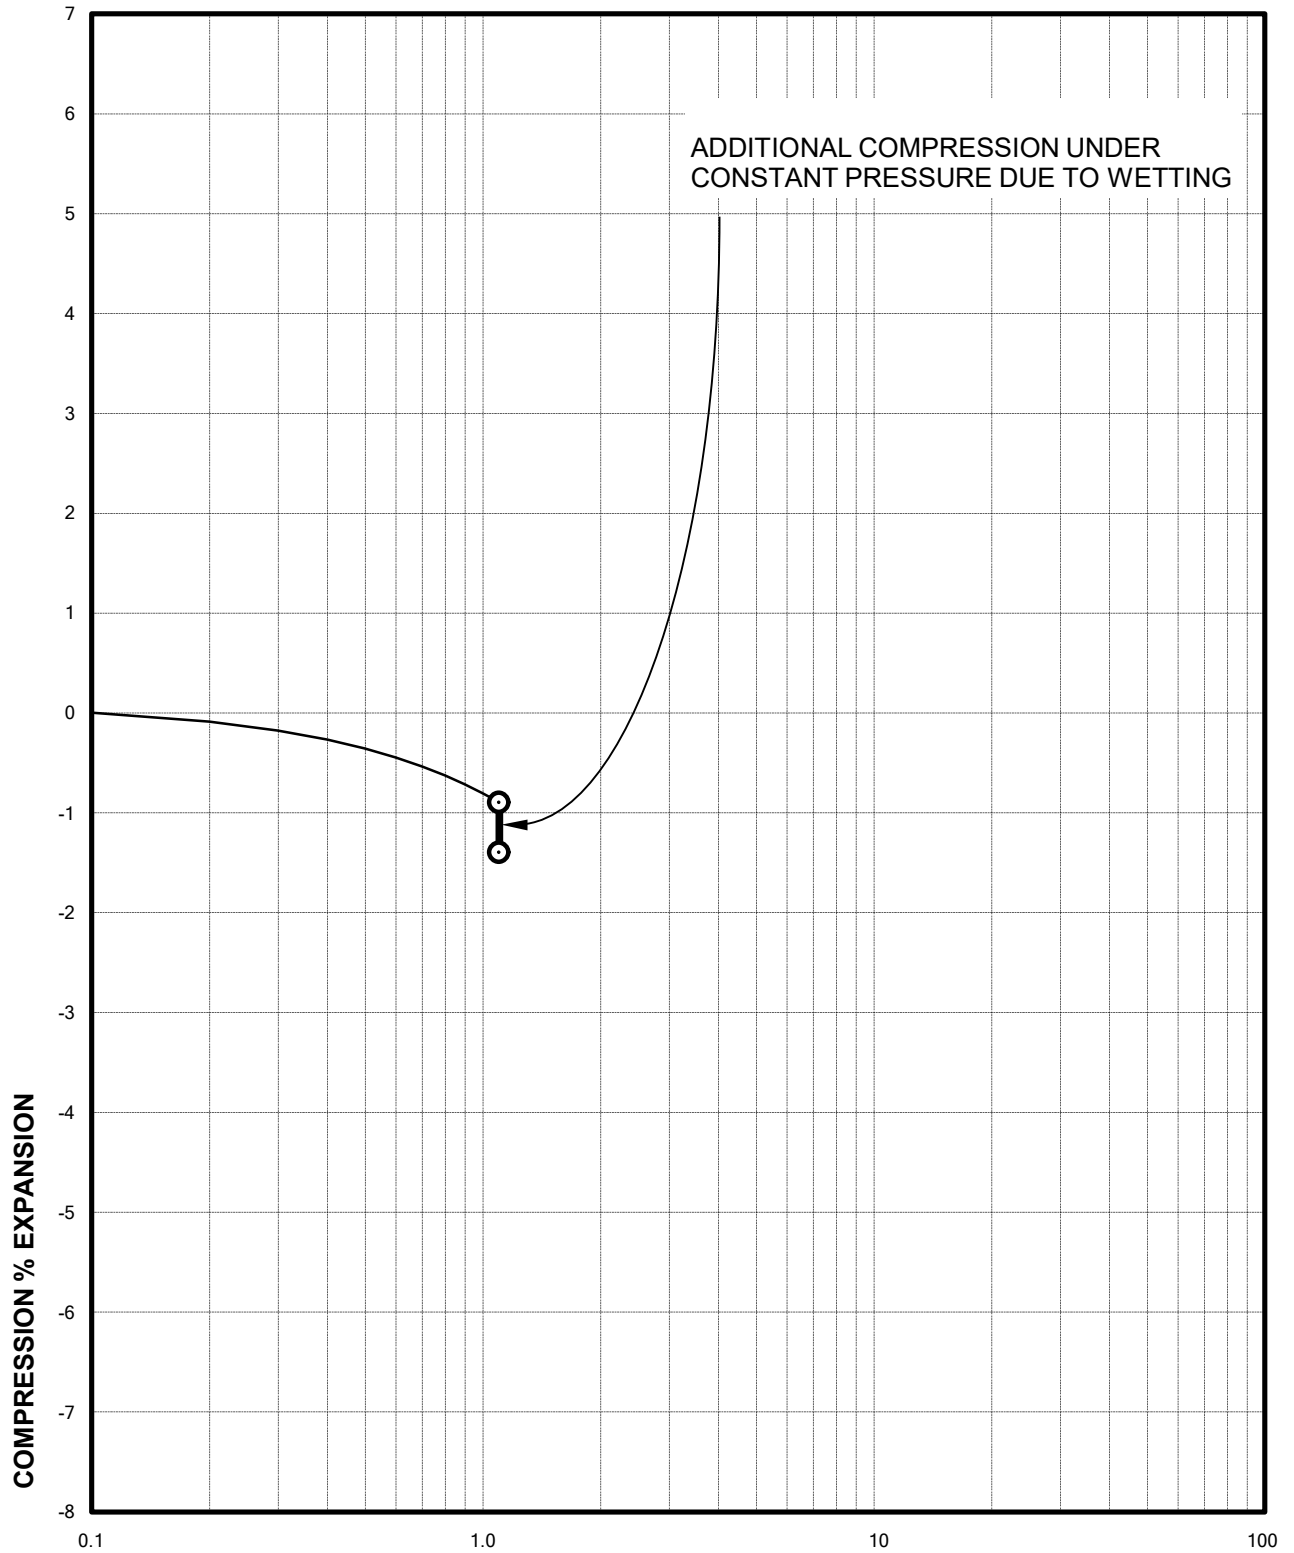
FIG. B-1

**APPLIED PRESSURE - KSF**  
Sample of SAND, CLAYEY (SC)  
From TH-4 AT 9 FEET

DRY UNIT WEIGHT= 125 PCF  
MOISTURE CONTENT= 6.7 %

### Swell Consolidation Test Results

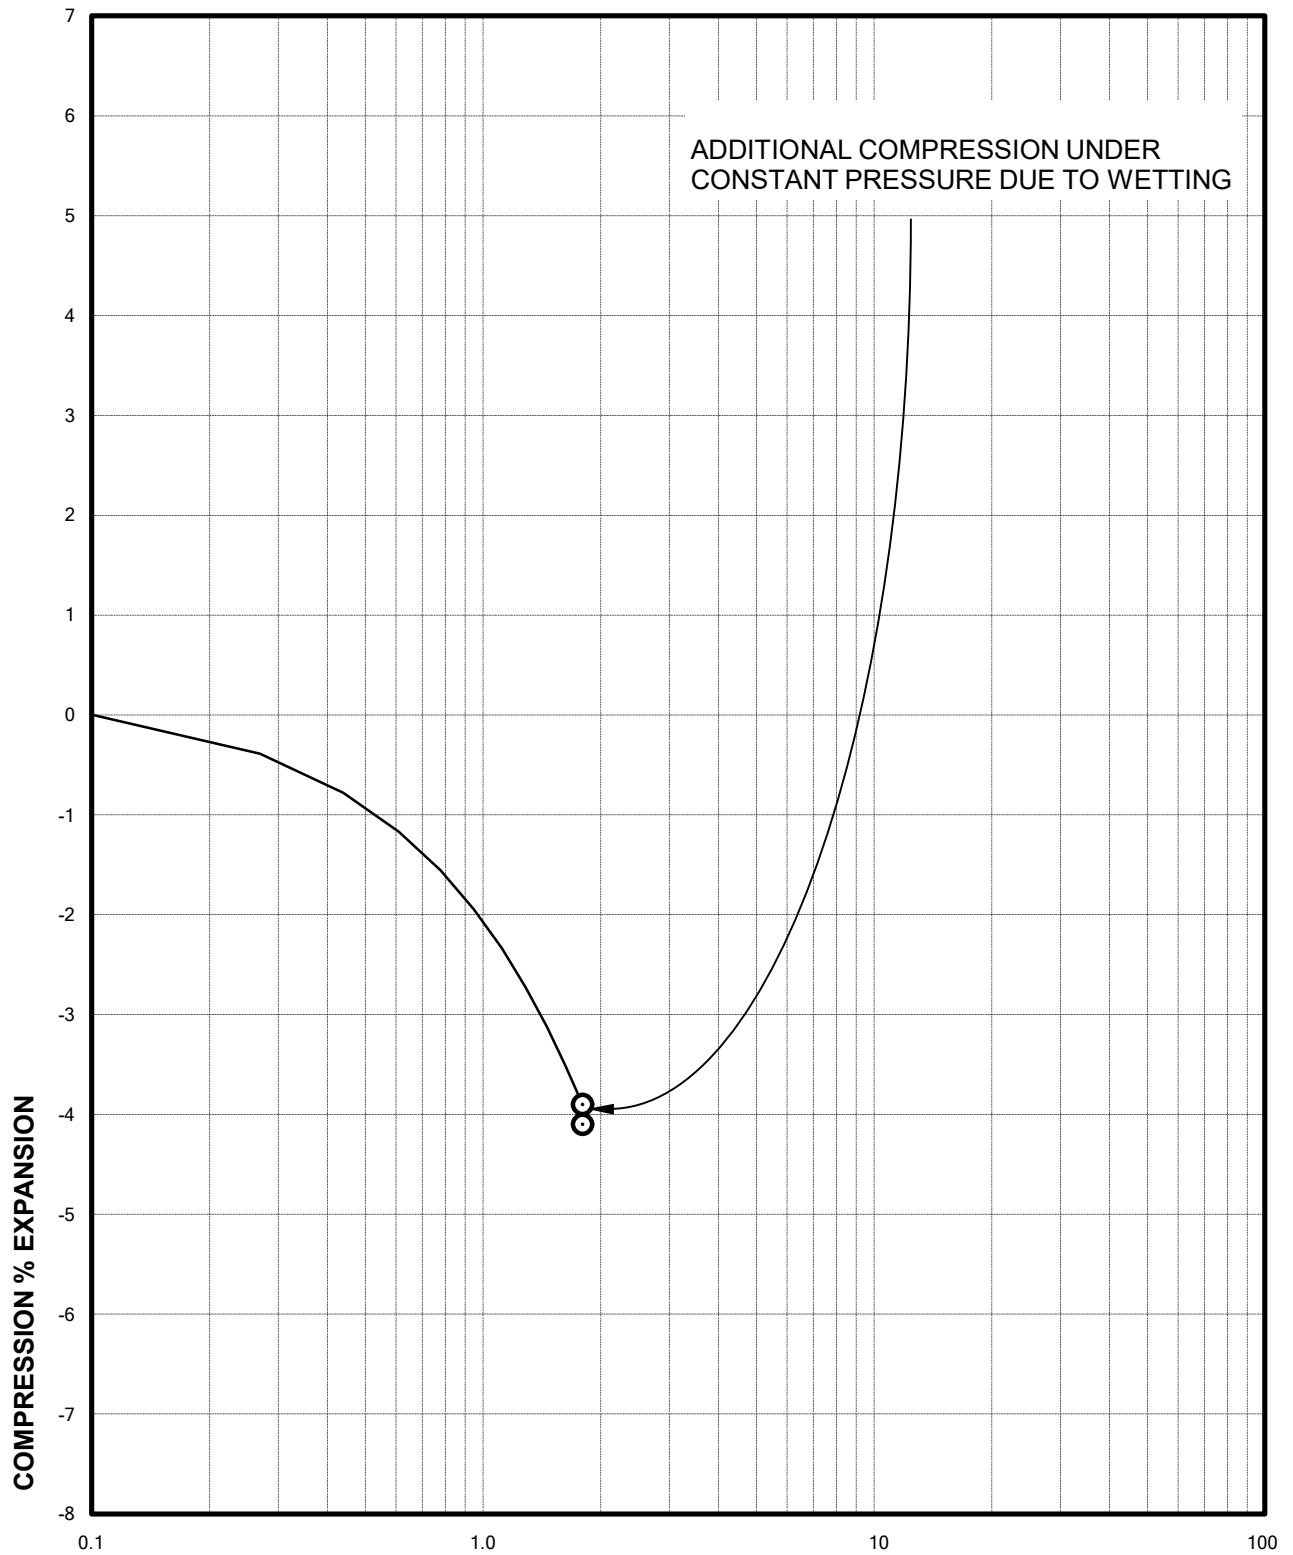
**APPLIED PRESSURE - KSF**  
Sample of SAND, VERY CLAYEY (SC)  
From TH-5 AT 14 FEET

DRY UNIT WEIGHT= 114 PCF  
MOISTURE CONTENT= 16.9 %

### Swell Consolidation Test Results

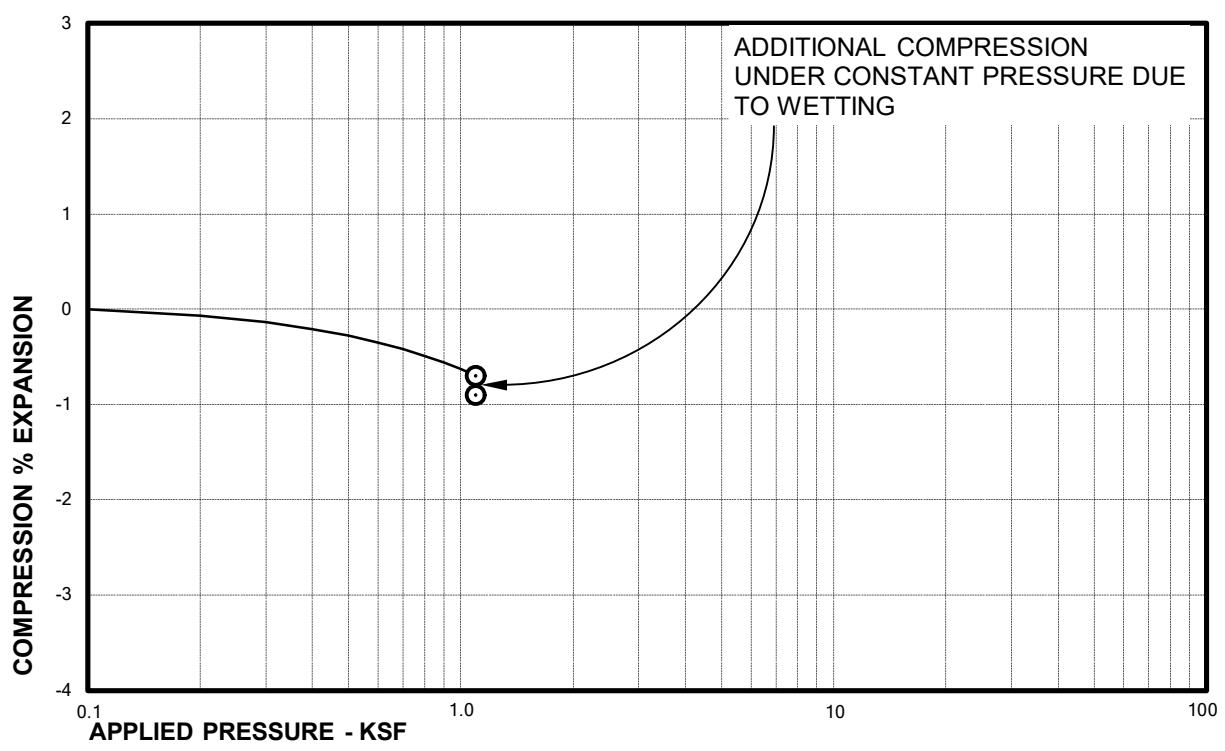
Sample of SAND, CLAYEY (SC)  
From TH-8 AT 9 FEET

DRY UNIT WEIGHT= 125 PCF  
MOISTURE CONTENT= 8.1 %

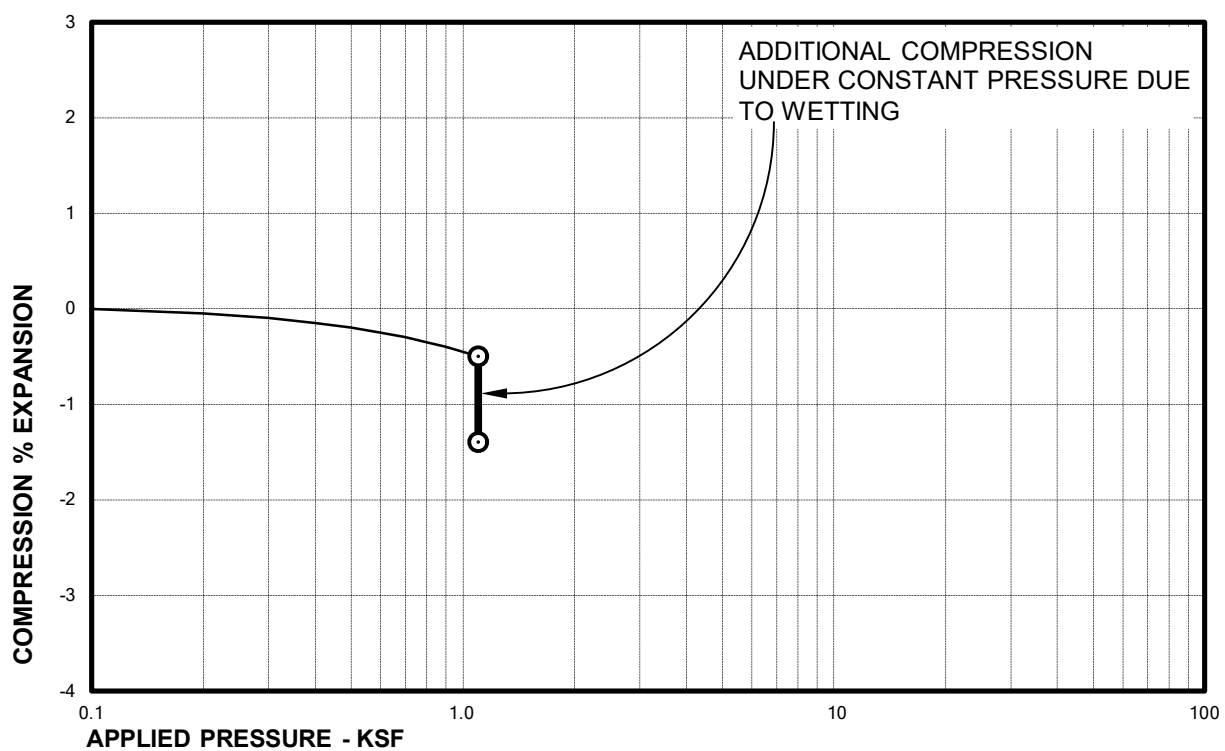
Sample of CLAY, SANDY (CL)  
From TH-14 AT 9 FEET

DRY UNIT WEIGHT= 115 PCF  
MOISTURE CONTENT= 6.1 %

The Mayberry 540 Acre Site is generally underlain by granular soils. Clay lenses were found sporadically and were generally 3 feet thick or less, with the exception of TH-14 where clay was found between depths of 4 and 11 feet. Swell testing indicates the clay exhibits low expansion potential in its current condition. Additional geotechnical investigation should be conducted for design level reports. The additional investigation borings may encounter more thicker clay layers with higher swell potential which may impact foundation performance. We believe expansive soils, if encountered, can be mitigated with engineering design and construction methods commonly employed in the area.

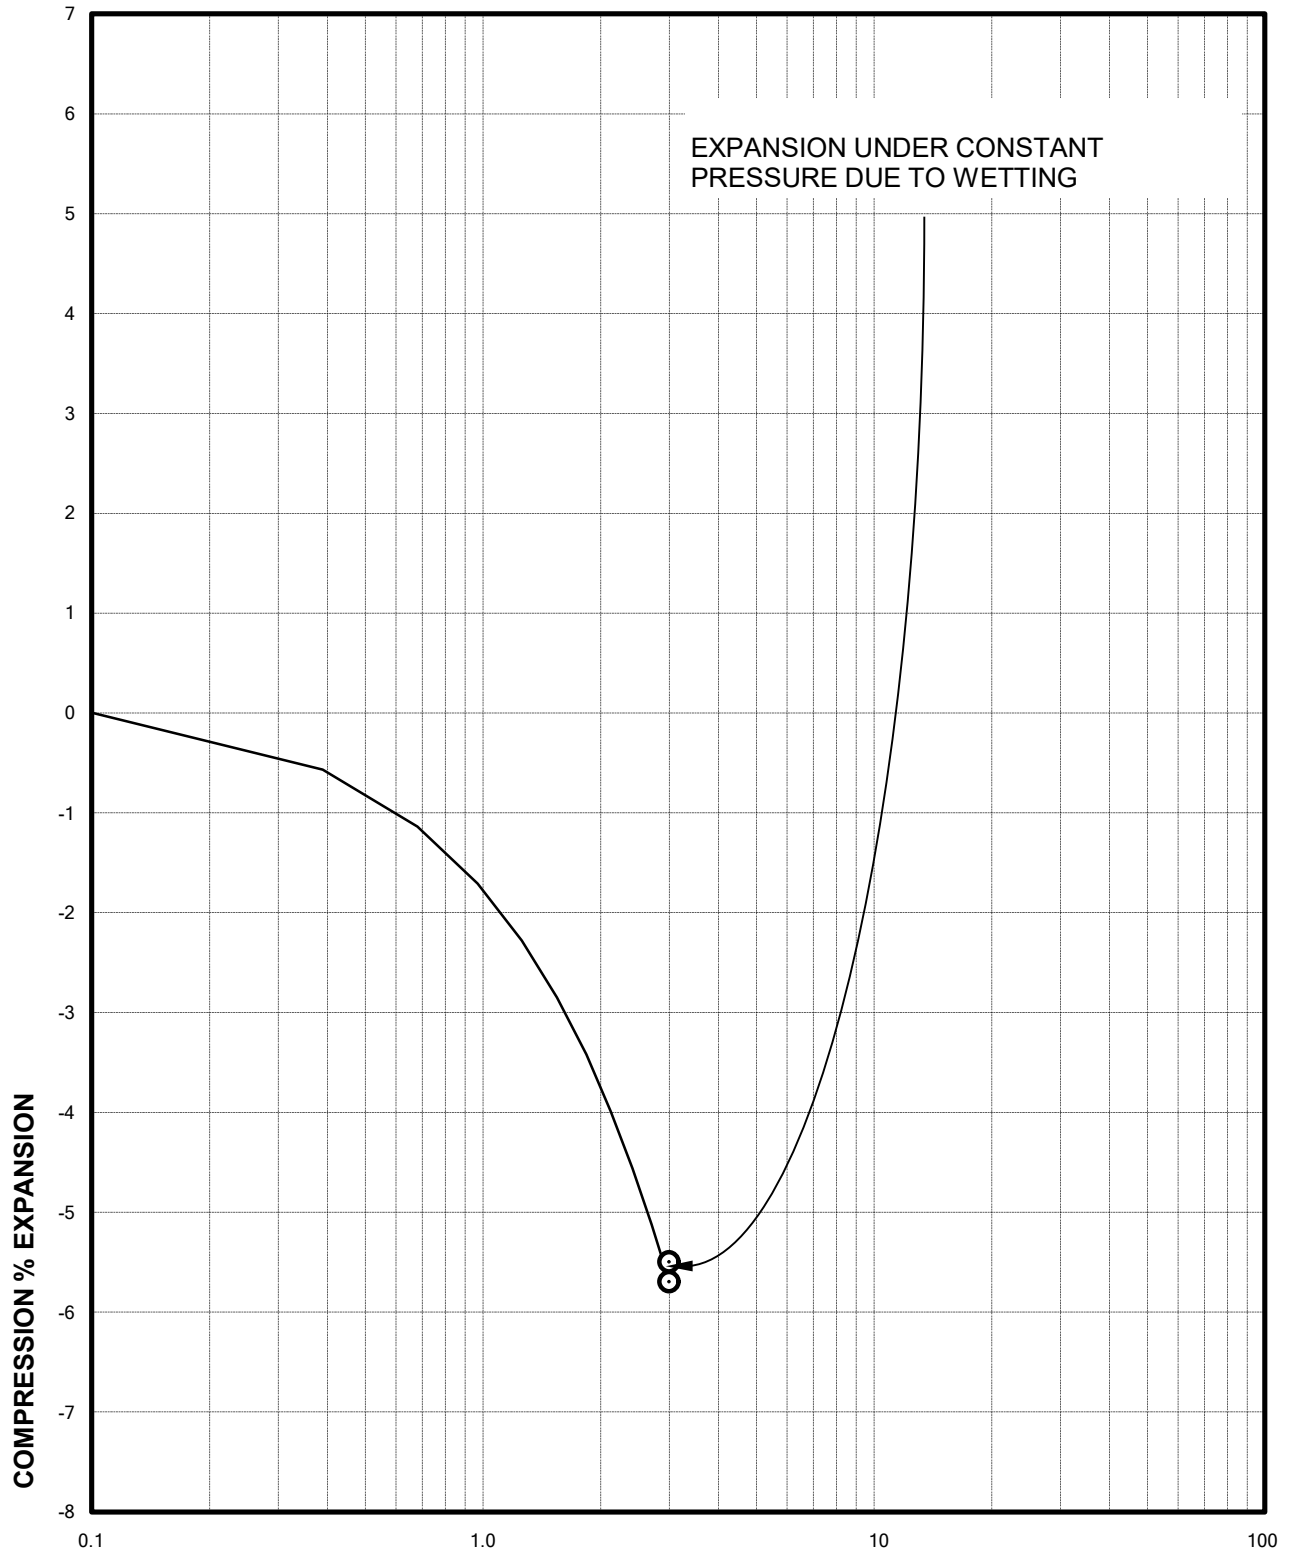
**APPLIED PRESSURE - KSF**  
Sample of CLAY, SANDY (CL)  
From TH-18 AT 24 FEET

DRY UNIT WEIGHT = 102 PCF  
MOISTURE CONTENT = 22.2 %
