**GEOLOGIC HAZARDS EVALUATION AND  
PRELIMINARY GEOTECHNICAL INVESTIGATION  
MAYBERRY – 540 ACRE SITE  
STATE HIGHWAY 94 AND LOG ROAD  
EL PASO COUNTY, COLORADO**

CTL|T Project No. CS18969.004-105

March 13, 2023

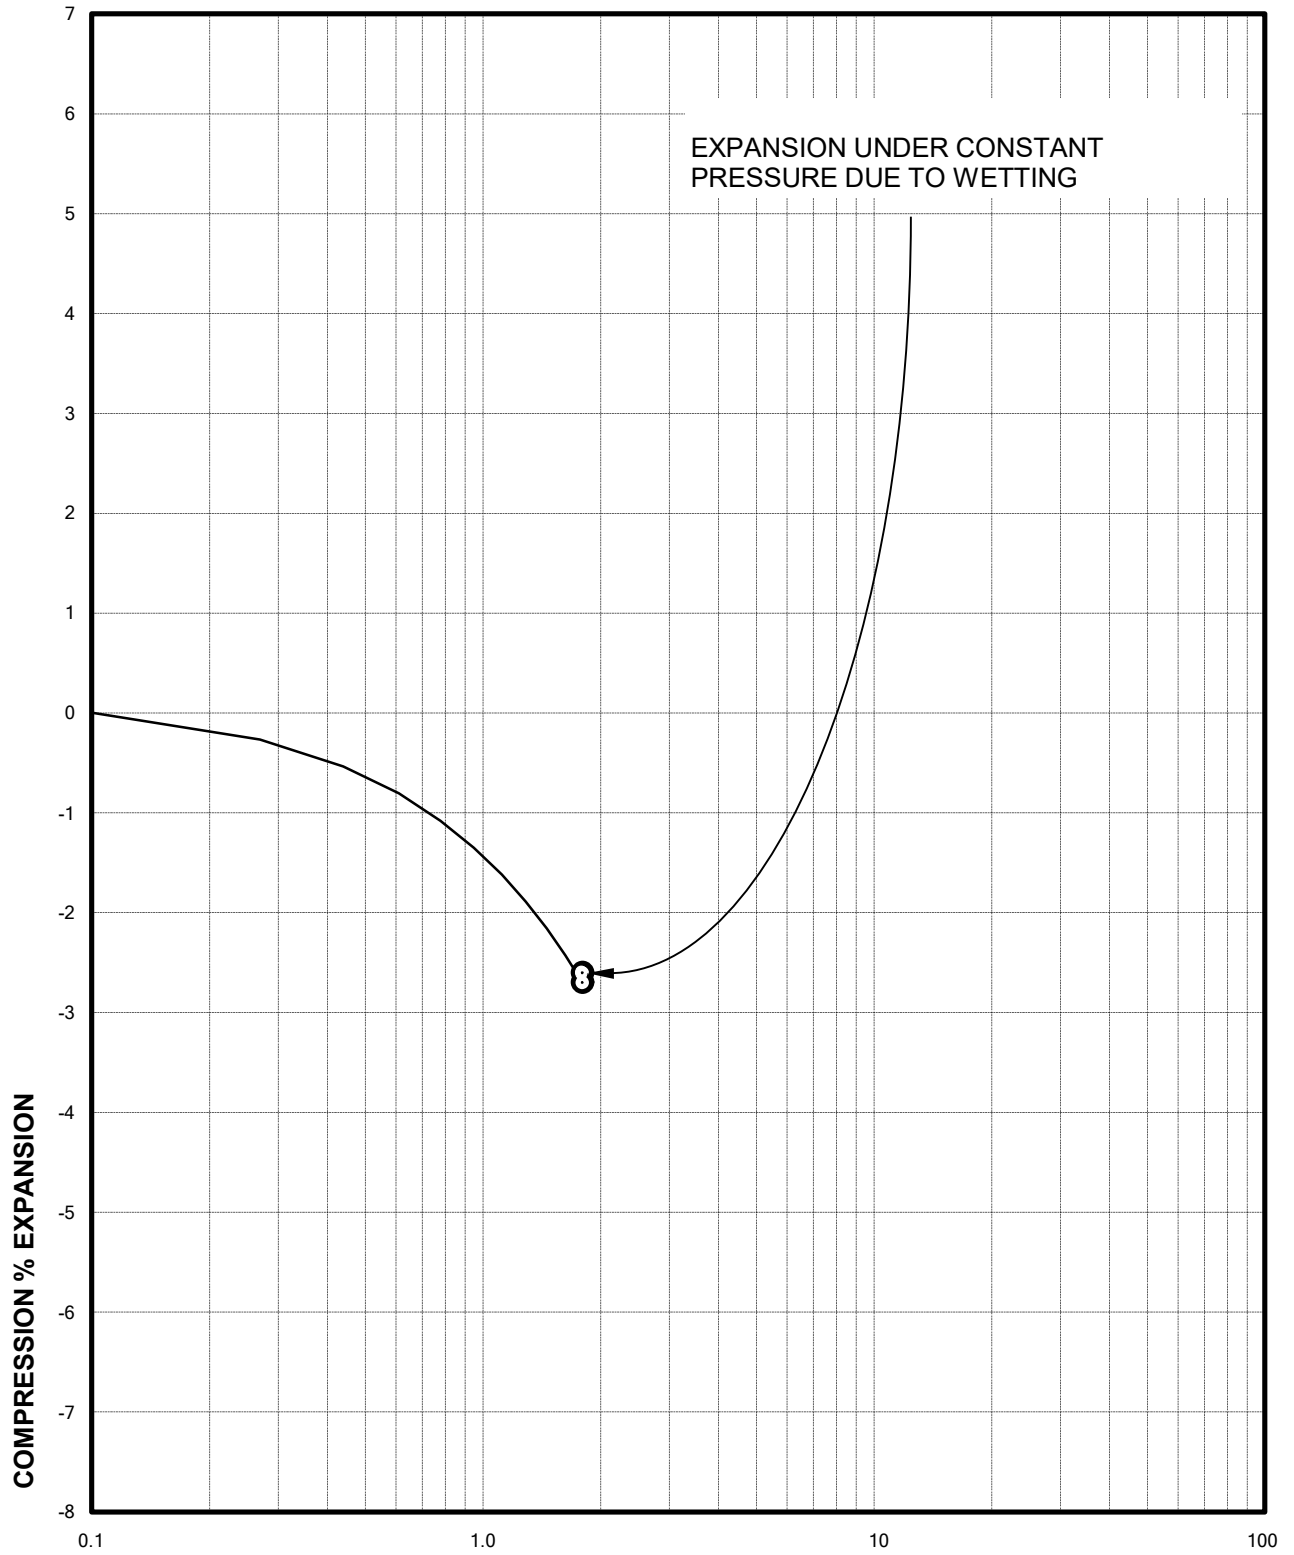
**APPLIED PRESSURE - KSF**  
Sample of CLAY, SANDY (CL)  
From TH-18 AT 14 FEET

DRY UNIT WEIGHT = 104 PCF  
MOISTURE CONTENT = 21.8 %

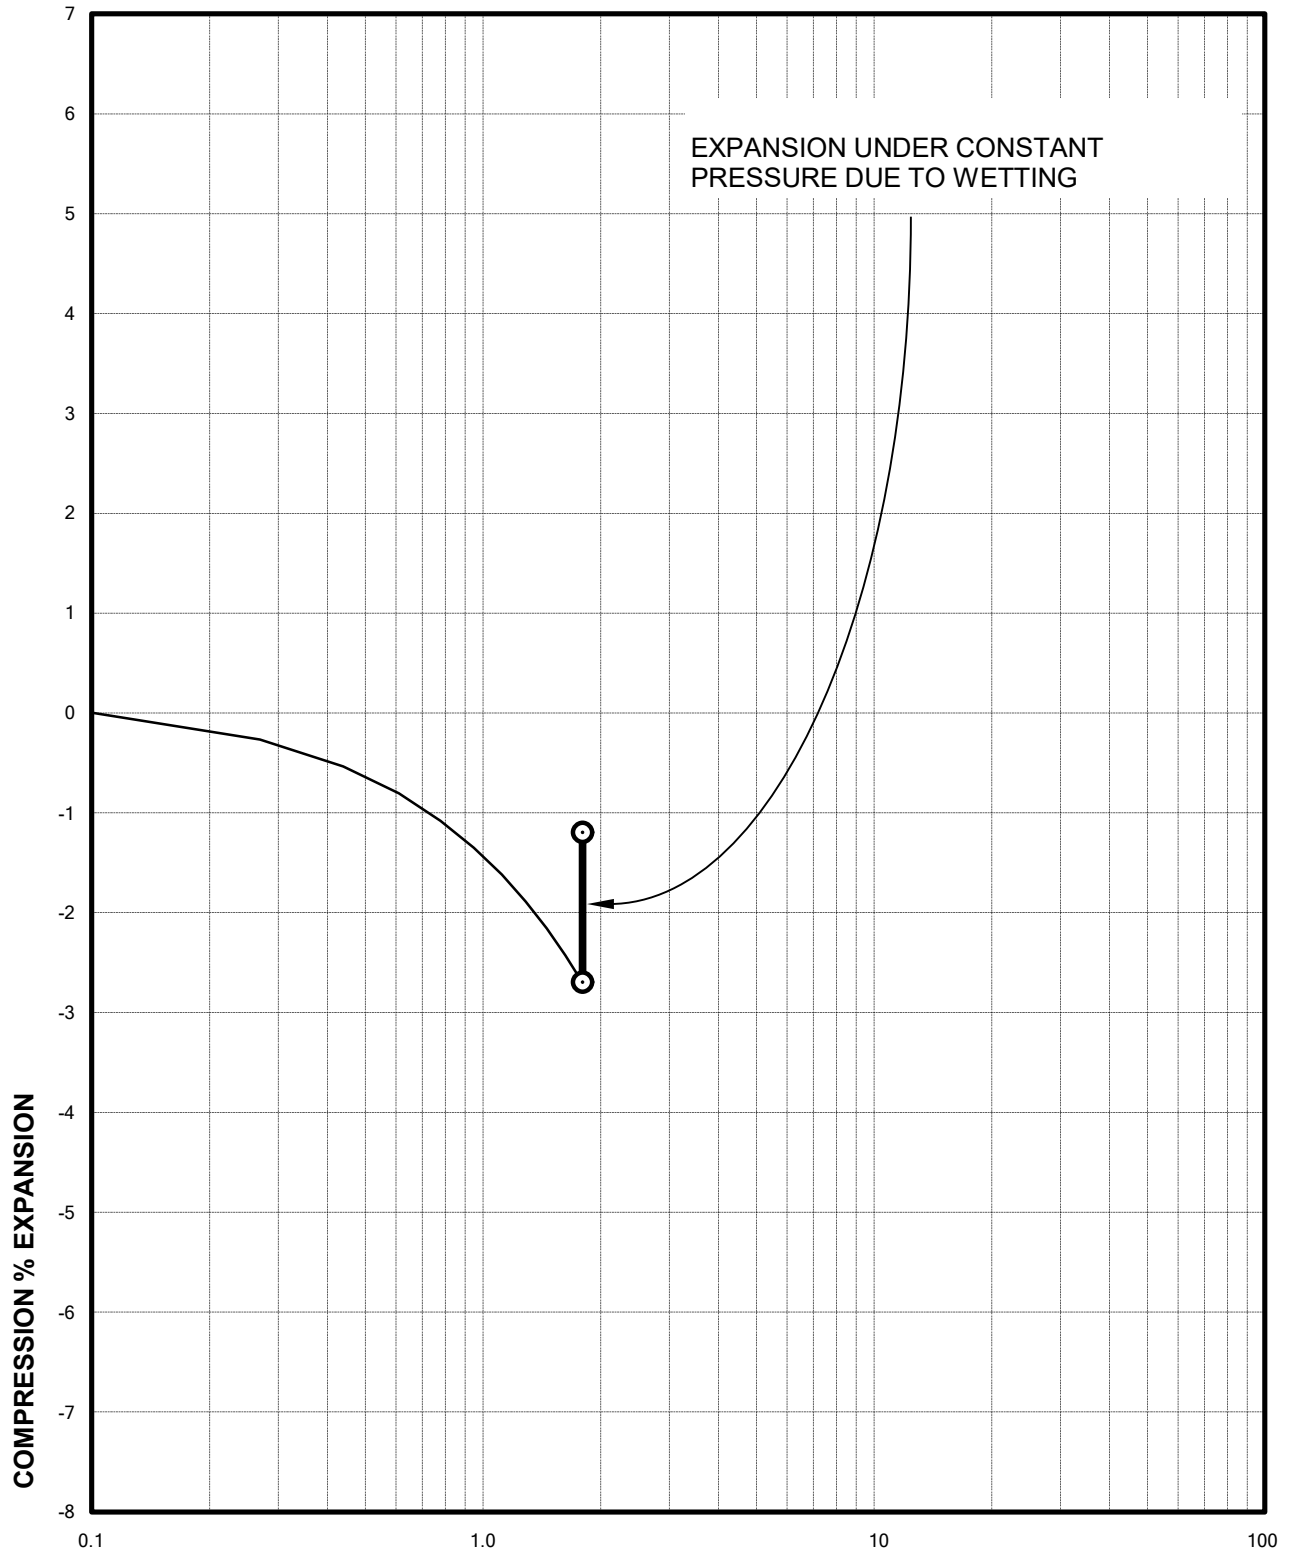
**APPLIED PRESSURE - KSF**  
Sample of CLAY, SANDY (CL)  
From TH-28 AT 14 FEET

DRY UNIT WEIGHT= 107 PCF  
MOISTURE CONTENT= 22.2 %

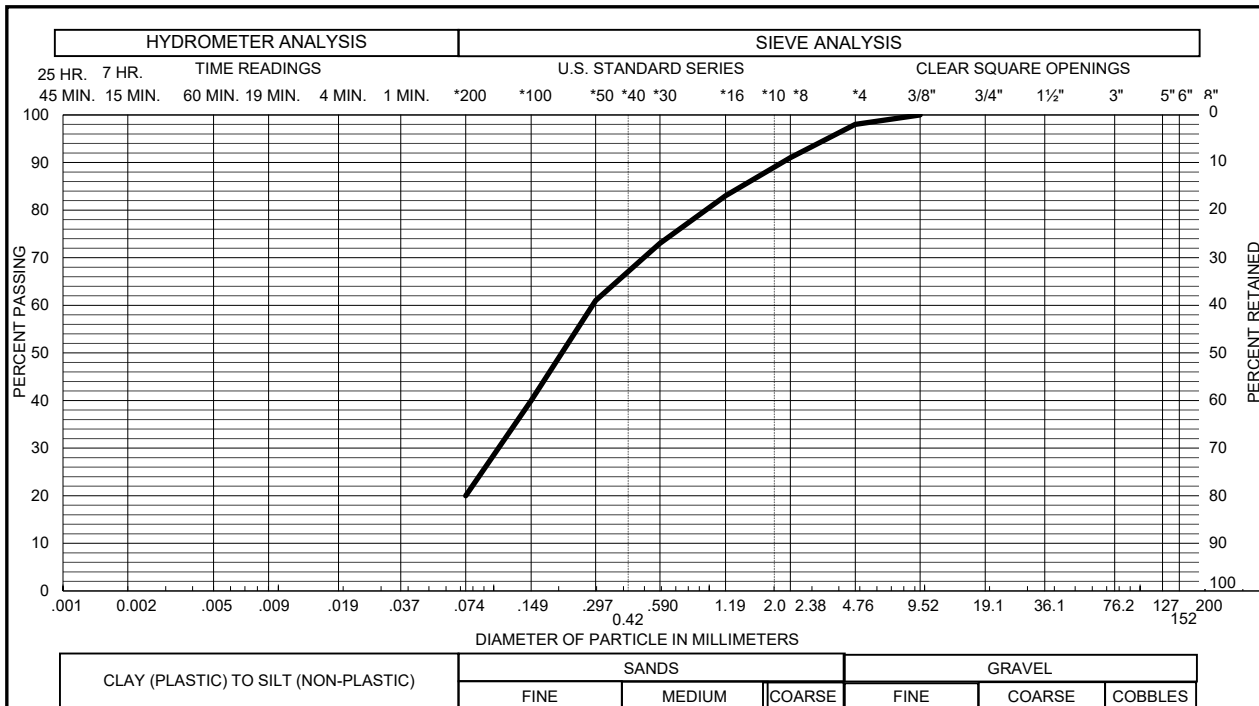
Sample of SAND, SILTY (SM) GRAVEL 2 % SAND 78 %  
 From TH - 1 AT 9 FEET SILT & CLAY 20 % LIQUID LIMIT \_\_\_\_\_  
 PLASTICITY INDEX \_\_\_\_\_

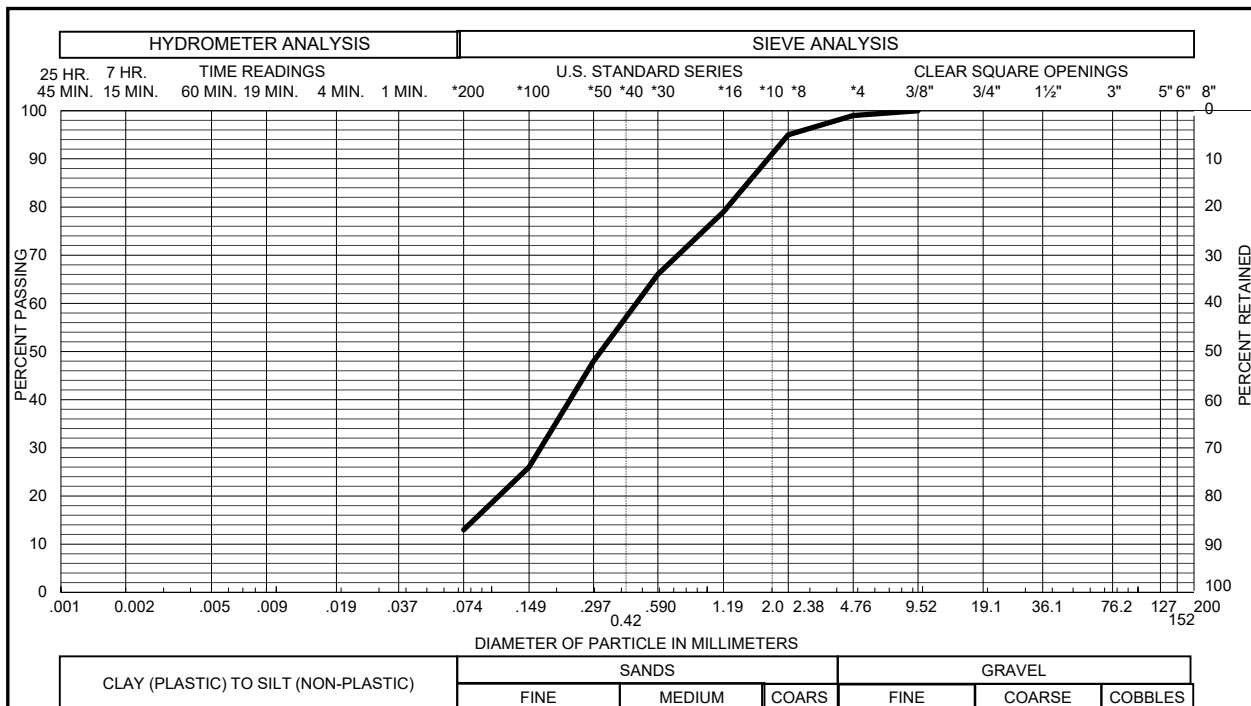
Sample of SAND, SILTY (SM) GRAVEL 1 % SAND 86 %  
 From TH - 2 AT 9 FEET SILT & CLAY 13 % LIQUID LIMIT \_\_\_\_\_  
 PLASTICITY INDEX \_\_\_\_\_

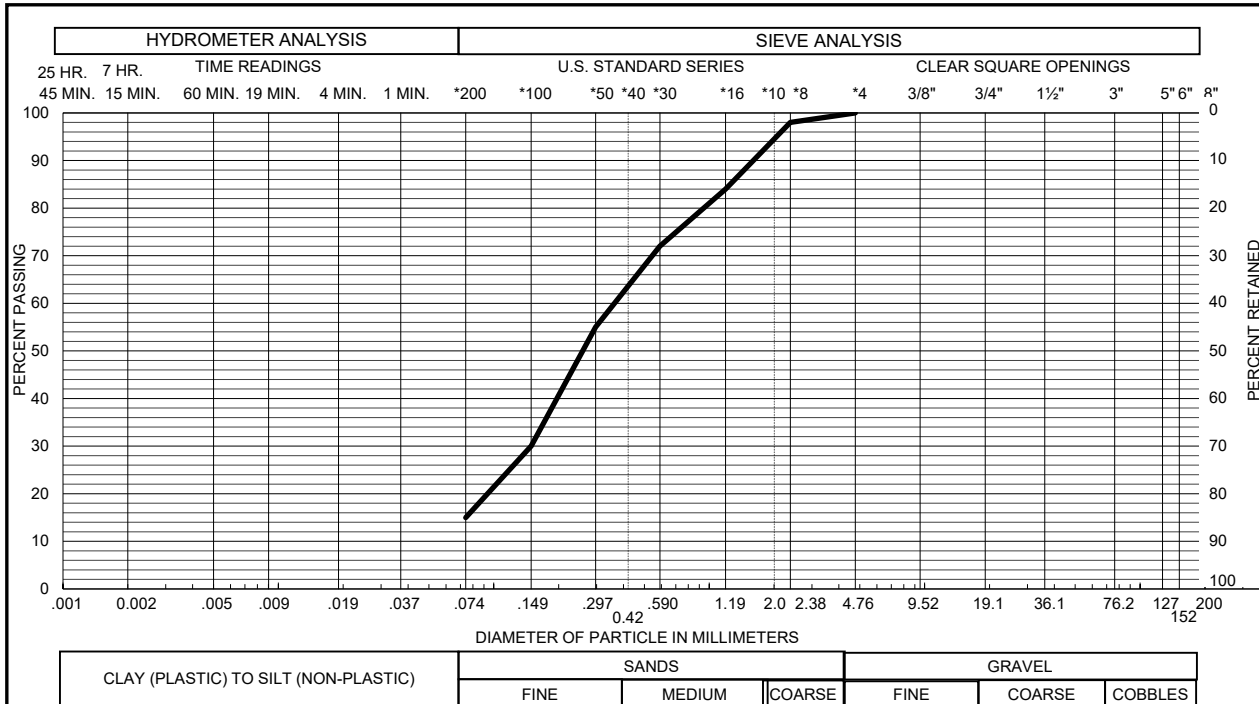
Sample of SAND, SILTY (SM) GRAVEL 0 % SAND 85 %  
 From TH - 4 AT 4 FEET SILT & CLAY 15 % LIQUID LIMIT \_\_\_\_\_  
 PLASTICITY INDEX \_\_\_\_\_

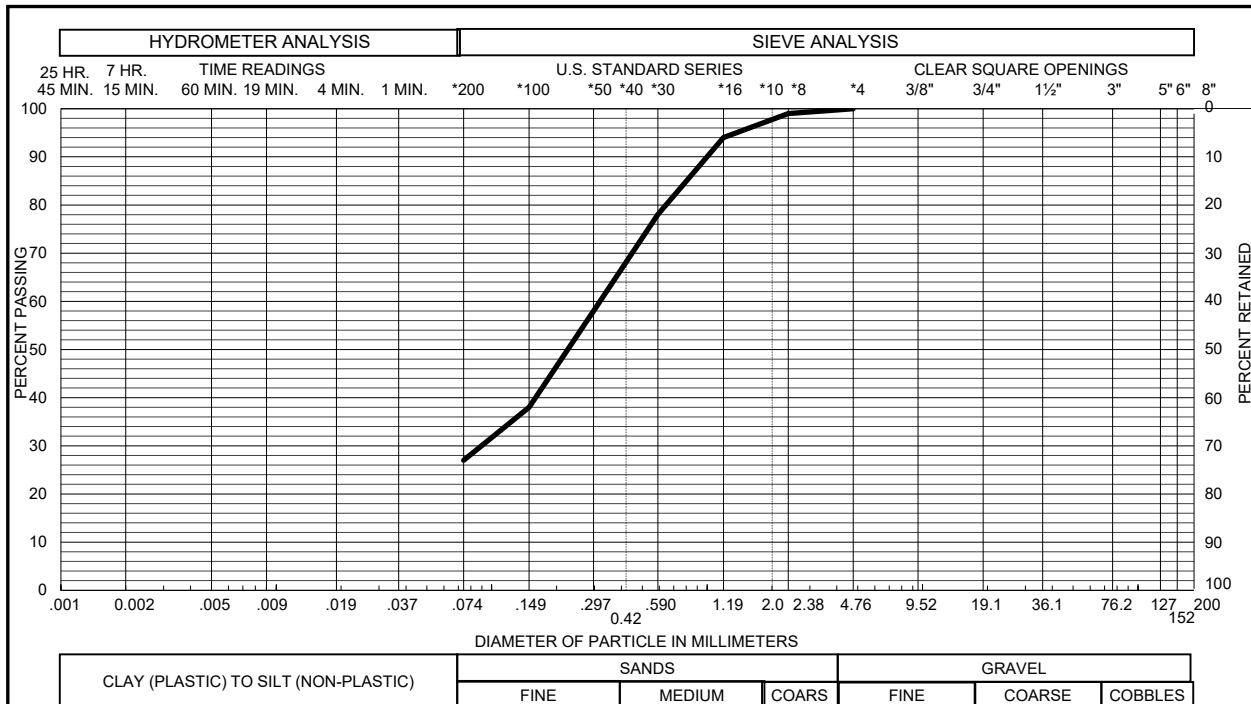
Sample of SAND, CLAYEY (SC) GRAVEL 0 % SAND 73 %  
 From TH - 6 AT 14 FEET SILT & CLAY 27 % LIQUID LIMIT \_\_\_\_\_  
 PLASTICITY INDEX \_\_\_\_\_

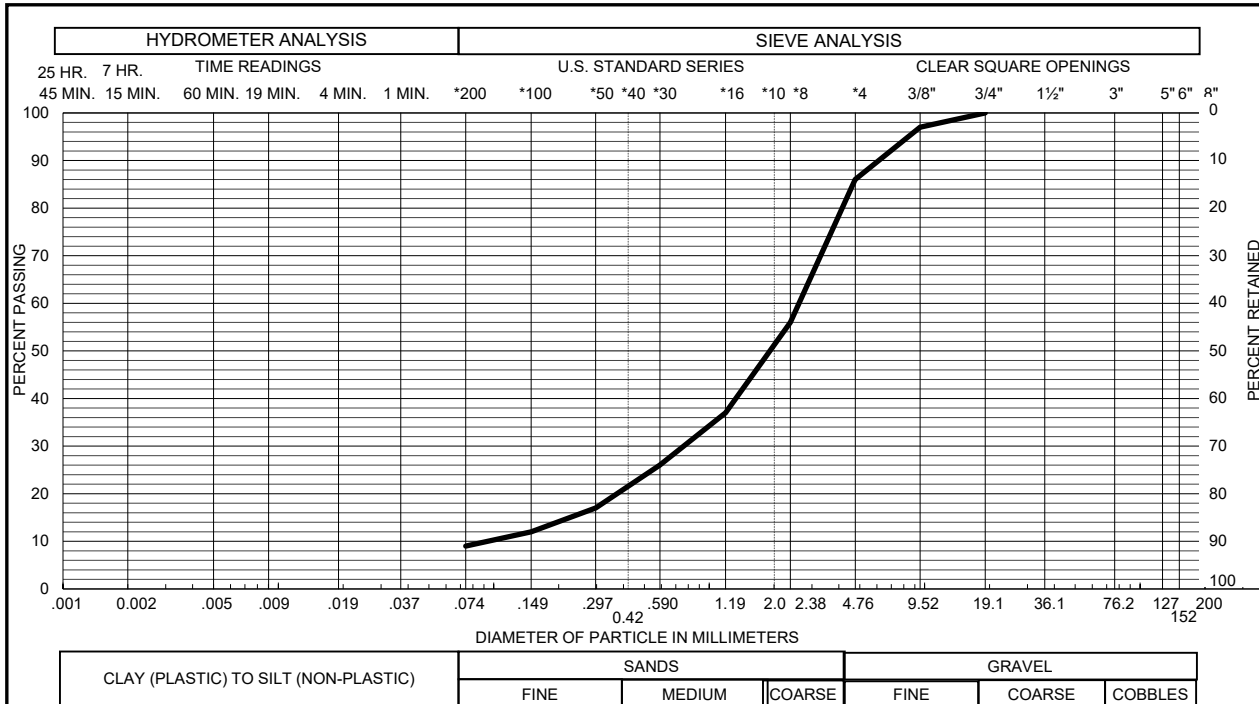
Sample of SAND, SLIGHTLY SILTY (SW-SM) GRAVEL 14 % SAND 77 %  
 From TH - 7 AT 9 FEET SILT & CLAY 9 % LIQUID LIMIT \_\_\_\_\_  
 PLASTICITY INDEX \_\_\_\_\_

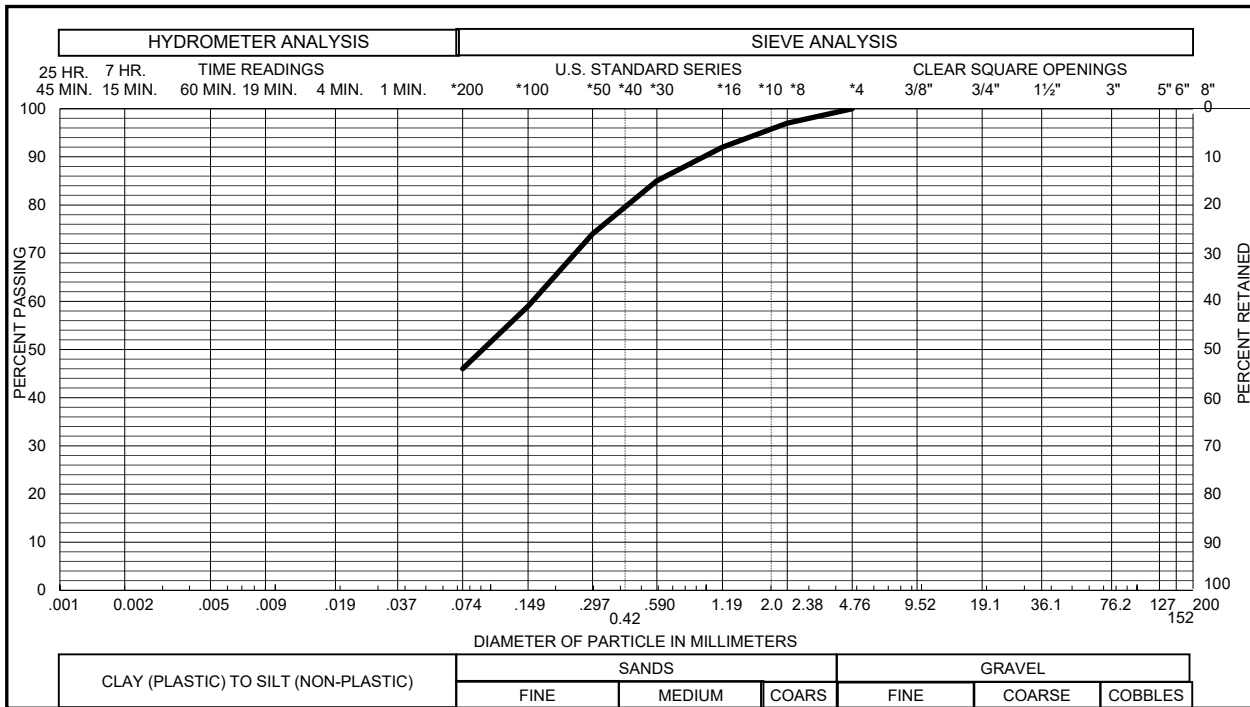
Sample of SAND, VERY CLAYEY (SC) GRAVEL 0 % SAND 54 %  
 From TH - 9 AT 4 FEET SILT & CLAY 46 % LIQUID LIMIT 25  
 PLASTICITY INDEX 8

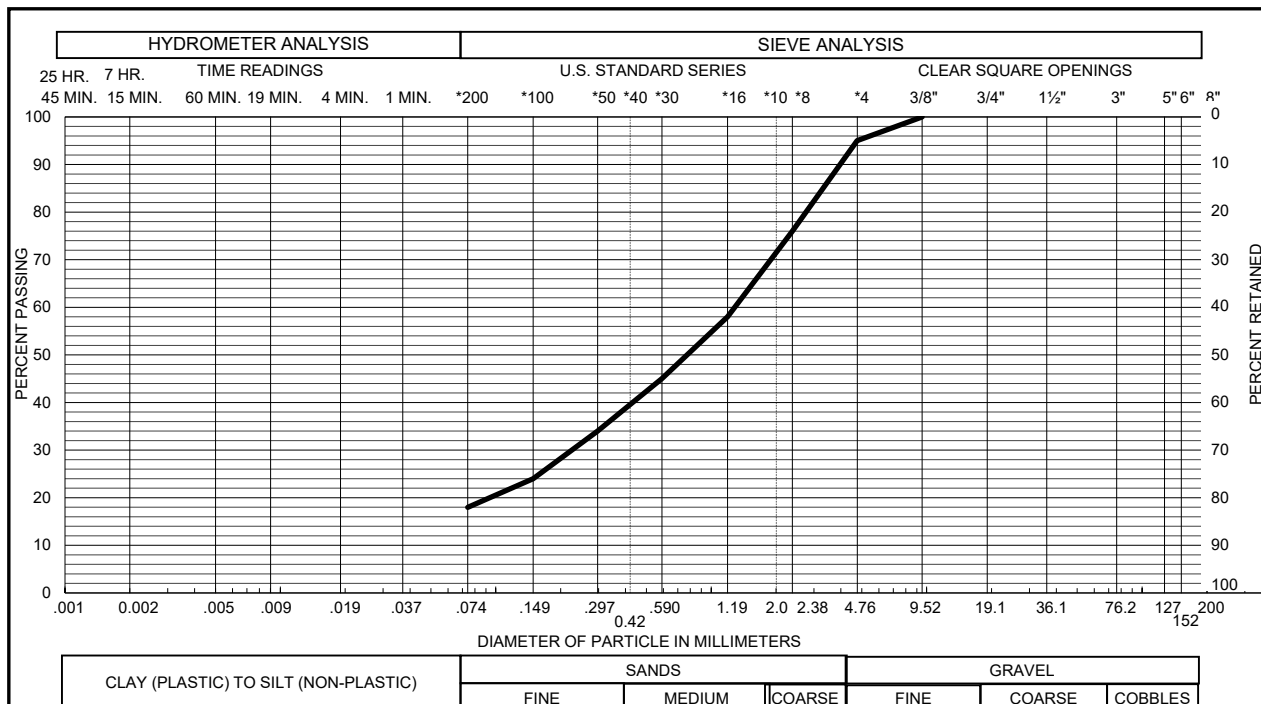
Sample of SAND, CLAYEY (SC) GRAVEL 5 % SAND 77 %  
 From TH - 9 AT 14 FEET SILT & CLAY 18 % LIQUID LIMIT 26  
 PLASTICITY INDEX 10

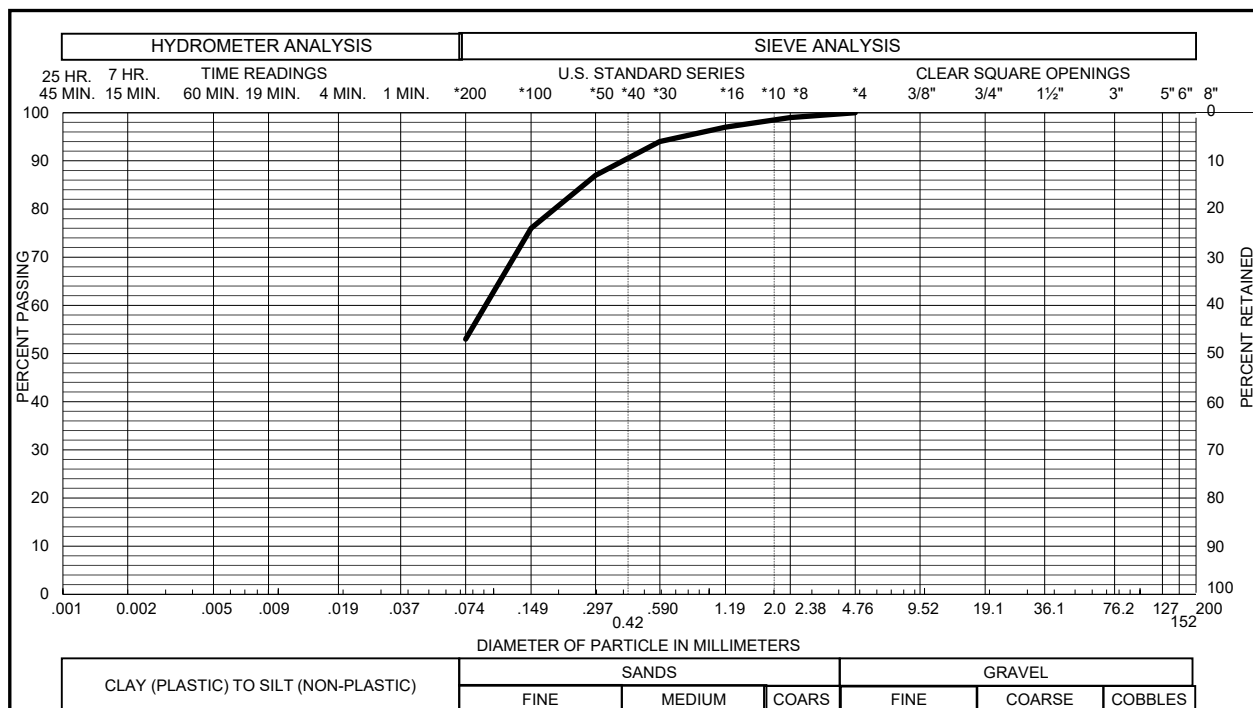
Sample of CLAY, VERY SANDY (CL) GRAVEL 0 % SAND 47 %  
 From TH - 12 AT 9 FEET SILT & CLAY 53 % LIQUID LIMIT \_\_\_\_\_  
 PLASTICITY INDEX \_\_\_\_\_

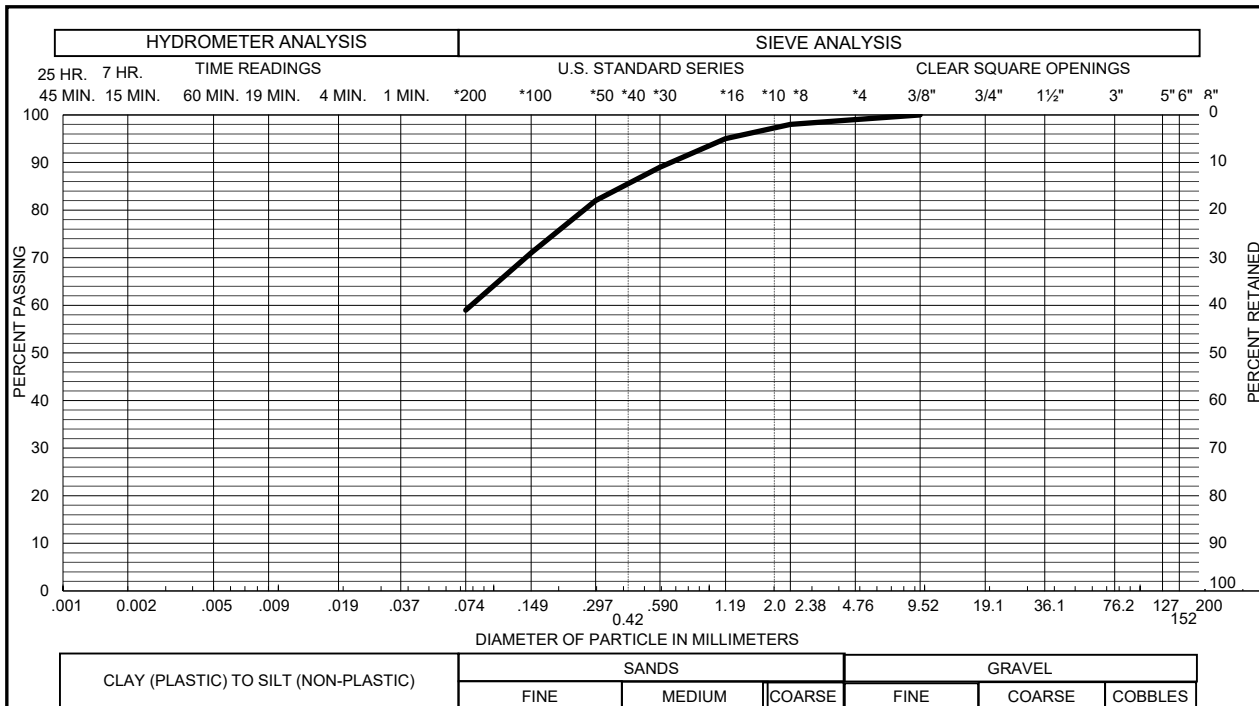
Sample of CLAY, VERY SANDY (CL) GRAVEL 1 % SAND 40 %  
 From TH - 14 AT 4 FEET SILT & CLAY 59 % LIQUID LIMIT 28  
 PLASTICITY INDEX 11

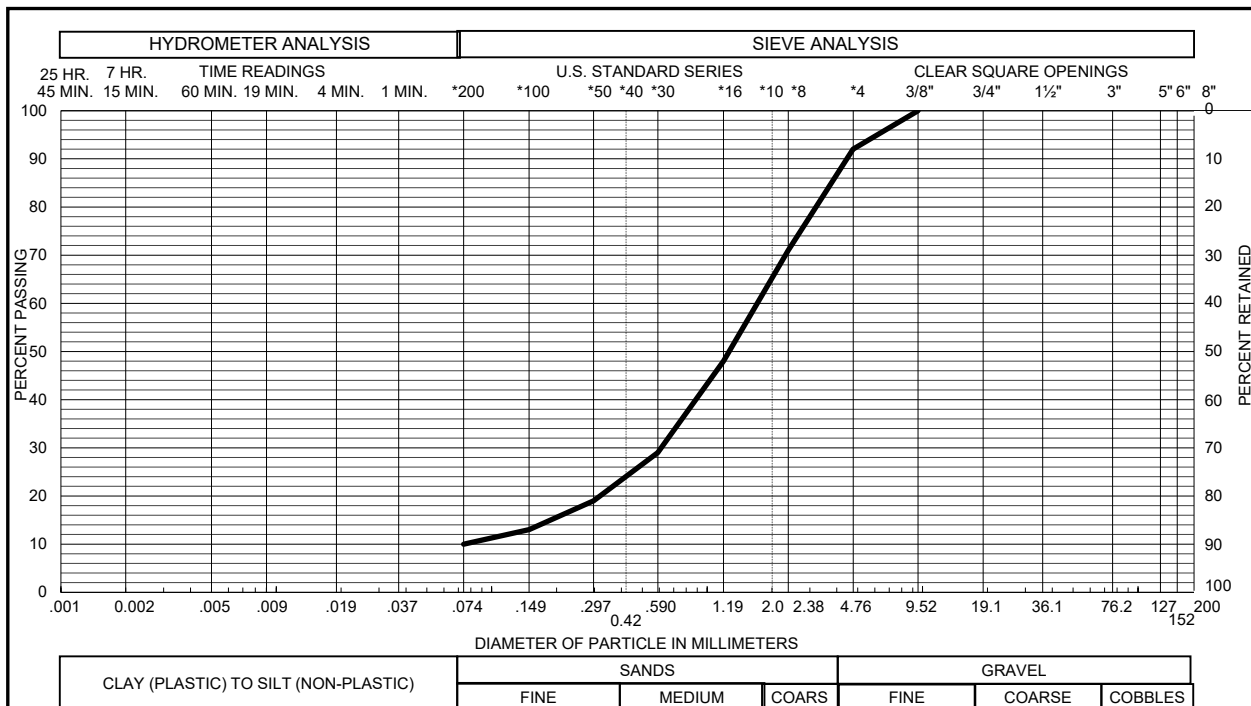
Sample of SAND, SLIGHTLY SILTY (SW-SM) GRAVEL 8 % SAND 82 %  
 From TH - 17 AT 19 FEET SILT & CLAY 10 % LIQUID LIMIT 24  
 PLASTICITY INDEX 5

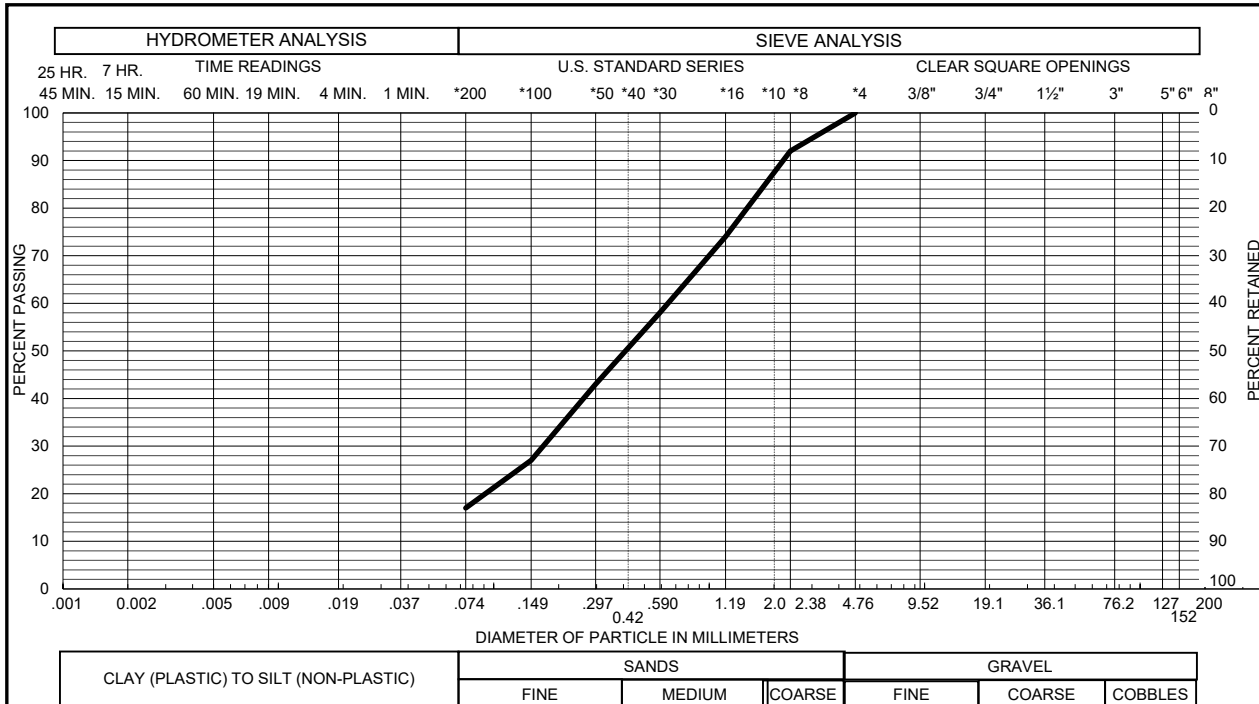
Sample of **SAND, SILTY (SM)** GRAVEL 0 % SAND 83 %  
 From TH - 23 AT 9 FEET SILT & CLAY 17 % LIQUID LIMIT \_\_\_\_\_  
 PLASTICITY INDEX \_\_\_\_\_

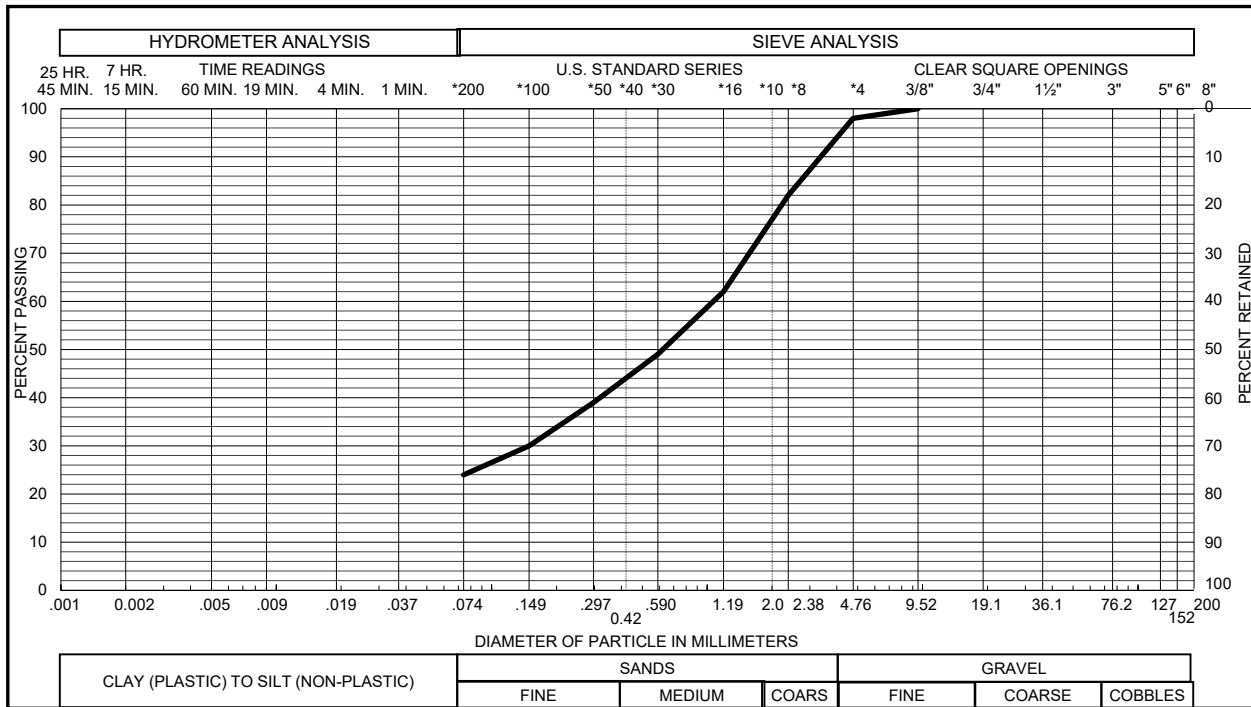
Sample of **SAND, CLAYEY (SC)** GRAVEL 2 % SAND 74 %  
 From TH - 25 AT 14 FEET SILT & CLAY 24 % LIQUID LIMIT \_\_\_\_\_  
 PLASTICITY INDEX \_\_\_\_\_

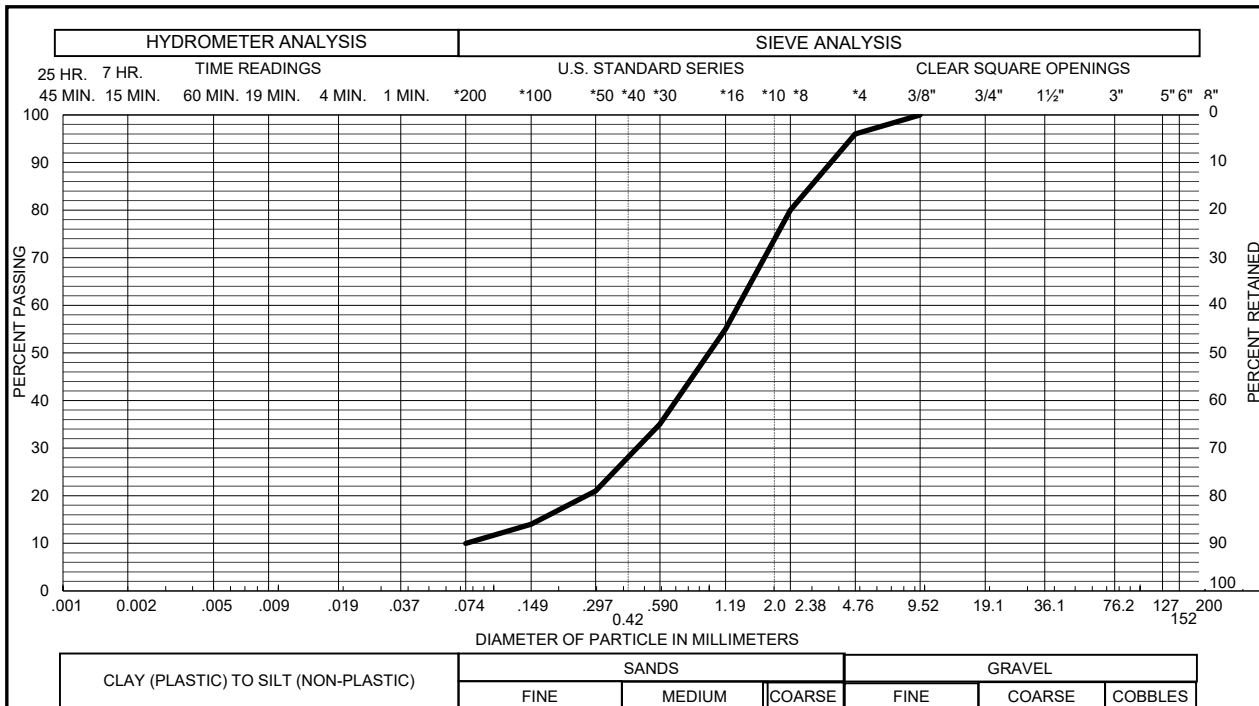
Sample of SAND, SLIGHTLY SILTY (SW-SM) GRAVEL 4 % SAND 86 %  
 From TH - 26 AT 9 FEET SILT & CLAY 10 % LIQUID LIMIT \_\_\_\_\_  
 PLASTICITY INDEX \_\_\_\_\_

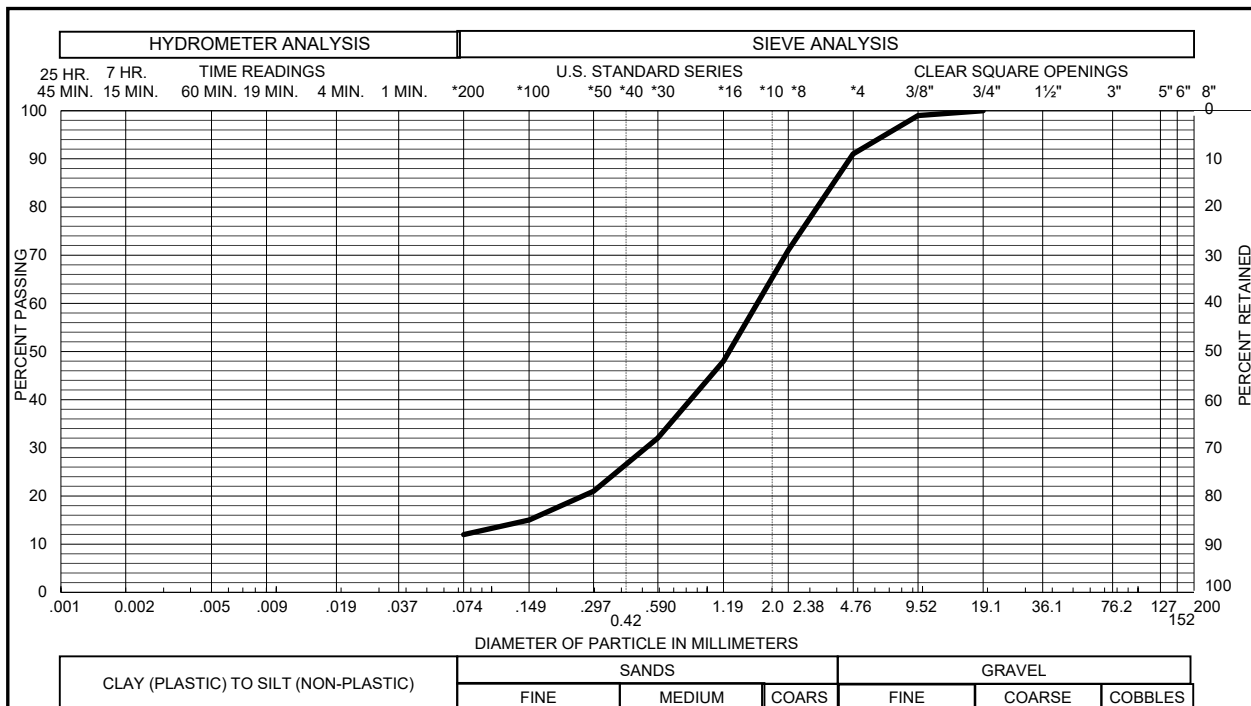
Sample of SAND, SLIGHTLY SILTY (SP-SM) GRAVEL 9 % SAND 79 %  
 From TH - 27 AT 14 FEET SILT & CLAY 12 % LIQUID LIMIT \_\_\_\_\_  
 PLASTICITY INDEX \_\_\_\_\_

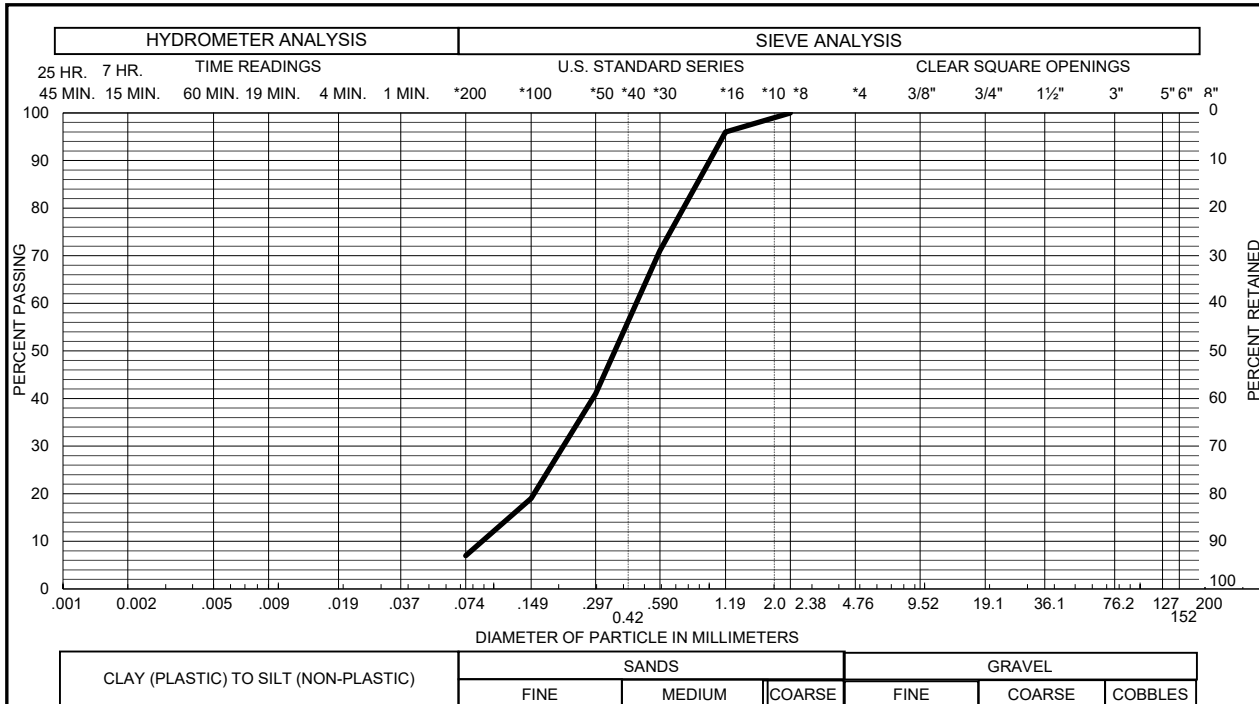
Sample of SAND, SLIGHTLY SILTY (SP-SM) GRAVEL 0 % SAND 93 %  
 From TH - 28 AT 9 FEET SILT & CLAY 7 % LIQUID LIMIT \_\_\_\_\_  
 PLASTICITY INDEX \_\_\_\_\_
