SOILS AND GEOLOGY STUDY

Cleese Court
EPC Schedule No. 4100000075
El Paso County, Colorado

JOB NO. 175674

October 1, 2020

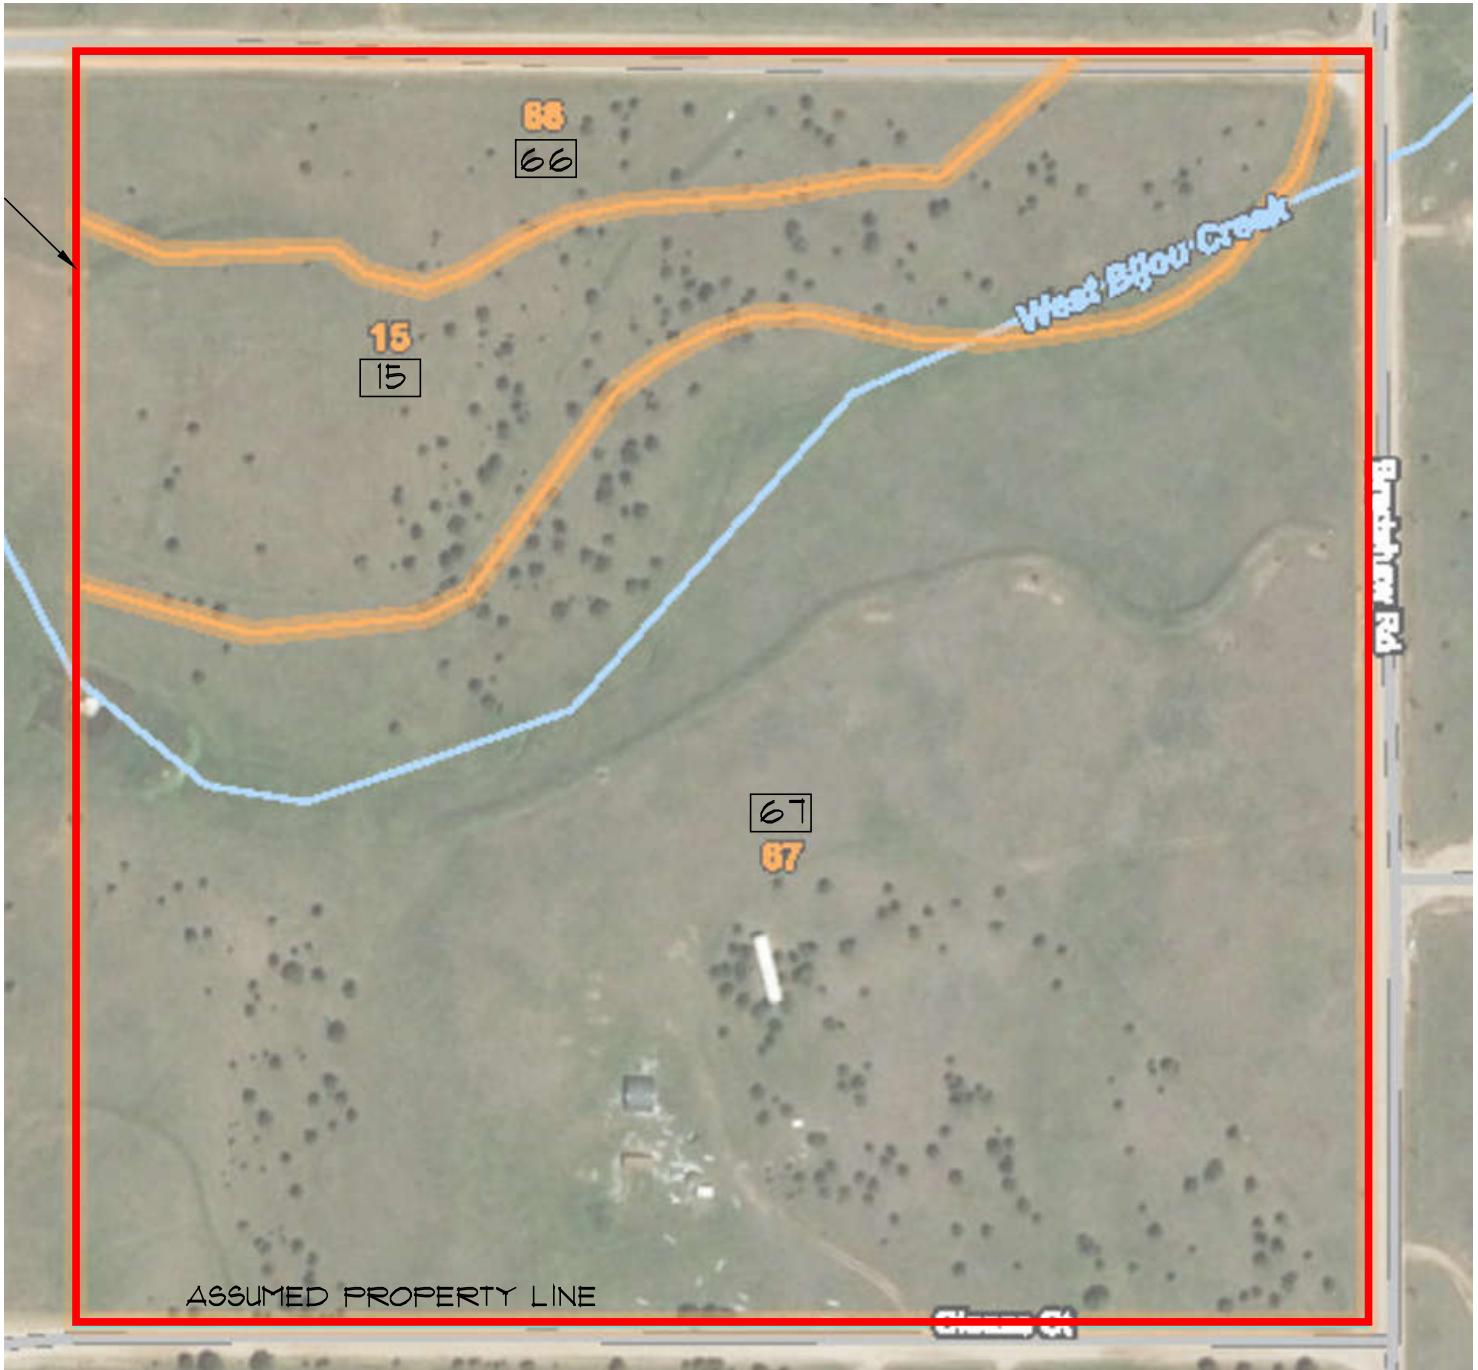
FIGURE No. 10

Map Unit Symbol	Map Unit Name
15	Brusett loam, 3 to 5 percent slopes
66	Peyton sandy loam, 1 to 5 percent slopes
67	Peyton sandy loam, 5 to 9 percent slopes
Totals for Area of Interest

Soil laboratory testing was performed as part of this investigation. The laboratory tests included moisture content, dry density, grain-size analyses, Atterberg Limits and Swell/Consolidation tests. A Summary of Laboratory Test Results is presented in Figure 8. Soil Classification Data is presented in Figure 9. Swell/Consolidation Test Results are presented in Figure 10.
