GEOLOGY AND SOILS REPORT

**Yarbrough Minor Subdivision
0 Rockbrook Road
El Paso County, CO**

JOB NO. 163771

June 20, 2018

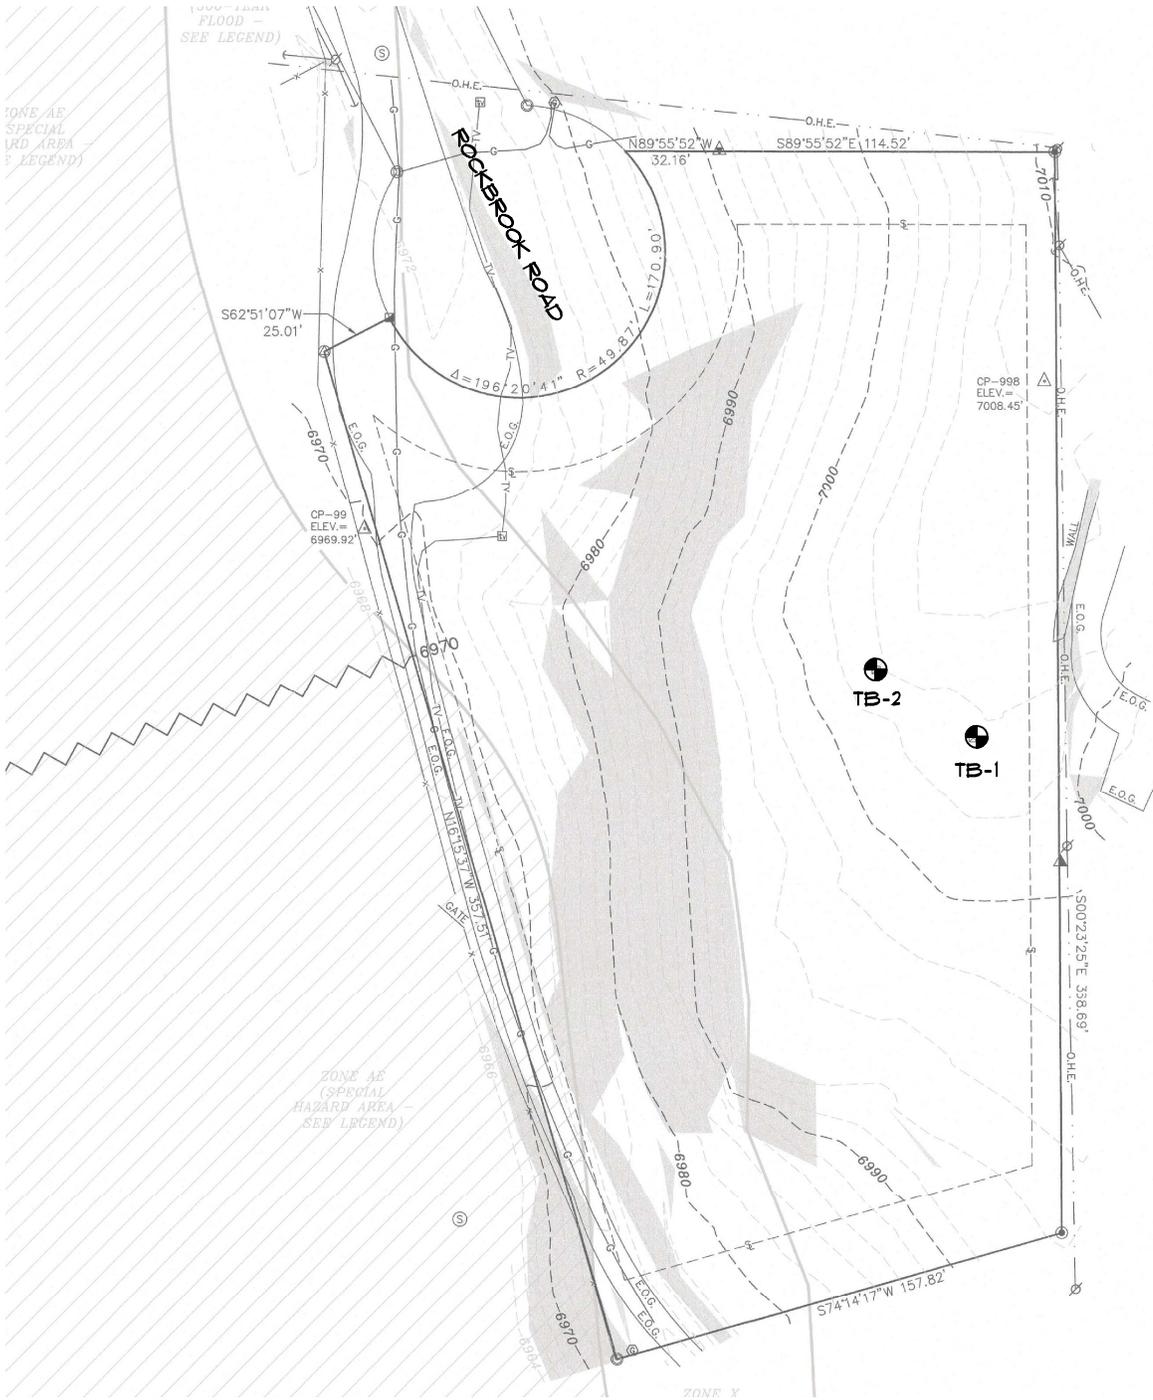
⊕ DENOTES APPROXIMATE LOCATION OF TEST BORINGS

The subsurface conditions within the property were explored by drilling two exploratory borings on May 3, 2018 extending to depths of approximately 20 feet below the existing ground surface. The test borings were performed to explore the subsurface soils underlying the proposed site. The Topographic Survey with Test Boring Locations is presented in Figure 3.

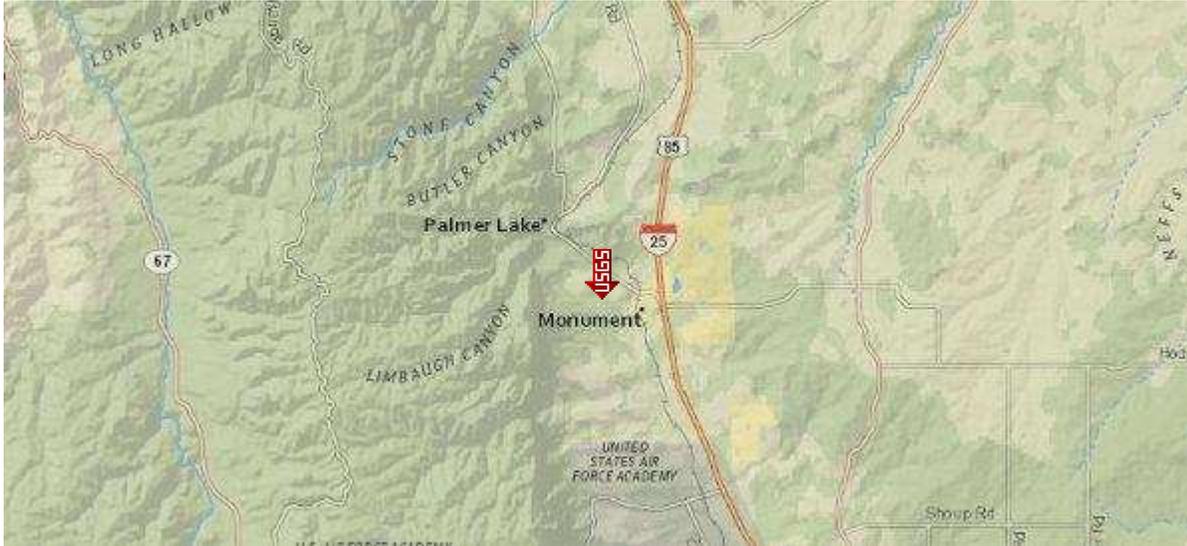
Site Soil Classification Site Class D – “Stiff Soil”

USGS-Provided Output

$S_S = 0.189 \text{ g}$	$S_{MS} = 0.302 \text{ g}$	$S_{DS} = 0.202 \text{ g}$
$S_1 = 0.061 \text{ g}$	$S_{M1} = 0.146 \text{ g}$	$S_{D1} = 0.098 \text{ g}$
