SOIL AND GEOLOGY STUDY

**Falcon Storage
7630 Bent Grass Meadows Drive
El Paso County, Colorado**

**Vollmer Road Partners, LLP
6035 Erin Park Dr, Ste #103
Colorado Springs, CO 80918**

JOB NO. 193324

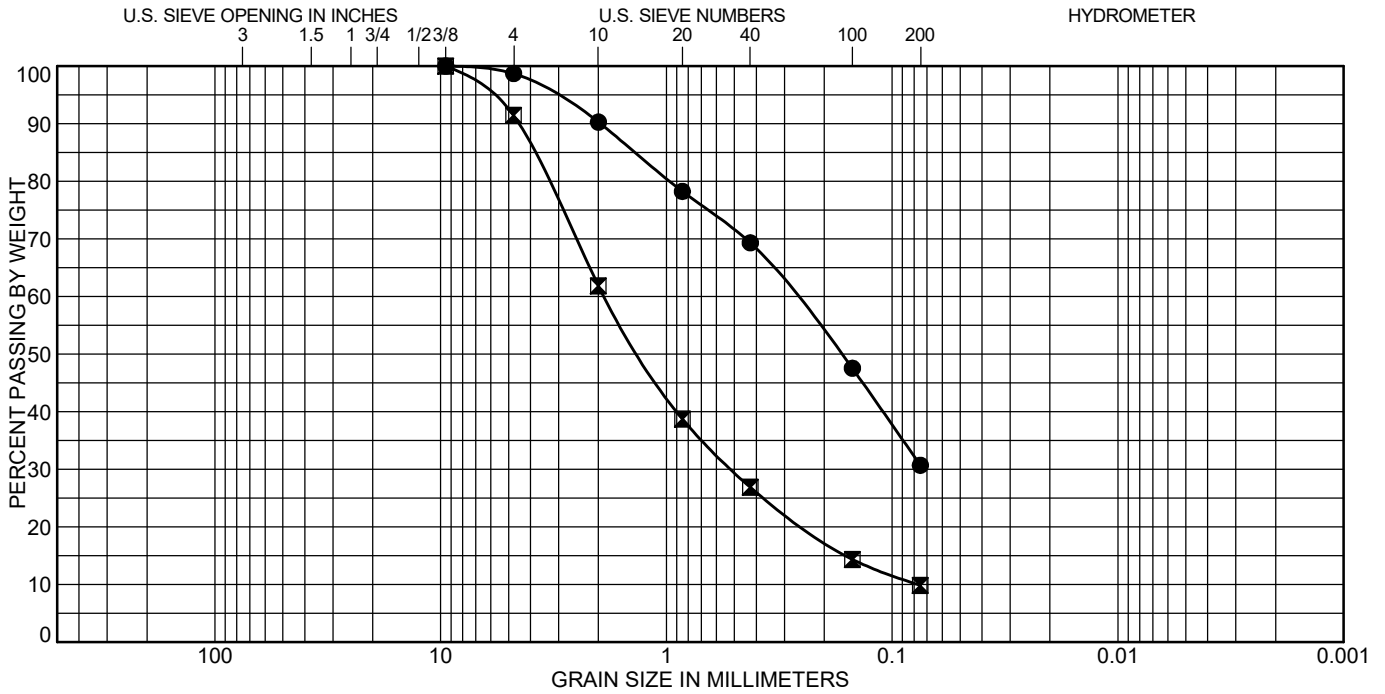
Test Boring	Depth (ft)	Classification	LL	PL	PI
● 1	2.0	SILTY SAND(SM)	NP	NP	NP
☒ 2	4.0	WELL-GRADED SAND with SILT(SW-SM)	NP	NP	NP

Soil laboratory testing was performed as part of this investigation. The laboratory tests included moisture content, grain-size analyses, and Atterberg Limit tests. A Summary of Laboratory Test Results is presented in Figure 6. Soils Classification Data is presented in Figure 7.
