SOIL, GEOLOGY AND GEOTECHNICAL REPORT

5080 Tamlin Road
EPC Schedule No. 5321002001
El Paso County, Colorado

JOB NO. 174679
PCD File No. PPR1945

March 2, 2020
Amended August 14, 2020

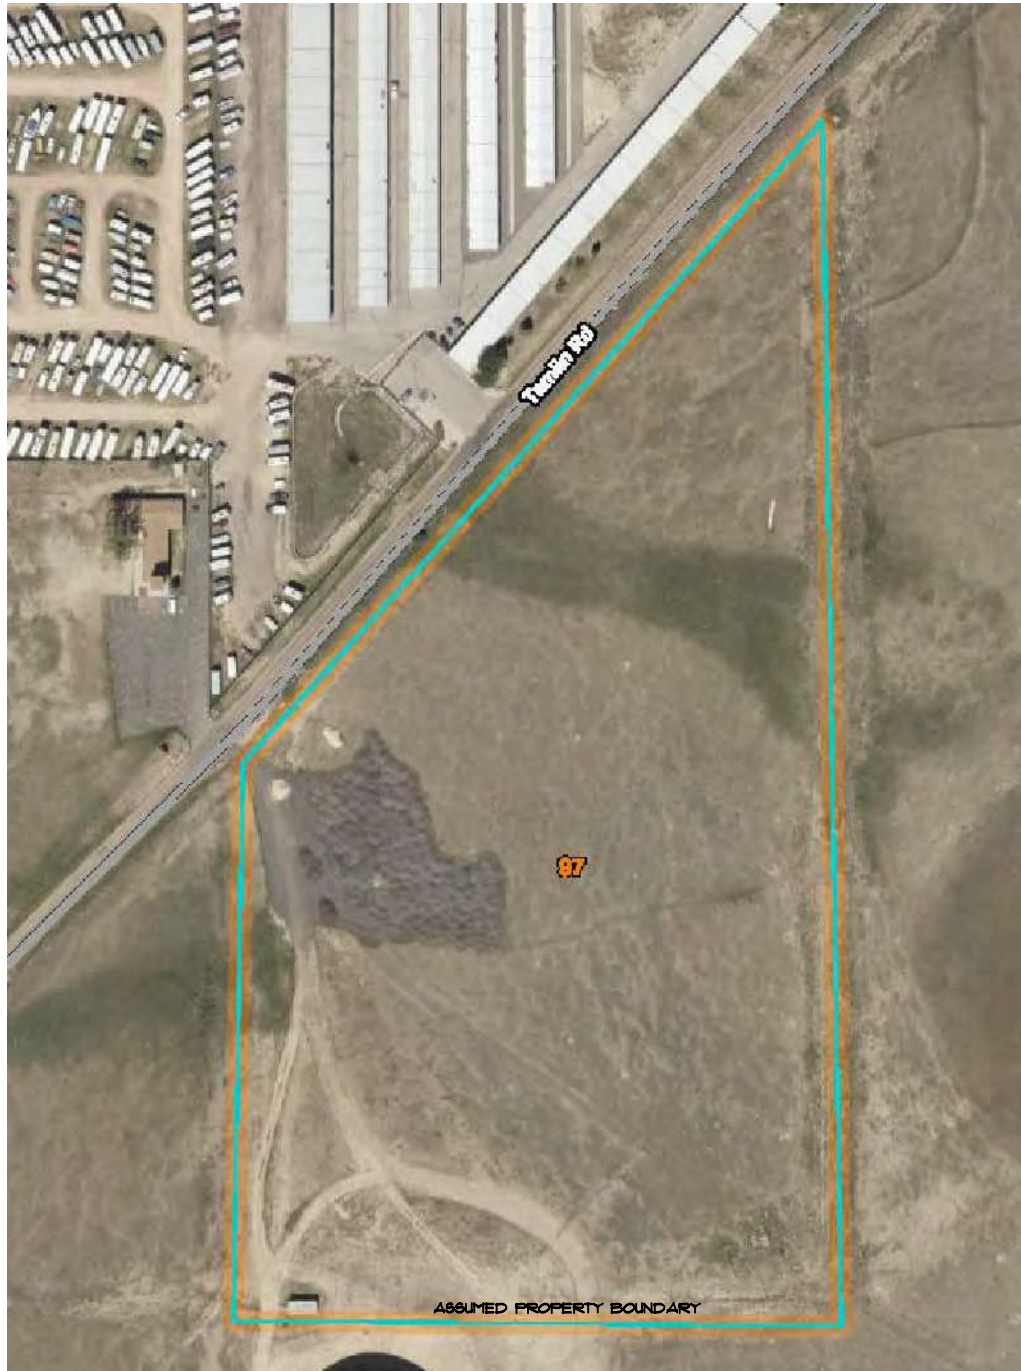
FIG No. 11

97 - Truckton sandy loam 3 to 9 percent slopes

The USDA Soil Survey Map is presented in Figure 11.
