SOIL, GEOLOGY AND GEOTECHNICAL REPORT

**5080 Tamlin Road
EPC Schedule No. 5321002001
El Paso County, Colorado**

**JOB NO. 174679
PCD File No. PPR1945**

**March 2, 2020
Amended August 14, 2020**

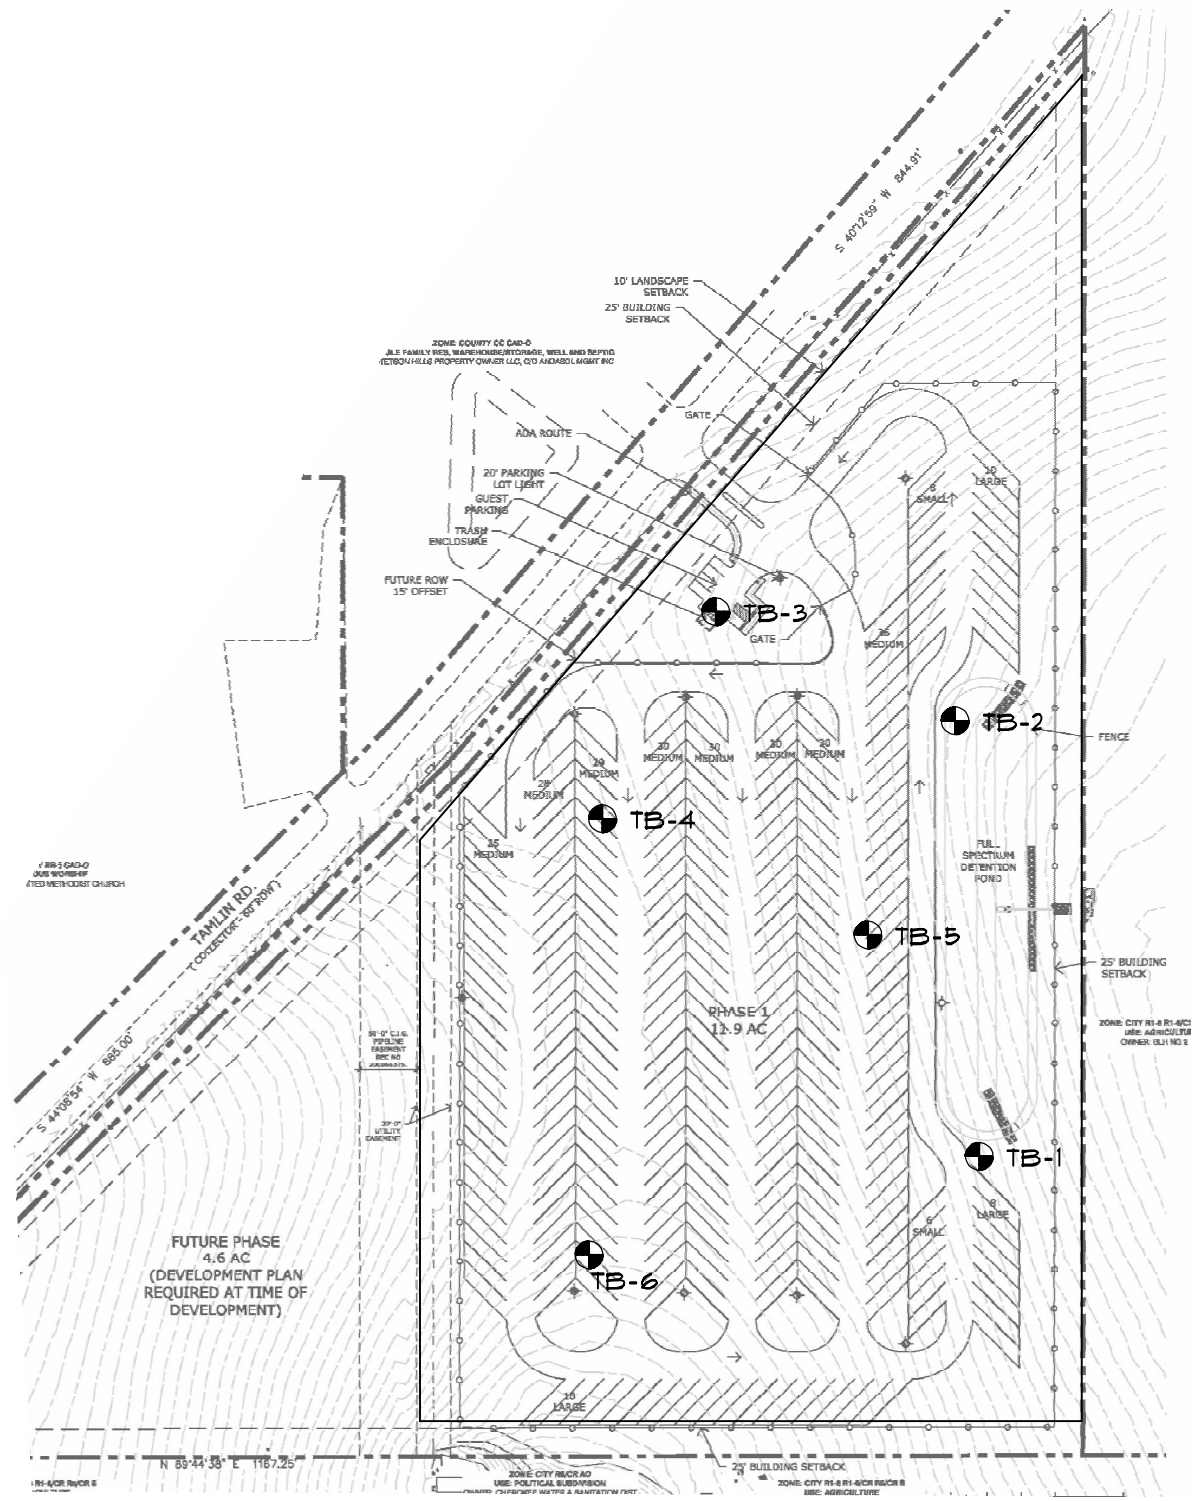
NOT TO SCALE
BASE MAP PROVIDED BY: N.E.S. INC.

● DENOTES APPROXIMATE LOCATION OF TEST BORINGS

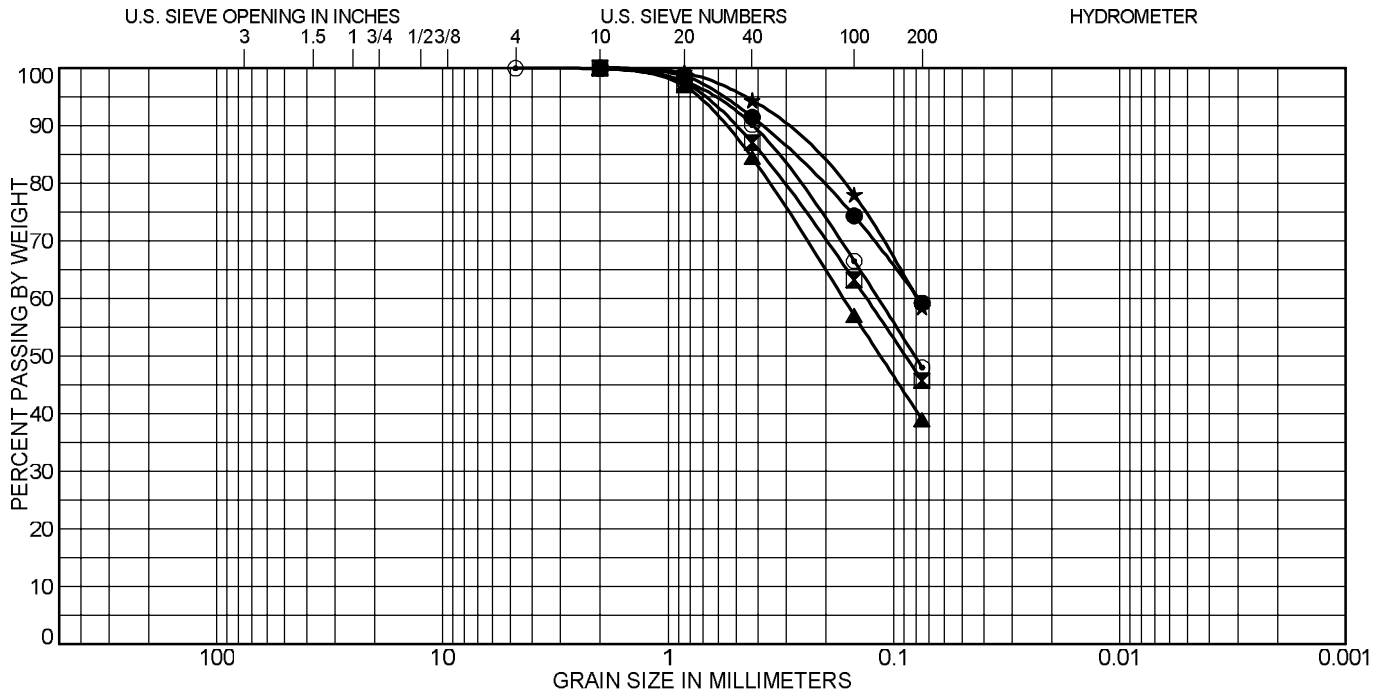
FIGURE No. 8

COBBLES	GRAVEL		SAND			SILT OR CLAY
	coarse	fine	coarse	medium	fine

Test Boring	Depth (ft)	Classification	LL	PL	PI
● 1	4.0	SANDY LEAN CLAY(CL)	45	18	27
☒ 2	9.0	CLAYEY SAND(SC)	30	16	14
▲ 3	4.0	CLAYEY SAND(SC)	28	14	14
★ 4	2.0	SANDY LEAN CLAY(CL)	38	15	23
◎ 5	2.0	CLAYEY SAND(SC)	33	13	20

Soil laboratory testing was performed as part of this investigation. The laboratory tests included moisture content, dry density, grain-size analyses and Atterberg Limits testing. A Summary of Laboratory Test Results is presented in Figure 7. Soils Classification Data is presented in Figures 8 and 9. Swell/Consolidation Test Results are presented in Figure 10.

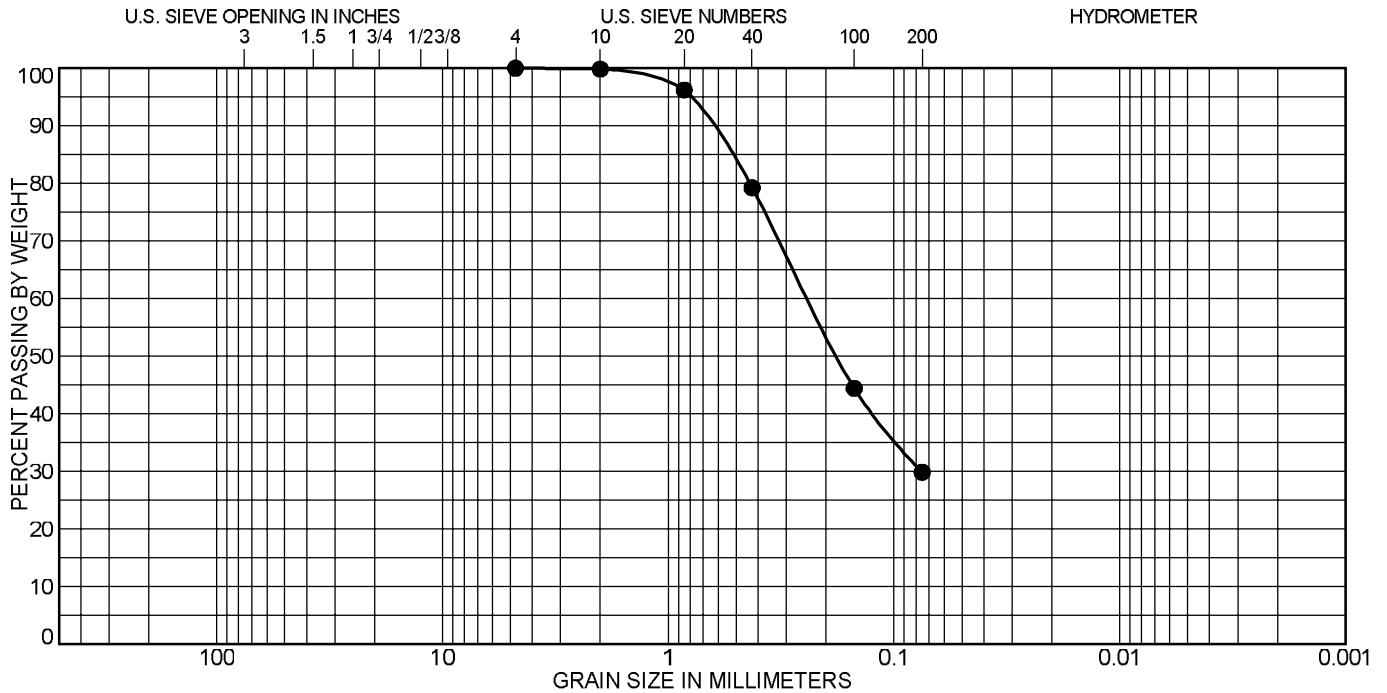
FIGURE No. 9

COBBLES	GRAVEL		SAND			SILT OR CLAY
	coarse	fine	coarse	medium	fine

Test Boring	Depth (ft)	Classification	LL	PL	PI
● 6	2.0	CLAYEY SAND(SC)	33	14	19

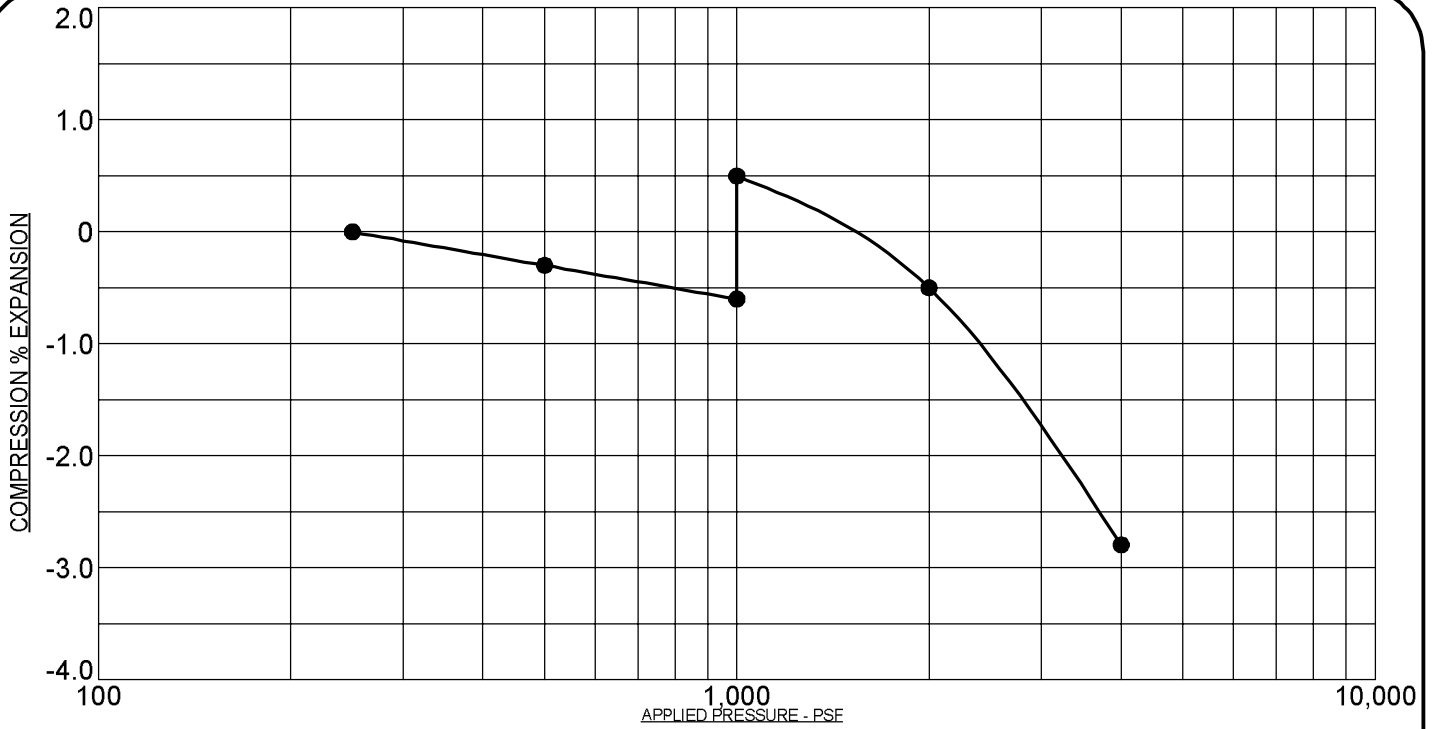
FIGURE No. 10

PROJECT: 5080 Tamlin Road, El Paso County, Colorado
 SAMPLE DESCRIPTION: CLAY, SANDY
 NOTE: SAMPLE WAS INUNDATED WITH WATER AT 1,000 PSF

SAMPLE LOCATION: 1 @ 4 FT
 NATURAL DRY UNIT WEIGHT: 99.8 PCF
 NATURAL MOISTURE CONTENT: 14.0%
 PERCENT SWELL/COMPRESSION: 1.1

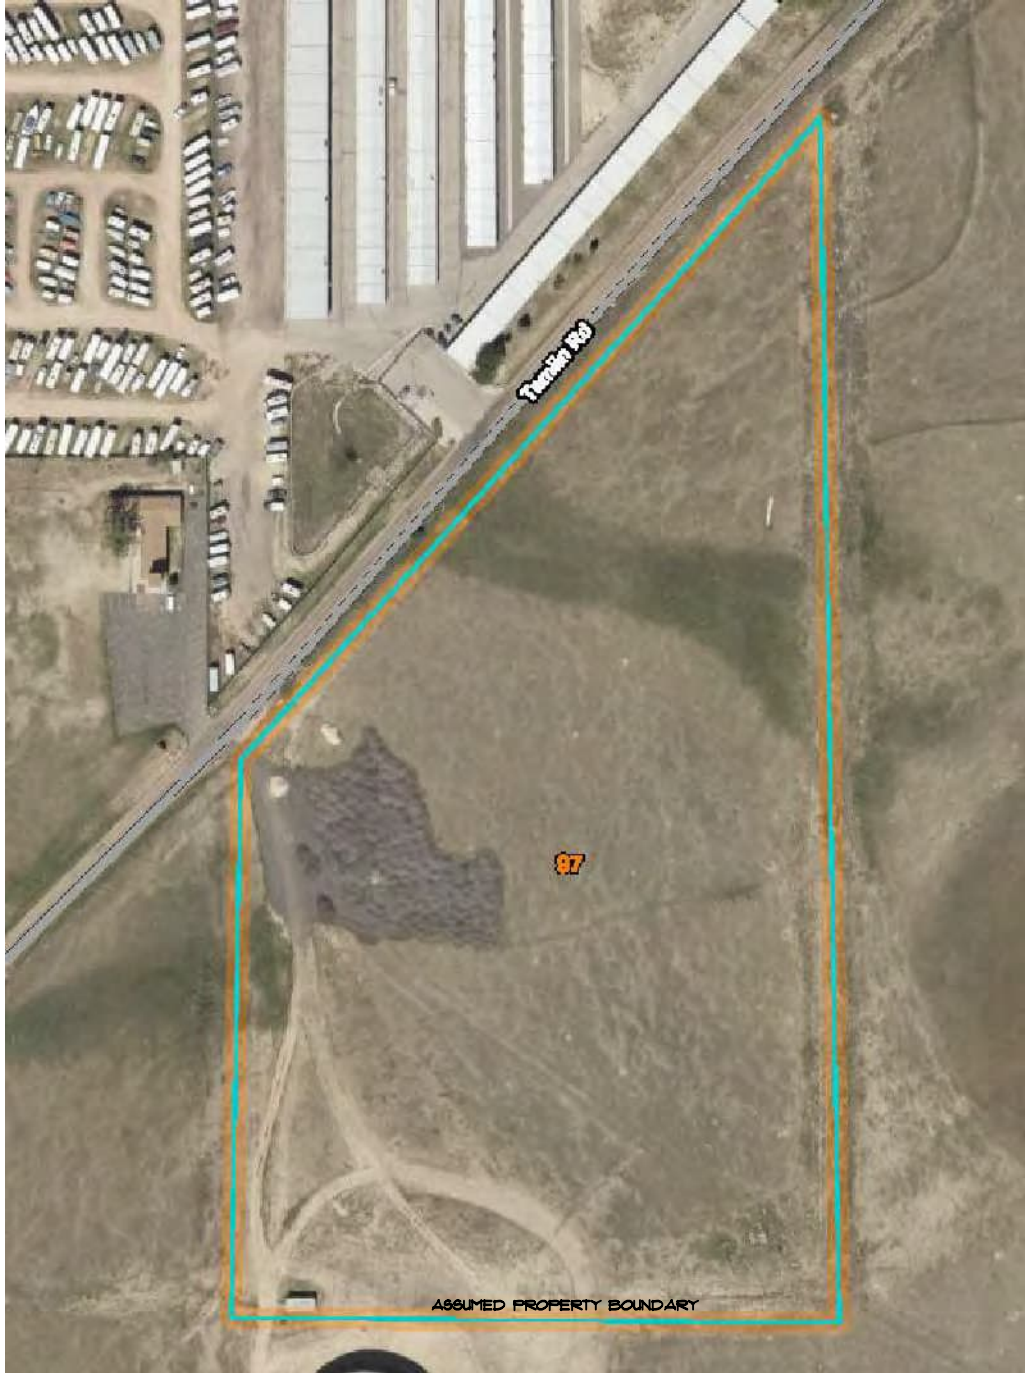
FIG No. 11

97 - Truckton sandy loam 3 to 9 percent slopes

The USDA Soil Survey Map is presented in Figure 11.

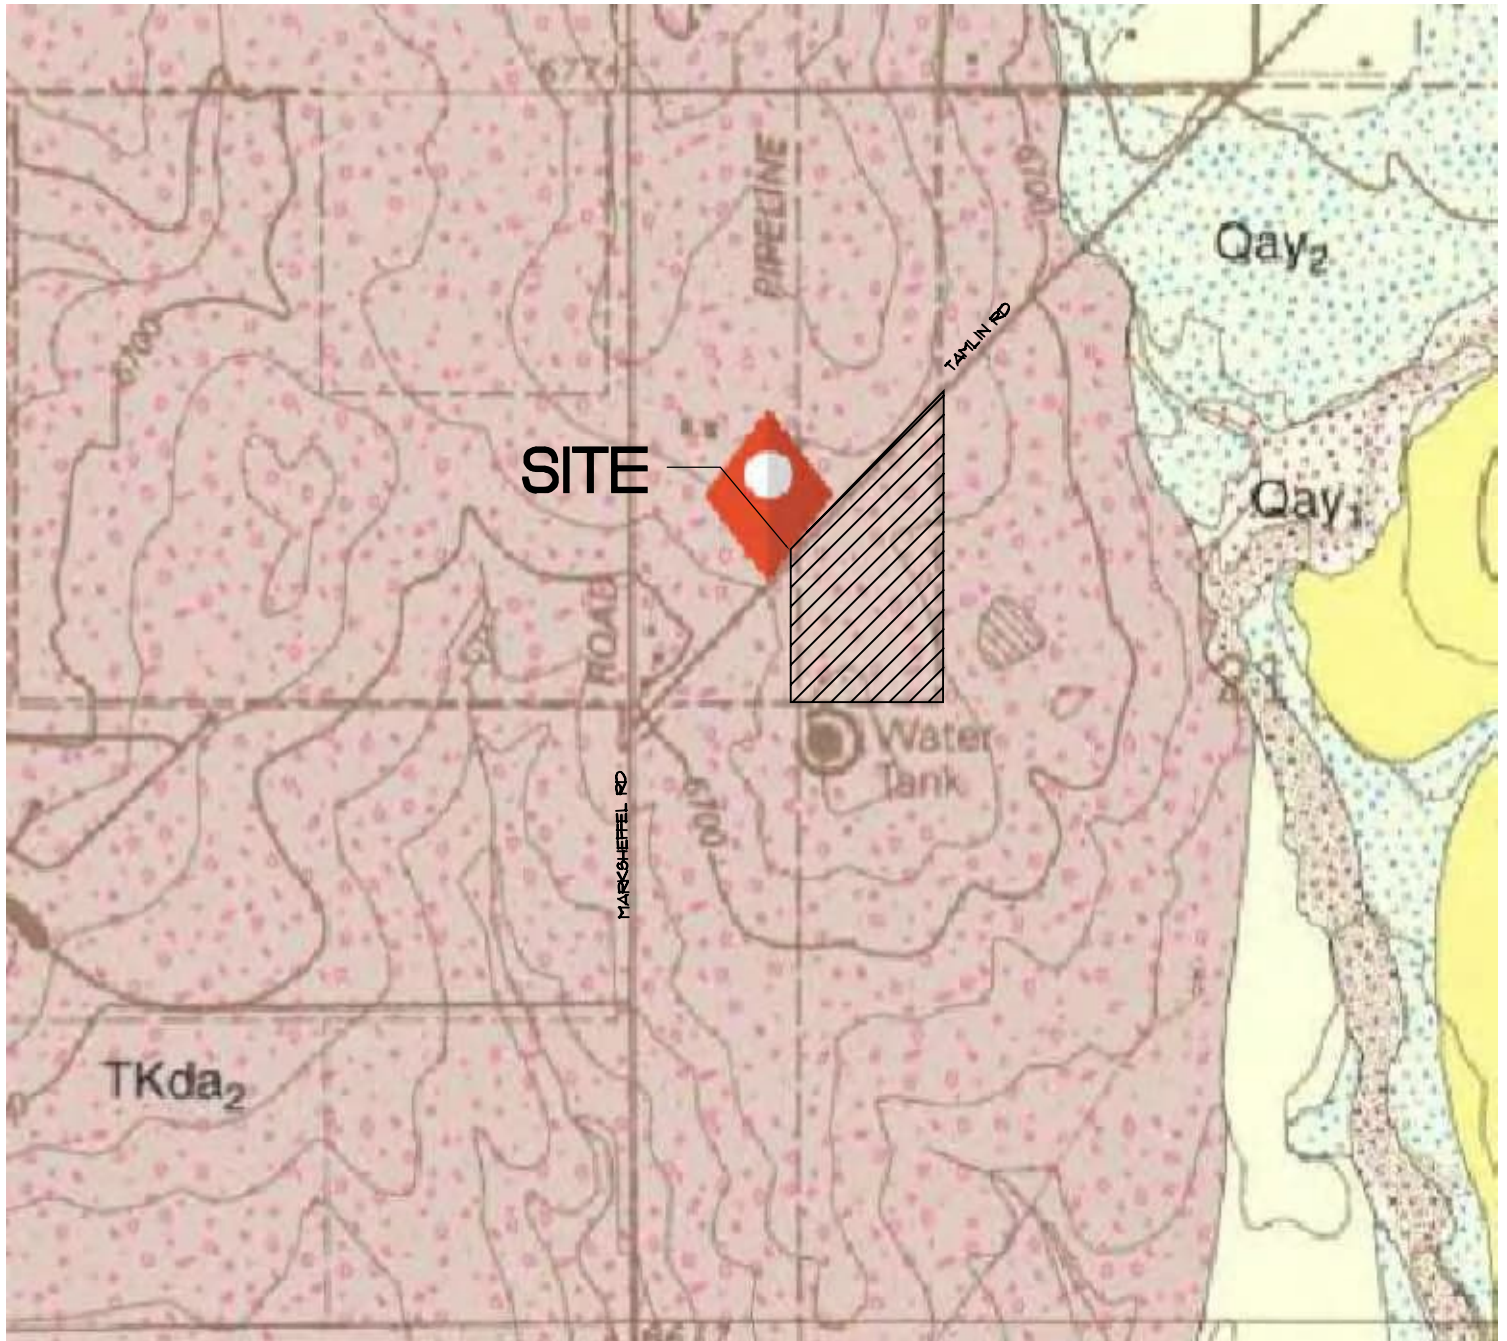
FIG No. 12

Tkda₂ - Dawson Formation

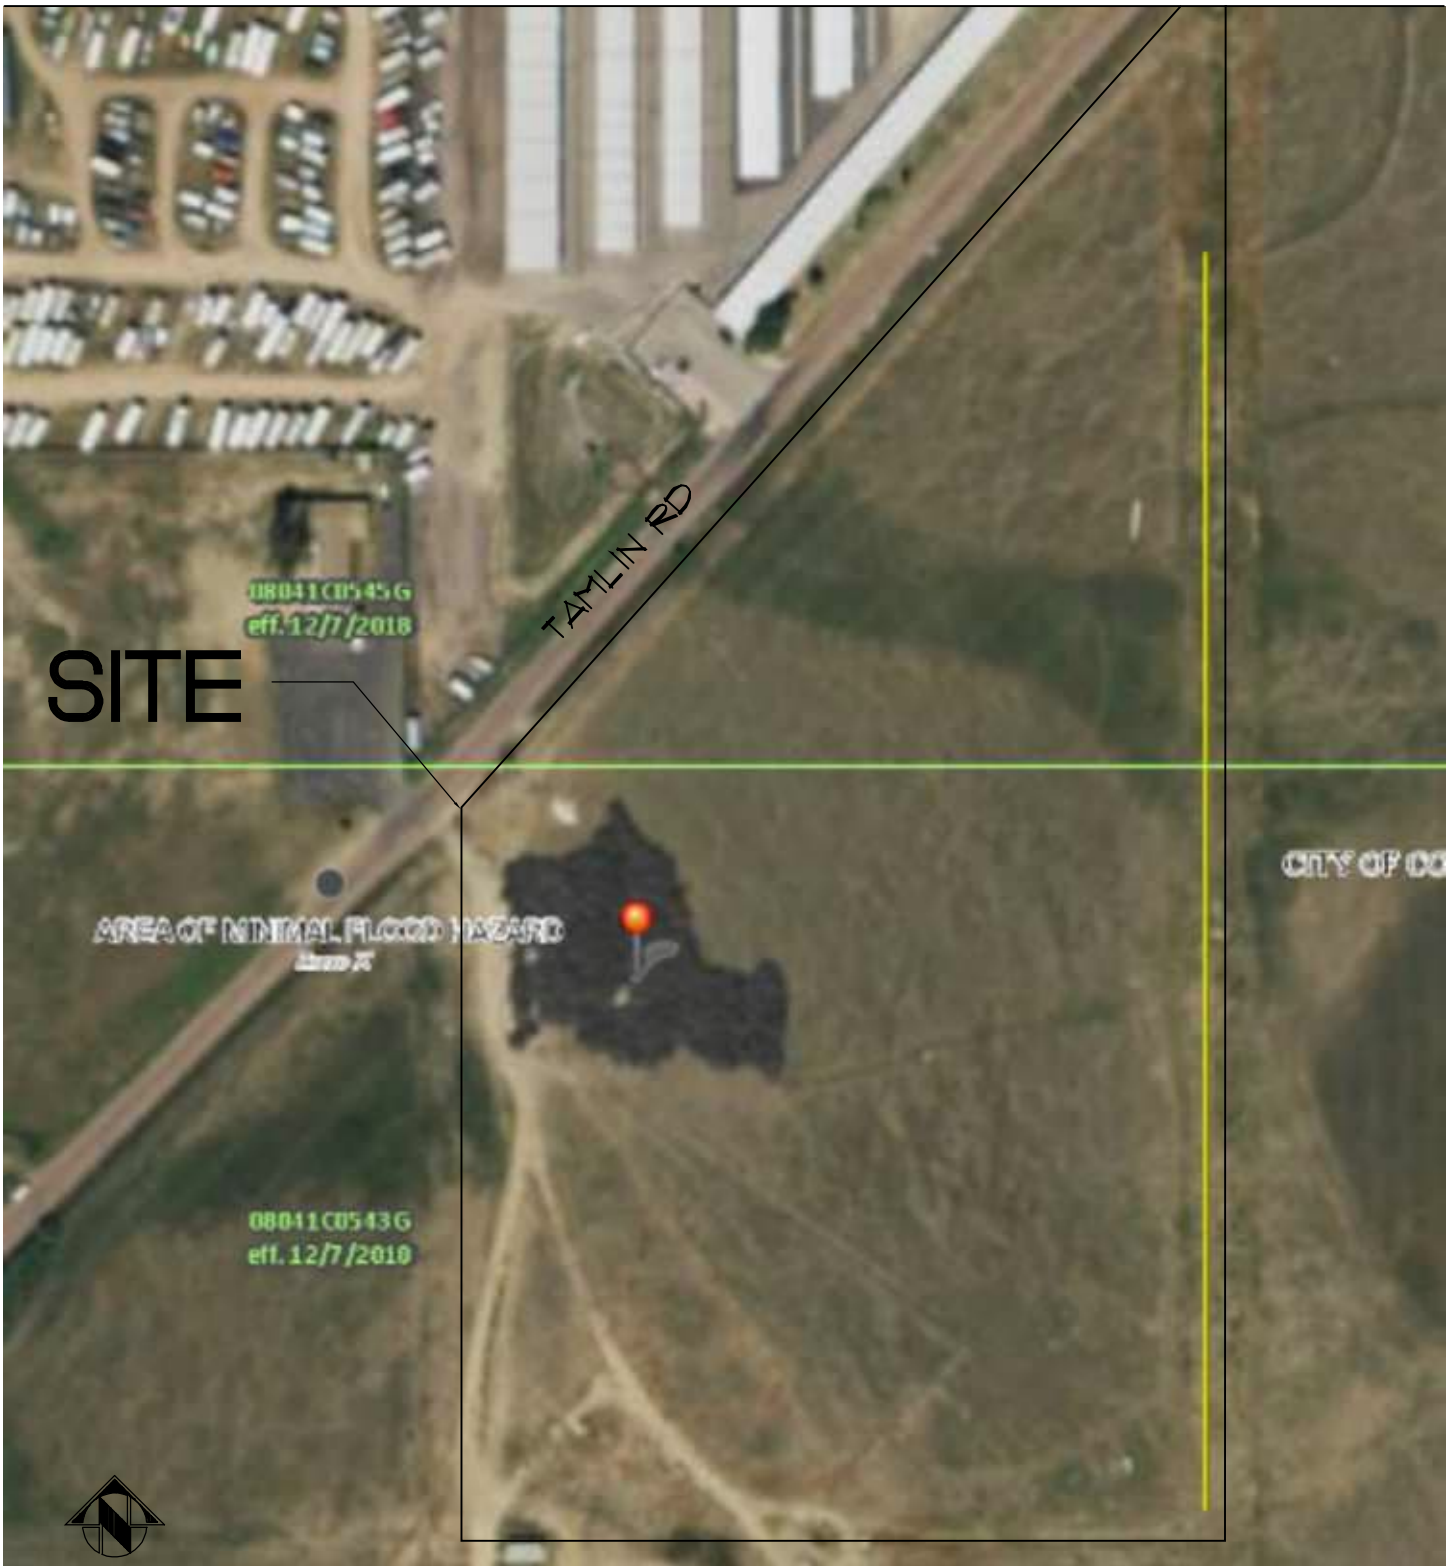
FIG No. 13

SITE

08041C0545G
eff. 12/7/2018

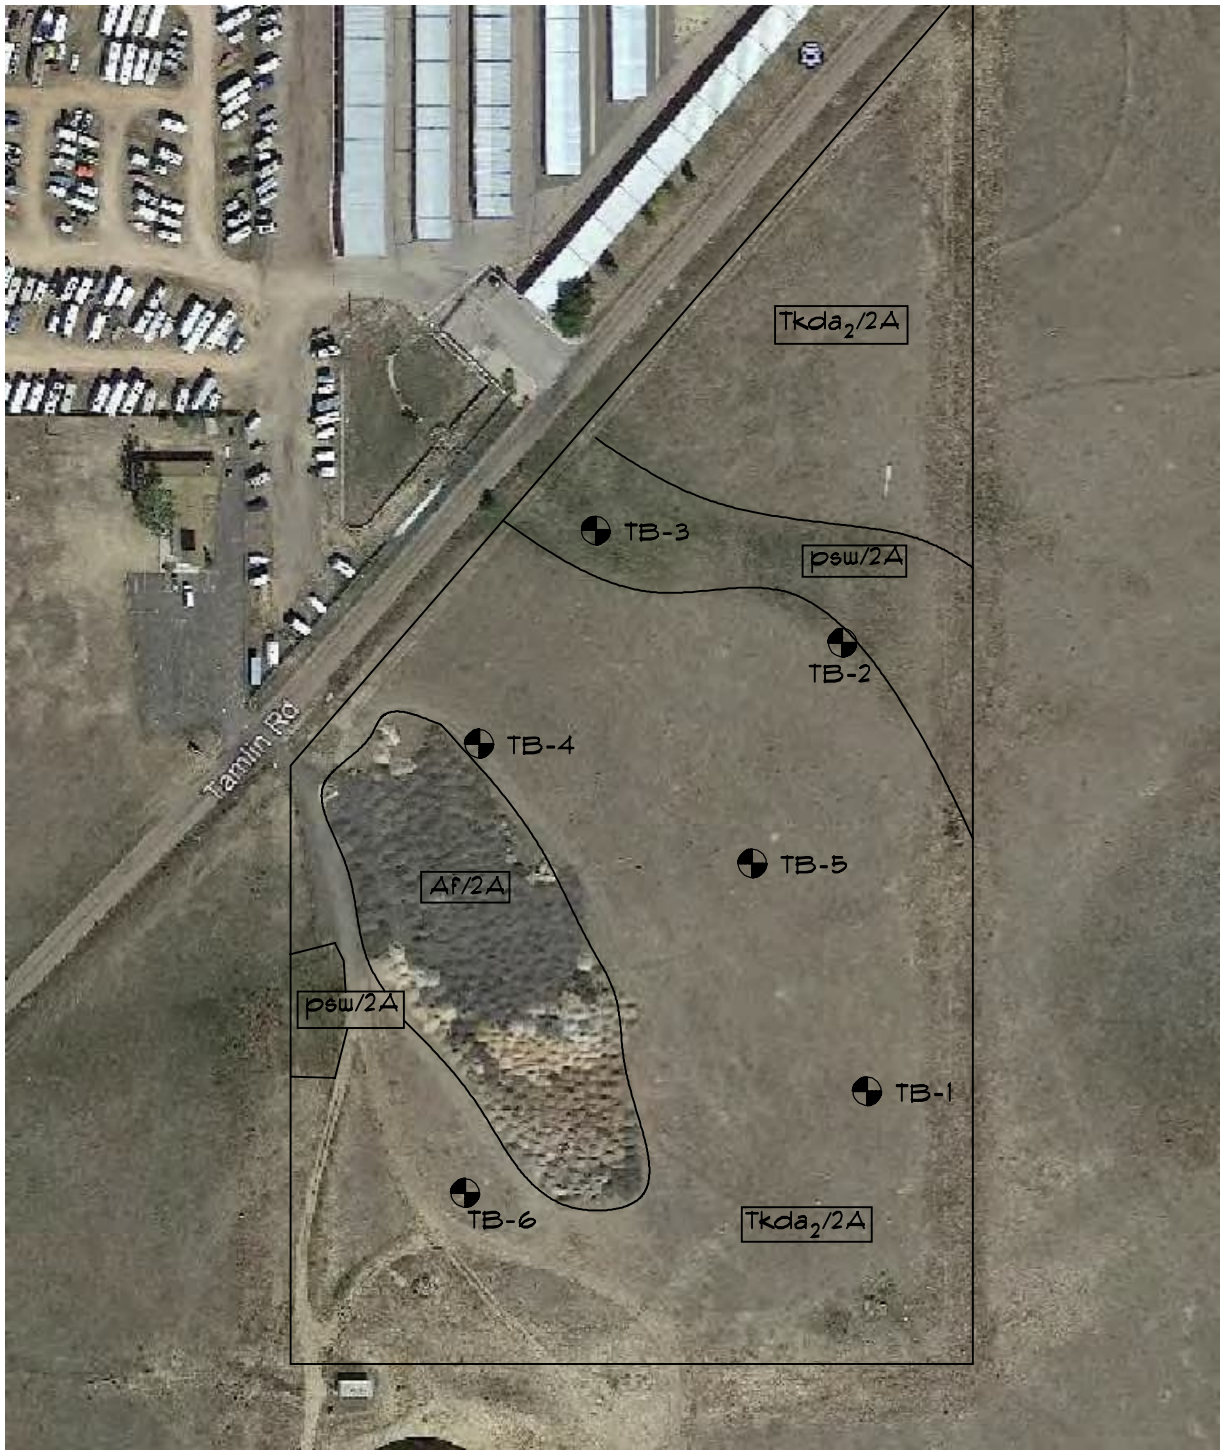
Geologic

Af - Artificial Fill
 psw - potentially seasonally wet
 Tkda₂ - Dawson Formation
