SOIL, GEOLOGY AND GEOTECHNICAL REPORT

**5080 Tamlin Rd
Western Portion of EPC Schedule No. 5321002001
El Paso County, Colorado**

**Tamlin Storage, LLC
5080 Tamlin Road
Colorado Springs, CO 80906**

JOB NO. 198022

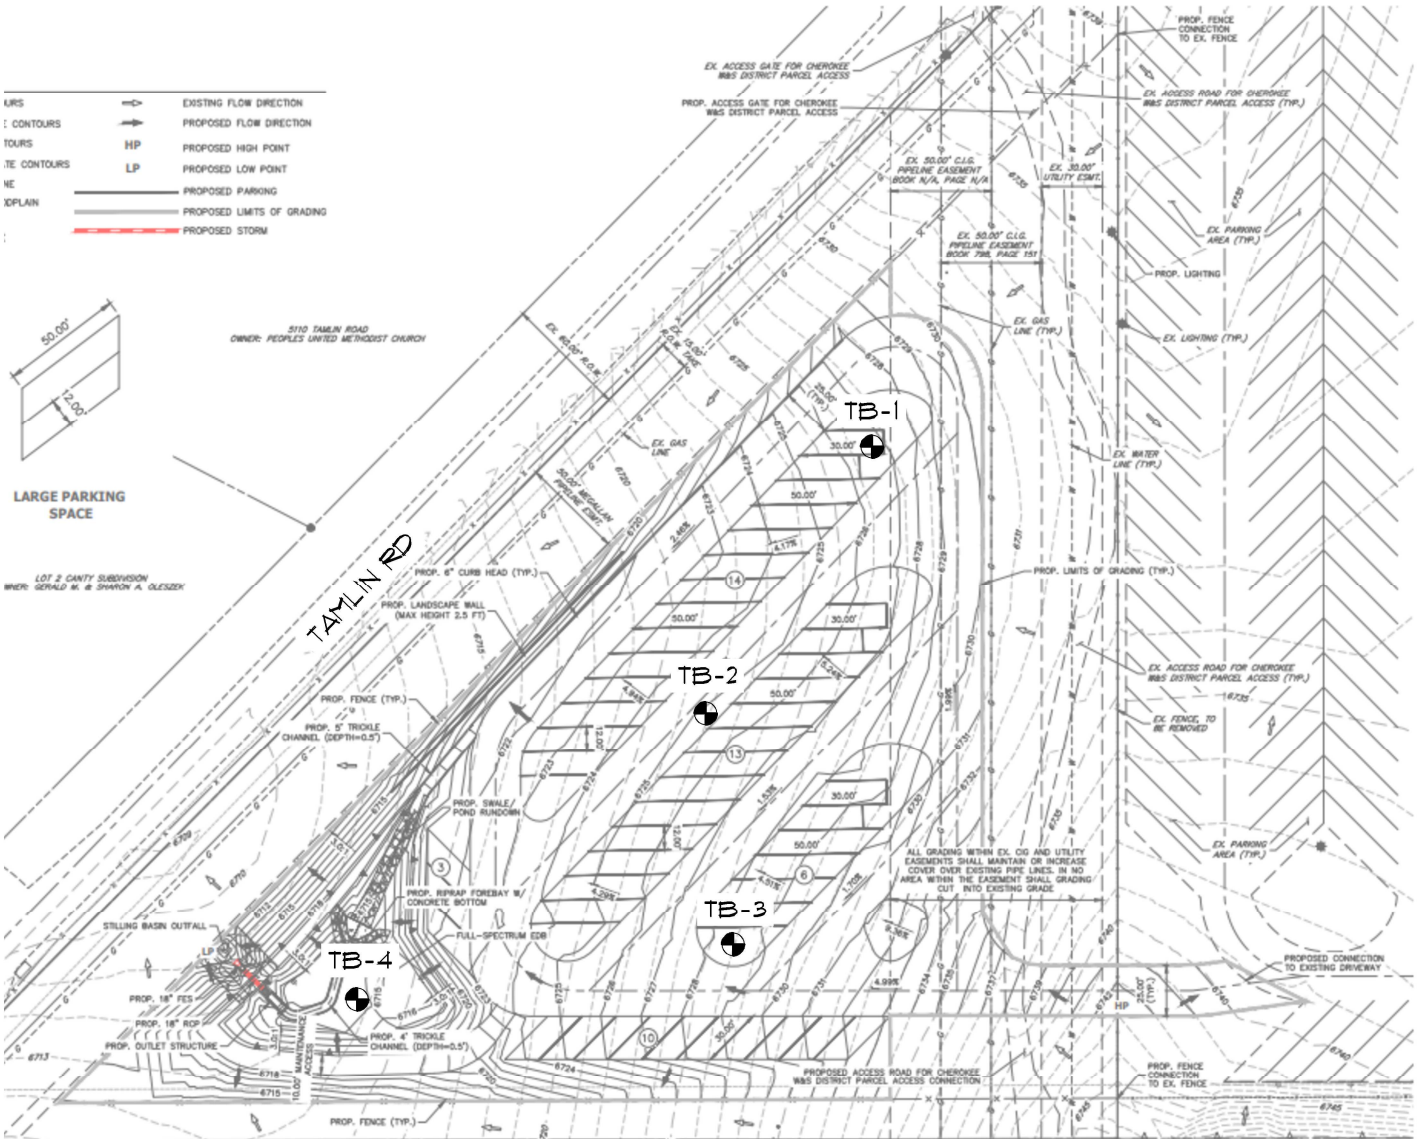
⊕ DENOTES APPROXIMATE LOCATION OF TEST BORINGS

The subsurface conditions within the property were explored by drilling three borings to 10 feet for pavement recommendations and one boring to 20 feet for the detention pond. This is in compliance with the minimum of one test boring per 10 acres of development up to 100 acres, required by the ECM.

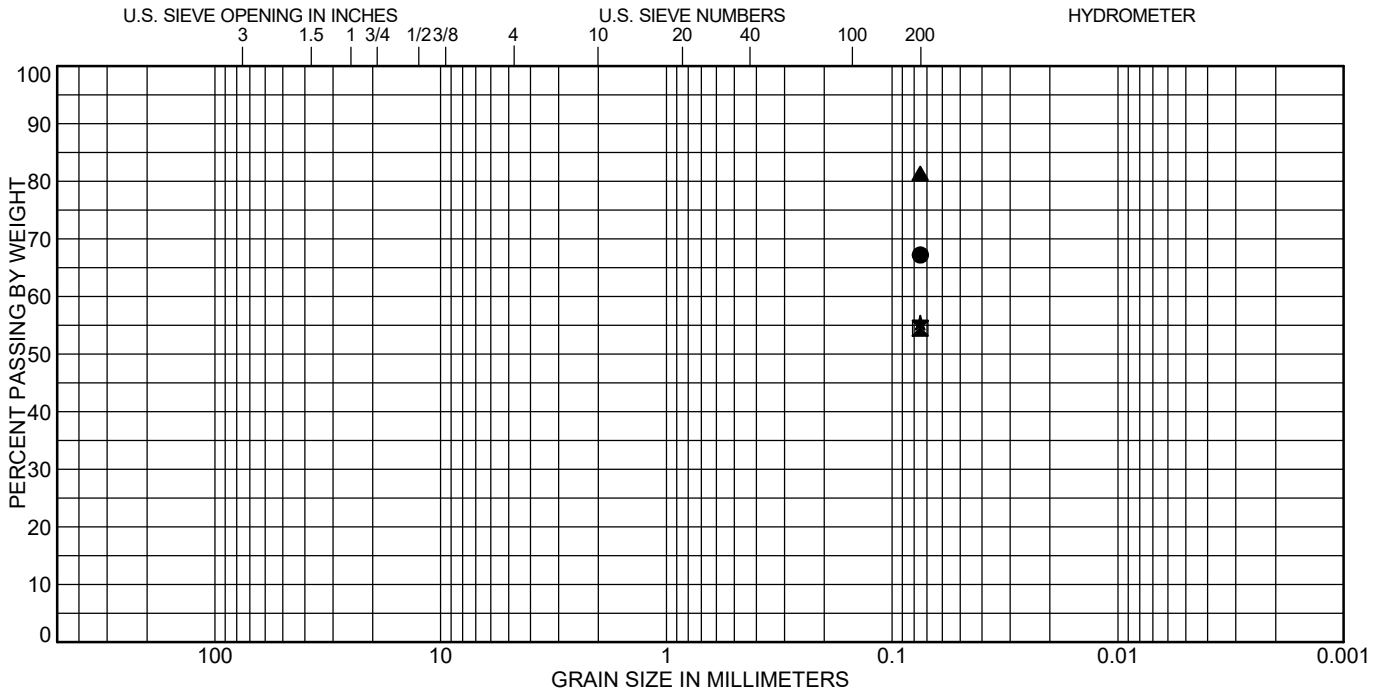
FIGURE No. 7

COBBLES	GRAVEL		SAND			SILT OR CLAY
	coarse	fine	coarse	medium	fine

Test Boring	Depth (ft)	Classification	LL	PL	PI
● 1	4.0	SANDY LEAN CLAY(CL)	46	22	24
☒ 2	2.0	SANDY LEAN CLAY(CL)	35	20	15
▲ 3	9.0	LEAN CLAY with SAND(CL)	44	26	18
★ 4	4.0	SANDY LEAN CLAY(CL)	39	23	16

Soil laboratory testing was performed as part of this investigation. The laboratory tests included moisture content, dry density, grain-size analyses and Atterberg Limits testing. A Summary of Laboratory Test Results is presented in Figure 6. Soils Classification Data is presented in Figure 7. Swell/Consolidation Test Results are presented in Figures 8 and 9.

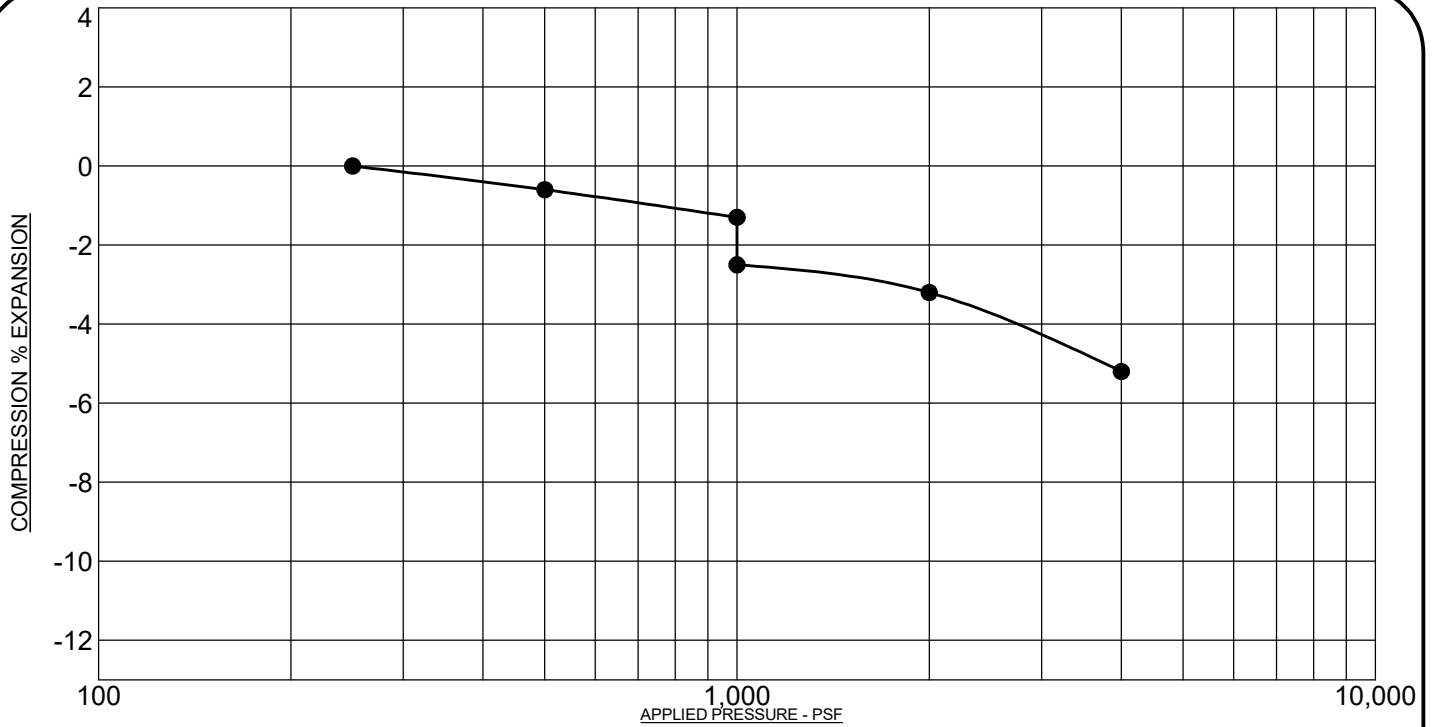
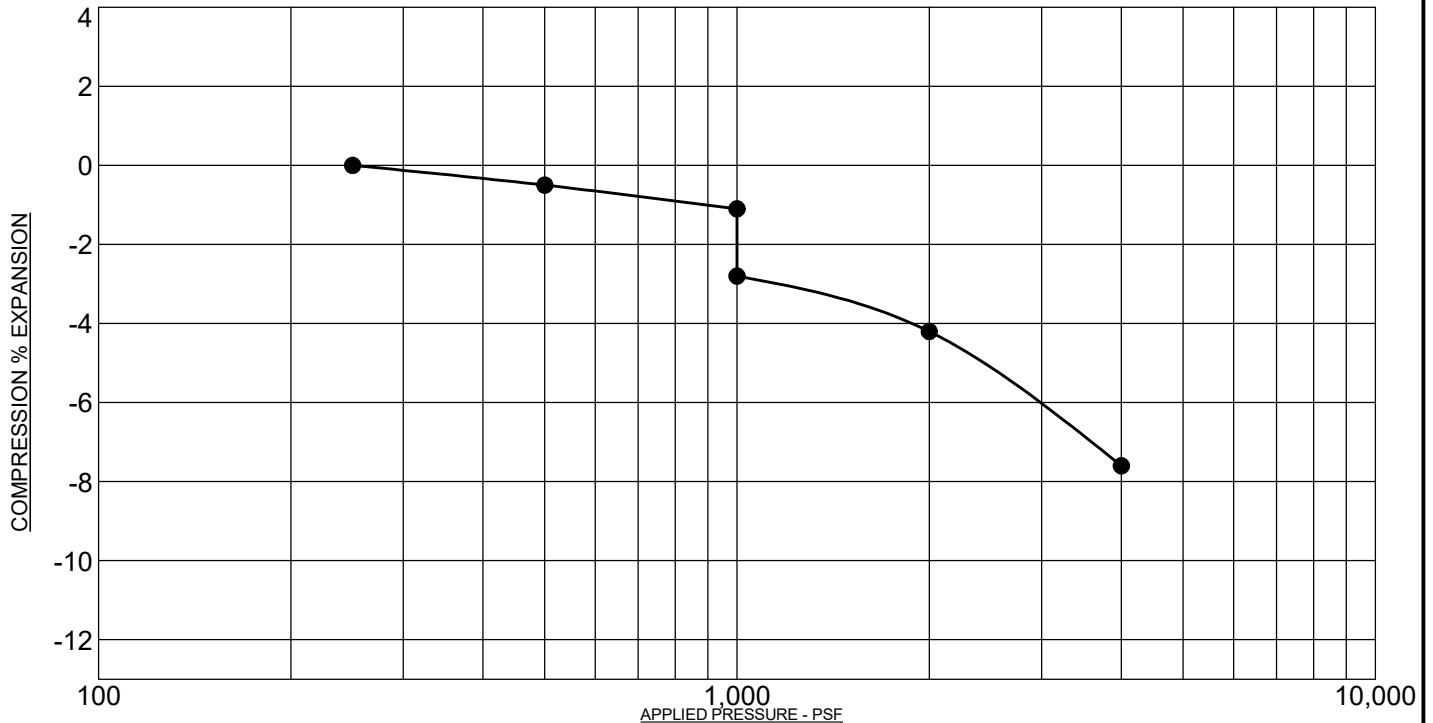
FIGURE No. 8

PROJECT: 5080 Tamlin Rd, El Paso County, Colorado
 SAMPLE DESCRIPTION: CLAY, SANDY
 NOTE: SAMPLE WAS INUNDATED WITH WATER AT 1,000 PSF

SAMPLE LOCATION: 1 @ 4 FT
 NATURAL DRY UNIT WEIGHT: 95.2 PCF
 NATURAL MOISTURE CONTENT: 12.9%
 PERCENT SWELL/COMPRESSION: - 1.2

SAMPLE LOCATION: 2 @ 2 FT
 NATURAL DRY UNIT WEIGHT: 102.3 PCF
 NATURAL MOISTURE CONTENT: 10.6%
 PERCENT SWELL/COMPRESSION: - 1.7

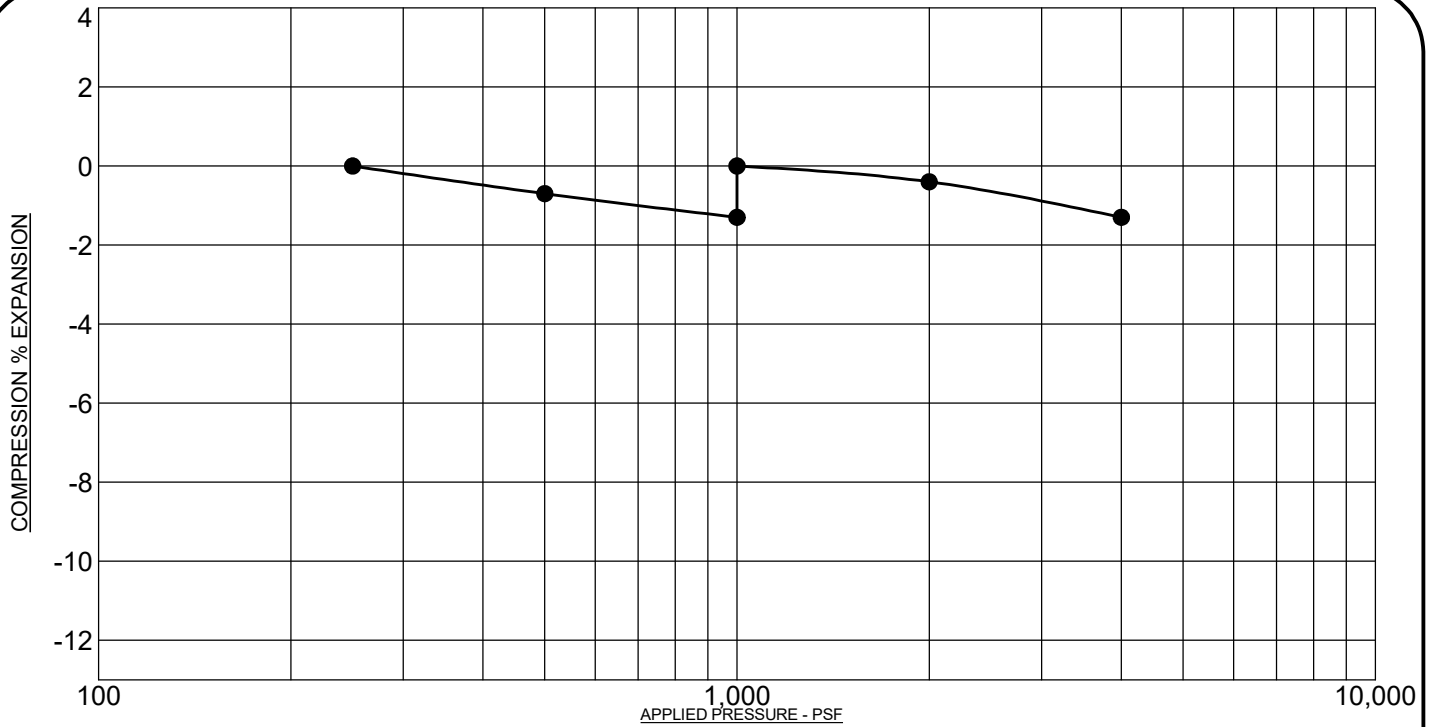
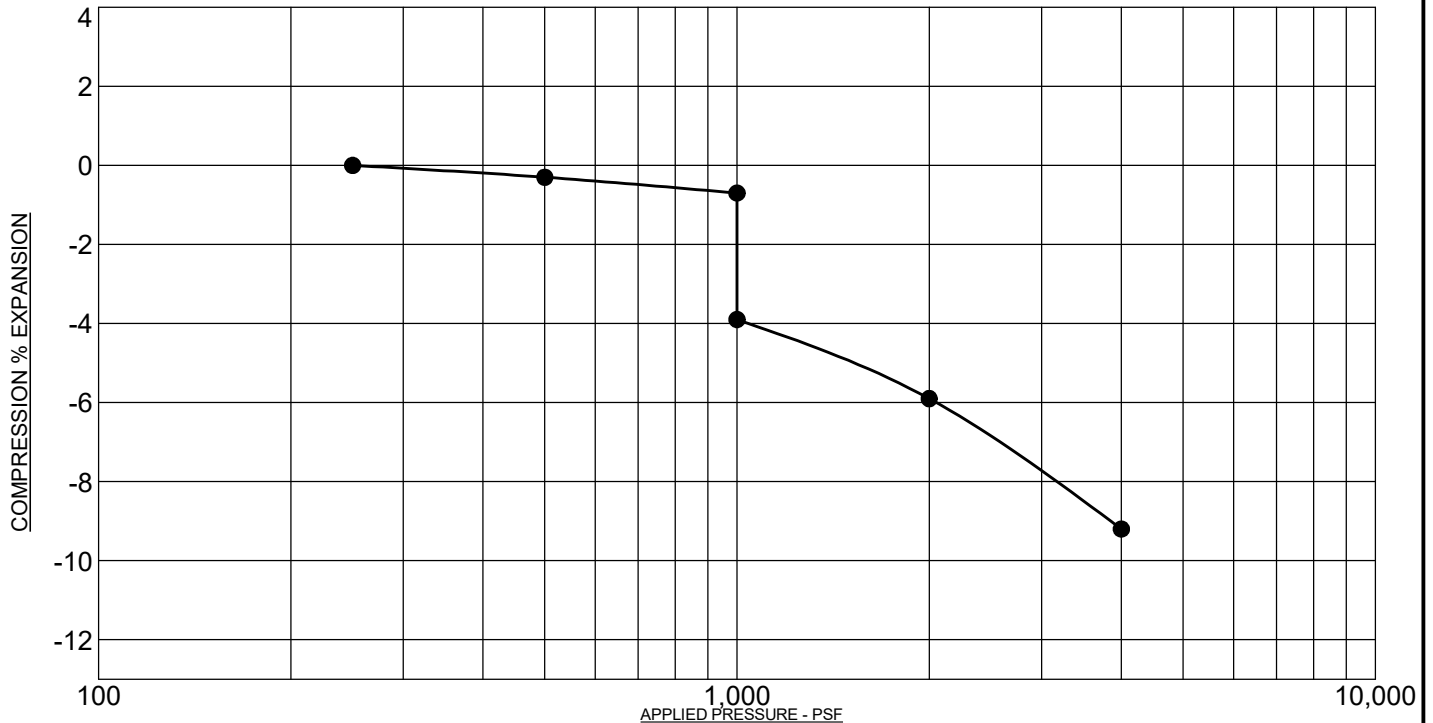
FIGURE No. 9

PROJECT: 5080 Tamlin Rd, El Paso County, Colorado
 SAMPLE DESCRIPTION: CLAYSTONE, SANDY
 NOTE: SAMPLE WAS INUNDATED WITH WATER AT 1,000 PSF

SAMPLE LOCATION: 3 @ 9 FT
 NATURAL DRY UNIT WEIGHT: 112.0 PCF
 NATURAL MOISTURE CONTENT: 15.0%
 PERCENT SWELL/COMPRESSION: 1.3

PROJECT: 5080 Tamlin Rd, El Paso County, Colorado
 SAMPLE DESCRIPTION: CLAY, SANDY
 NOTE: SAMPLE WAS INUNDATED WITH WATER AT 1,000 PSF

SAMPLE LOCATION: 4 @ 4 FT
 NATURAL DRY UNIT WEIGHT: 86.5 PCF
 NATURAL MOISTURE CONTENT: 14.1%
 PERCENT SWELL/COMPRESSION: -3.2

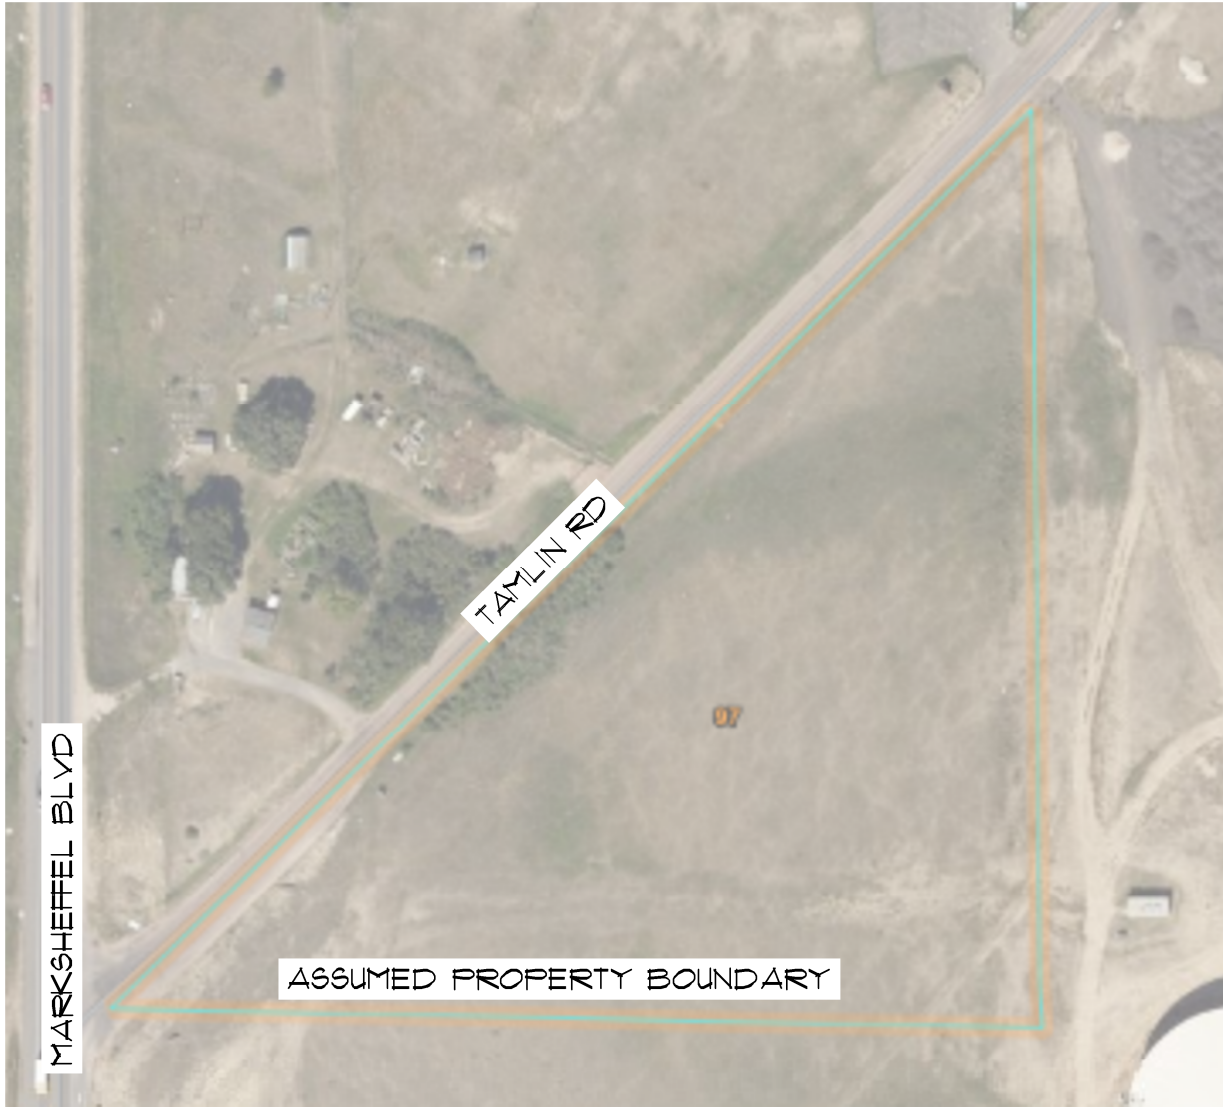
FIG No. 10

97 - TRUCKTON SANDY LOAM, 3 TO 9 PERCENT SLOPES

The USDA Soil Survey Map is presented in Figure 10.

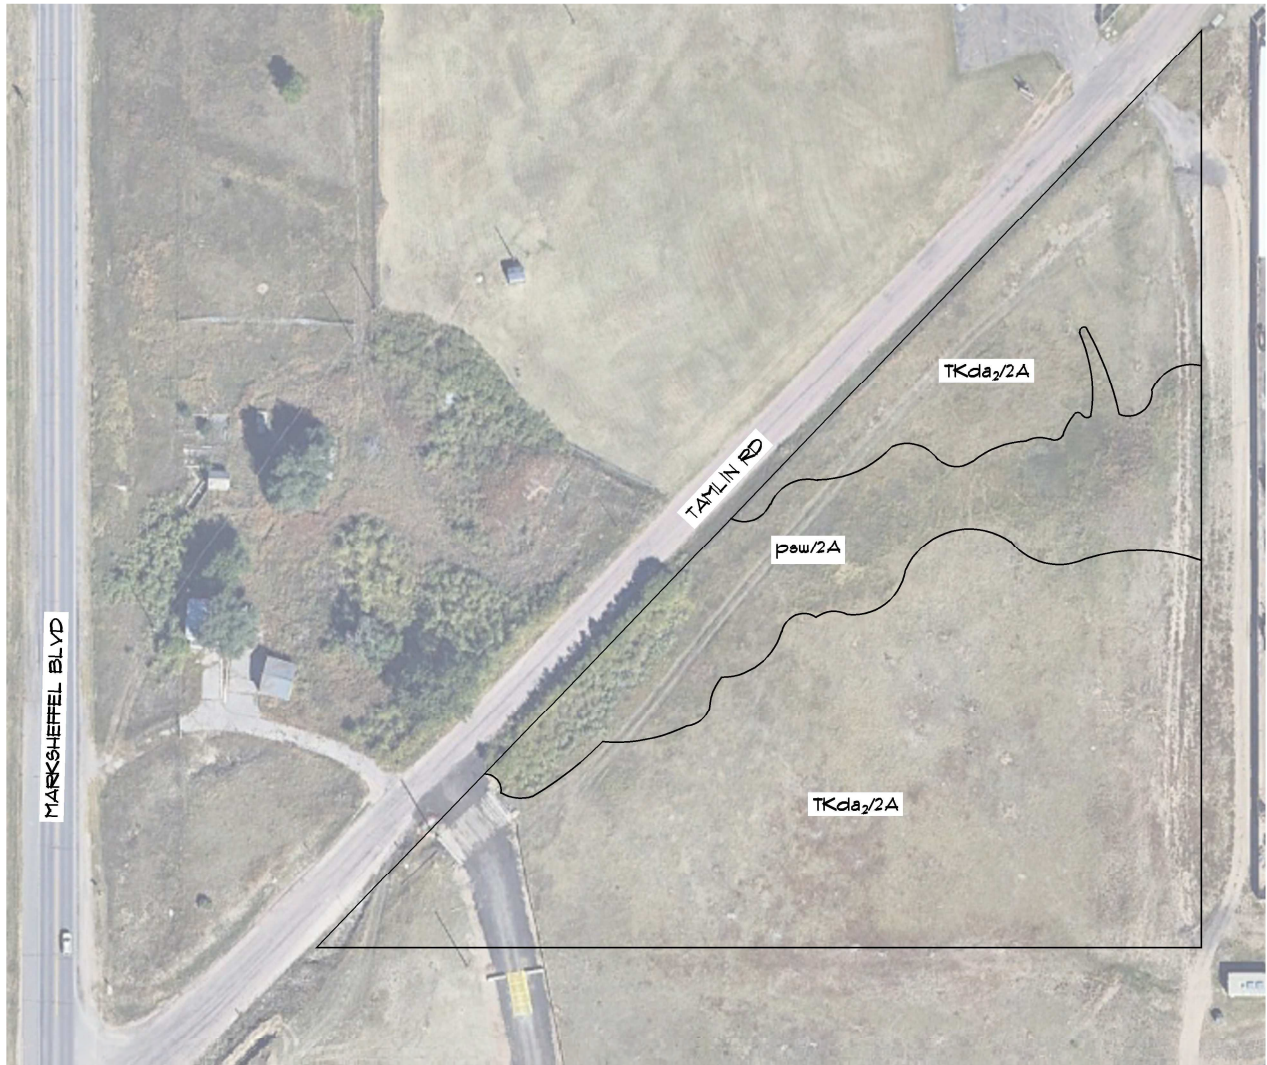
GEOLOGIC

psw - POTENTIALLY SEASONALLY WET
 TKda₂ - DAWSON FORMATION
