From: [Joe DesJardin](mailto:Joe.DesJardin@entechengineers.com)
To: jlovekin@mines.edu; [Joe Goode \(jgoode@entechengineers.com\)](mailto:jgoode@entechengineers.com); [Mike Bramlett \(mbramlett@jrengineering.com\)](mailto:mbramlett@jrengineering.com)
Cc: [Nina Ruiz \(ninaruiz@elpasoco.com\)](mailto:ninaruiz@elpasoco.com); [Tamara Baxter](#); [Andrew Biggs](#)
Subject: Cloverleaf Preliminary Plan
Date: Monday, January 11, 2021 11:13:09 AM
Attachments: [CGS Comments.png](#)
[Pages from 200100-Proterra Properties-Cloverleaf Development-Soil GeologyGeoHaz-Rev 11.10.20.pdf](#)

PRELIMINARY GRADING PLAN
 CLOVERLEAF DEVELOPMENT
 HIGBY ROAD & CLOVERLEAF ROAD
 MONUMENT, CO
 FOR: PROTERRA PROPERTIES, LLC

**SOIL, GEOLOGY AND
GEOLOGIC HAZARD STUDY
CLOVERLEAF DEVELOPMENT
EL PASO COUNTY, COLORADO**

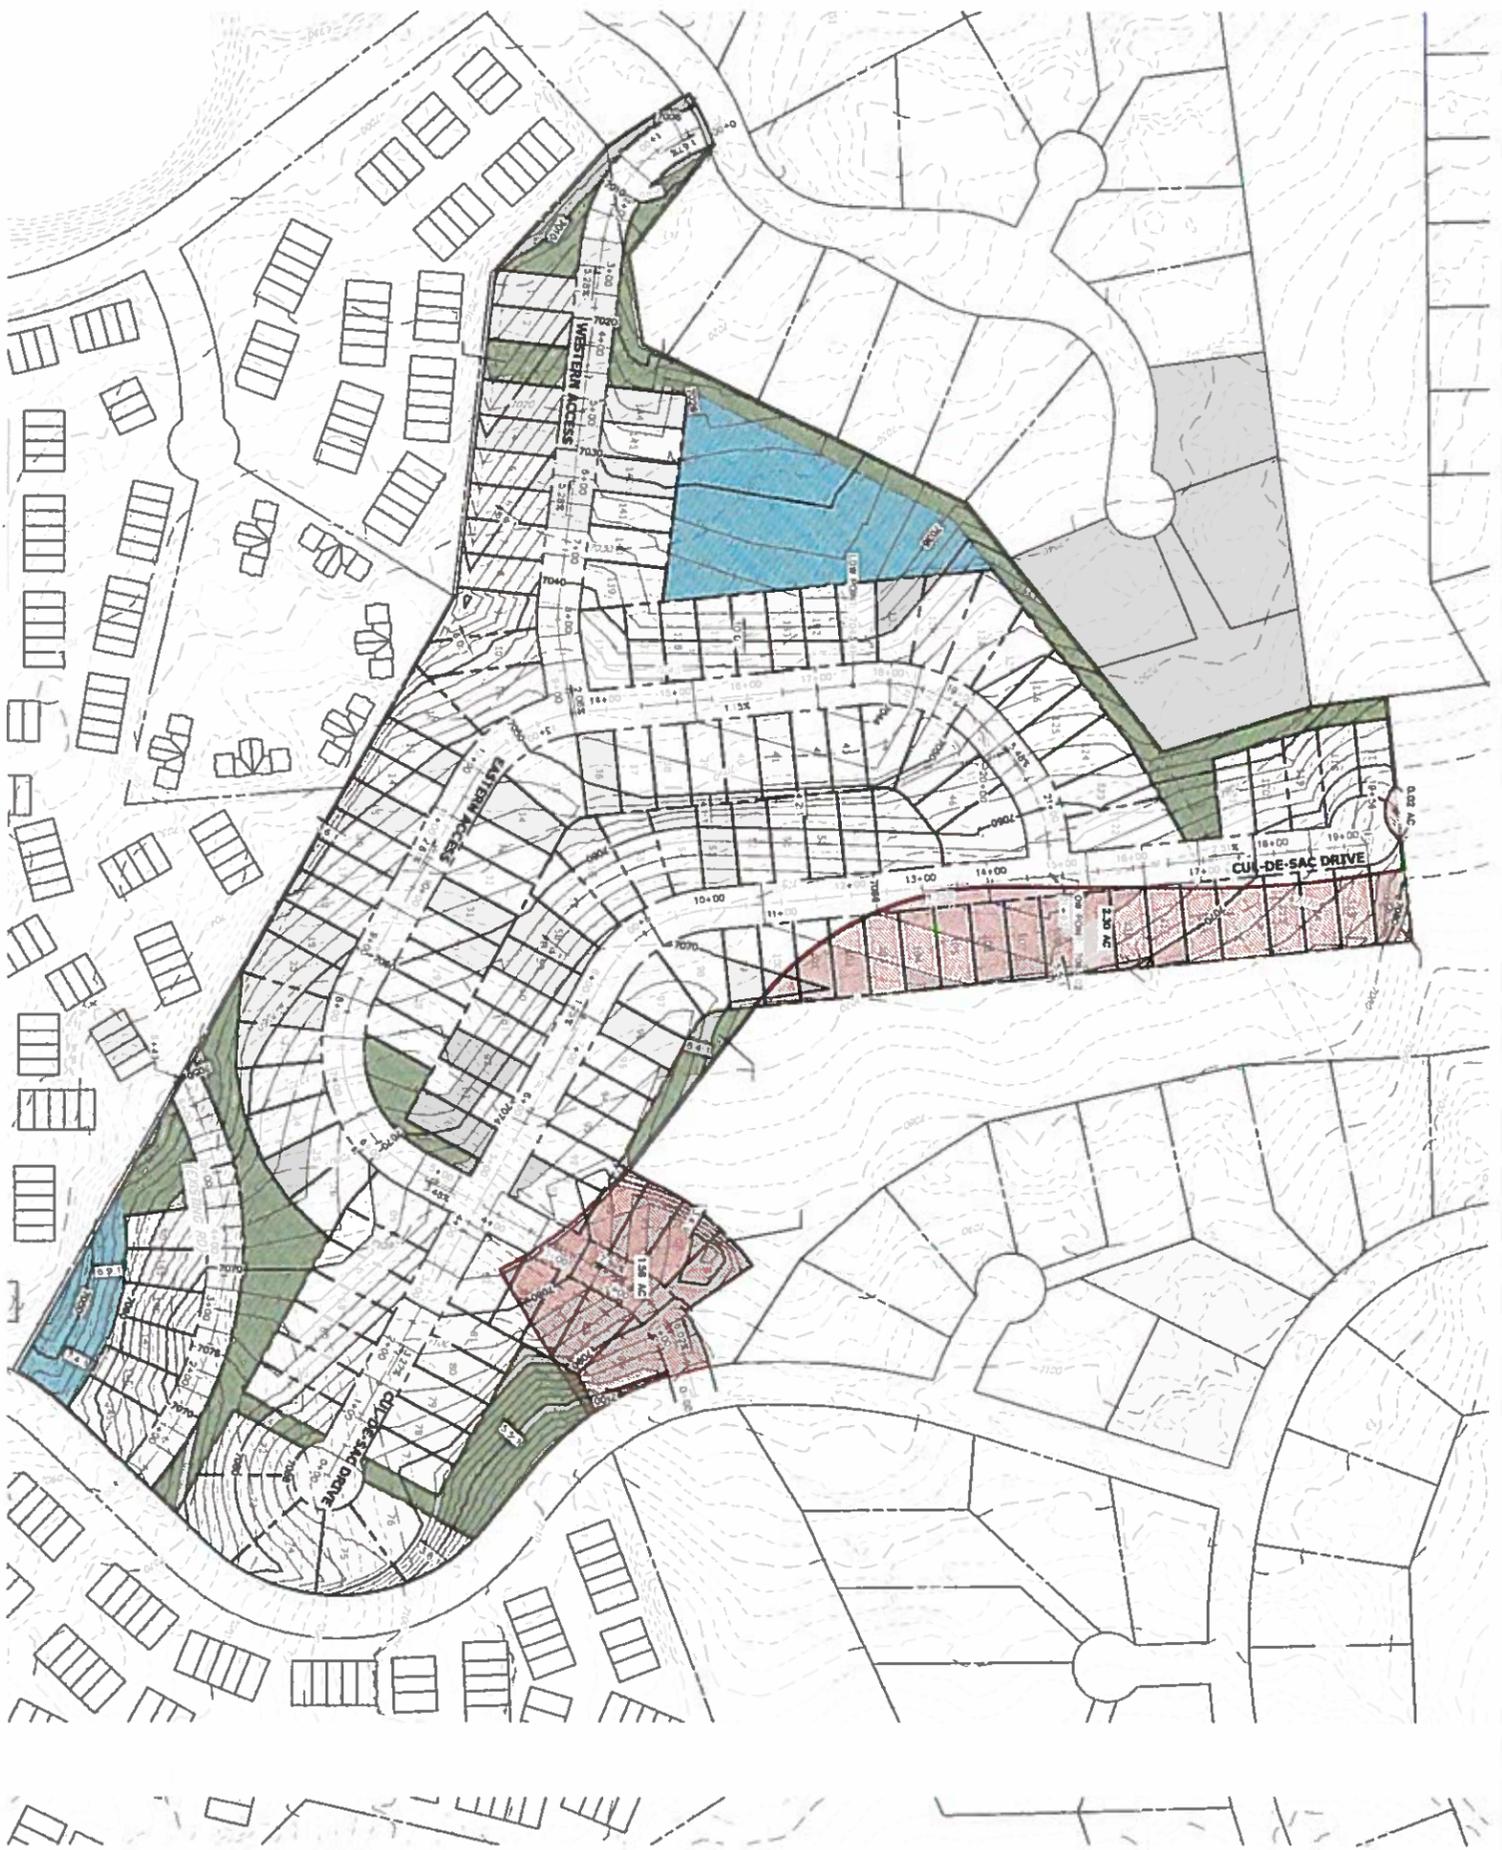
CLOVERLEAF LAYOUT F GRADING PLAN

EARTHWORK
 CUT: 154,525 CY
 FILL: 127,650 CY
 Net: 26,875 CY (C)

- Regarding the shaded areas on Entech’s Figure 3A, you are correct; they are not cut fill areas. The colors were added to the site plan as a convenience for me, to identify property that used to be owned by others, open space and ground designated for detention ponds.
- Regarding groundwater, all homes will include a subsurface foundation perimeter drain. We have requested the civil engineer include an underdrain system during final design, to be installed in the roadways to facilitate a gravity outfall.
- Regarding the seasonally wet area in the center of the site, we agree that over excavation and/or stabilization and/or subsurface drainage may be required. We have asked the civil engineer to add that note to the plans and Entech will be onsite to ensure proper installation during construction.

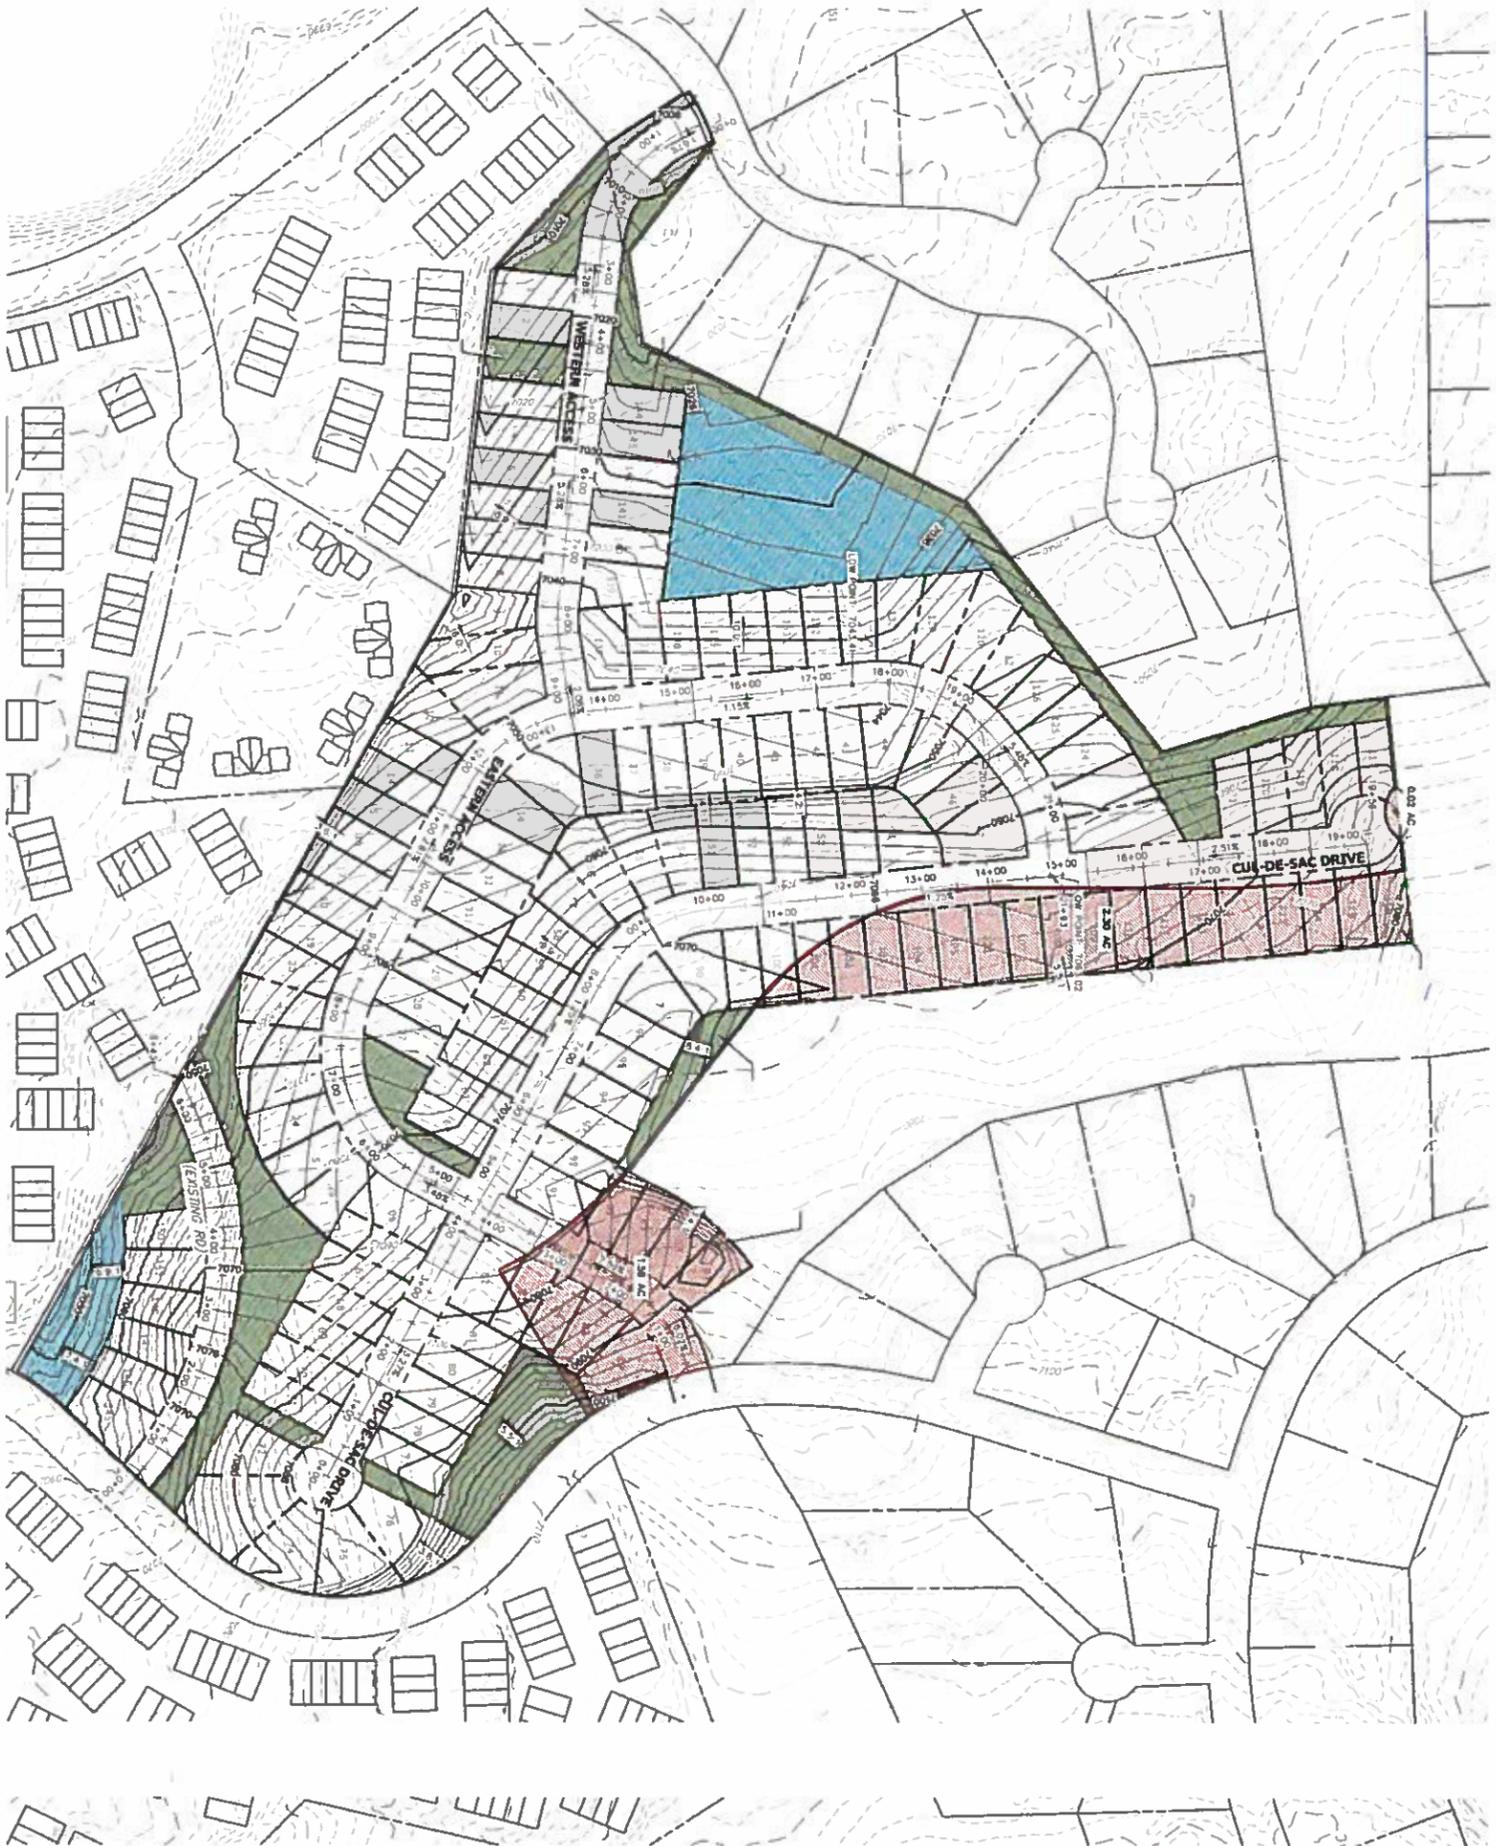
CLOVERLEAF LAYOUT F GRADING PLAN

ADDITIONAL PURCHASE AREA: 3.89 AC
ORIGINAL PURCHASE AREA: 33.33 AC

EARTHWORK
CUT: 154,525 CY
FILL: 127,650 CY
Net: 26,875 CY (C)

Groundwater was observed at relatively shallow depths of approximately 12.5 to 13.5 feet below the ground surface in three of Entech's borings (TB-1, TB-3, and TB-5). The grading plans indicate that these borings are located in proposed fill or minimal grade change areas. Entech's recommendation for subsurface foundation perimeter drains (page 11) is valid, but should apply to all homes with below-grade space (basements and crawl spaces), not just homes constructed within Entech's mapped potentially seasonal and seasonal shallow groundwater areas. As noted on Entech's Figure 8, subsurface drainage systems should discharge to a gravity outlet that discharges water as far as possible away from all structures. If lot topography does not allow for a gravity outfall, drains should discharge to an interior pumped sump.

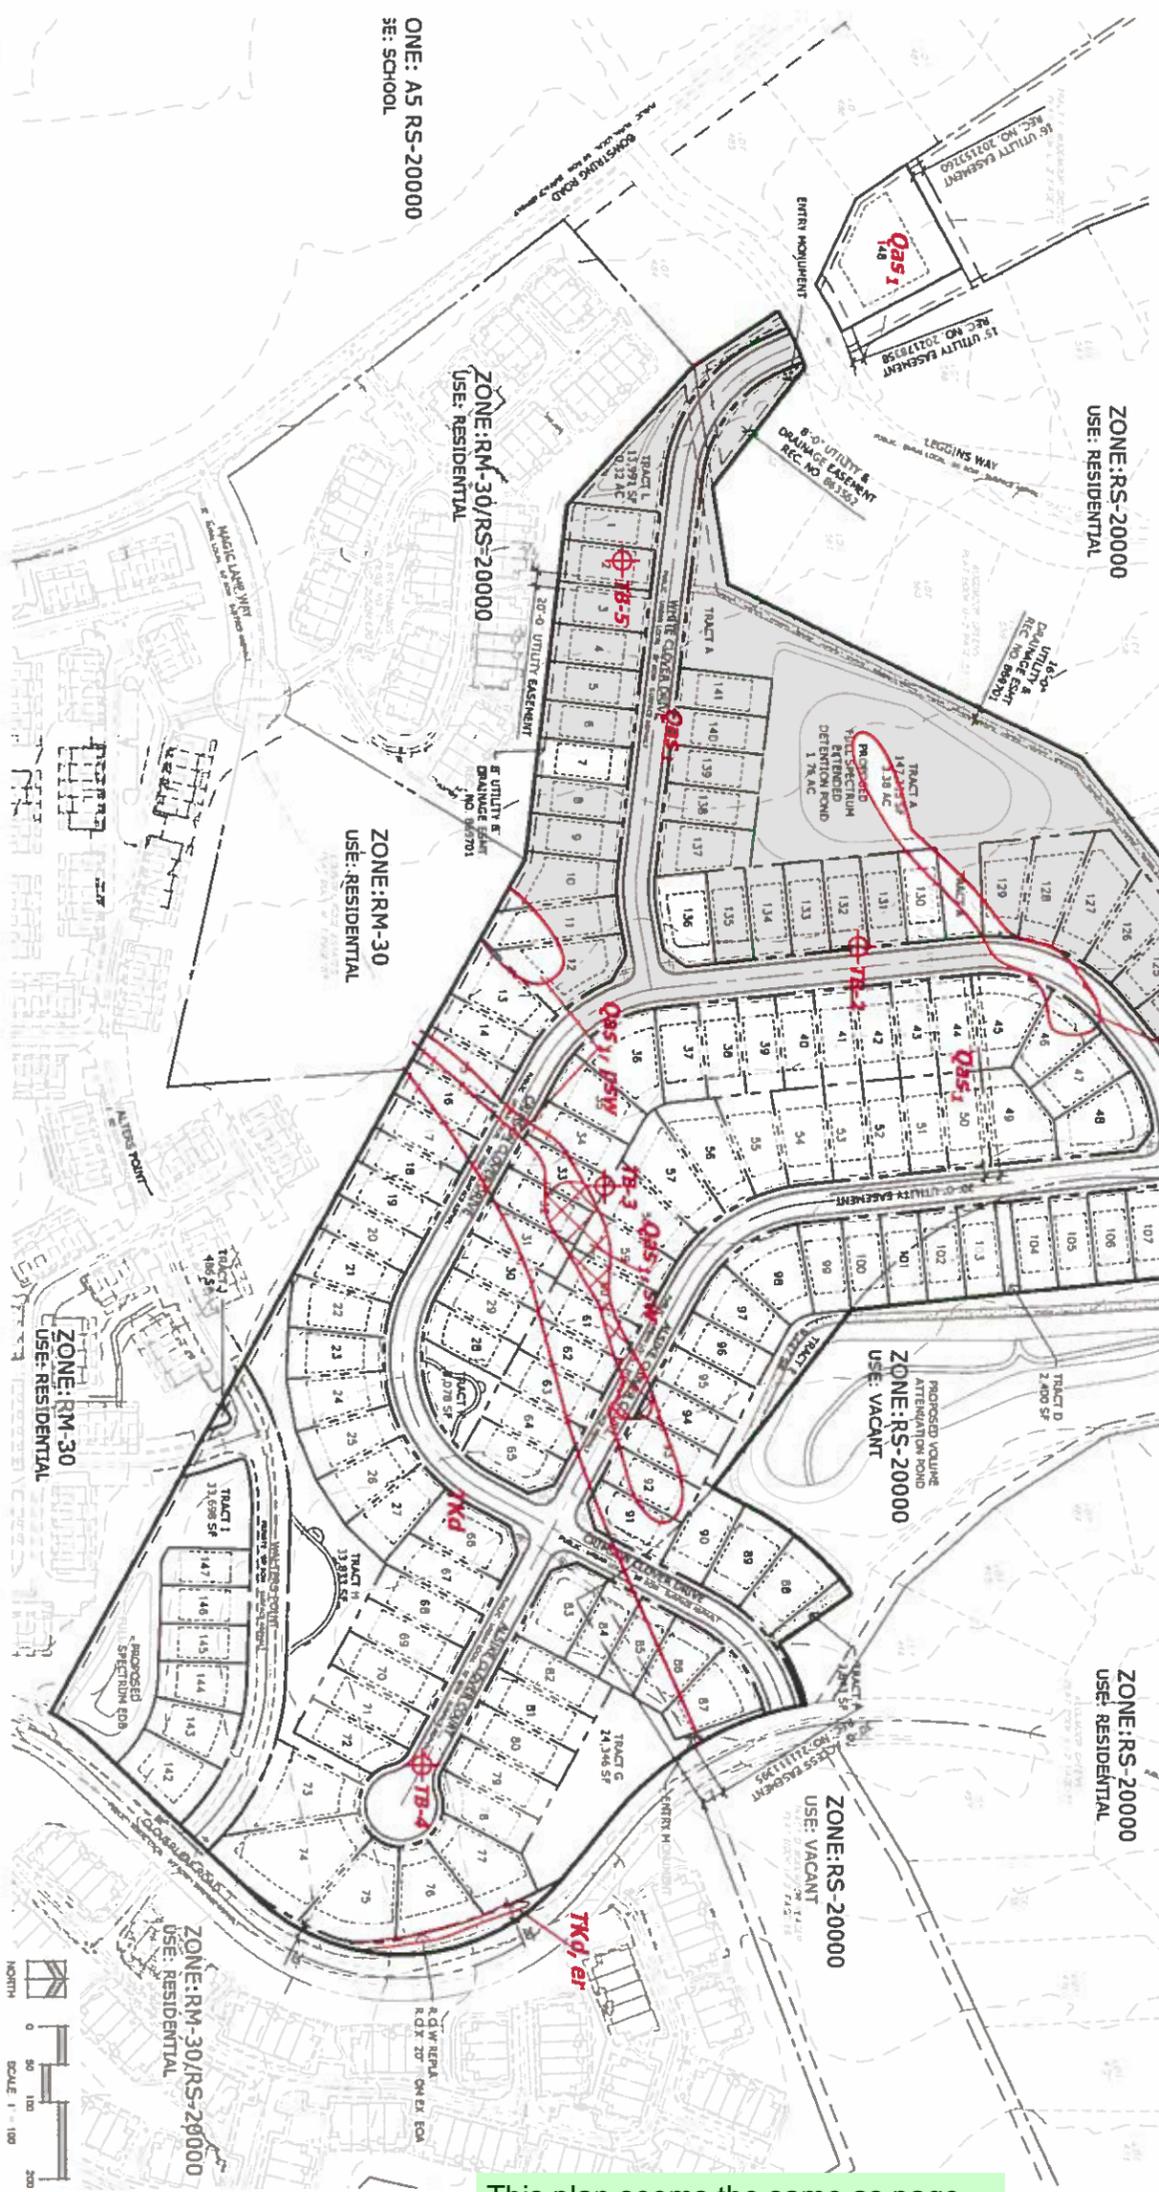
**ENGINEERING GEOLOGY MAP
 CLOVERLEAF DEVELOPMENT
 HIGBY ROAD & CLOVERLEAF ROAD
 MONUMENT, CO
 FOR: PT CLOVERLEAF, LLC**

- Legend:**
- Qas1 - Dawson Formation of Tertiary to Cretaceous Age: arkosic sandstone, with interbedded claystone and siltstone
 - TKd - Younger Alluvial Slope Deposits of Holocene to Late Pleistocene Age: sheet flow and fluvial sand deposits
 - er - erosion
 - psw - potentially seasonal shallow groundwater
 - sw - seasonally shallow groundwater
 - mapped wetlands

As mentioned previously, detailed mapping has been performed on this site to produce an Engineering Geology Map (Figure 6). This map shows the location of various geologic conditions of which the developers and planners should be cognizant during the planning, design and construction stages of the project. The hazards identified on this site include loose soils, erosion, potentially seasonal shallow groundwater, and seasonal shallow groundwater areas. The following hazards have been addressed as a part of this investigation:

These are areas that are undergoing erosion by water and sheetwash producing gullies and rill erosion. Areas of erosion were observed in the Teachout Creek drainage in the northern portion of the site, and an area along eastern side of the site along Cloverleaf Road.

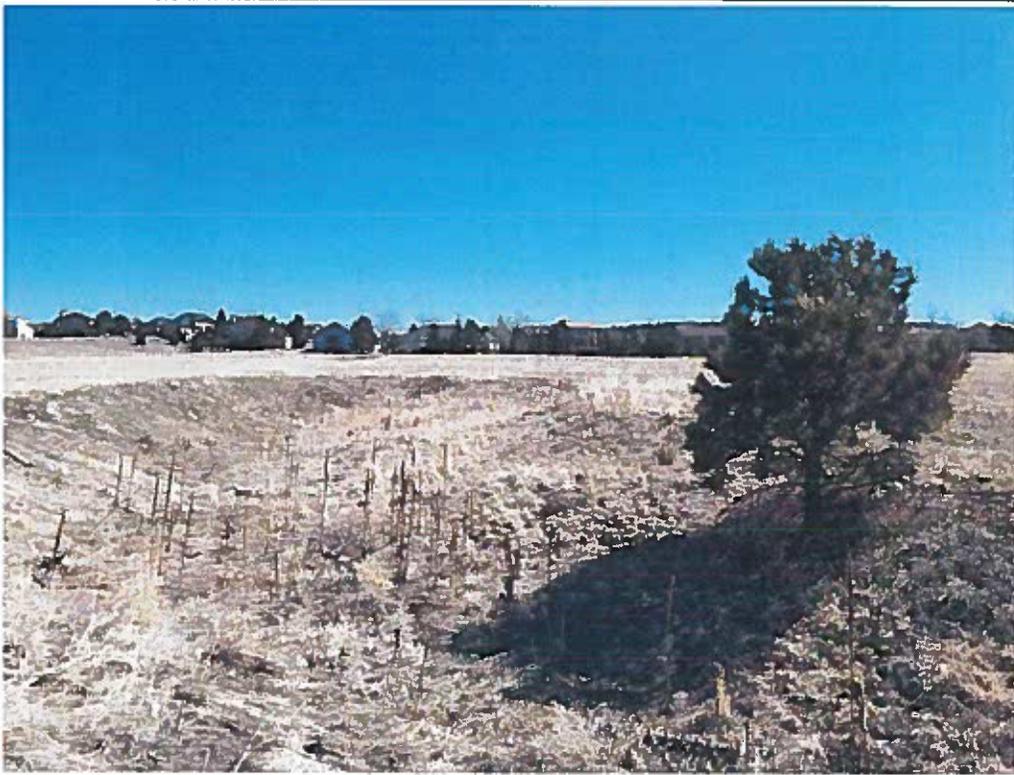
**Looking northeast
along Teachout Creek
in the northwestern
portion of the site.**

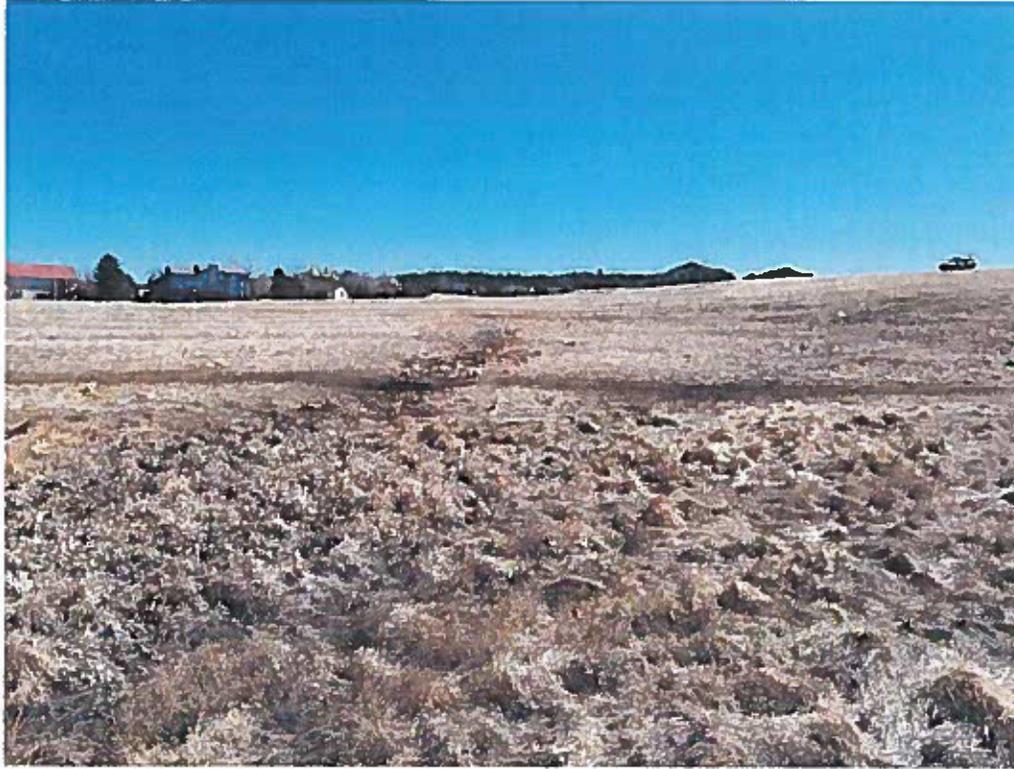
**Looking east along
seasonally wet area in
the central portion of
the site.**
