**SOIL, GEOLOGY AND
GEOLOGIC HAZARD STUDY
CLOVERLEAF DEVELOPMENT
EL PASO COUNTY, COLORADO**

PT Cloverleaf, LLC
1864 Woodmoor Drive, Suite 100
Monument, Colorado 80132

April 7, 2020
Revised August 21, 2020

Entech Job No. 200100
AAProjects/2020/200100 soil ge

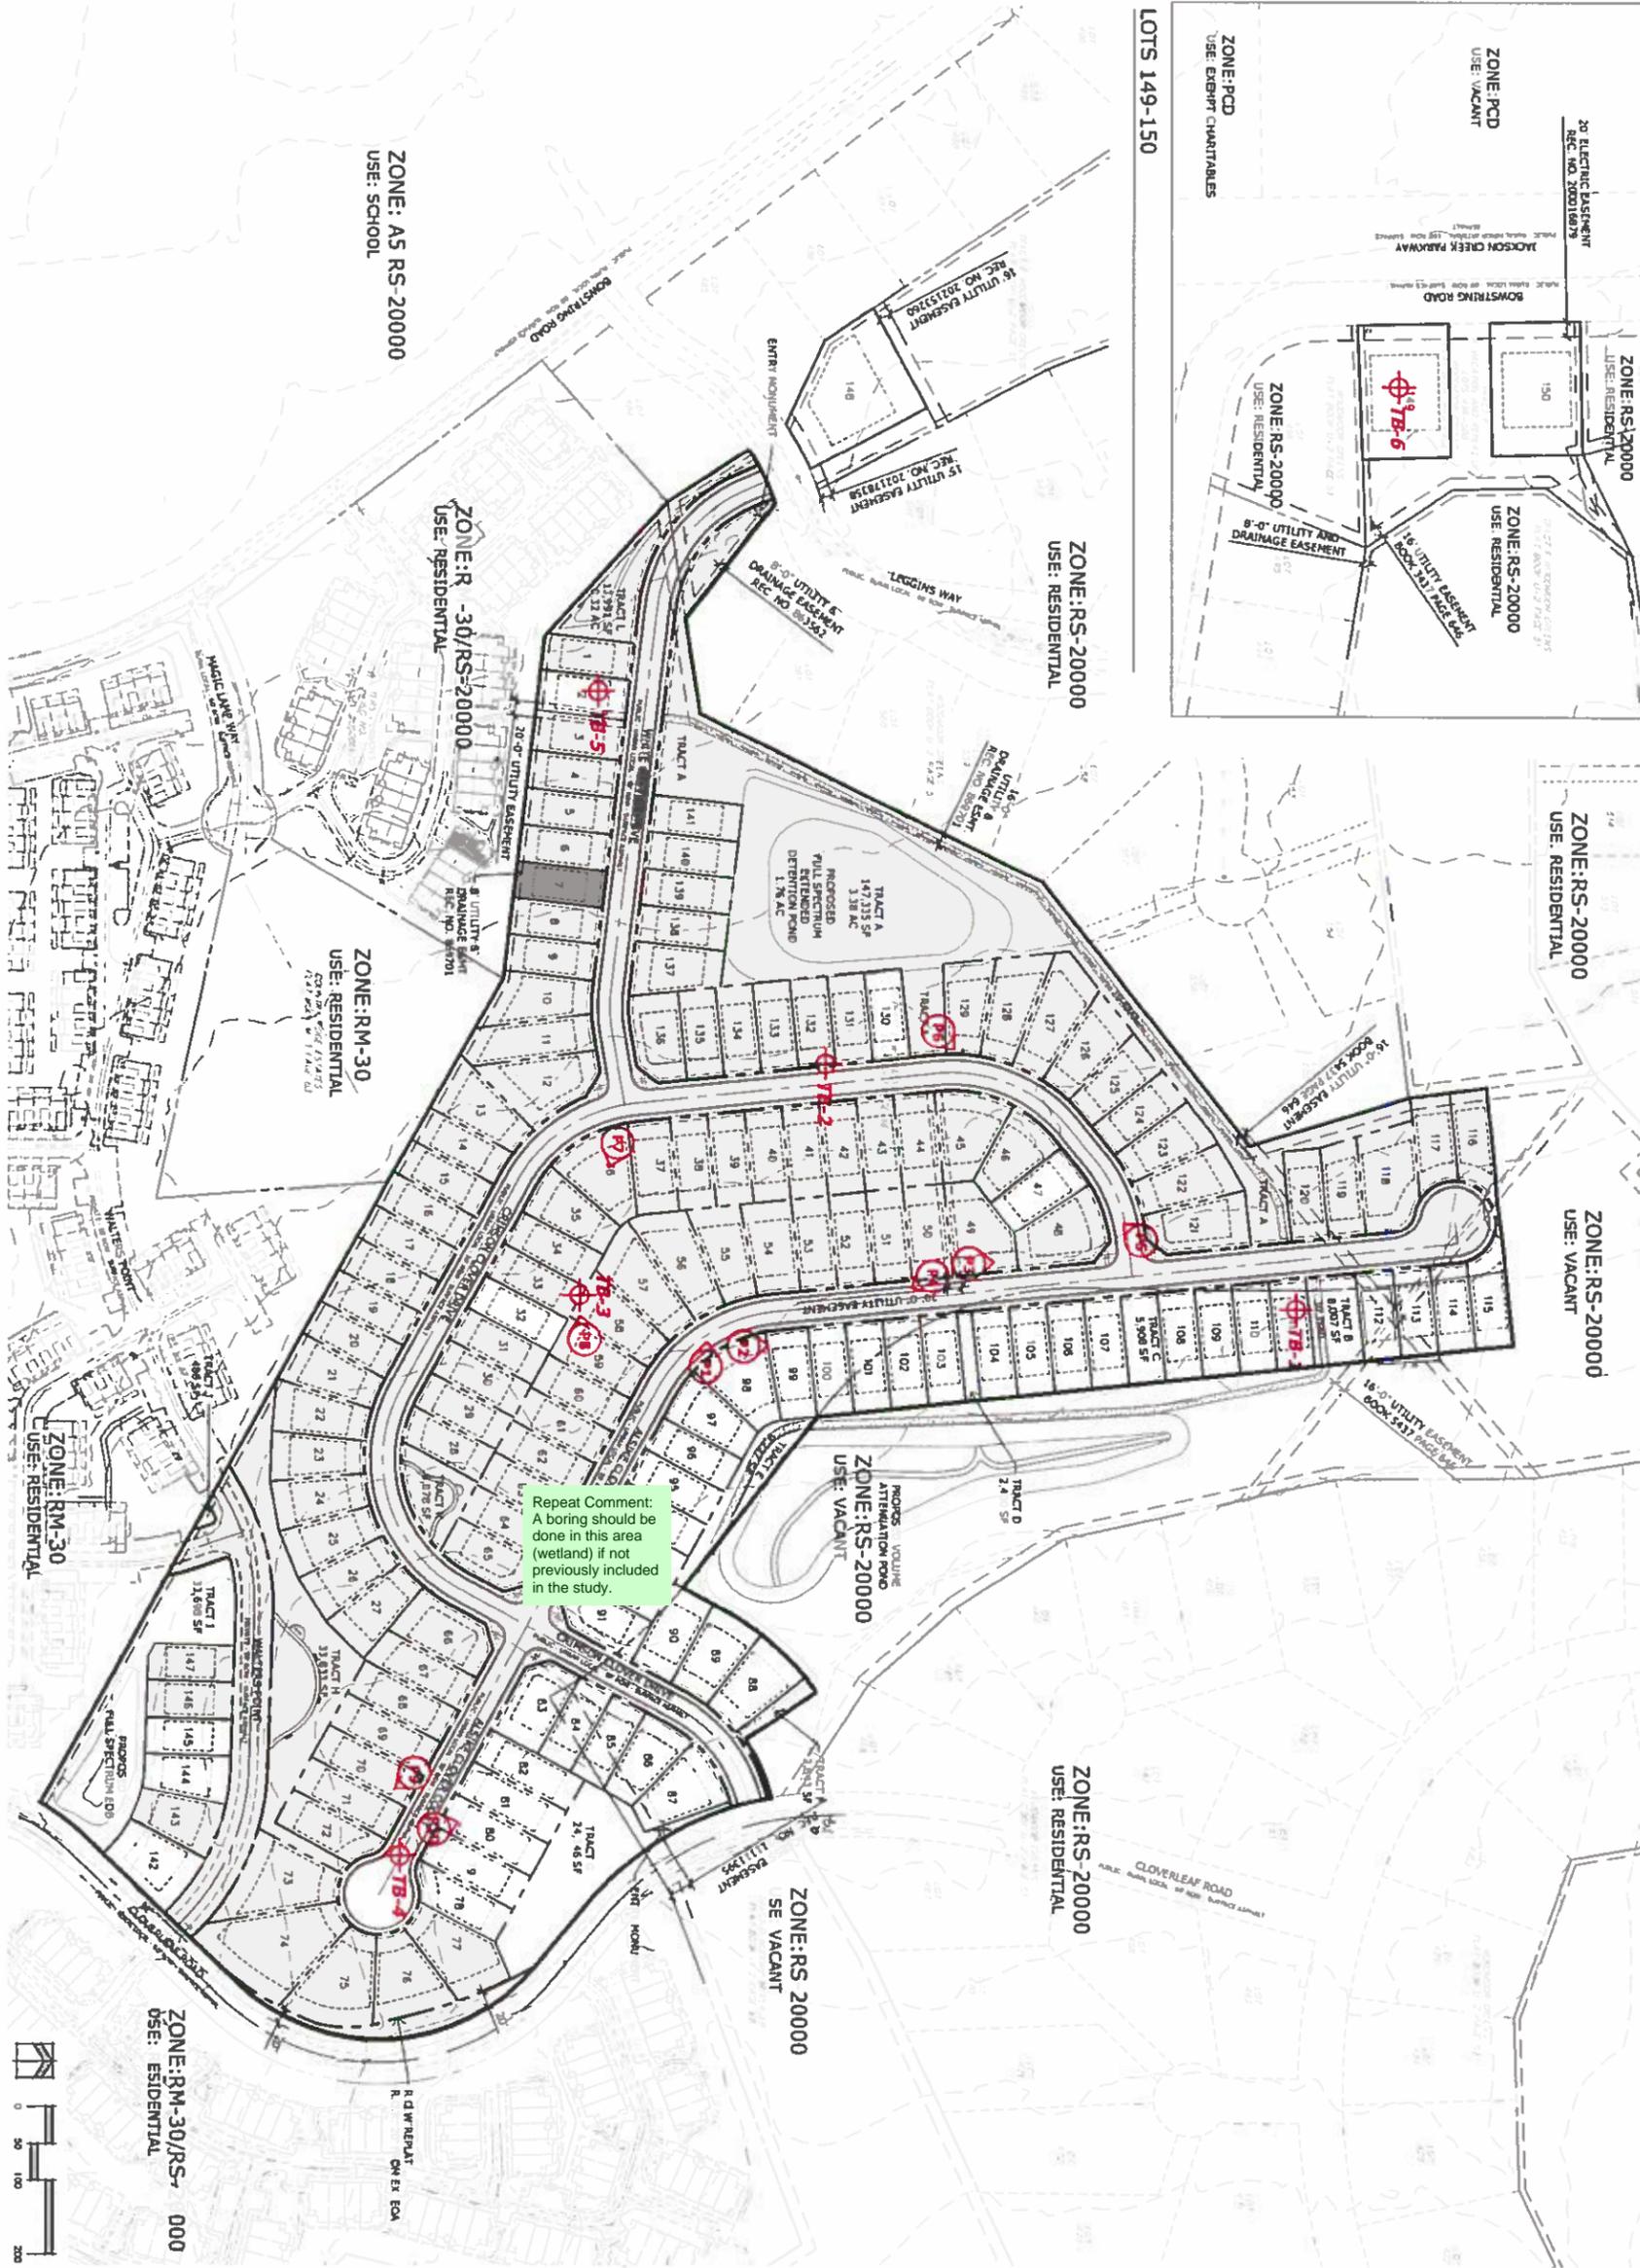
DATE	6/21/20
CHECKED	AS SEBOWIN
DATE	3/20/20
BY	THOMAS M.
3

P2 - APPROXIMATE TEST PIT LOCATION AND NUMBER

SITE PLAN/TEST BORING LOCATION MAP
CLOVERLEAF DEVELOPMENT
HIGBY ROAD & CLOVERLEAF ROAD
MONUMENT, CO
FOR: PT CLOVERLEAF, LLC

The topography of the site is generally gently to gradually sloping to the west with some moderate slopes along small ridge in the southeast part of the site. Drainages on-site flow in southerly directions. Only minor amounts of water were observed flowing in some of the drainages at the time of this investigation, however, some minor areas of ponded water were observed. The approximate boundaries of the site are indicated on the USGS Map, Figure 2. Previous site uses have included grazing and pasture land. Vegetation on site consists primarily of field grasses and weeds. Site photographs are included in Appendix A. The approximate locations and directions of the photographs are indicated on Figure 3.

Additionally, six (6) test borings were drilled as a part of the preliminary subsurface soil investigation for the subdivision to determine general soil conditions. The borings were drilled with a power-driven continuous flight auger drill rig to depths of 20 to 35 feet. Samples were obtained during drilling using the Standard Penetration Test, ASTM D-1586, utilizing a 2-inch O.D. Split Barrel Sampler and a California Sampler. Results of the penetration tests are shown on the drilling logs to the right of the sampling point. The location of the test borings is shown on the Test Boring Location Map, Figure 3. The drilling logs are included in Appendix B.

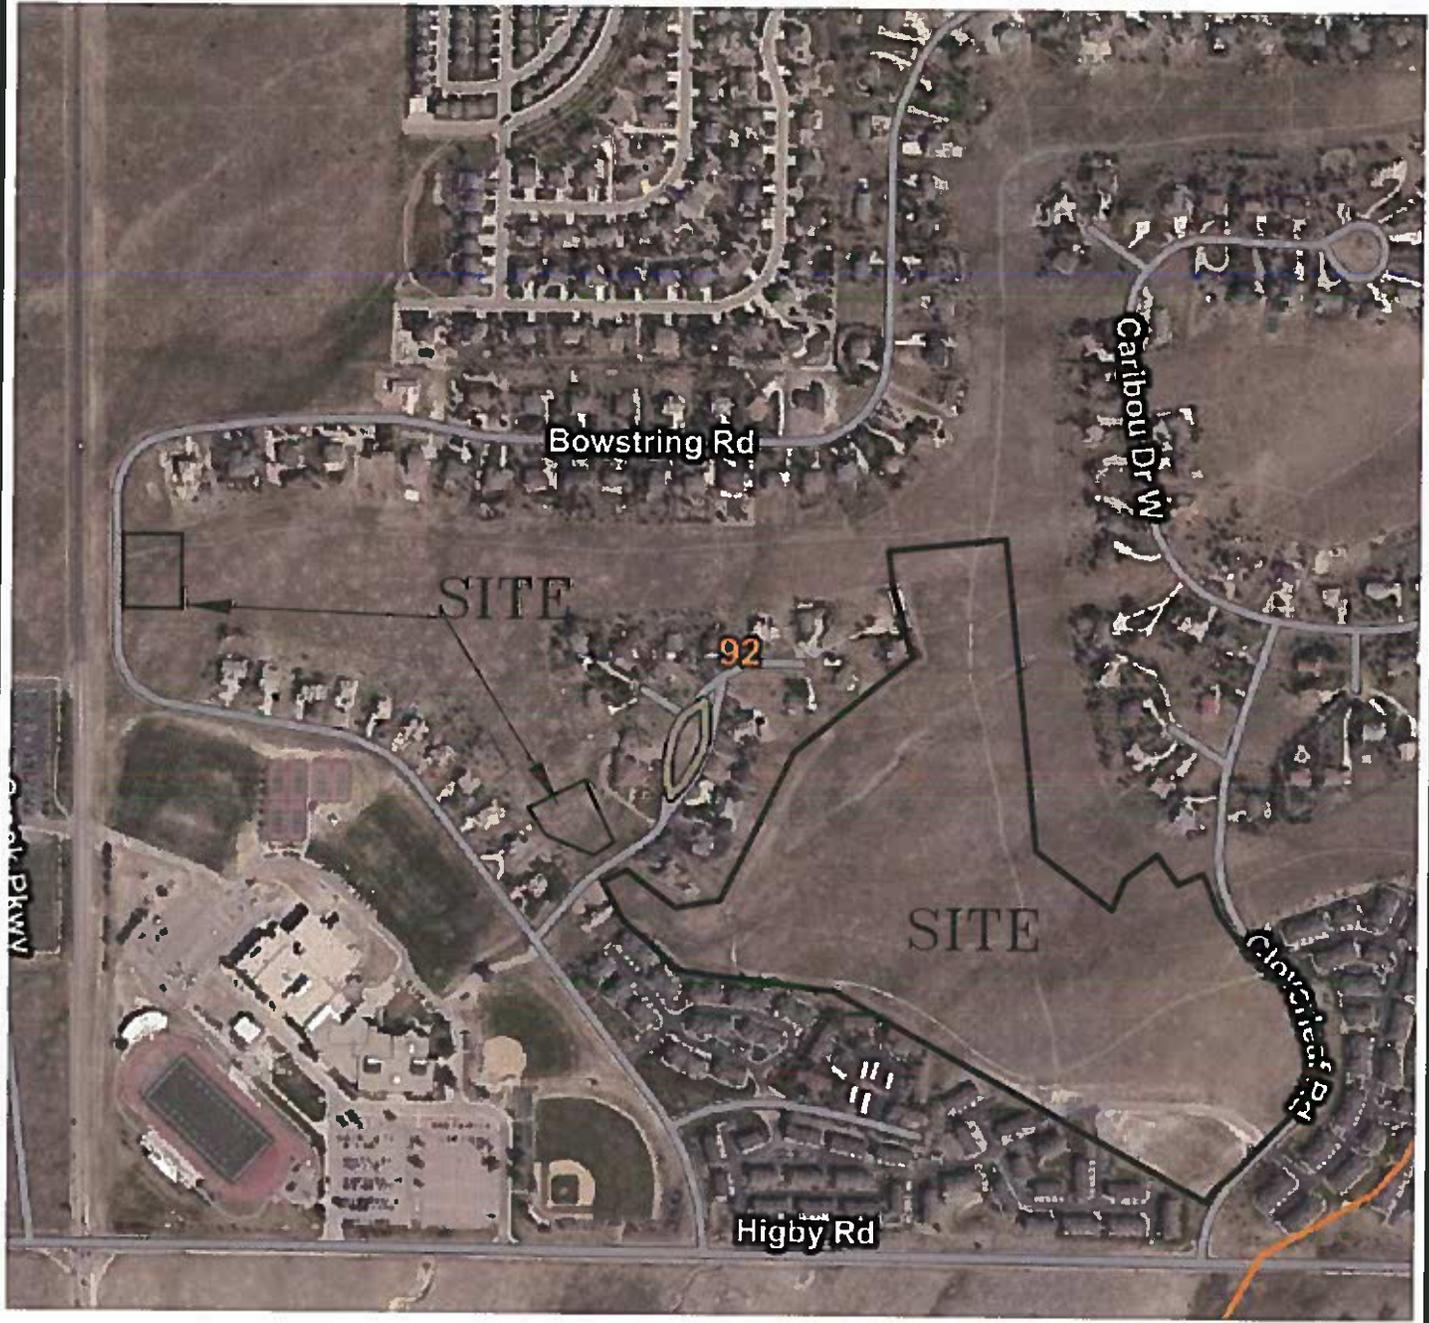
FIG NO.:
4

SOIL SURVEY MAP
CLOVERLEAF DEVELOPMENT
HIGBY ROAD & CLOVERLEAF ROAD
MONUMENT, CO
FOR: PT CLOVERLEAF, LLC

Complete descriptions of the soils are presented in Appendix C. The soils have generally been described to have rapid to very rapid permeabilities. The majority of the soils have been described by the Soil Conservation Service as good potential for urban development. Possible hazards with soil erosion are present on the site. The erosion potential can be controlled with vegetation. The majority of the soils have been described to have slight to moderate erosion hazards. The soil blowing hazard is severe if vegetation is removed.

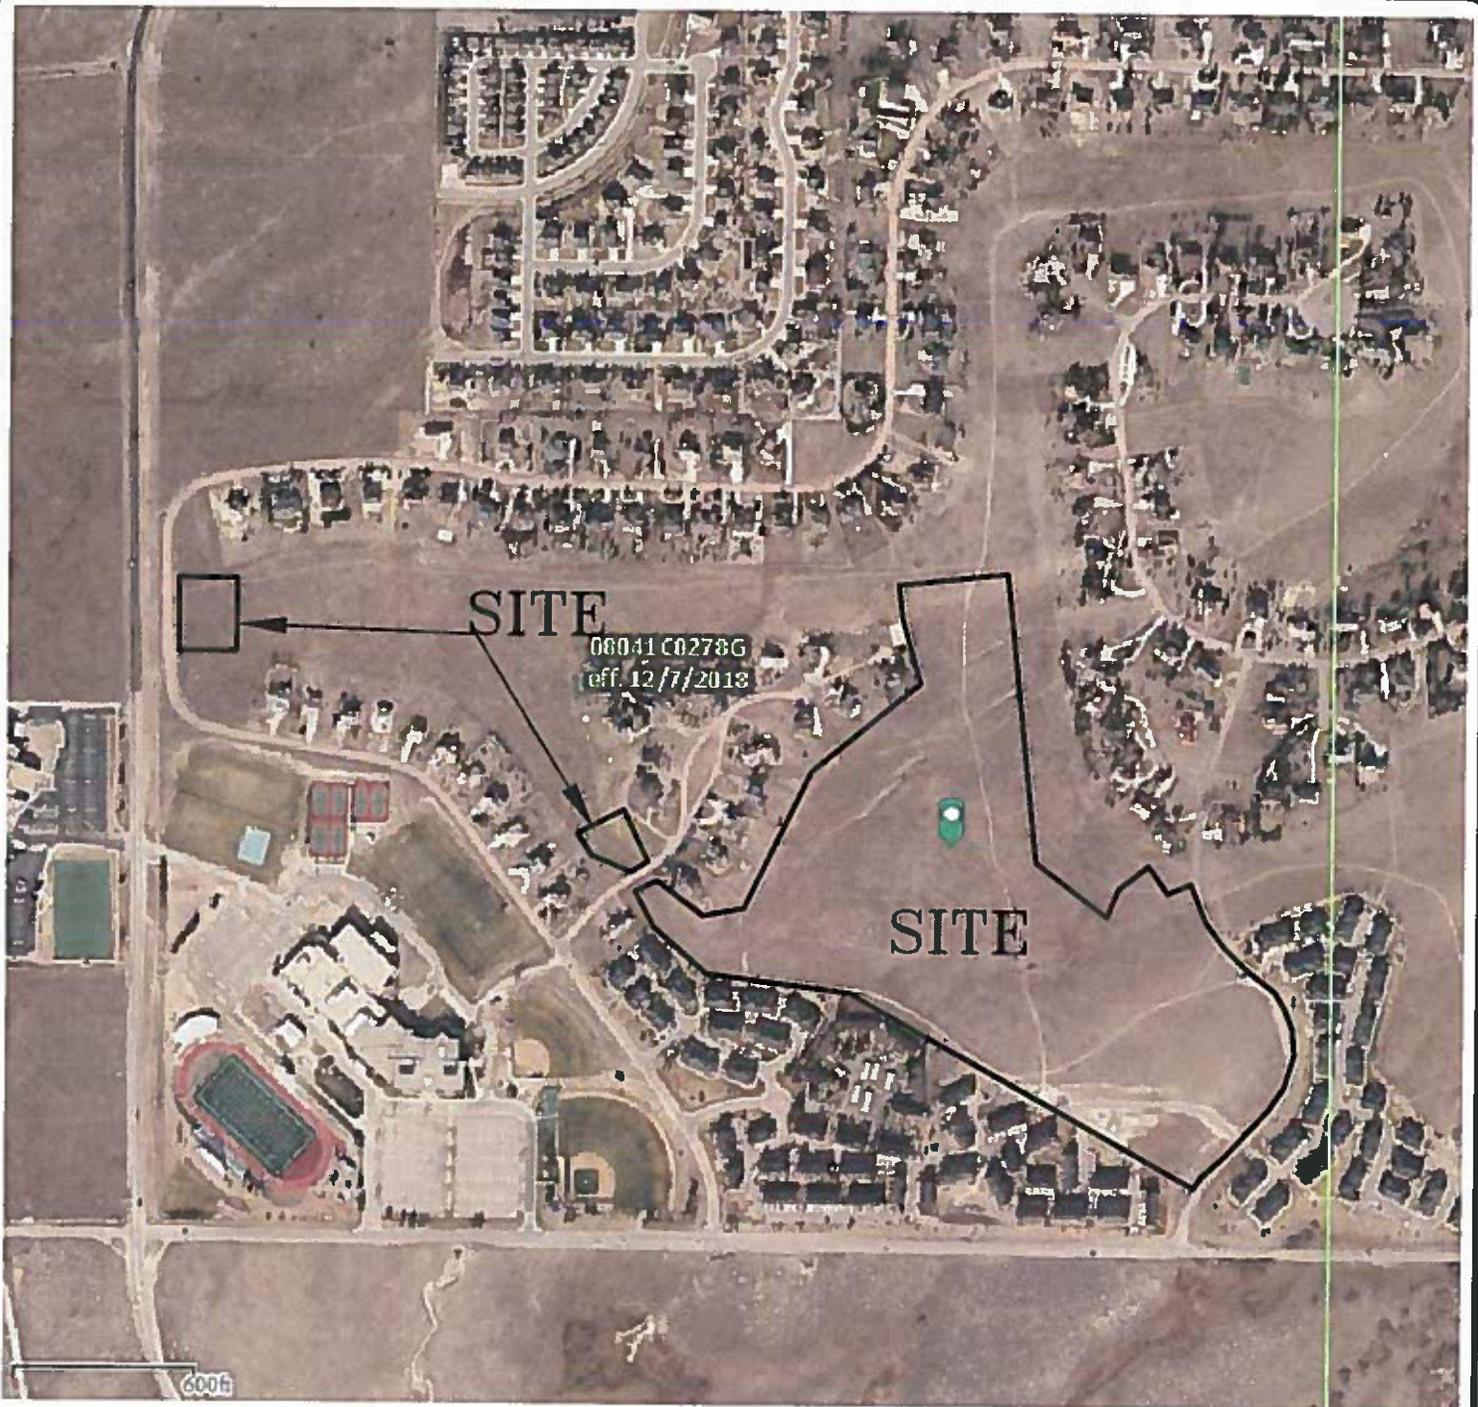
FIG NO.:
7

FLOODPLAIN MAP
CLOVERLEAF DEVELOPMENT
HIGBY ROAD & CLOVERLEAF ROAD
MONUMENT, CO
FOR: PT CLOVERLEAF, LLC

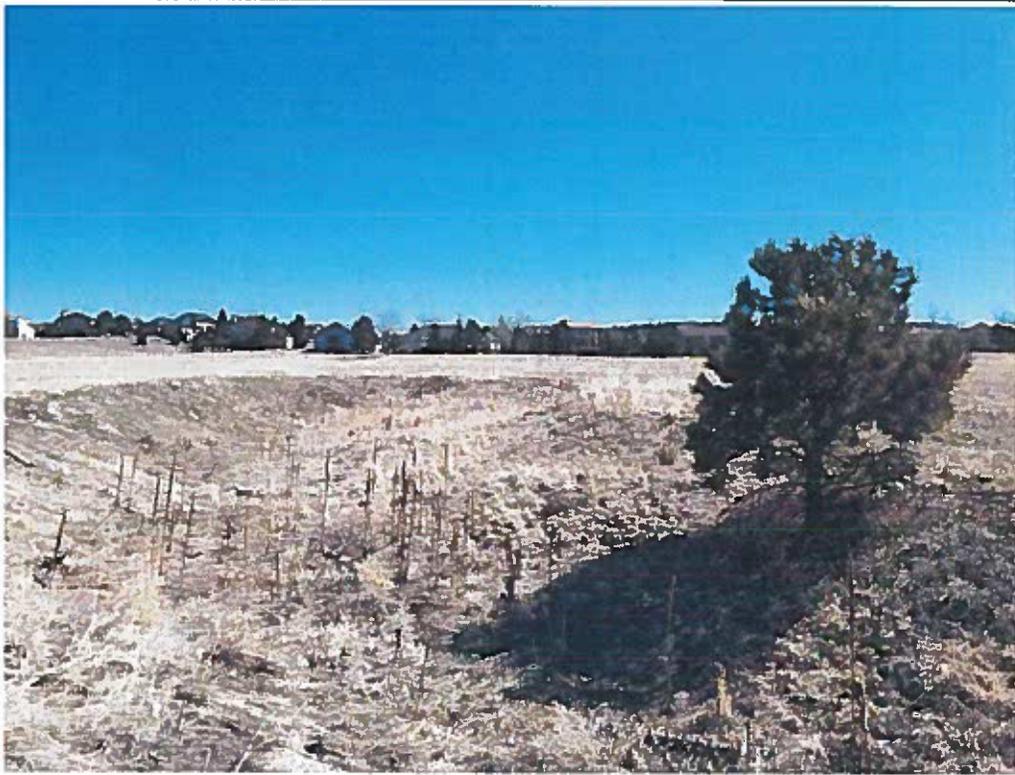
**Looking northeast
along Teachout Creek
in the northwestern
portion of the site.**

These are areas that are undergoing erosion by water and sheetwash producing gullies and rill erosion. Areas of erosion were observed in the Teachout Creek drainage in the northern portion of the site, and an area along eastern side of the site along Cloverleaf Road.

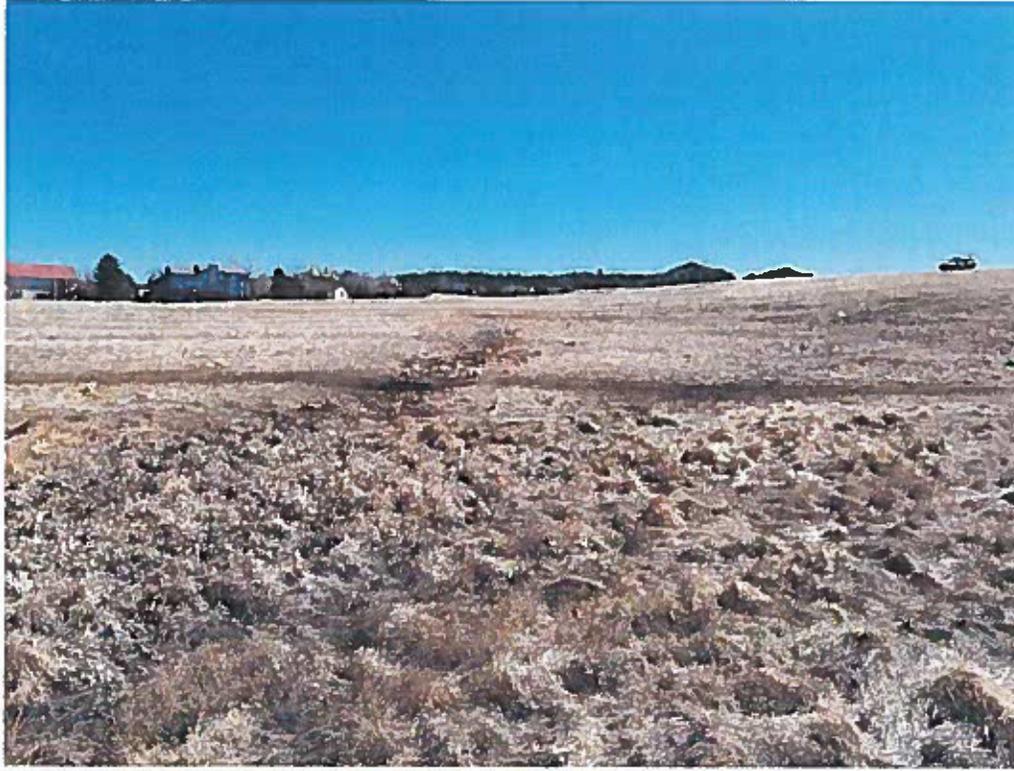
**Looking east along
seasonally wet area in
the central portion of
the site.**

In these areas, we would anticipate the potential for periodically high subsurface moisture conditions and possible frost heave potential, depending on the soil conditions. Areas within the drainages on-site have been identified as potentially seasonal shallow groundwater, and the seasonal shallow groundwater area is located in a minor drainage area in the south-central portion of the site, and is also identified as a wetland in the National Wetland Inventory. In this wetland area we would anticipate the potential for surface and near surface groundwater conditions depending on seasonal changes in precipitation and runoff. This area had saturated surface conditions and minor areas of standing water during our field mapping. The areas identified as potentially seasonal and seasonal shallow groundwater lie within drainages and low-lying areas that will be regraded during overlot grading. Where structures or utility trenches encroach on, or lie within these areas, the following mitigation is recommended:
