ENTECH
ENGINEERING, INC.

**SOIL, GEOLOGY AND
GEOLOGIC HAZARD STUDY
CLOVERLEAF DEVELOPMENT
EL PASO COUNTY, COLORADO**

April 7, 2020
Revised November 9, 2020
Revised March 22, 2021

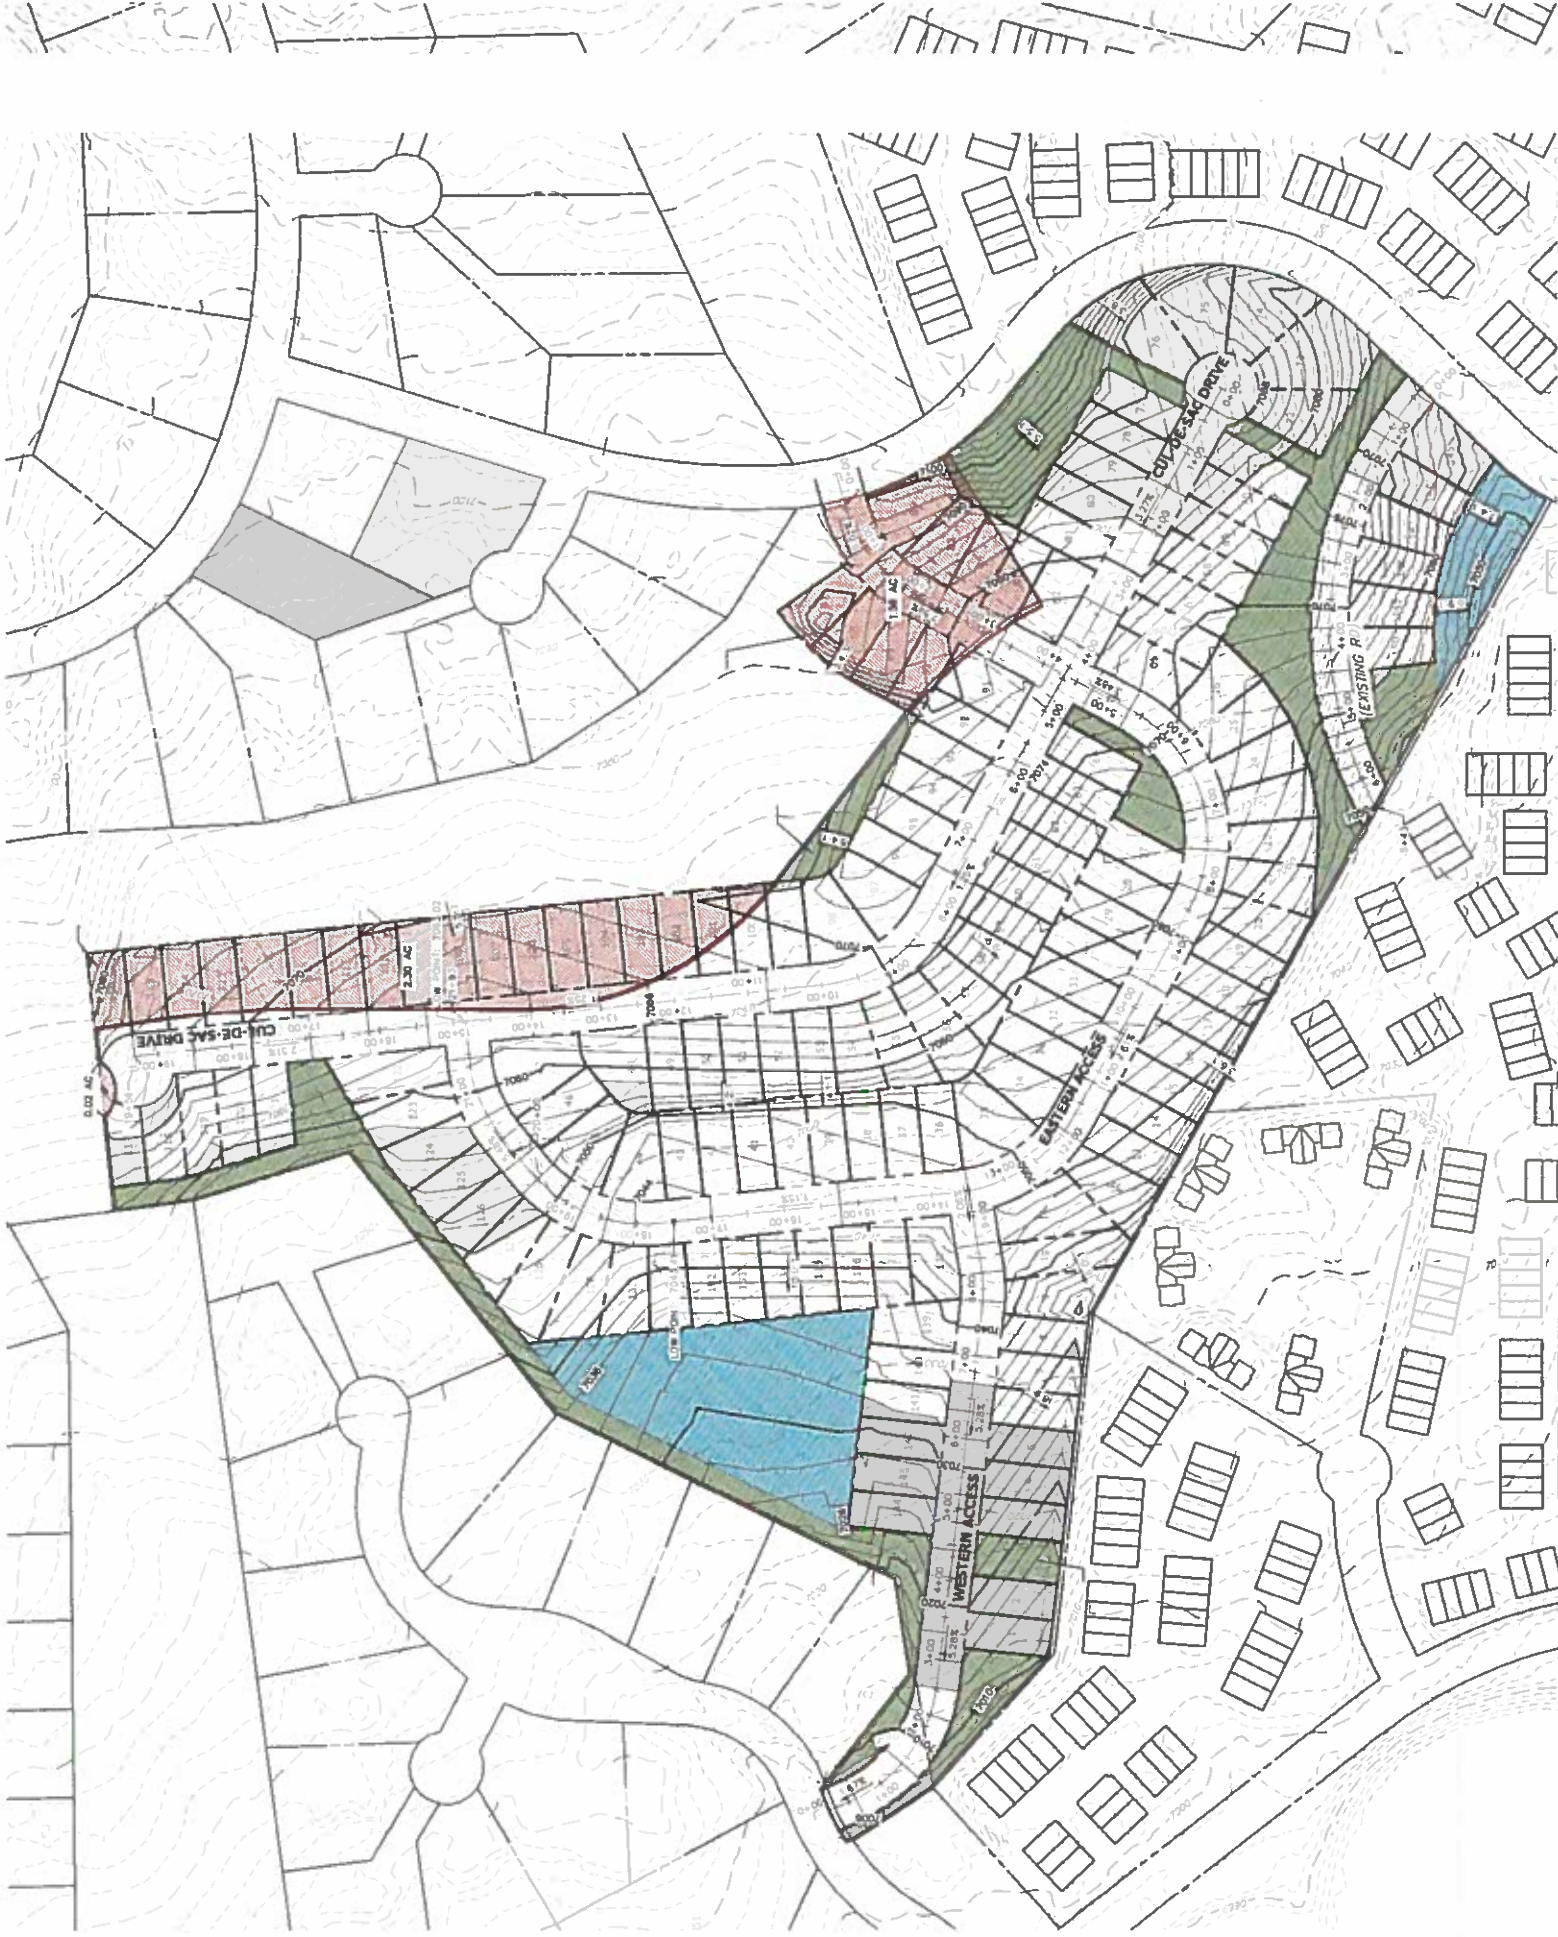
PRELIMINARY GRADING PLAN
CLOVERLEAF DEVELOPMENT
HIGBY ROAD & CLOVERLEAF ROAD
MONUMENT, CO
FOR: PROTERRA PROPERTIES, LLC

EARTHWORK
CUT: 154,525 CY
FILL: 127,650 CY
Net: 26,875 CY (C)

Mitigation: In these locations, foundations in areas subject to severe frost heave potential should penetrate sufficient depth so as to discourage the formation of ice lenses beneath foundations. Preliminary grading plans indicate the seasonally wet area will be filled. At this location and elevation, a foundation depth for frost protection of 30 inches is recommended. In areas where high subsurface moisture conditions are anticipated periodically, a subsurface perimeter drain will be necessary to help prevent the intrusion of water into areas located below grade. A typical perimeter drain detail is presented in Figure 8. Where shallow groundwater is encountered, additional drains, such as capillary breaks and/or interceptor drains may be necessary typical drain details are presented in Figures 9 and 10. Unstable conditions should be expected where excavations approach the groundwater level. The use of rock, shotcrete, or geo-grids may be necessary to stabilize excavations. Additionally, swales should be created to intercept surface runoff and carry it safely around and away from structures. The drainages will be filled during site grading mitigating the seasonal shallow and potentially seasonally shallow groundwater hazards. The water table may be of sufficient depth to minimize the effects on buildings; however, groundwater may be encountered during utility trenches during site development. All soft and organic soils should be removed prior to fill placement. Stabilization of the subgrade with rock and fabric prior to placing fill may be necessary if saturated unstable conditions are encountered.

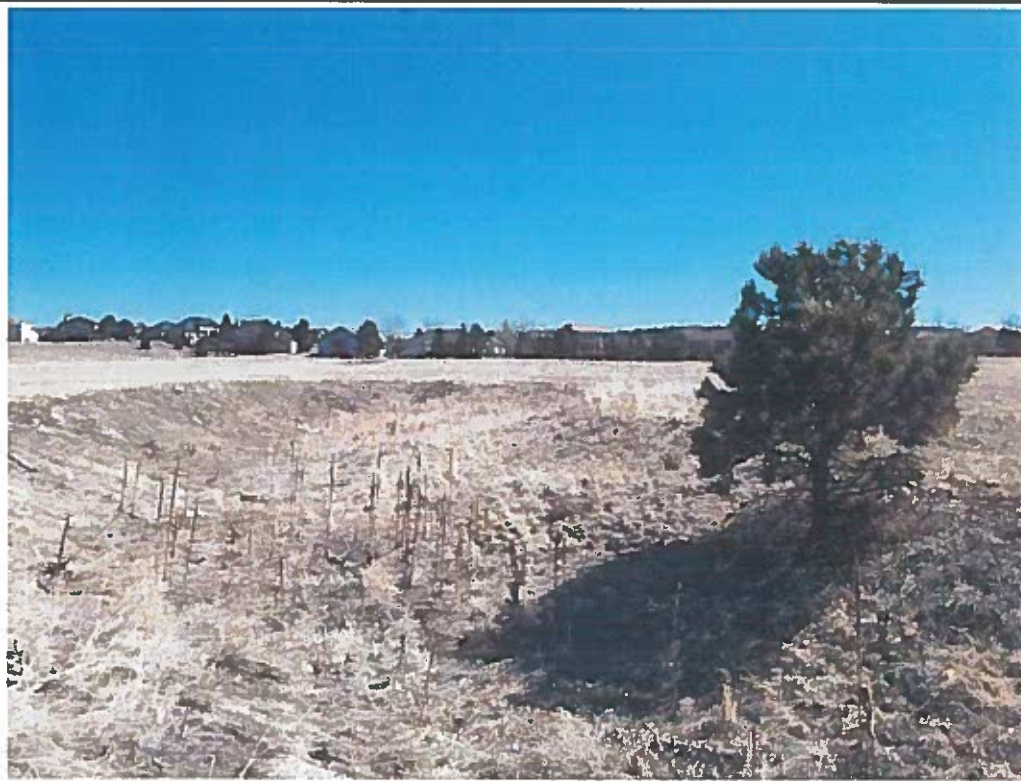
**Looking northeast
along Teachout Creek
in the northwestern
portion of the site.**

These are areas that are undergoing erosion by water and sheetwash producing gullies and rill erosion. Areas of erosion were observed in the Teachout Creek drainage in the northern portion of the site, and an area along eastern side of the site along Cloverleaf Road.

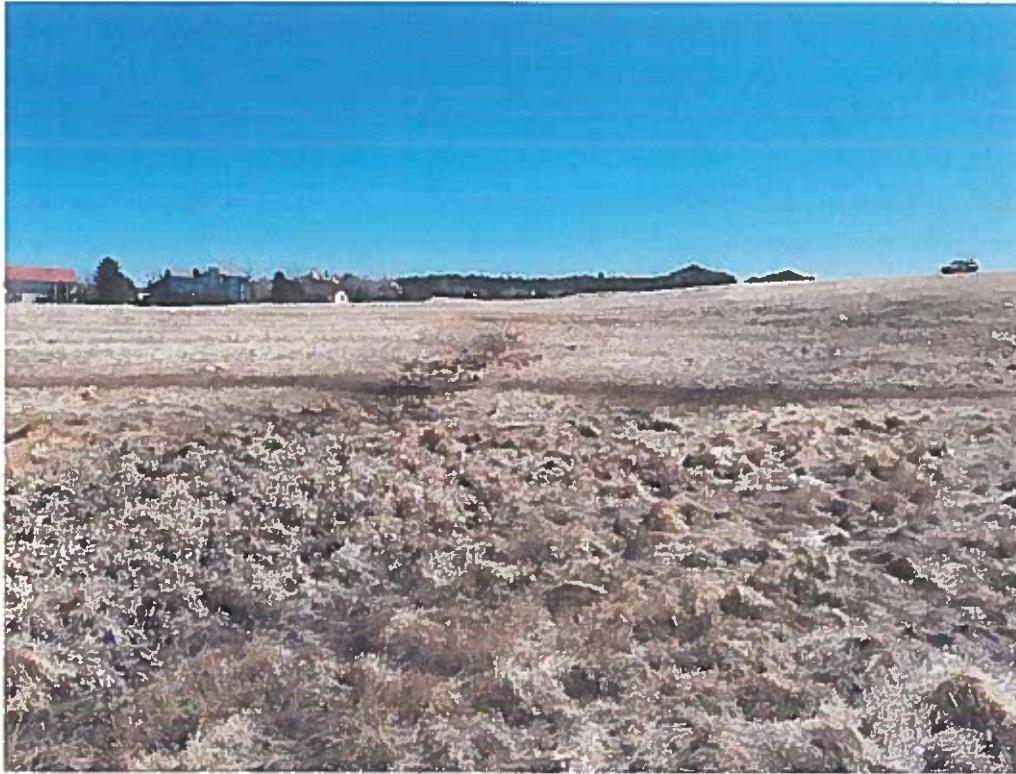
**Looking east along
seasonally wet area in
the central portion of
the site.**

In these areas, we would anticipate the potential for periodically high subsurface moisture conditions and possible frost heave potential, depending on the soil conditions. Areas within the drainages on-site have been identified as potentially seasonal shallow groundwater, and the seasonal shallow groundwater area is located in a minor drainage area in the south-central portion of the site, and is also identified as a wetland in the National Wetland Inventory. In this wetland area we would anticipate the potential for surface and near surface groundwater conditions depending on seasonal changes in precipitation and runoff. This area had saturated surface conditions and minor areas of standing water during our field mapping. The areas identified as potentially seasonal and seasonal shallow groundwater lie within drainages and low-lying areas that will be regraded during overlot grading. Where structures or utility trenches encroach on, or lie within these areas, the following mitigation is recommended:
