SOILS AND GEOLOGY STUDY

**Treasured Acres
El Paso County, Colorado**

JOB NO. 177644

July 27, 2021

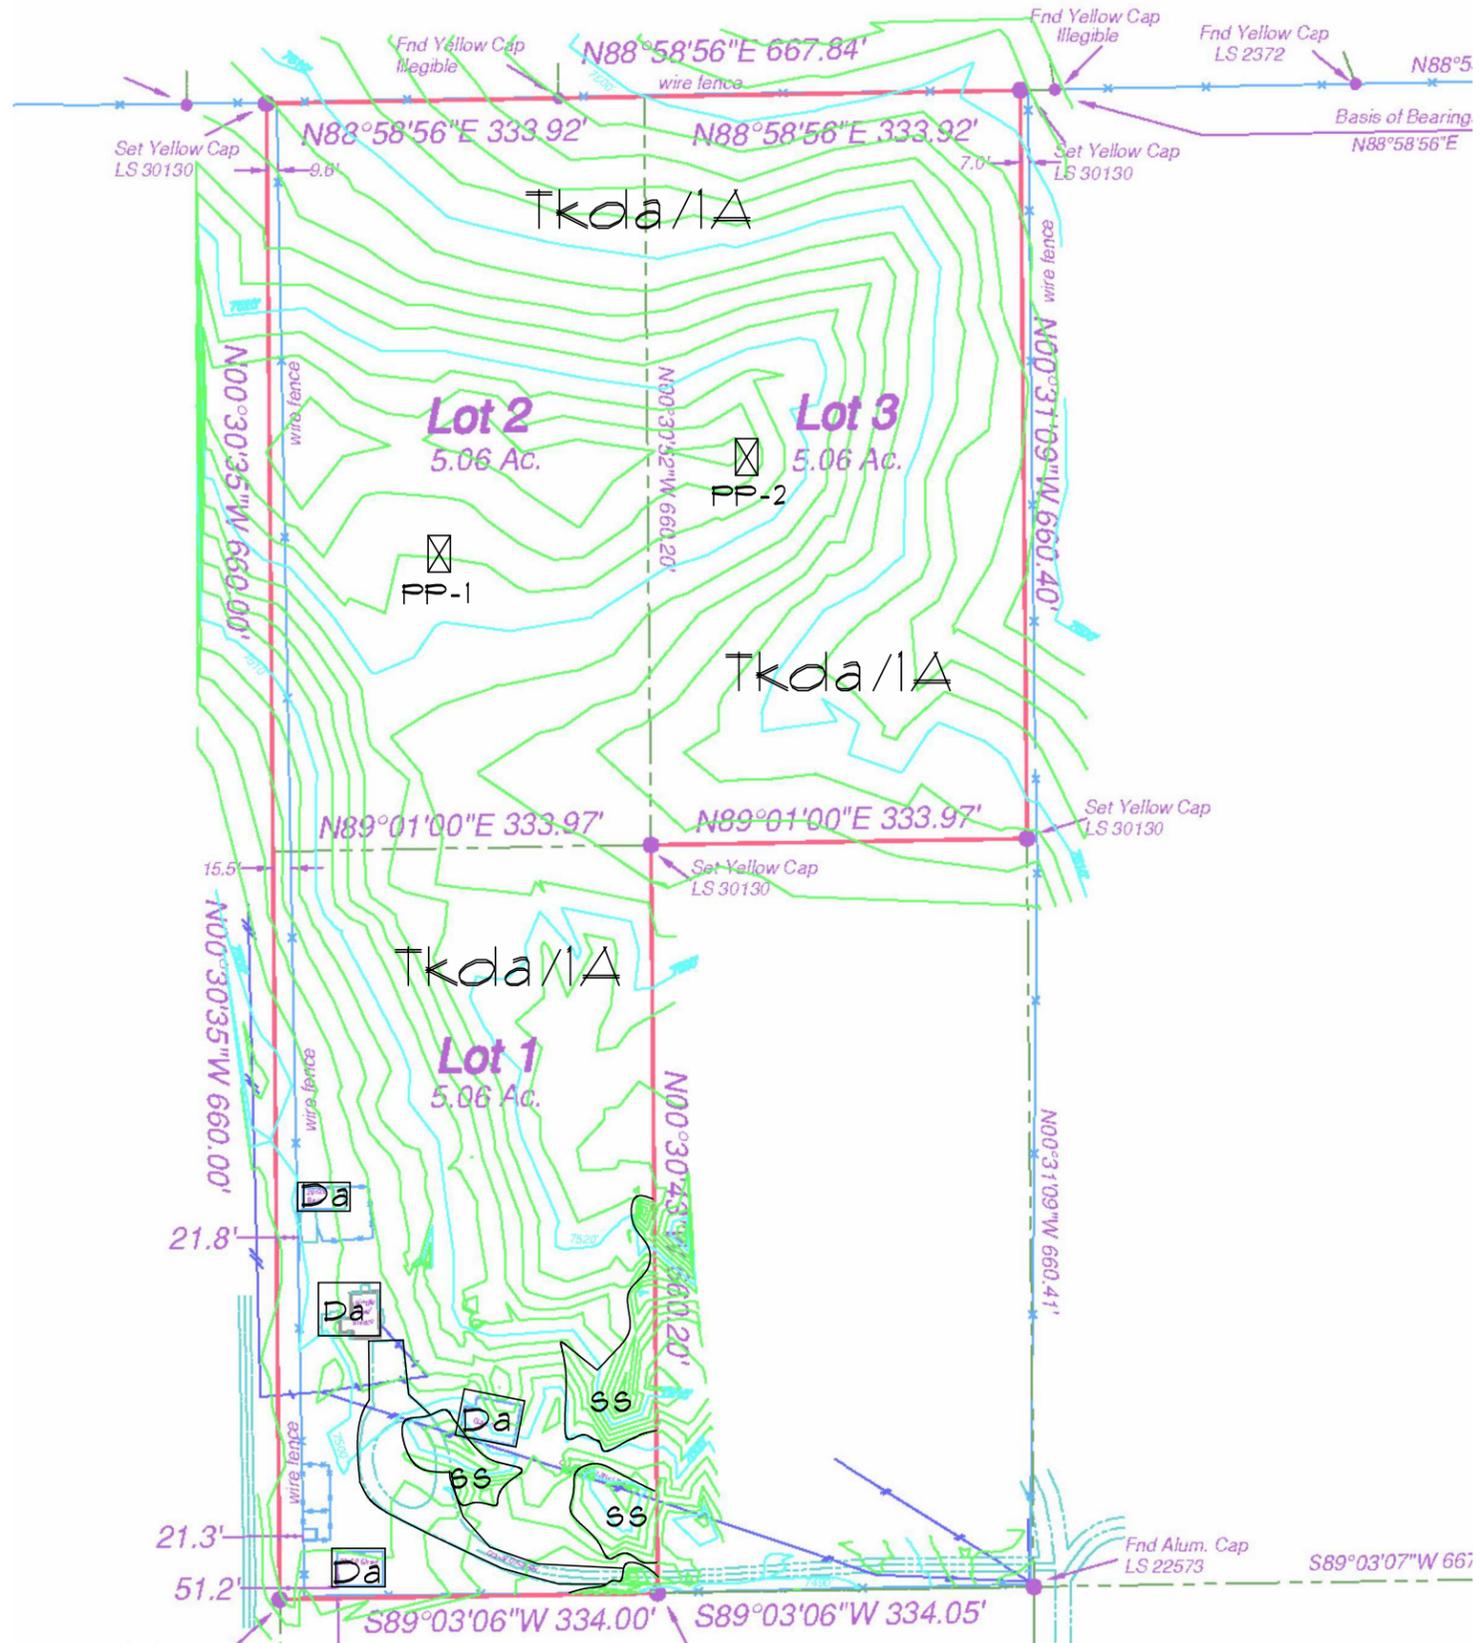
NOT TO SCALE
 BASE MAP PROVIDED BY:
 ALESSI and ASSOCIATES, Inc.

General Geology

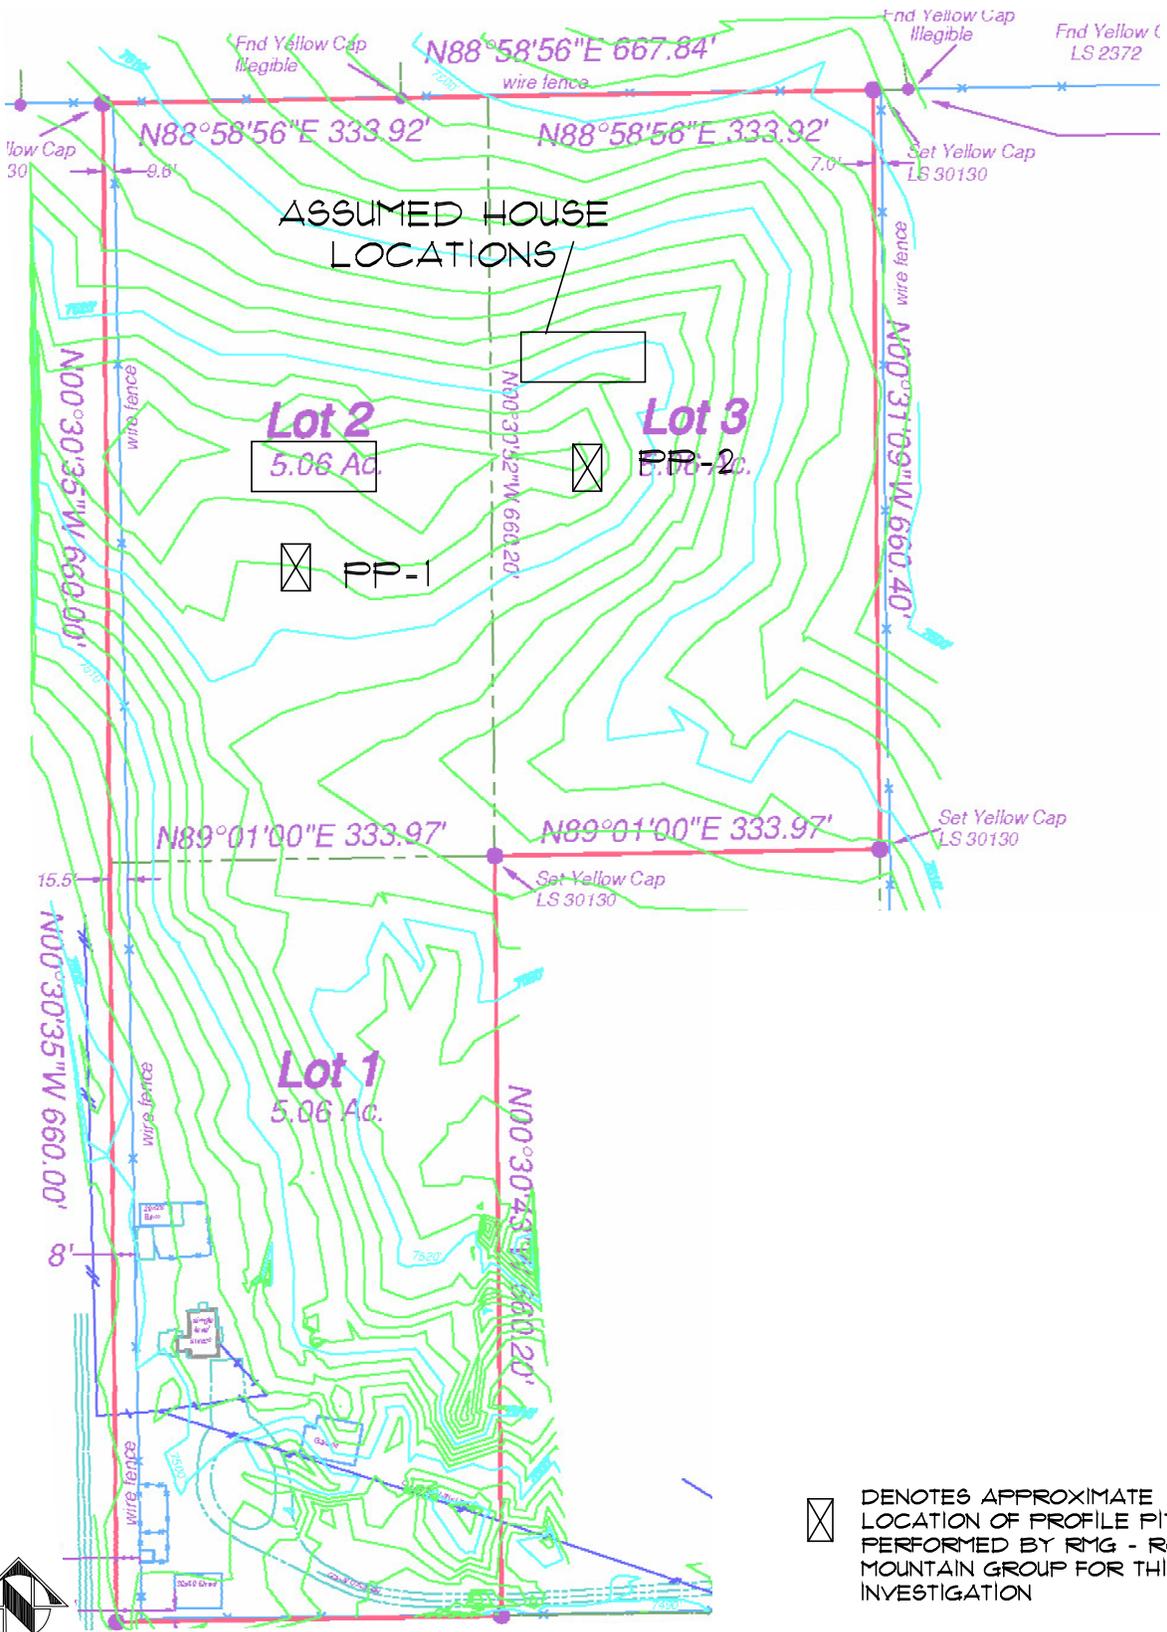
APPENDIX A
Profile Pit Location Plan

⊗ DENOTES APPROXIMATE LOCATION OF PROFILE PITS PERFORMED BY RMG - ROCKY MOUNTAIN GROUP FOR THIS INVESTIGATION

NOT TO SCALE

RMG observed two 8-foot deep profile pits on site. One profile pit was performed on each Lot 2 and Lot 3. The profile pits were excavated and observed to explore the subsurface soils underlying the proposed Onsite Wastewater Treatment Systems. The number of test pits is in accordance with Regulations of the El Paso County Board of Health, Chapter 8, Onsite Wastewater Treatment Systems (OWTS) as required by 8.5.D.3.a.

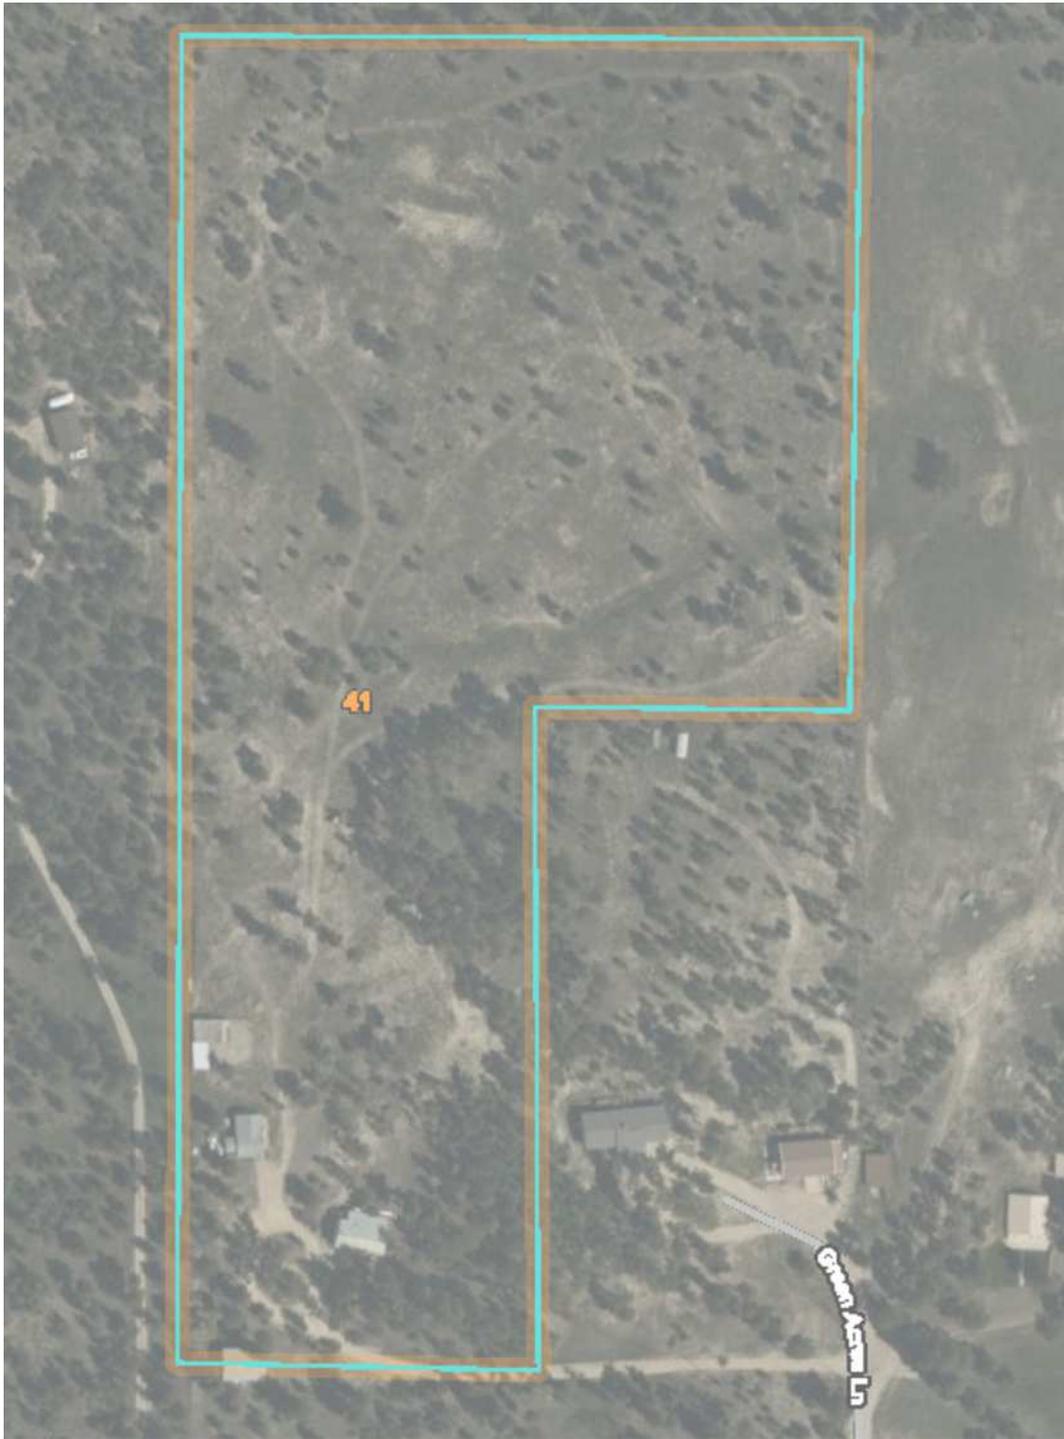
APPENDIX C
USDA Soil Map and Map Unit Descriptions

- 41 - Kettle gravelly loamy sand
