**SOILS AND GEOLOGY STUDY  
MONUMENT RIDGE EAST – FILING NO. 1  
MONUMENT HILL ROAD AND PALMER DIVIDE ROAD  
EL PASO COUNTY, COLORADO**

March 7, 2023  
Revised August 7, 2024  
Revised July 16, 2026

**PCD No. SF2514**

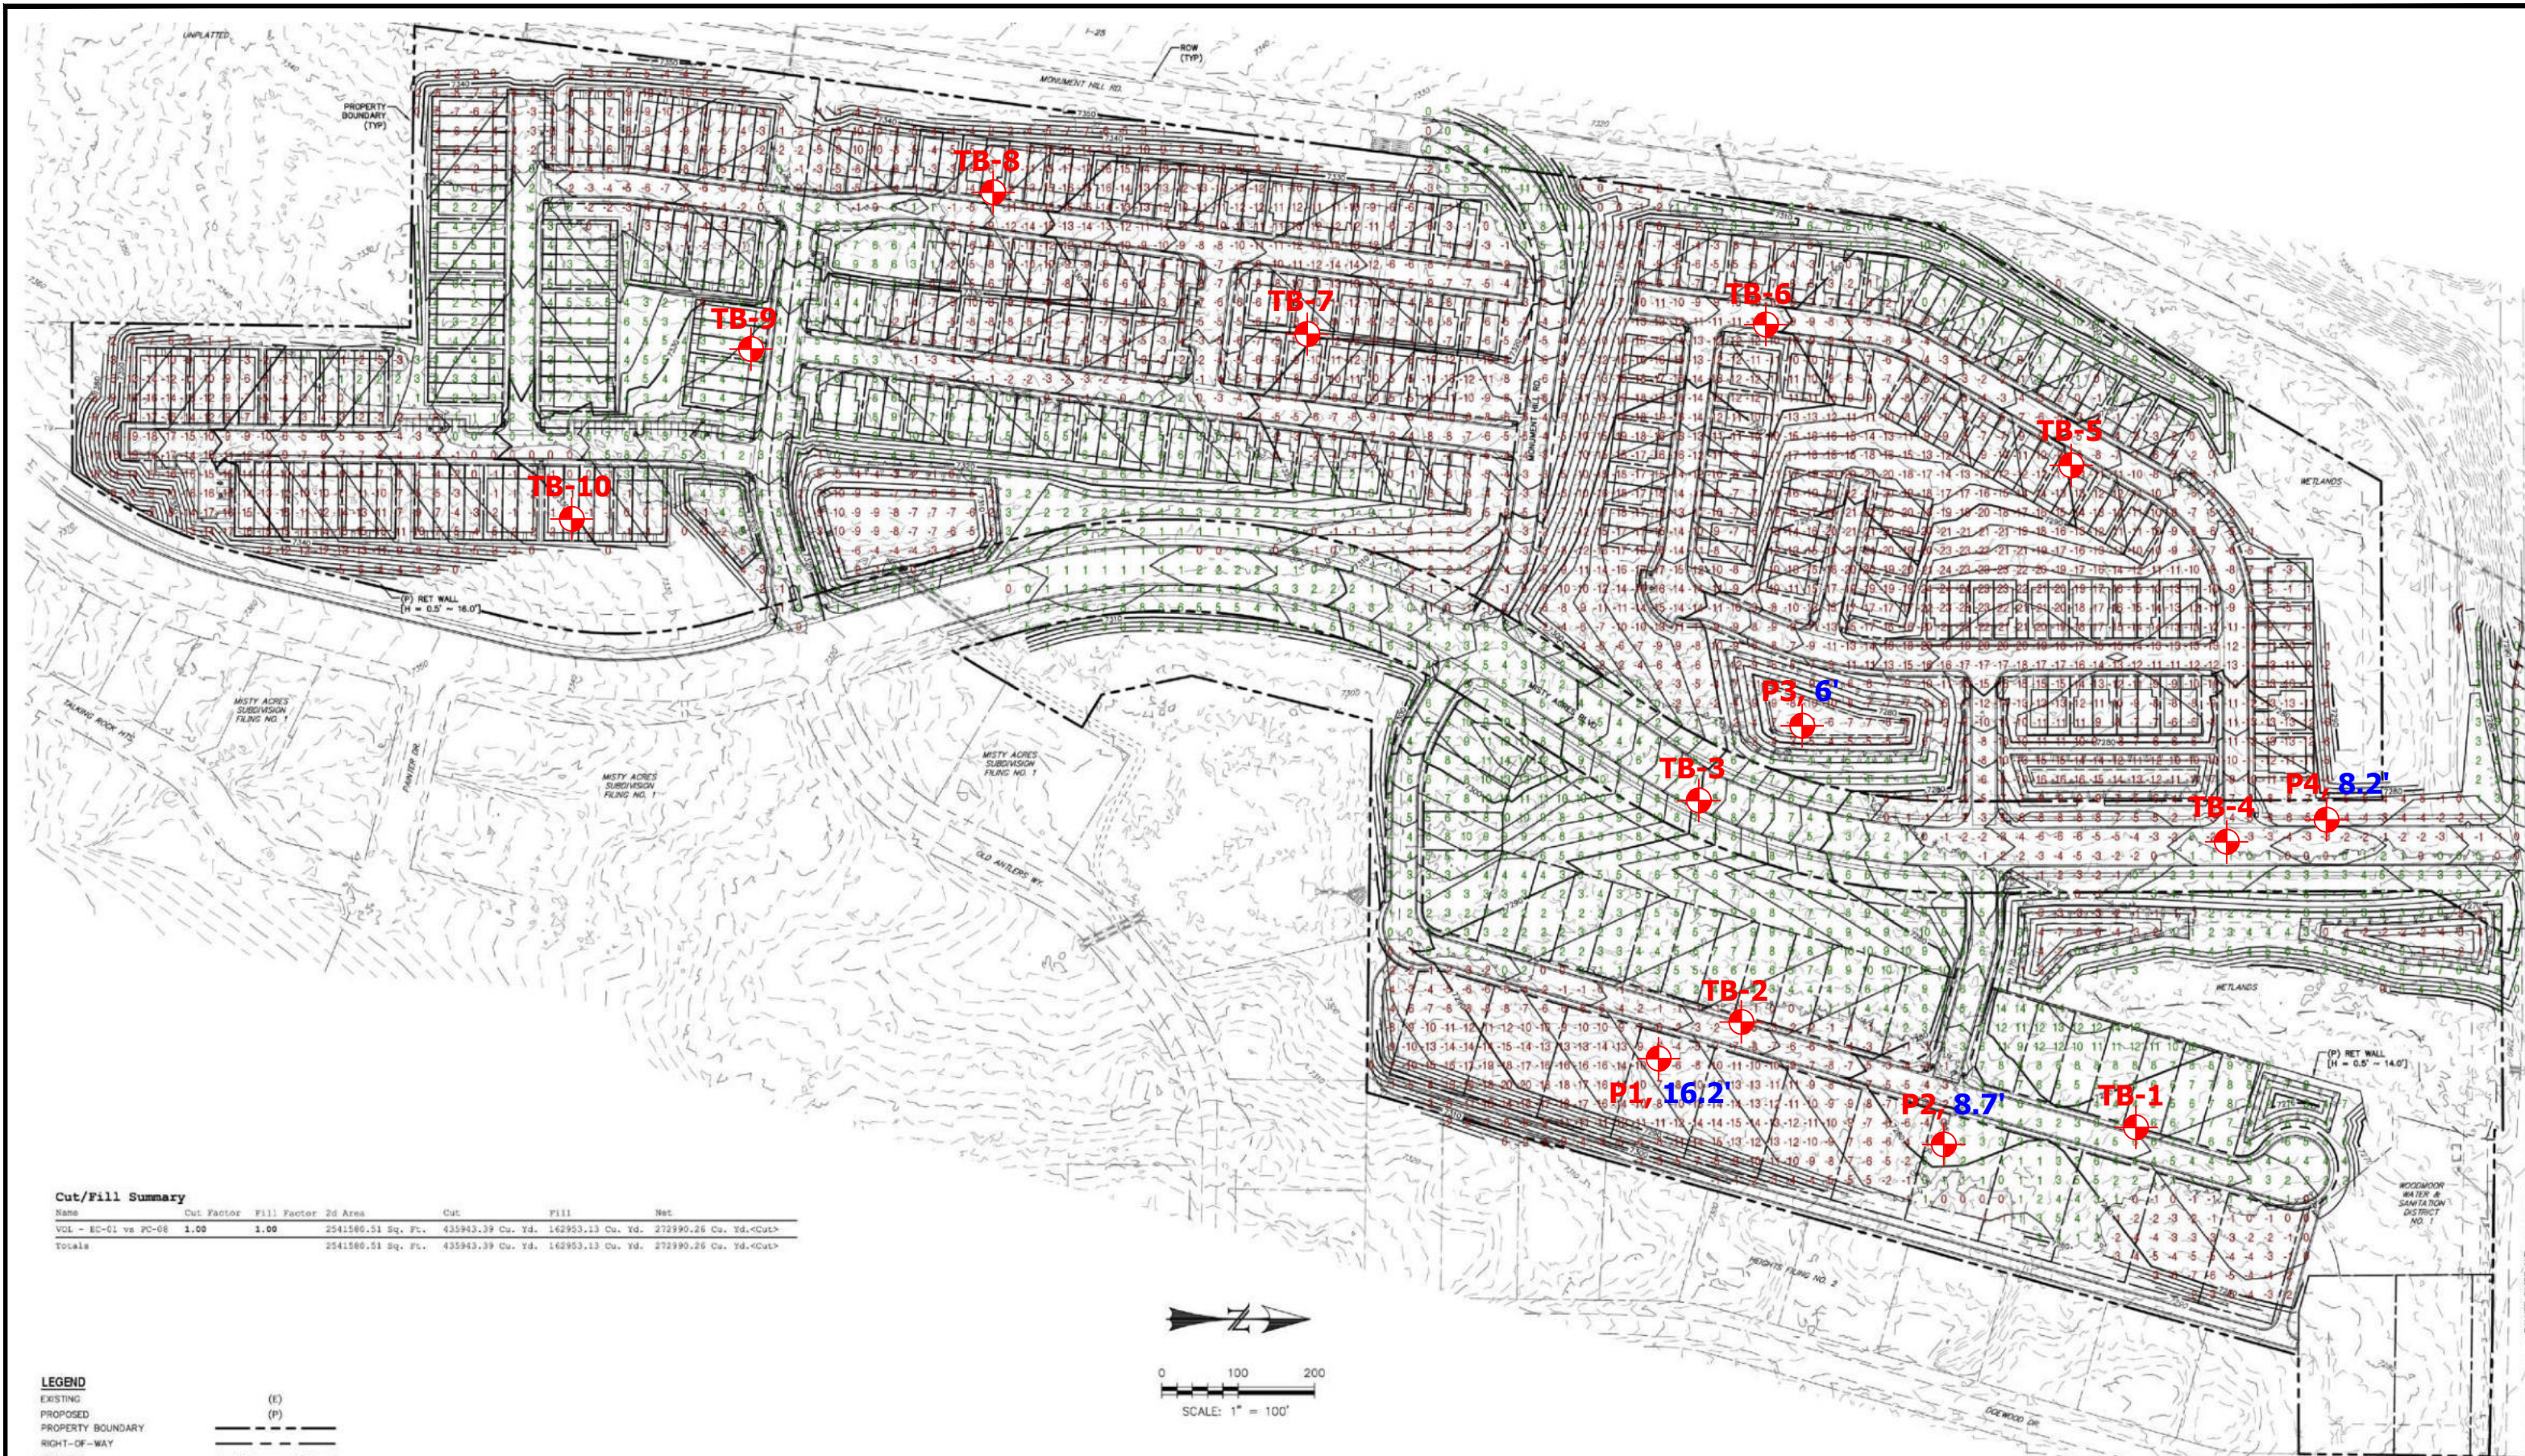
**FIG. 3**

- TB- APPROXIMATE TEST BORING LOCATION AND NUMBER**
- P- APPROXIMATE PIEZOMETER LOCATION AND NUMBER, GROUNDWATER DEPTH**

The topography of the site is generally gradually to moderately sloping to the east, west, and north along a drainage through the central portion of the site. Portions of the delineated wetlands indicated on Figure 3 were wet, however, flowing water was not observed. Several minor drainage swales were observed across the site. The drainages onsite flow in a northerly direction. The site is currently mostly undeveloped with an old farm house and barn located in the central portion of the site. Misty Acres Boulevard extends into the site and is partially paved. The site boundaries are indicated on the USGS Map, Figure 2. Previous land uses have included agricultural grazing and pasture land. The site contains primarily field grasses, weeds, scrub oak, and ponderosa pines. Site photographs, taken February 28, 2023, are included in Appendix A, and approximate locations are indicated on Figure 3.

Ten (10) test borings were performed on the site to determine general soil and bedrock characteristics. The locations of the test borings are indicated on the Site and Exploration Plan, Figure 3. The Test Boring Logs are presented in Appendix B. Results of this testing will be discussed later in this report.

Four (4) additional test borings were performed and temporary piezometers installed on July 29, 2024. The piezometers, designated P1 through P4 were installed in areas of proposed cuts, and where shallow groundwater conditions were previously encountered. The Test Boring Logs and Summary of Laboratory Testing for the Piezometers are presented in Appendix C, and locations indicated on the Site and Exploration Plan, Figure 3.

Proposed grading is shown on Figure 3, and the Cut/Fill Exhibit is presented on Figure 4. Significant cuts up to 20 feet or more are proposed in a few areas the site with the drainage area in the central portion of the site to be filled. Several detention ponds and significant drainage improvements area proposed as part of the development. Retaining walls are proposed in the southern and northern portions of the site varying in height from 0.5 to 16 feet. The retaining walls should be designed for the existing site conditions by a qualified professional engineer and be designed for internal and external global slope stability.

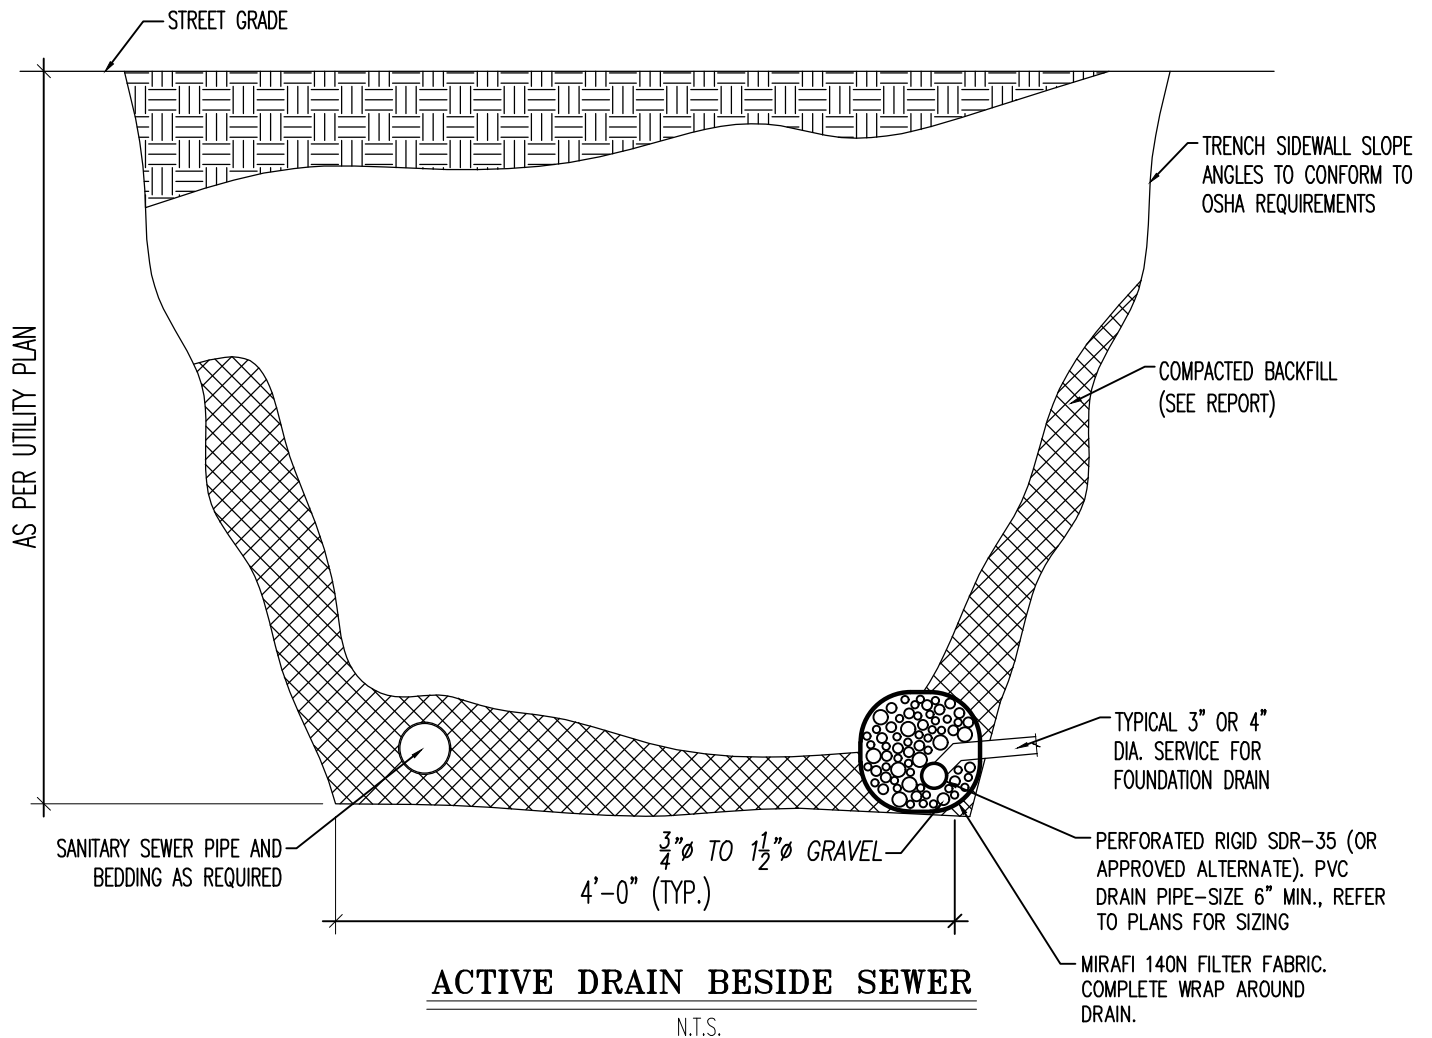
**FIG. 8**

## ACTIVE SEWER UNDERDRAIN

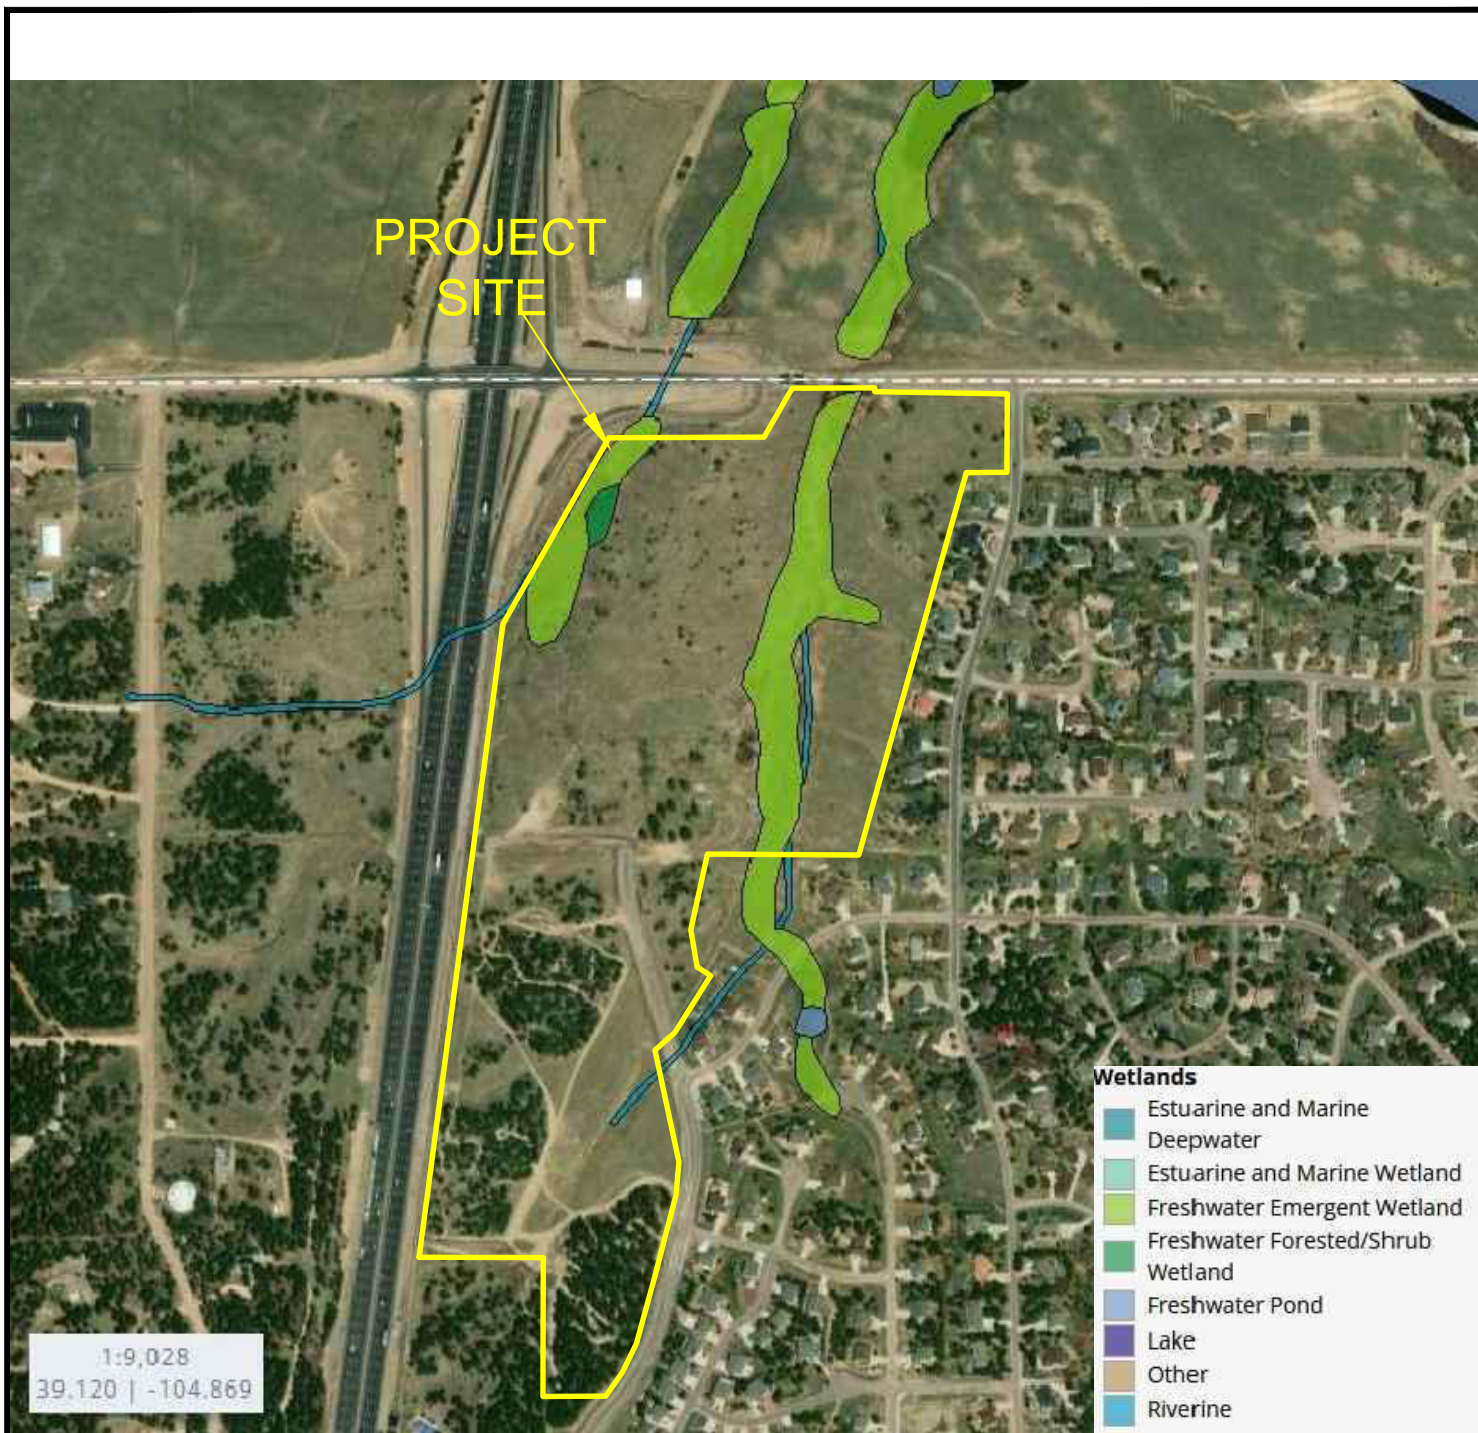
**FIG. 10**

## USFWS WETLANDS MAP

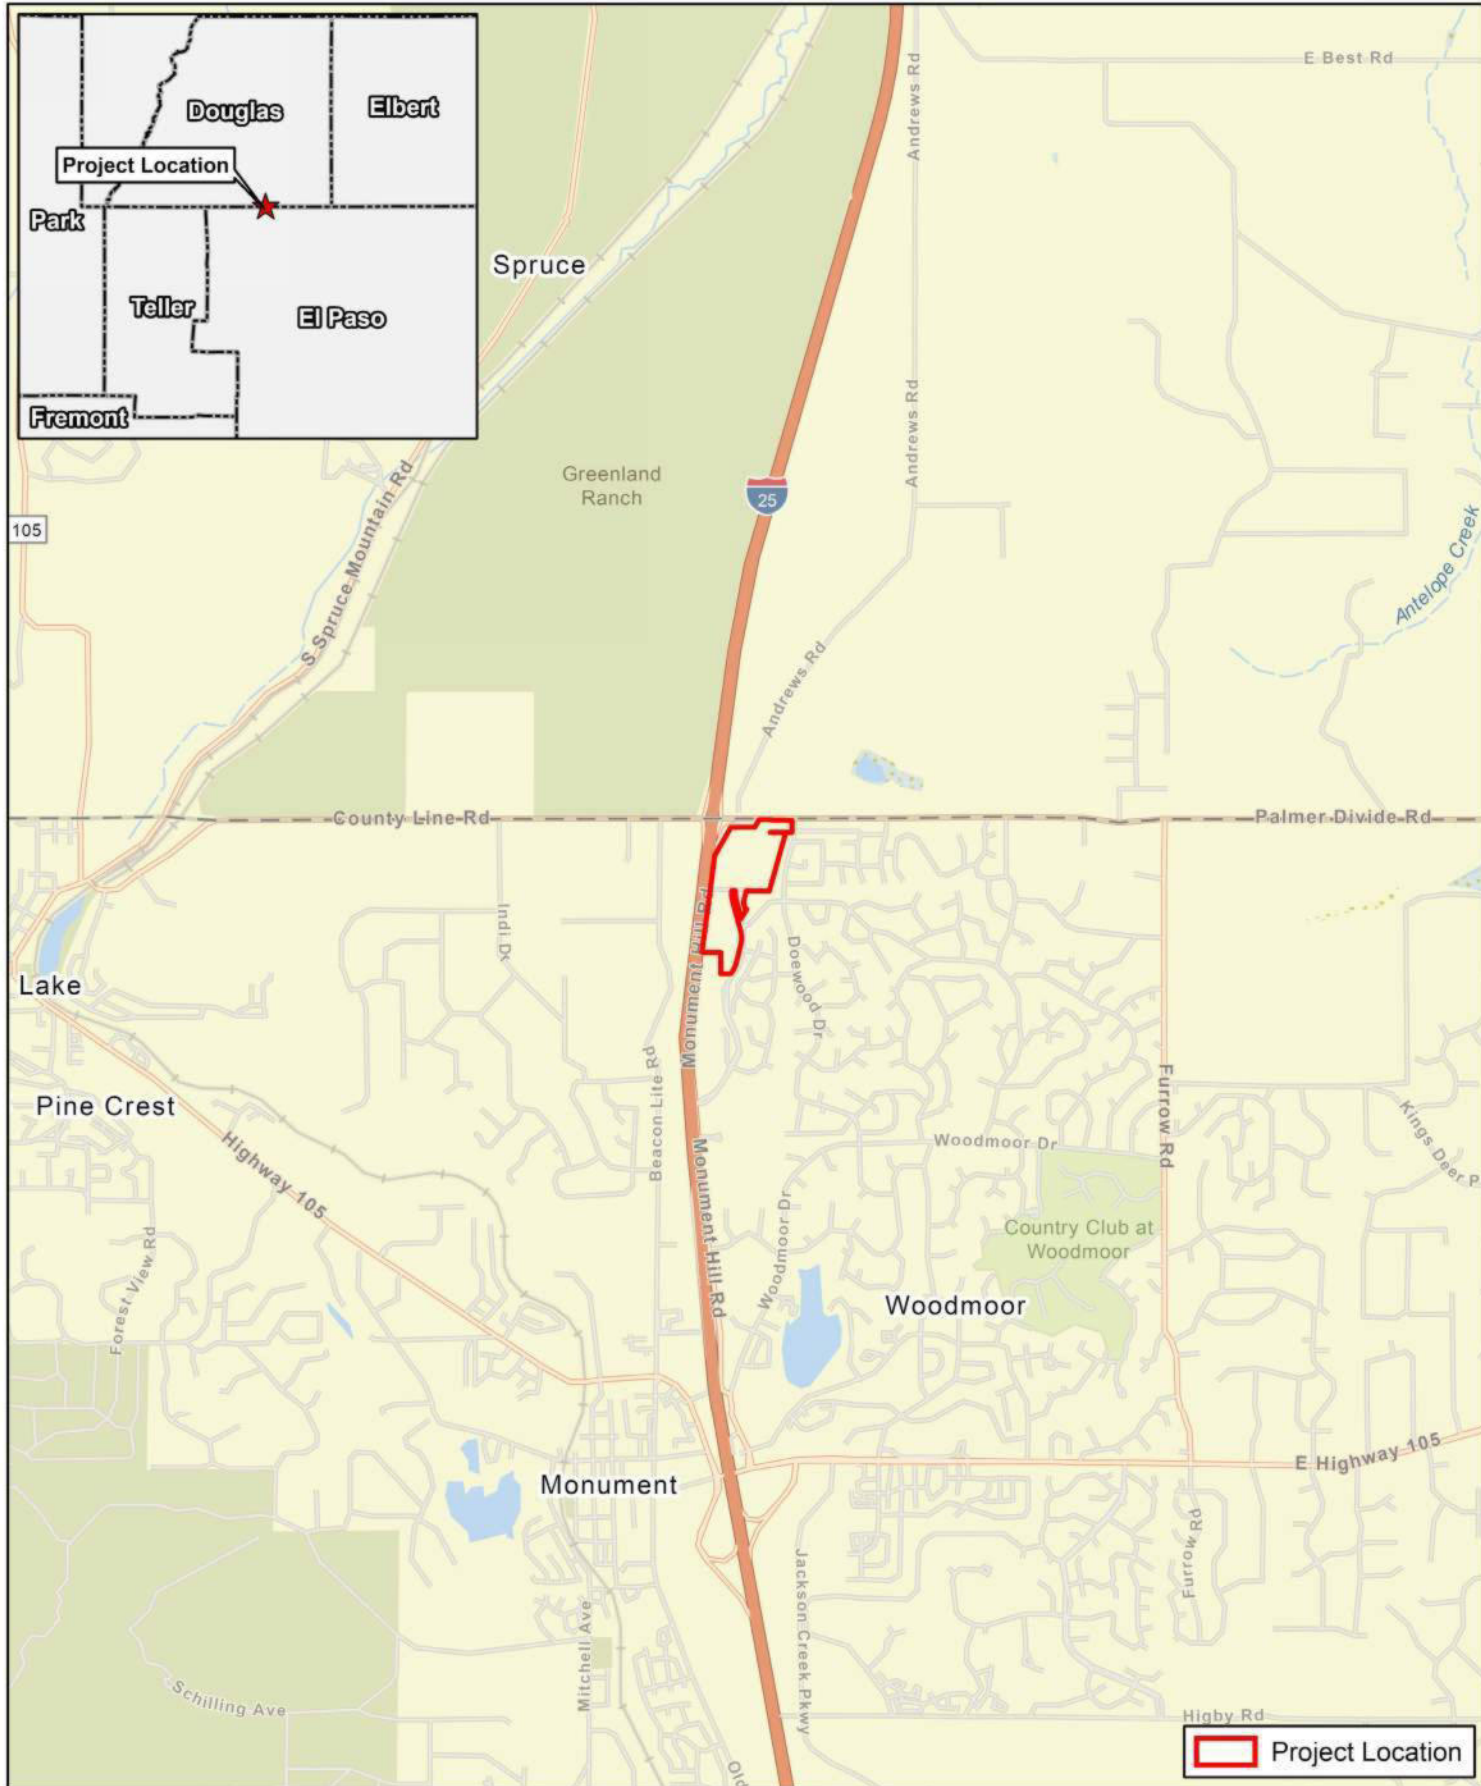
**Figure 1 - Project Location**

The project is located immediately southeast of the intersection of Interstate 25 and Palmer Divide Road in the City of Monument (Woodmoor), El Paso County, CO. The project area consists of approximately 66 acres (**Figure 1, Appendix A**).

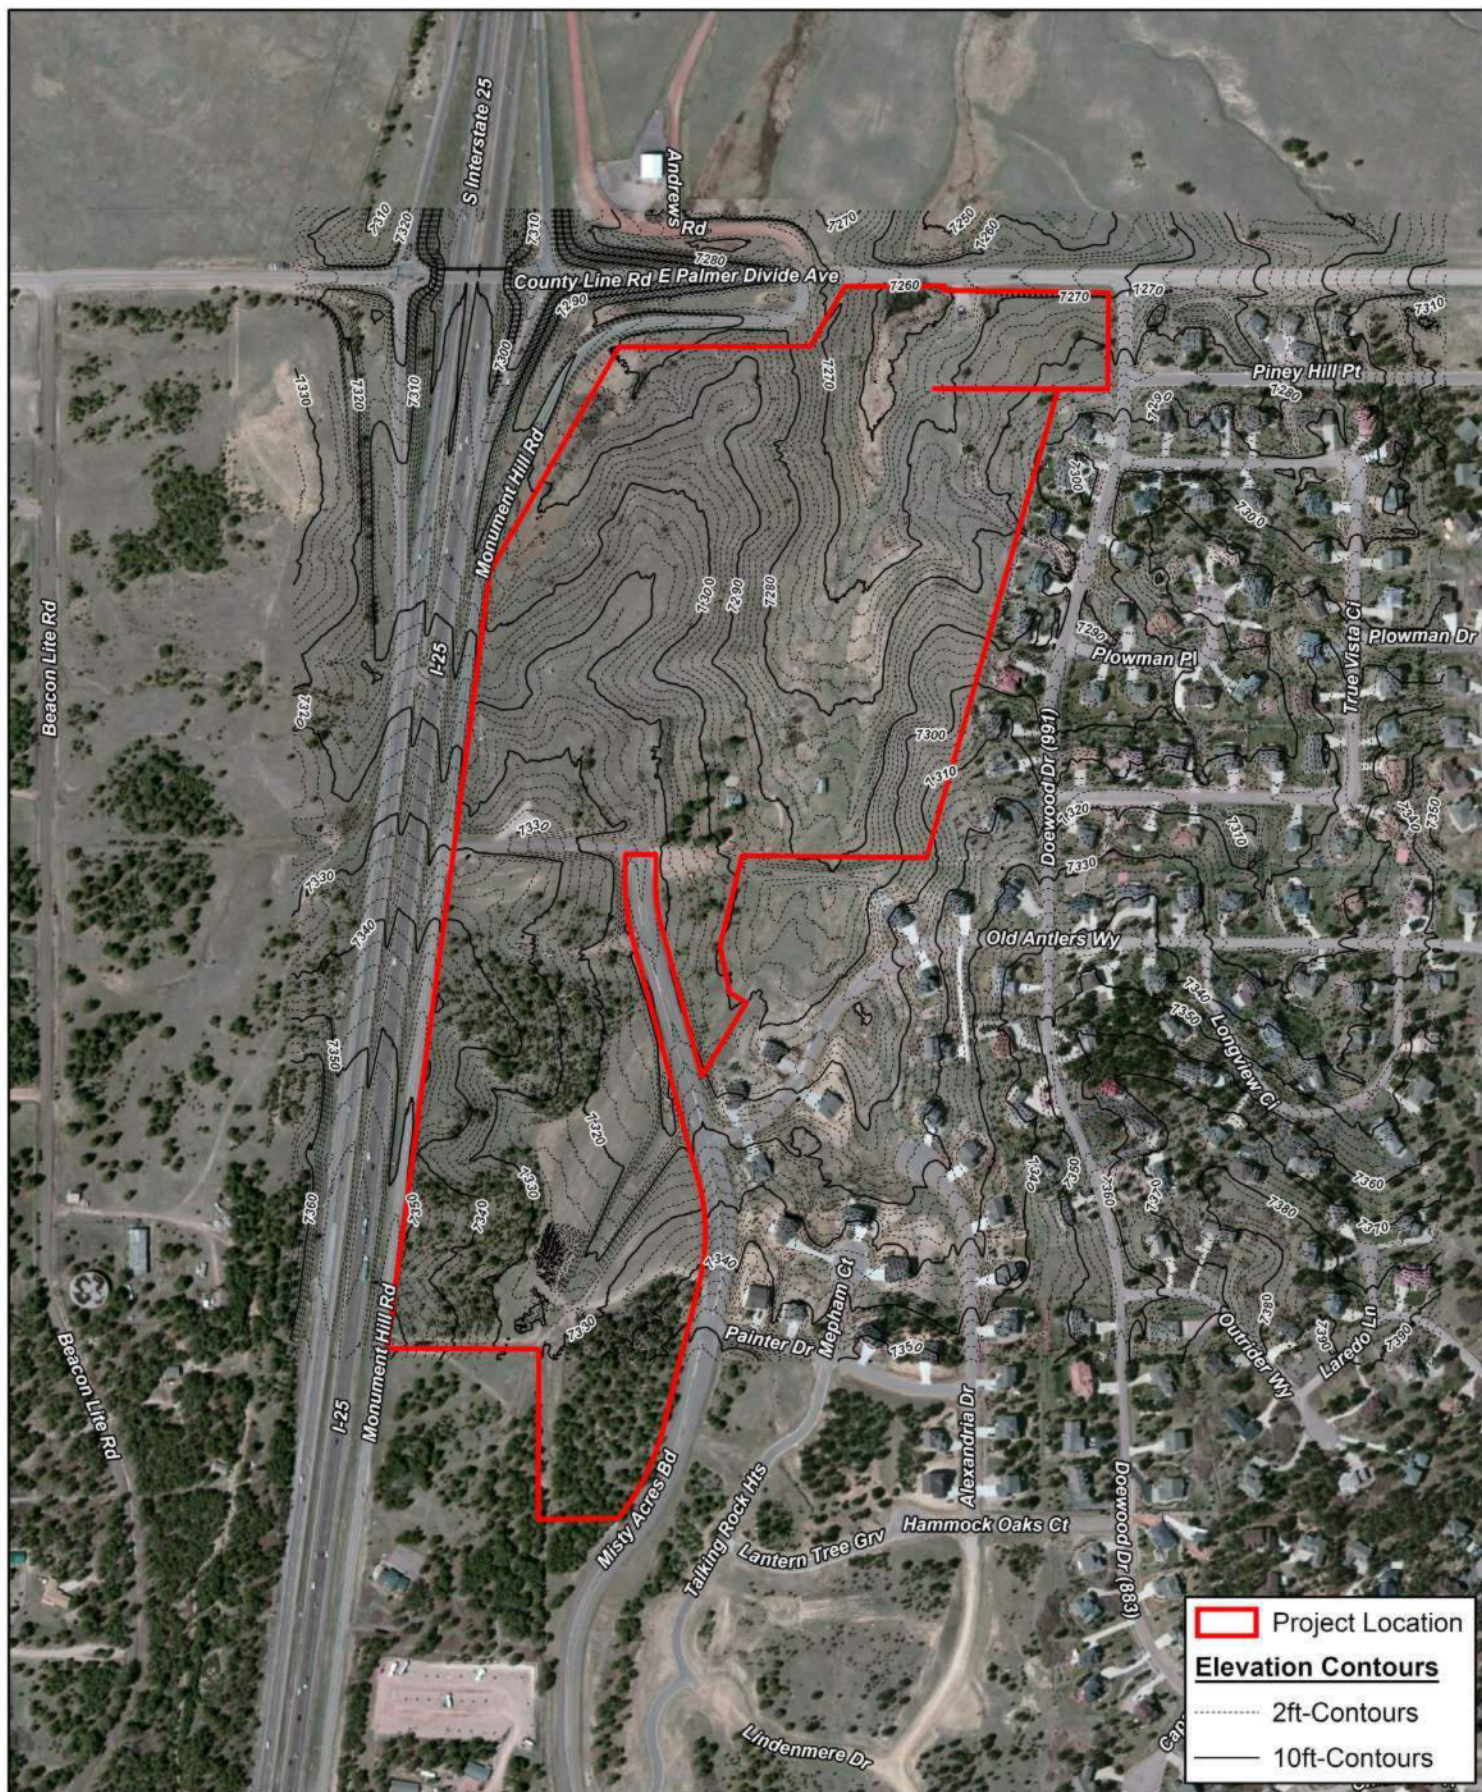
**Figure 2 - Topography**

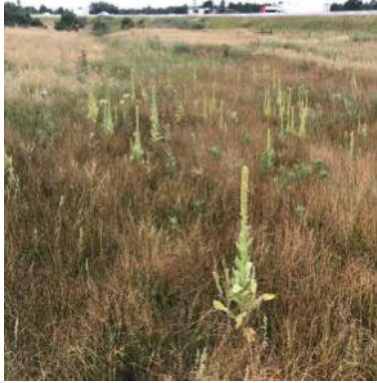
| | <p><b>Photo 1 – Sample Point 2 Up</b></p> <p>Date: 8/26/2021</p> <p>Direction Photo is Taken: Southwest</p> <p>Photo Location: Near Sample Point 2 Up</p> |

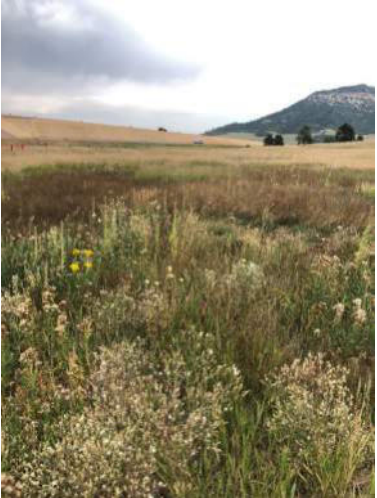
| | <p><b>Photo 2 – Sample Point 2 Up</b></p> <p>Date: 8/26/2021</p> <p>Direction Photo is Taken: Northeast</p> <p>Photo Location: Near Sample Point 2 Up</p> |

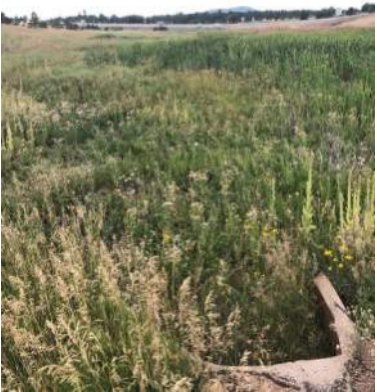
| | <p><b>Photo 3 – Wetland B</b></p> <p>Date: 8/26/2021</p> <p>Direction Photo is Taken: Southwest</p> <p>Photo Location: Looking at Wetland B, from Storm structure.</p> |

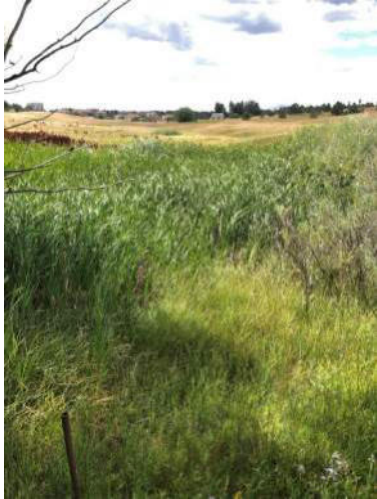
| | <p><b>Photo 4 – Wetland A</b></p> <p>Date: 8/26/2021</p> <p>Direction Photo is Taken: South</p> <p>Photo Location: Looking south from East Palmer Divide Road.</p> |
