**SOILS AND GEOLOGY STUDY  
MONUMENT RIDGE EAST – FILING NO. 1  
MONUMENT HILL ROAD AND PALMER DIVIDE ROAD  
EL PASO COUNTY, COLORADO**

March 7, 2023  
Revised August 7, 2024  
Revised July 16, 2026

**PCD No. SF2514**

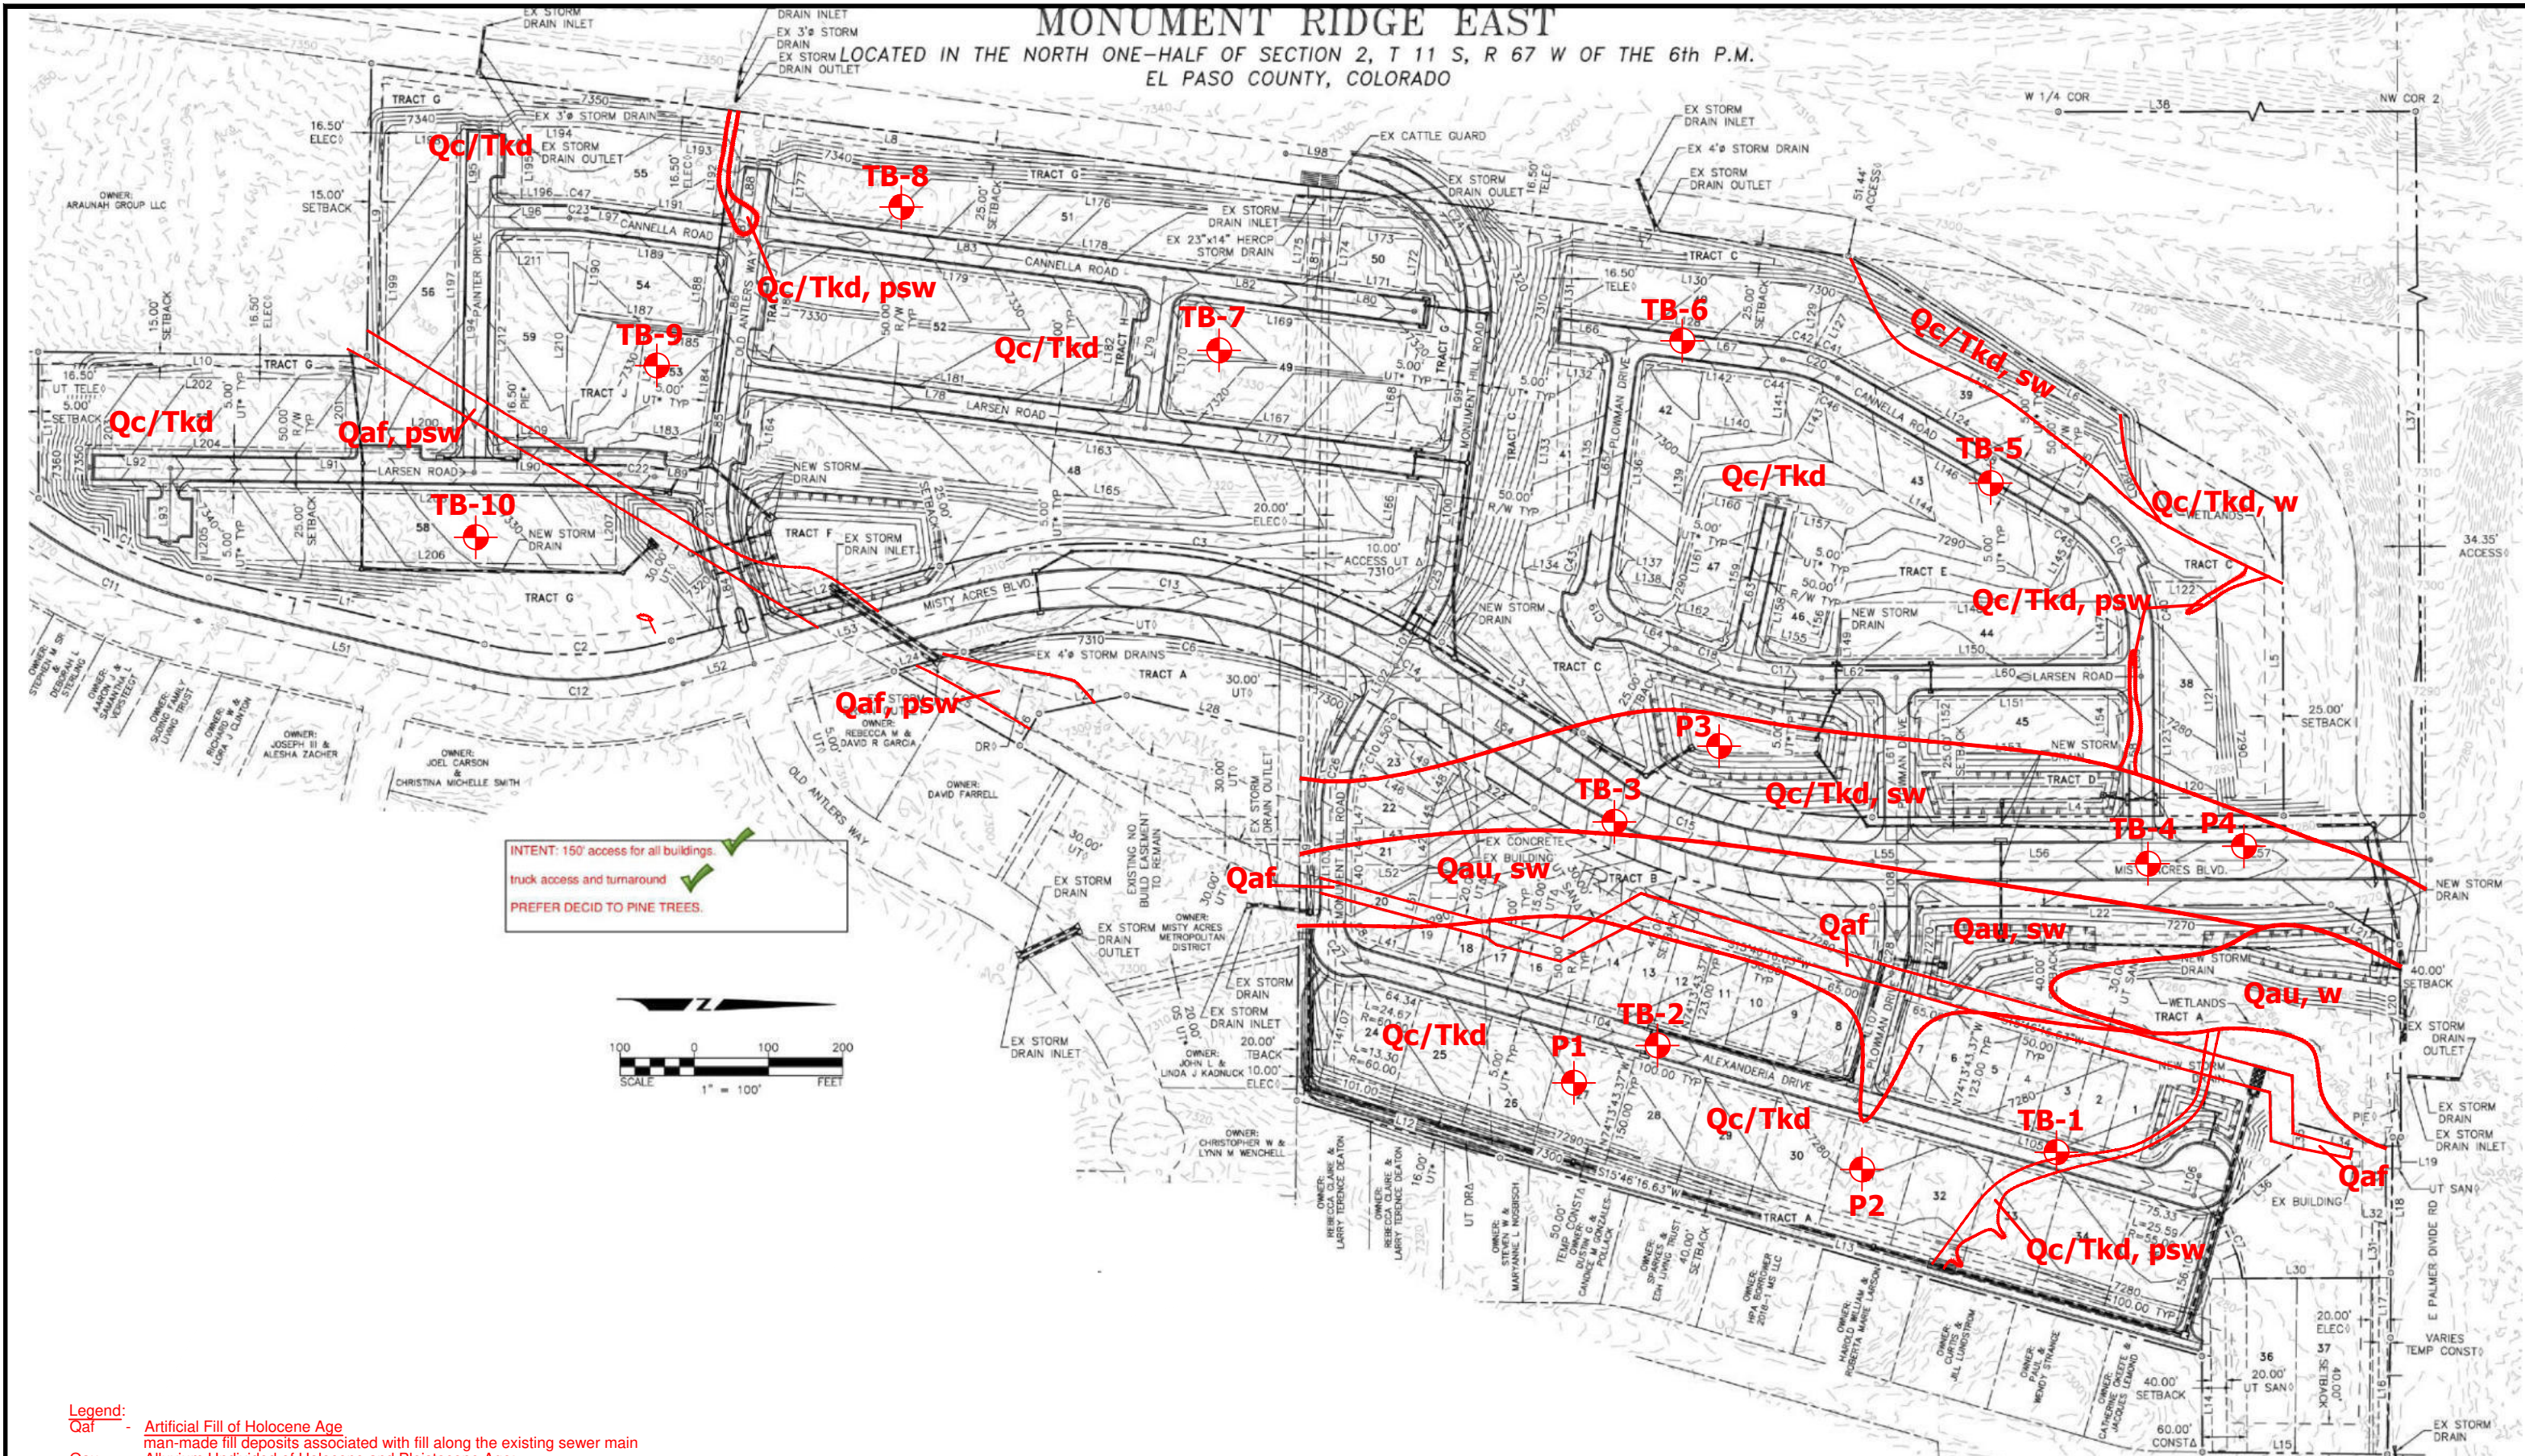
JOB NO.  
 230248  
 FIG. 7

**Legend:**  
 Qaf - Artificial Fill of Holocene Age  
 man-made fill deposits associated with fill along the existing sewer main  
 Qau - Alluvium Undivided of Holocene and Pleistocene Age:  
 sheetwash and channel deposited alluvium along active drainage way  
 QcTkd - Colluvium of Quaternary Age overlying Dawson Formation of Tertiary to Cretaceous Age:  
 colluvial and residual soils overlying arkosic sandstone with interbedded fine-grained  
 sandstone, siltstone and claystone  
 psw - potentially shallow groundwater area  
 sw - seasonally shallow groundwater area  
 w - standing water/wetlands

**GEOLOGY / ENGINEERING MAP**  
 MONUMENT RIDGE EAST  
 MONUMENT RIDGE EAST, LLC

**Entech Response to Comment 4:** Figure 7 has been updated, and a geologic hazard note provided for the preliminary plan/plat.

1. Entech encountered groundwater at depths ranging from 1 to 10 feet during drilling. However, figure 7 of their report fails to depict this shallow groundwater in the relevant areas. Test Boring No. 3, which includes groundwater at 1 foot, is mapped as Colluvium and Dawson Formation without shallow groundwater. It is imperative that Figure 7 is revised to reflect the geologic hazards and constraints.

4. A geologic hazard note is not included in the preliminary plan drawings. CGS recommends updating Figure 7 of Entech’s report and adding a note to the preliminary plan/plat listing the geologic hazards and constraints, along with mitigation measures.

5. Wetlands (Freshwater Emergent/Freshwater Forested/Shrub Wetland) are located within the site. However, these areas do not appear to be portrayed correctly in Figure 7 of Entech’s report. These areas are associated with standing water; lots should not be located within these areas, a setback should be established, and these areas should be designated as “No Build Areas”. Setbacks and no build areas should be noted on the plans.
