**SOIL, GEOLOGY, GEOLOGIC HAZARD STUDY
FLYING HORSE NORTH**

~~FILING NO. 2~~
EL PASO COUNTY, COLORADO

Flying Horse Development, LLC
2138 Flying Horse Club Drive
Colorado Springs, Colorado 80921

March 8, 2022

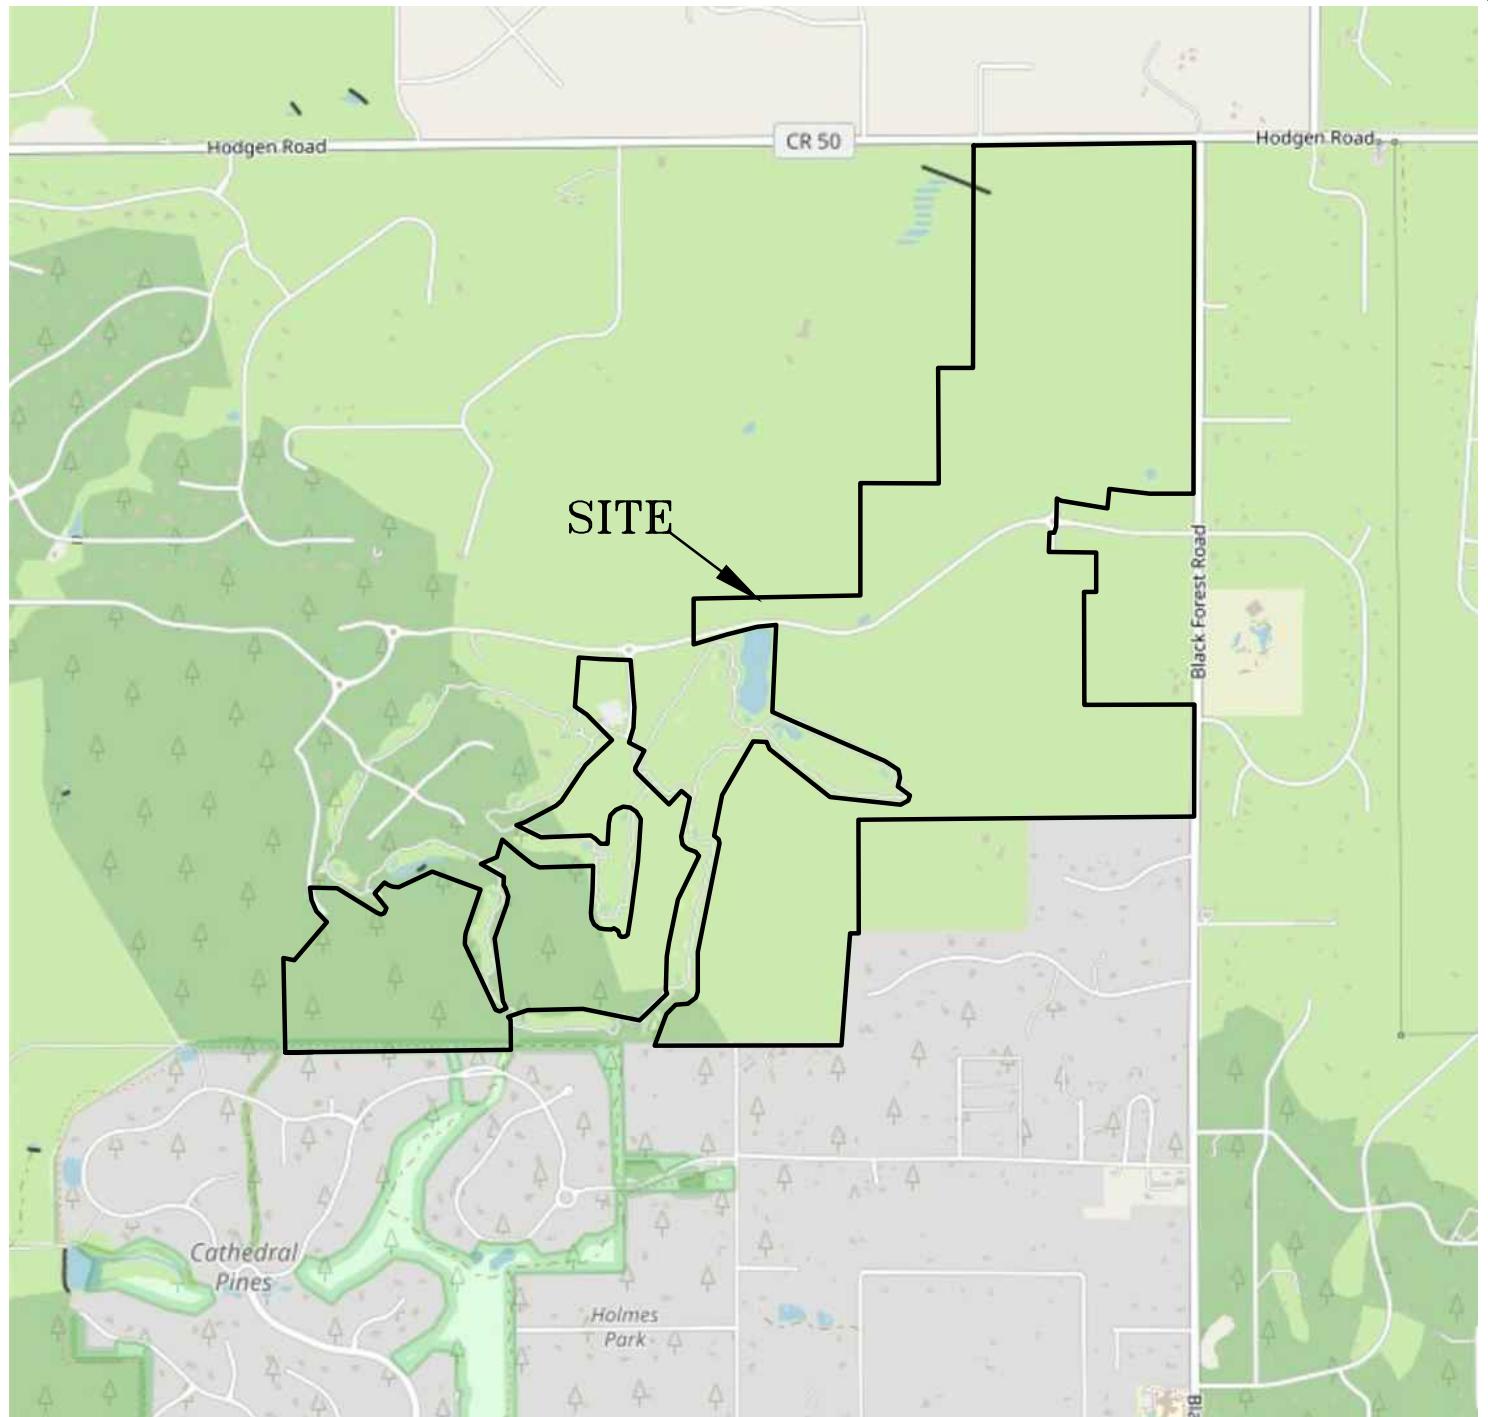
JOB NO.:
220404
FIG NO.:
1

VICINITY MAP
FLYING HORSE NORTH FILING NO. 2
EL PASO COUNTY, CO.
FOR: FLYING HORSE DEVELOPMENT, LLC

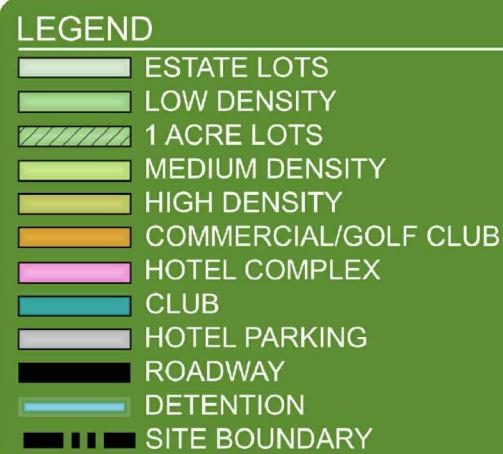
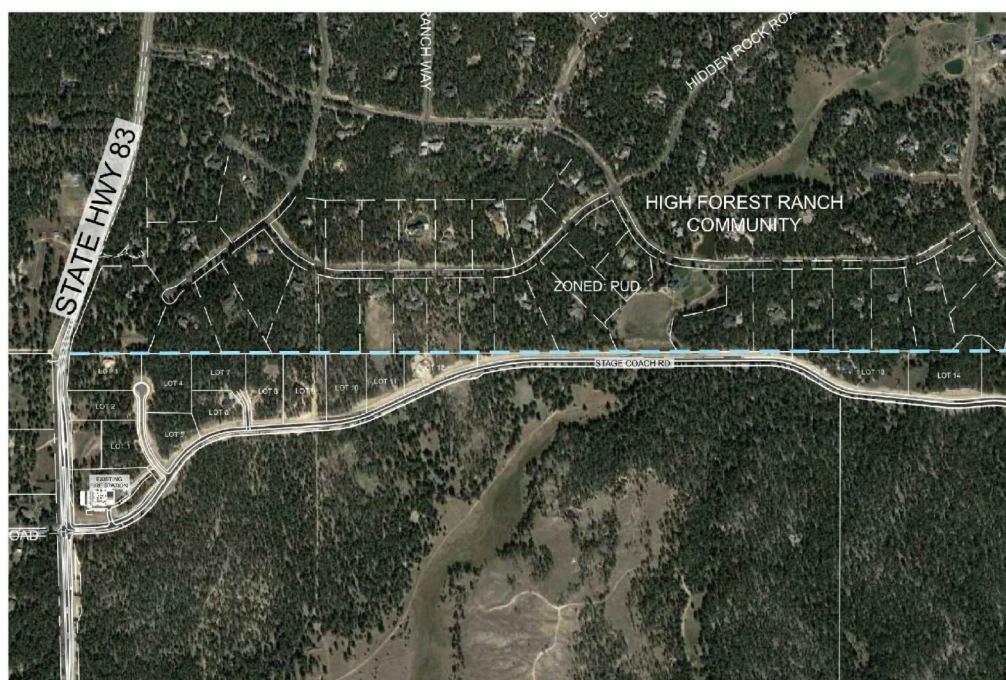
DRAWN
3/22
CHECKED
DATE
SCALE
AS SHOWN
JOB NO.
220404
FIGURE NO.
4

FLYING HORSE NORTH SKETCH PLAN

LAND USE SUMMARY				
LAND USE CATEGORY	ACREAGE	ACREAGE PERCENTAGE	MAX DU/AC	MAX UNITS
ESTATE LOTS RESIDENTIAL	161.7 AC.	17.7%	0.4	64
LOW DENSITY RESIDENTIAL	346.4 AC.	38.0%	2.7	935
MEDIUM DENSITY RESIDENTIAL	97.7 AC.	10.6%	3.5	341
HIGH DENSITY RESIDENTIAL	38.5 AC.	4.2%	6	231
RESIDENTIAL SUB-TOTAL	644.3 AC.	70.5%		1571
COMMERCIAL	17.0 AC.	1.9%	N/A	N/A
HOTEL ROOMS/GOLF CASITAS	18.0 AC.	2%	N/A	225*
FITNESS CENTER	4.3 AC.	0.5%	N/A	N/A
CLUBHOUSE	2.4 AC.	0.3%	N/A	N/A
ROAD RIGHT-OF-WAY (MAJOR ROADS)	63.0 AC.	6.9%	N/A	N/A
TOTAL OPEN SPACE	200.9 AC.	22.0%	N/A	N/A
OPEN SPACE TO BE INCLUDED WITHIN PARCELS**	-37.4 AC.	-4.1%		
TOTAL	912.5 AC	100.0%

Total acreage involved in Filing No. 2 of the proposed development is 912.5 acres. Single-family residential estate lots, low to high density lots, commercial golf club, hotel, fitness center, potential fire station, detention ponds, open space, parks and trail system. The area will be serviced by Cherokee Water and Sanitation. The proposed Sketch Plan prepared by HRGreen is presented in Figure 4.

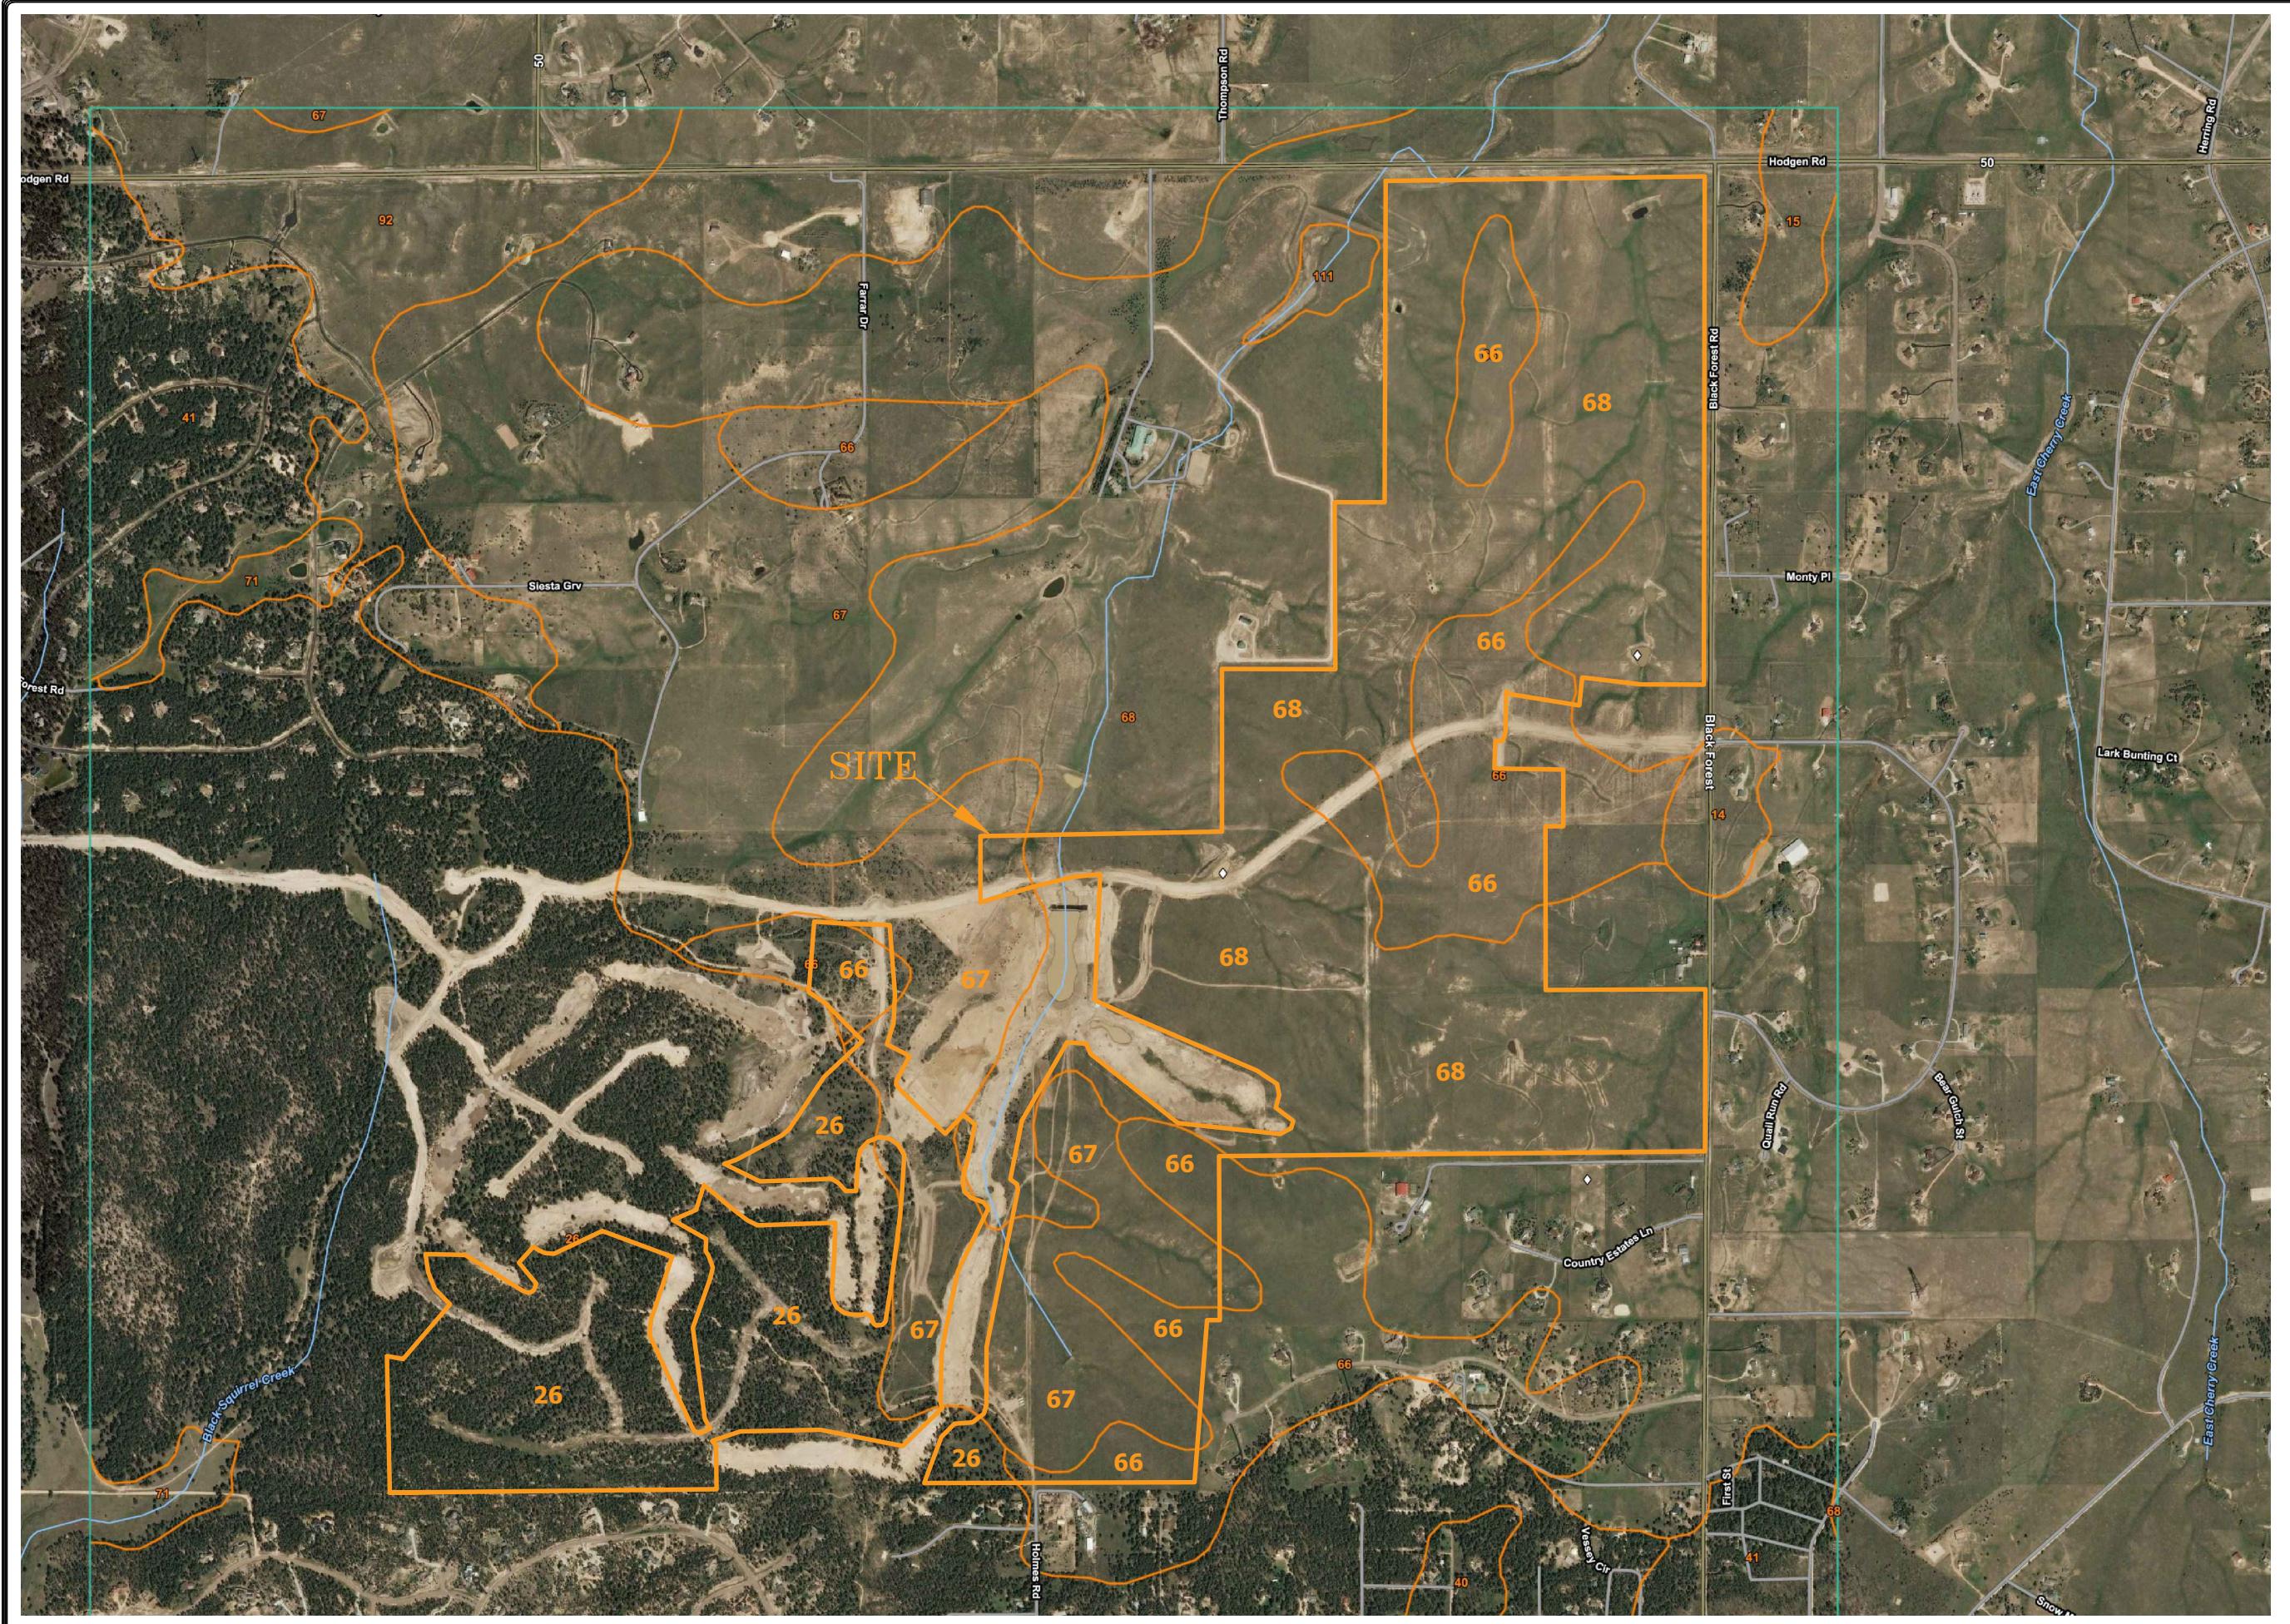
5

**SOIL SURVEY MAP
FLYING HORSE NORTH FILING NO. 2
EL PASO COUNTY, CO.
FOR: FLYING HORSE DEVELOPMENT, LLC**

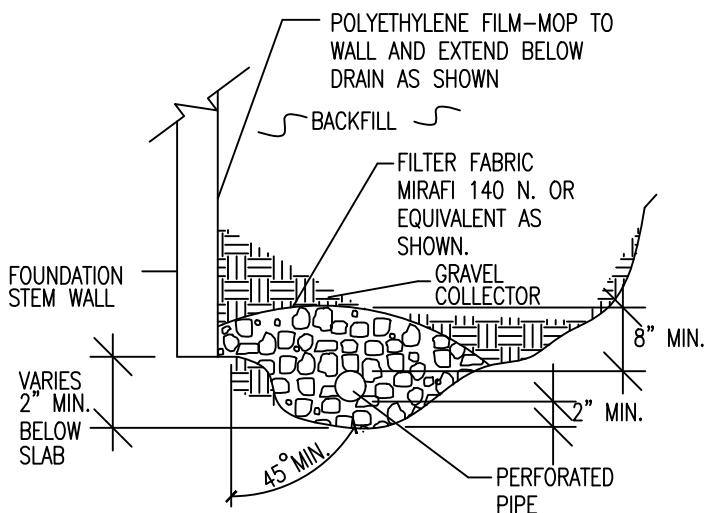
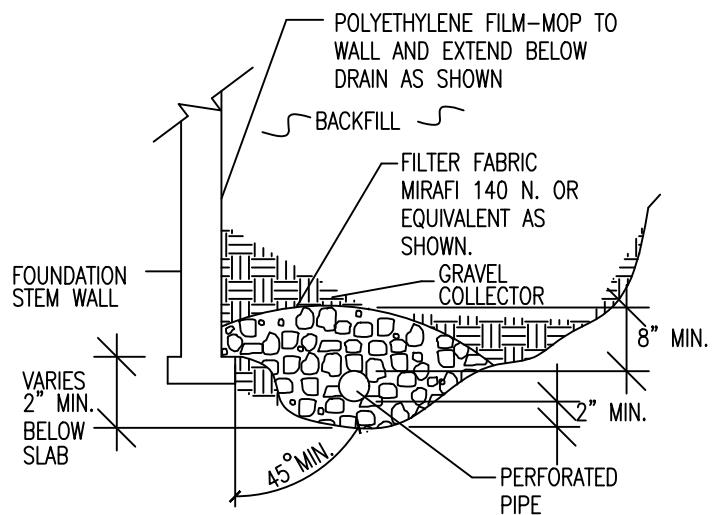
8

-GRAVEL SIZE IS RELATED TO DIAMETER OF PIPE PERFORATIONS-85% GRAVEL GREATER THAN 2x PERFORATION DIAMETER.

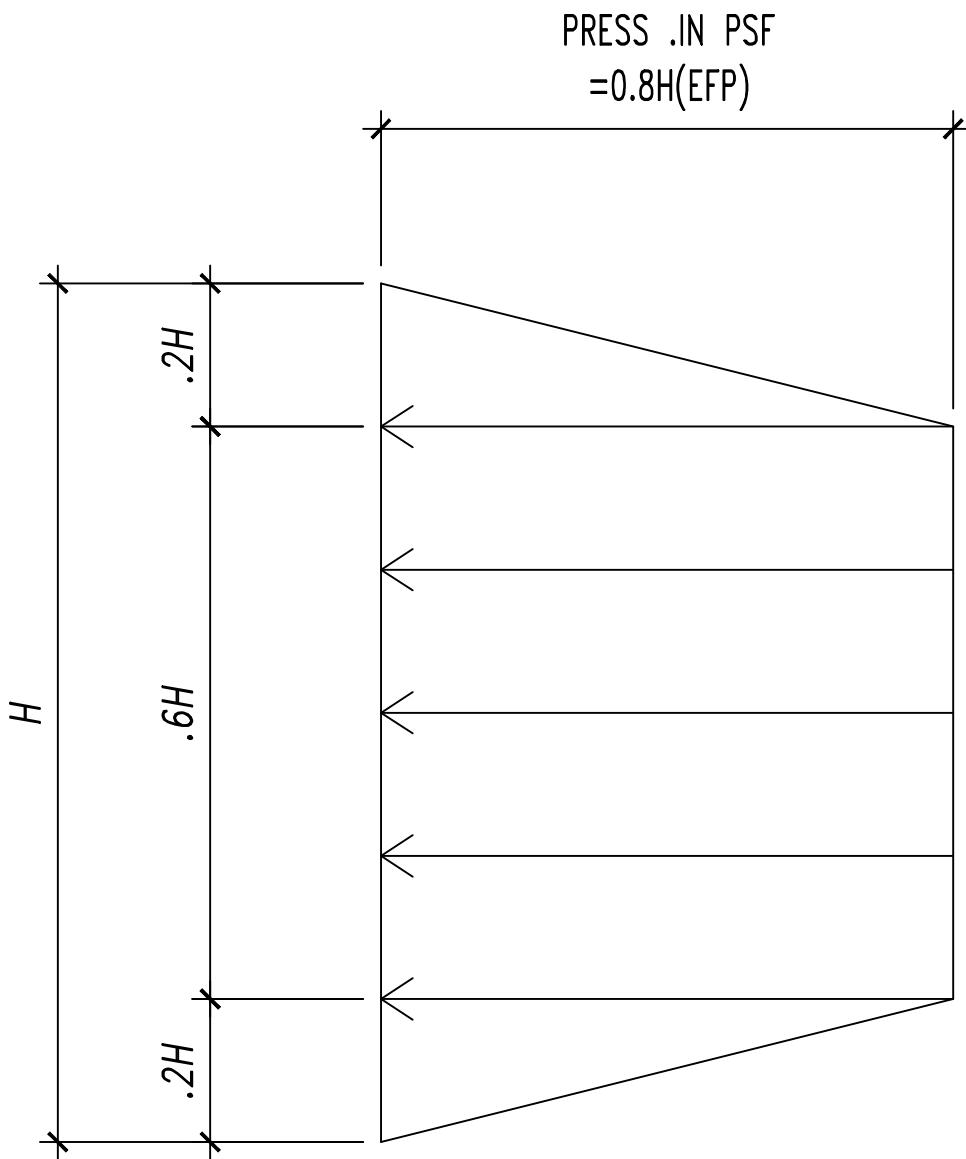
FIG. NO.:
10

PRESSURE DISTRIBUTION

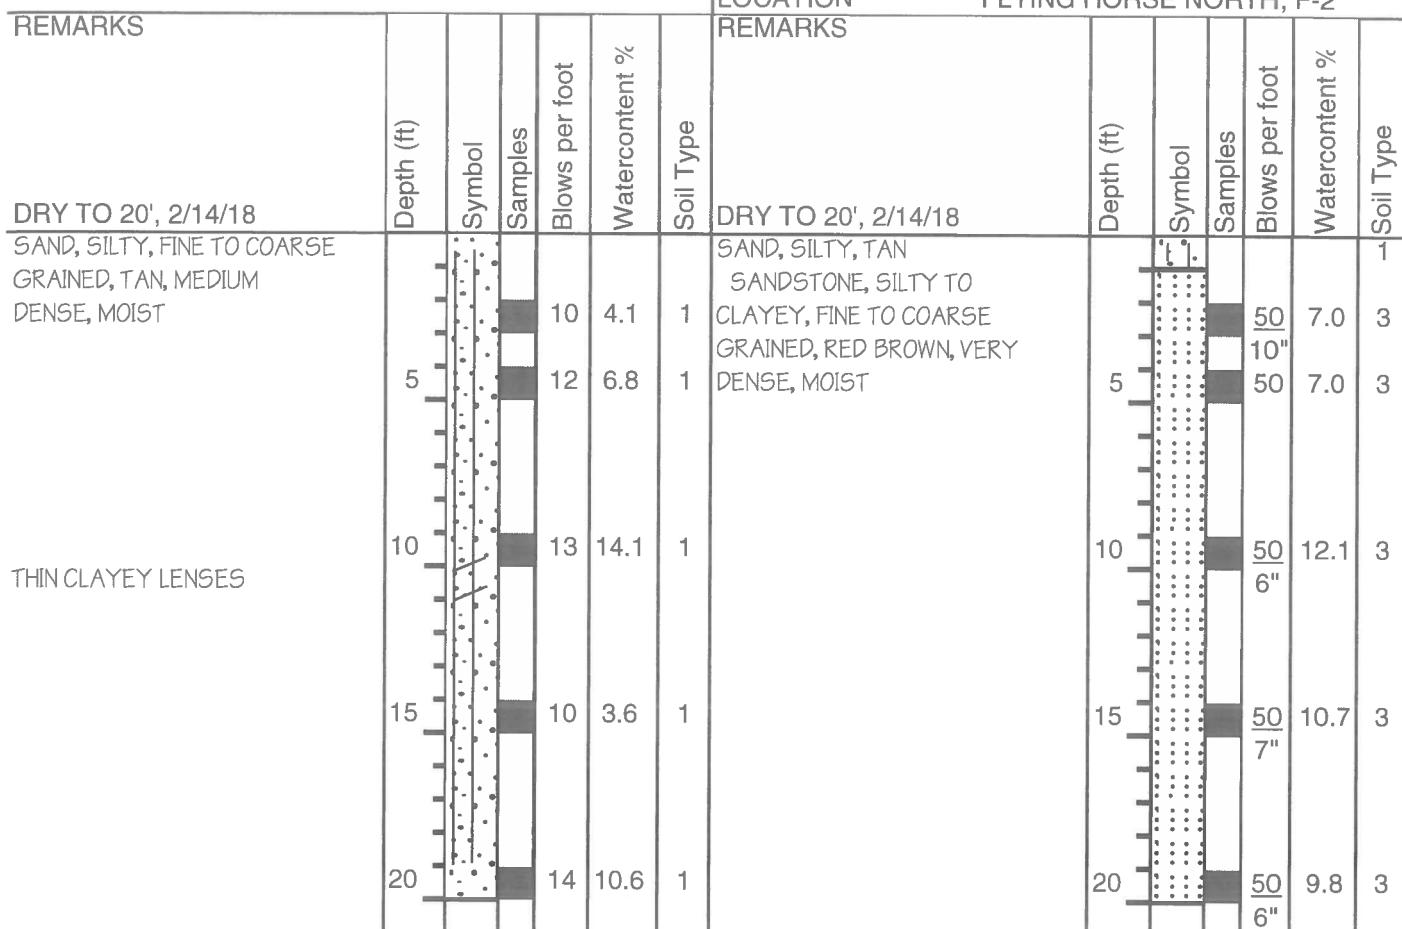
TEST BORING NO. 1
 DATE DRILLED 2/14/2018
 Job # 220404

TEST BORING NO. 2
 DATE DRILLED 2/14/2018
 CLIENT FLYING HORSE DEV.
 LOCATION FLYING HORSE NORTH, F-2

Test Boring No.	Depth to Bedrock (ft.)	Depth to Groundwater (ft.)
1	>20	>20
2	1	>20
3	>20	>20
4	3	>20
5	18	>20
6	17	13

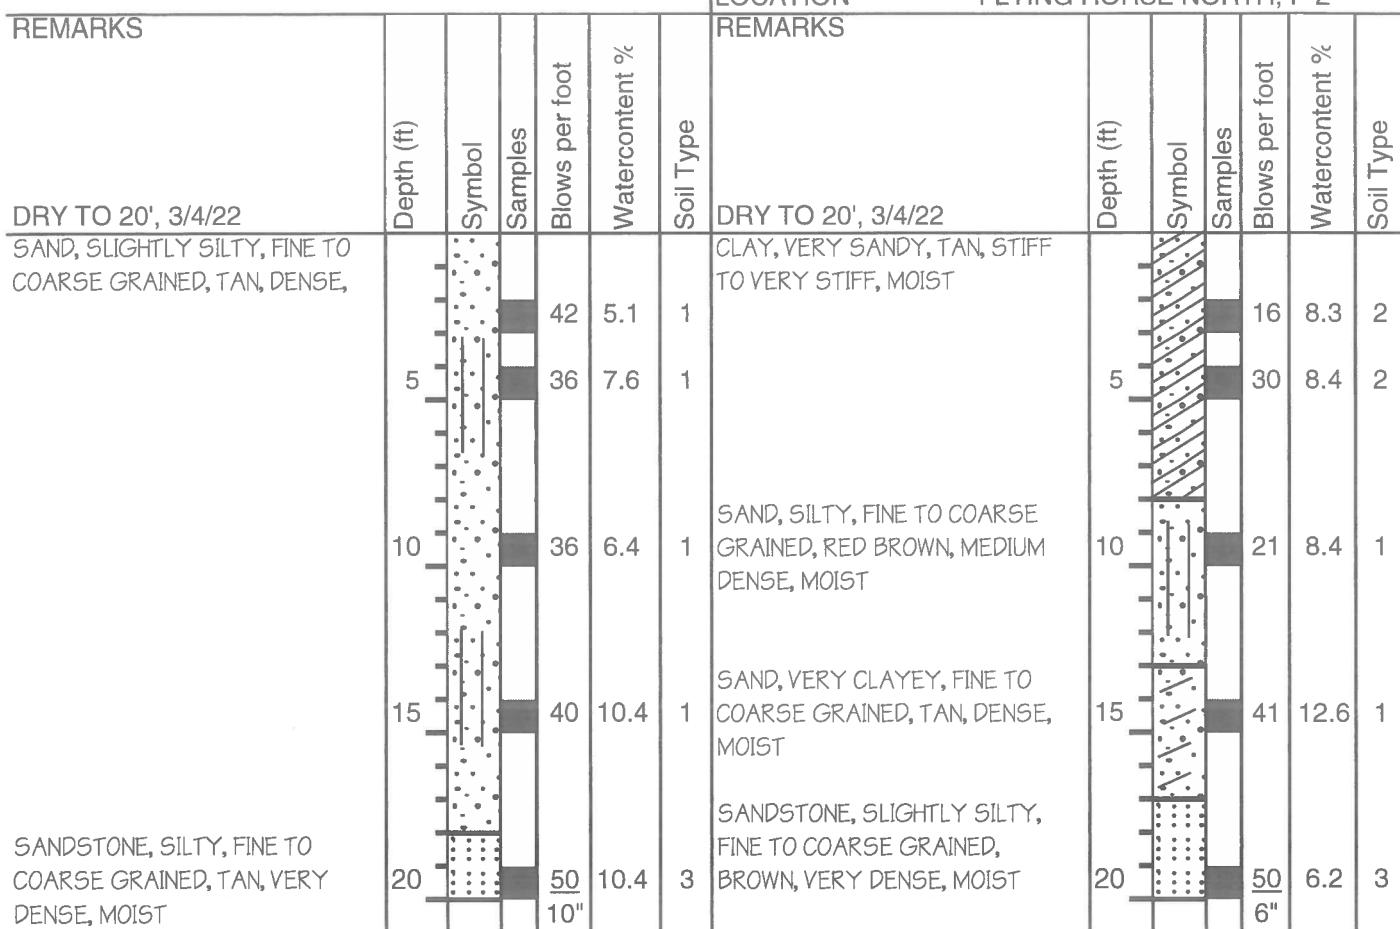
TEST BORING NO. 5
 DATE DRILLED 3/4/2022
 Job # 220404

TEST BORING NO. 6
 DATE DRILLED 3/4/2022
 CLIENT FLYING HORSE DEV.
 LOCATION FLYING HORSE NORTH, F-2

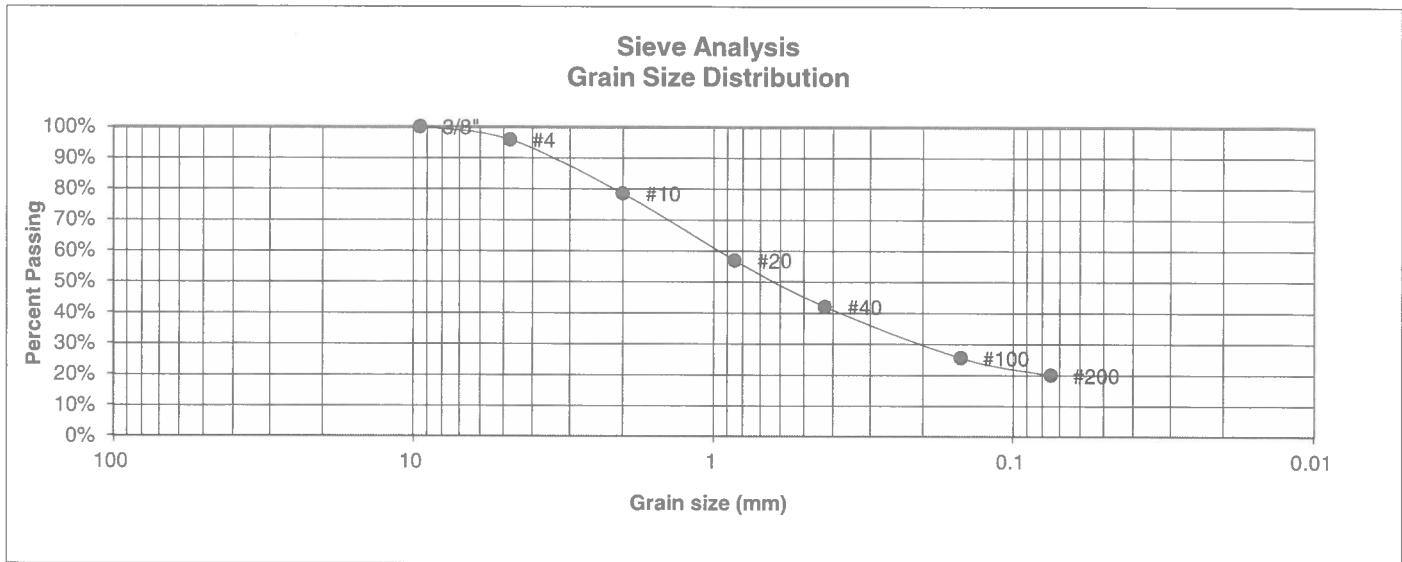
UNIFIED CLASSIFICATION	SM	CLIENT	FLYING HORSE DEV.
SOIL TYPE #	1	PROJECT	FLYING HORSE NORTH, F-2
TEST BORING #	1	JOB NO.	220404
DEPTH (FT)	2-3	TEST BY	BL

U.S. Sieve #	Percent Finer	Atterberg Limits	
3"		Plastic Limit	NP
1 1/2"		Liquid Limit	NV
3/4"		Plastic Index	NP
1/2"			
3/8"	100.0%		
4	95.9%	<u>Swell</u>	
10	78.5%	Moisture at start	
20	57.0%	Moisture at finish	
40	42.0%	Moisture increase	
100	25.6%	Initial dry density (pcf)	
200	20.0%	Swell (psf)

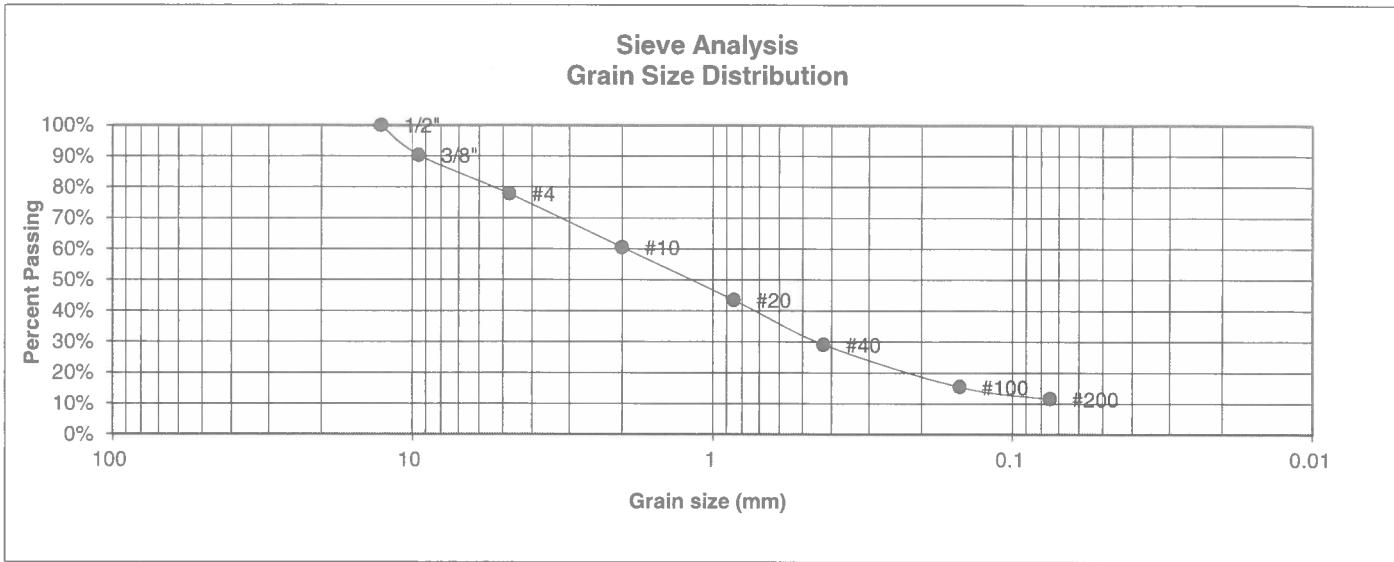
<u>UNIFIED CLASSIFICATION</u>	SM-SW
<u>SOIL TYPE #</u>	1
<u>TEST BORING #</u>	5
<u>DEPTH (FT)</u>	2-3

<u>U.S. Sieve #</u>	<u>Percent Finer</u>
3"	
1 1/2"	
3/4"	
1/2"	100.0%
3/8"	90.3%
4	77.8%
10	60.5%
20	43.5%
40	29.1%
100	15.4%
200	11.6%

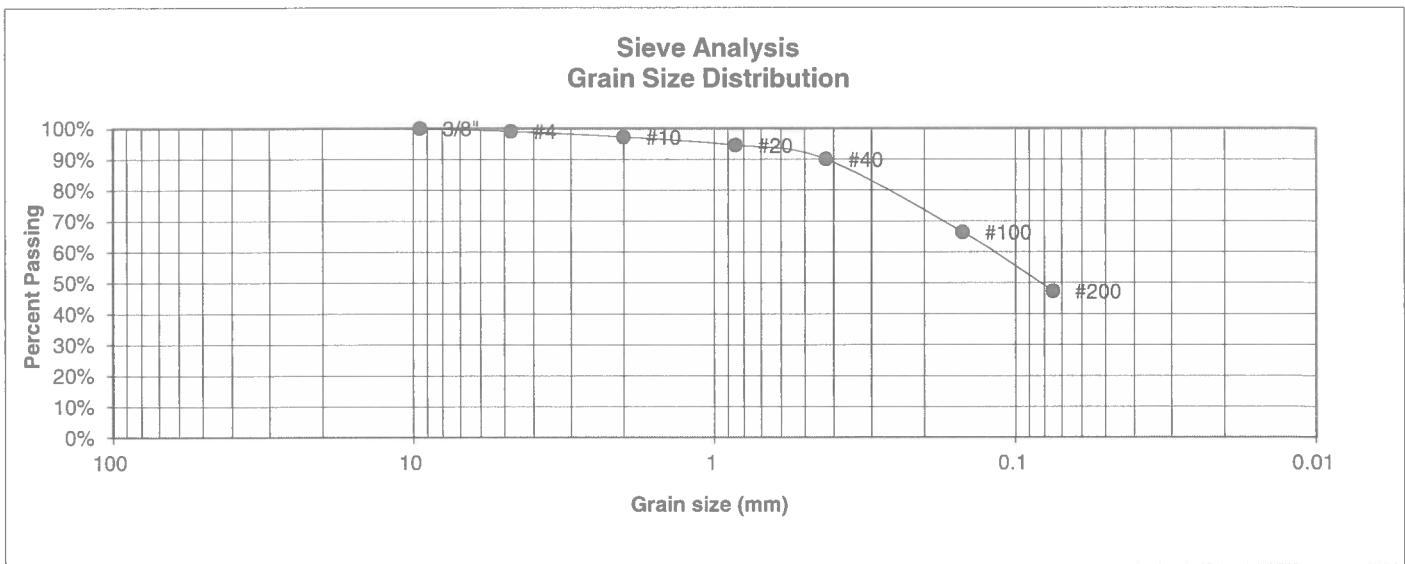
<u>UNIFIED CLASSIFICATION</u>	SC	<u>CLIENT</u>	FLYING HORSE DEV.
<u>SOIL TYPE #</u>	1	<u>PROJECT</u>	FLYING HORSE NORTH, F-2
<u>TEST BORING #</u>	6	<u>JOB NO.</u>	220404
<u>DEPTH (FT)</u>	15	<u>TEST BY</u>	BL

<u>U.S. Sieve #</u>	<u>Percent Finer</u>	<u>Atterberg Limits</u>
3"		Plastic Limit
1 1/2"		Liquid Limit
3/4"		Plastic Index
1/2"		
3/8"	100.0%	
4	99.0%	<u>Swell</u>
10	97.2%	Moisture at start
20	94.6%	Moisture at finish
40	90.0%	Moisture increase
100	66.4%	Initial dry density (pcf)
200	47.3%	Swell (psf)

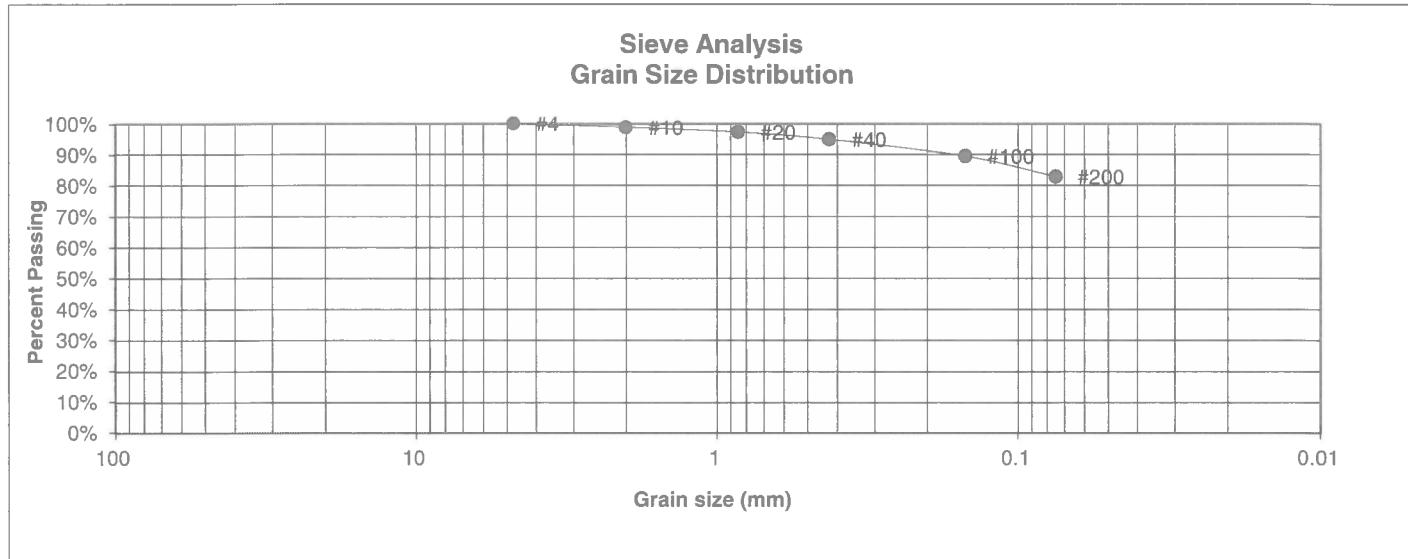
<u>UNIFIED CLASSIFICATION</u>	CL	<u>CLIENT</u>	FLYING HORSE DEV.
<u>SOIL TYPE #</u>	2	<u>PROJECT</u>	FLYING HORSE NORTH, F-2
<u>TEST BORING #</u>	3	<u>JOB NO.</u>	220404
<u>DEPTH (FT)</u>	5	<u>TEST BY</u>	BL

<u>U.S. Sieve #</u>	<u>Percent Finer</u>	<u>Atterberg Limits</u>	
3"		Plastic Limit	17
1 1/2"		Liquid Limit	38
3/4"		Plastic Index	21
1/2"			
3/8"			
4	100.0%	<u>Swell</u>	
10	98.8%	Moisture at start	7.5%
20	97.2%	Moisture at finish	18.5%
40	94.9%	Moisture increase	11.1%
100	89.5%	Initial dry density (pcf)	105
200	82.8%	Swell (psf)	930

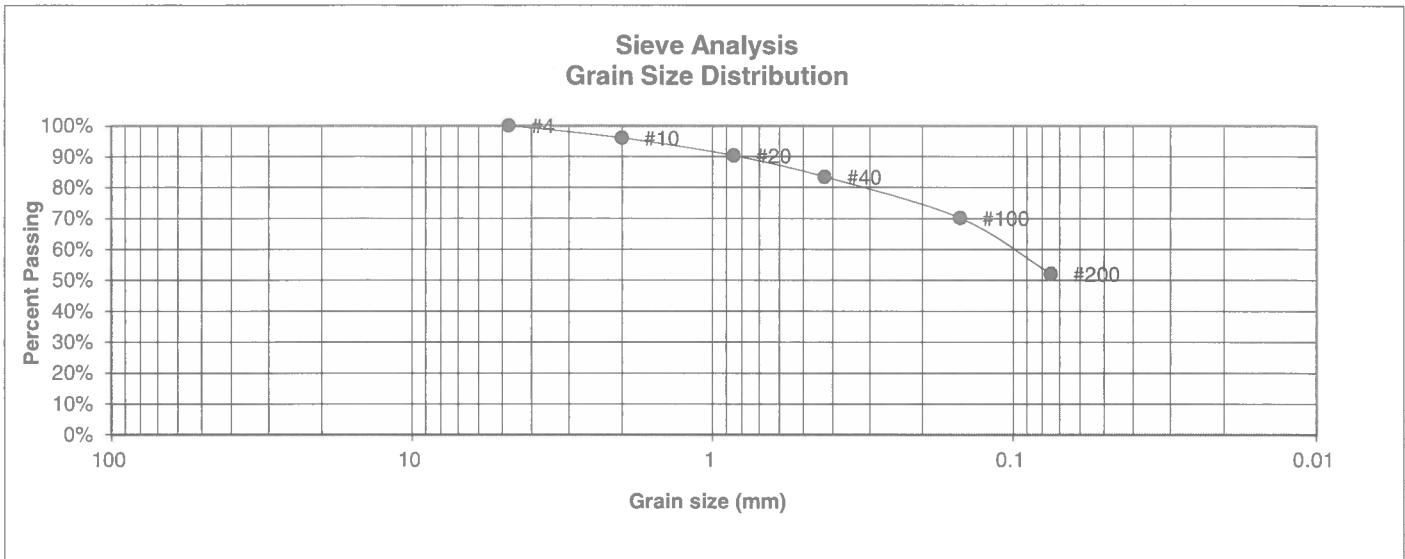
<u>UNIFIED CLASSIFICATION</u>	CL	<u>CLIENT</u>	FLYING HORSE DEV.
<u>SOIL TYPE #</u>	2	<u>PROJECT</u>	FLYING HORSE NORTH, F-2
<u>TEST BORING #</u>	6	<u>JOB NO.</u>	220404
<u>DEPTH (FT)</u>	2-3	<u>TEST BY</u>	BL

<u>U.S. Sieve #</u>	<u>Percent Finer</u>	<u>Atterberg Limits</u>
3"		Plastic Limit
1 1/2"		Liquid Limit
3/4"		Plastic Index
1/2"		
3/8"		
4	100.0%	<u>Swell</u>
10	96.0%	Moisture at start
20	90.3%	11.5%
40	83.4%	Moisture at finish
100	70.2%	21.3%
200	52.1%	Moisture increase
		9.8%
		Initial dry density (pcf)
		101
		Swell (psf)
		270

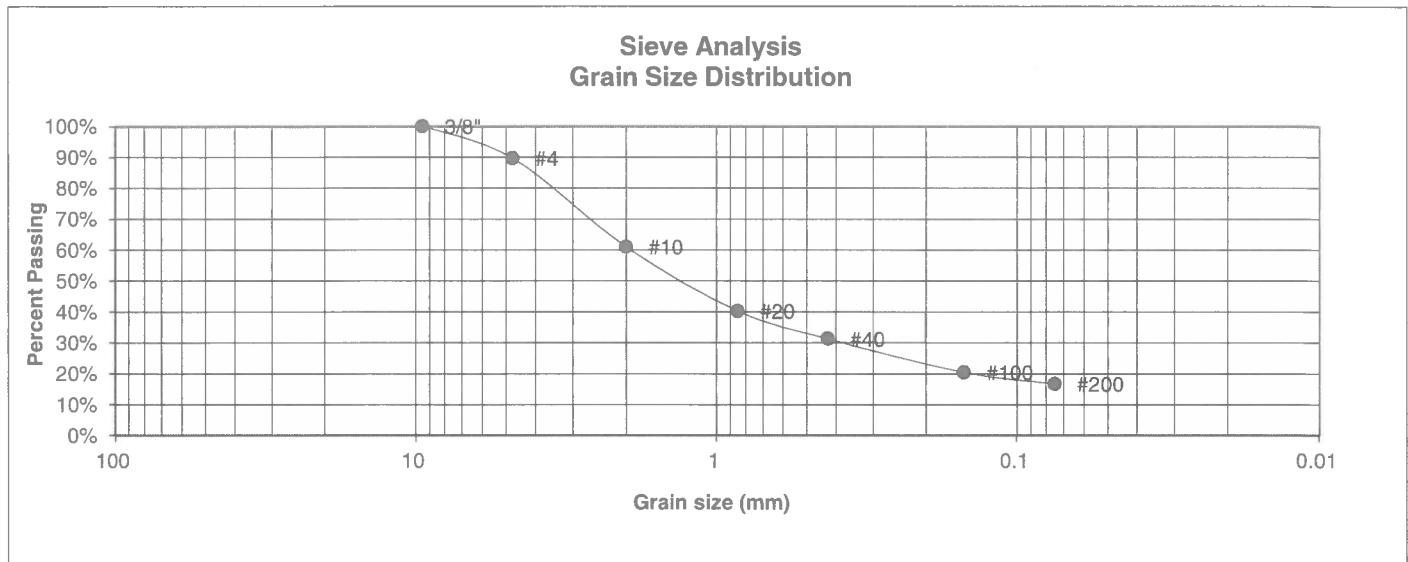
FIG NO.:
C-5

<u>UNIFIED CLASSIFICATION</u>	SM	<u>CLIENT</u>	FLYING HORSE DEV.
<u>SOIL TYPE #</u>	3	<u>PROJECT</u>	FLYING HORSE NORTH, F-2
<u>TEST BORING #</u>	5	<u>JOB NO.</u>	220404
<u>DEPTH (FT)</u>	20	<u>TEST BY</u>	BL

<u>U.S. Sieve #</u>	<u>Percent Finer</u>	<u>Atterberg Limits</u>
3"		Plastic Limit
1 1/2"		Liquid Limit
3/4"		Plastic Index
1/2"		
3/8"	100.0%	<u>Swell</u>
4	89.7%	Moisture at start
10	61.0%	Moisture at finish
20	40.3%	Moisture increase
40	31.3%	Initial dry density (pcf)
100	20.5%	Swell (psf)
200	16.7%

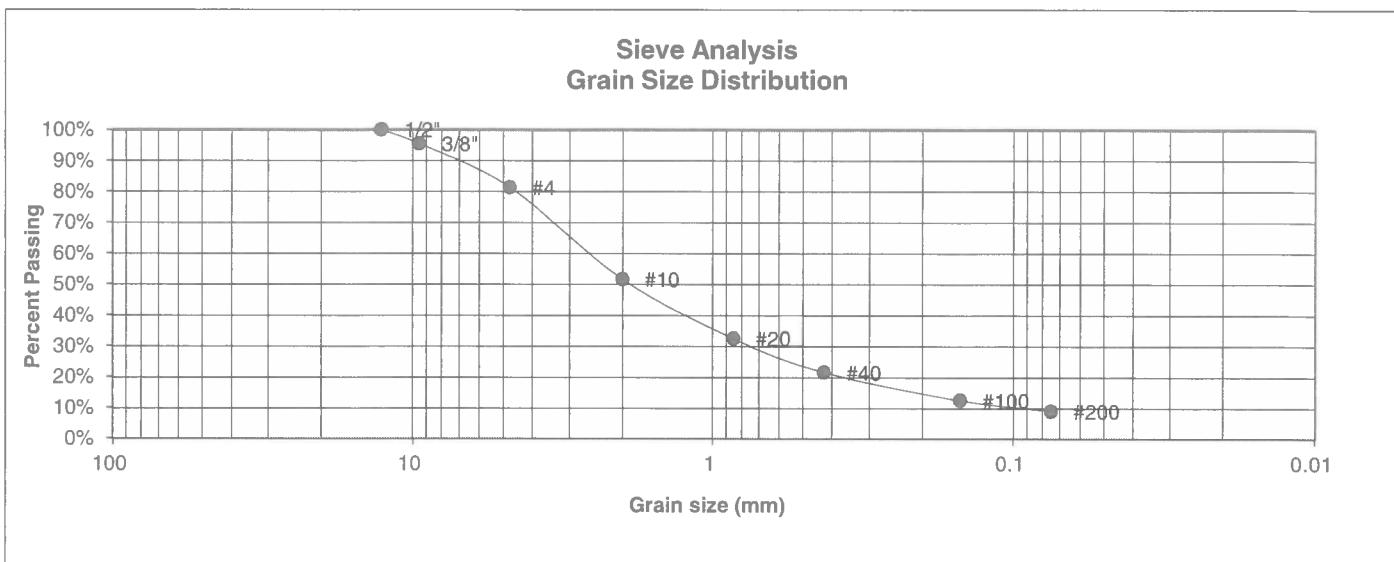
<u>UNIFIED CLASSIFICATION</u>	SM-SW
<u>SOIL TYPE #</u>	3
<u>TEST BORING #</u>	6
<u>DEPTH (FT)</u>	20

U.S. <u>Sieve #</u>	Percent <u>Finer</u>
3"	
1 1/2"	
3/4"	
1/2"	100.0%
3/8"	95.5%
4	81.4%
10	51.6%
20	32.5%
40	21.6%
100	12.6%
200	9.1%

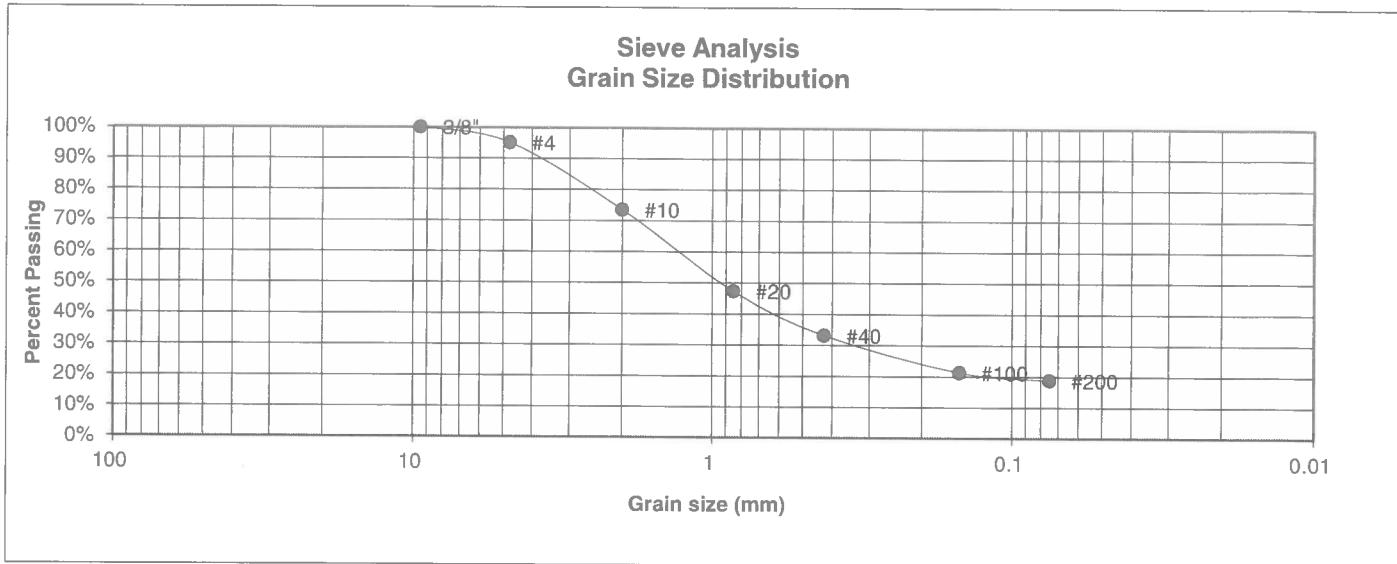
C-7

<u>UNIFIED CLASSIFICATION</u>	SM	<u>CLIENT</u>	FLYING HORSE DEV.
<u>SOIL TYPE #</u>	3	<u>PROJECT</u>	FLYING HORSE NORTH, F-2
<u>TEST BORING #</u>	2	<u>JOB NO.</u>	220404
<u>DEPTH (FT)</u>	5	<u>TEST BY</u>	BL

<u>U.S. Sieve #</u>	<u>Percent Finer</u>	<u>Atterberg Limits</u>	
3"		Plastic Limit	NP
1 1/2"		Liquid Limit	NV
3/4"		Plastic Index	NP
1/2"			
3/8"	100.0%		
4	95.1%	<u>Swell</u>	
10	73.4%	Moisture at start	
20	47.3%	Moisture at finish	
40	33.1%	Moisture increase	
100	21.3%	Initial dry density (pcf)	
200	18.8%	Swell (psf)

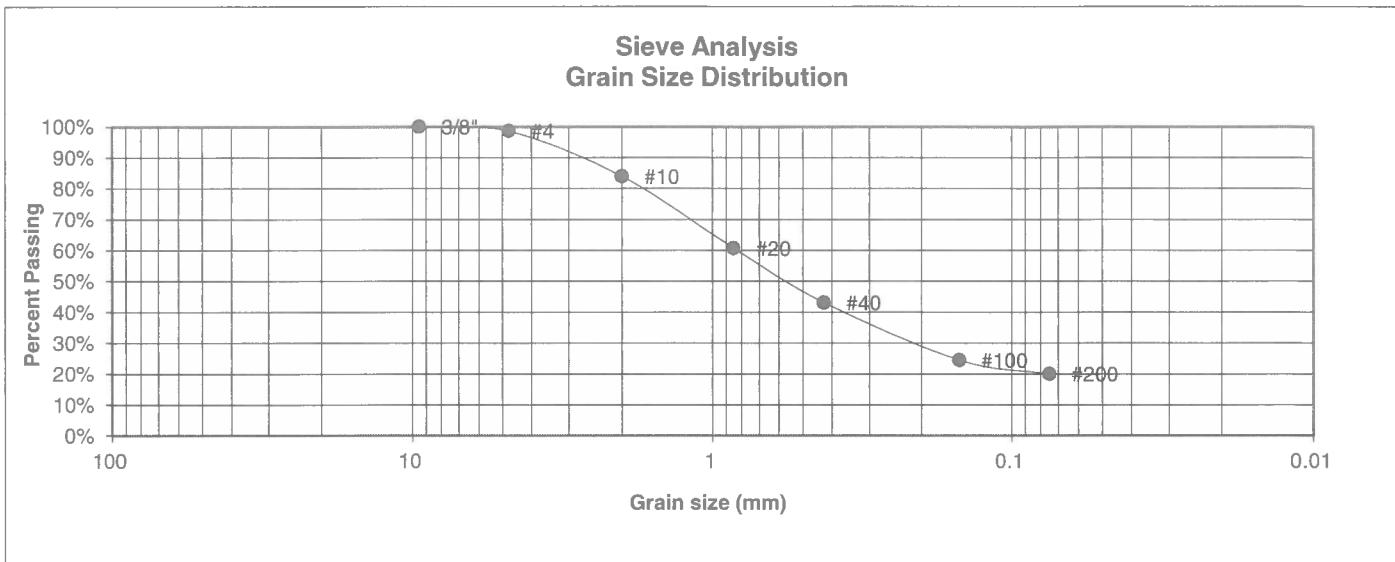
FIG NO.:
C-8

<u>UNIFIED CLASSIFICATION</u>	SM	<u>CLIENT</u>	FLYING HORSE DEV.
<u>SOIL TYPE #</u>	3	<u>PROJECT</u>	FLYING HORSE NORTH, F-2
<u>TEST BORING #</u>	4	<u>JOB NO.</u>	220404
<u>DEPTH (FT)</u>	10	<u>TEST BY</u>	BL

<u>U.S. Sieve #</u>	<u>Percent Finer</u>	<u>Atterberg Limits</u>
3"		Plastic Limit
1 1/2"		Liquid Limit
3/4"		Plastic Index
1/2"		
3/8"	100.0%	
4	98.6%	<u>Swell</u>
10	84.0%	Moisture at start
20	60.7%	Moisture at finish
40	43.0%	Moisture increase
100	24.5%	Initial dry density (pcf)
200	20.0%	Swell (psf)

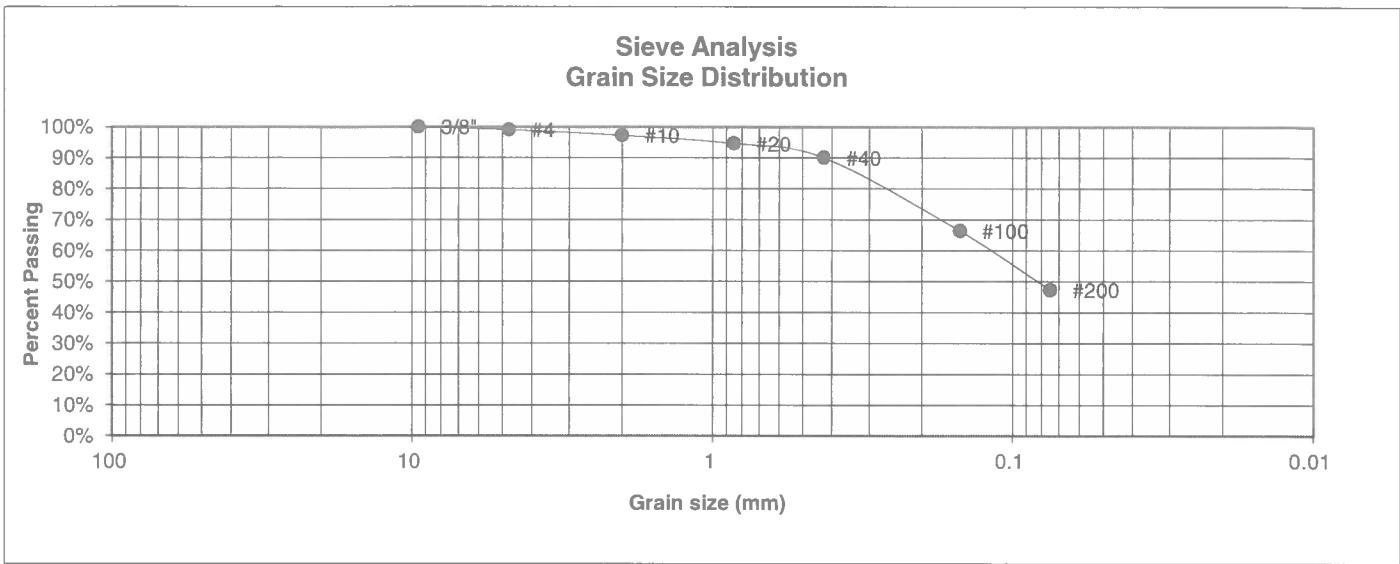
FIG NO.:
L-9

<u>UNIFIED CLASSIFICATION</u>	SC	<u>CLIENT</u>	FLYING HORSE DEV.
<u>SOIL TYPE #</u>	2	<u>PROJECT</u>	FLYING HORSE NORTH, F-2
<u>TEST BORING #</u>	6	<u>JOB NO.</u>	220404
<u>DEPTH (FT)</u>	15	<u>TEST BY</u>	BL

<u>U.S. Sieve #</u>	<u>Percent Finer</u>	<u>Atterberg Limits</u>
3"		Plastic Limit
1 1/2"		Liquid Limit
3/4"		Plastic Index
1/2"		
3/8"	100.0%	
4	99.0%	<u>Swell</u>
10	97.2%	Moisture at start
20	94.6%	Moisture at finish
40	90.0%	Moisture increase
100	66.4%	Initial dry density (pcf)
200	47.3%	Swell (psf)

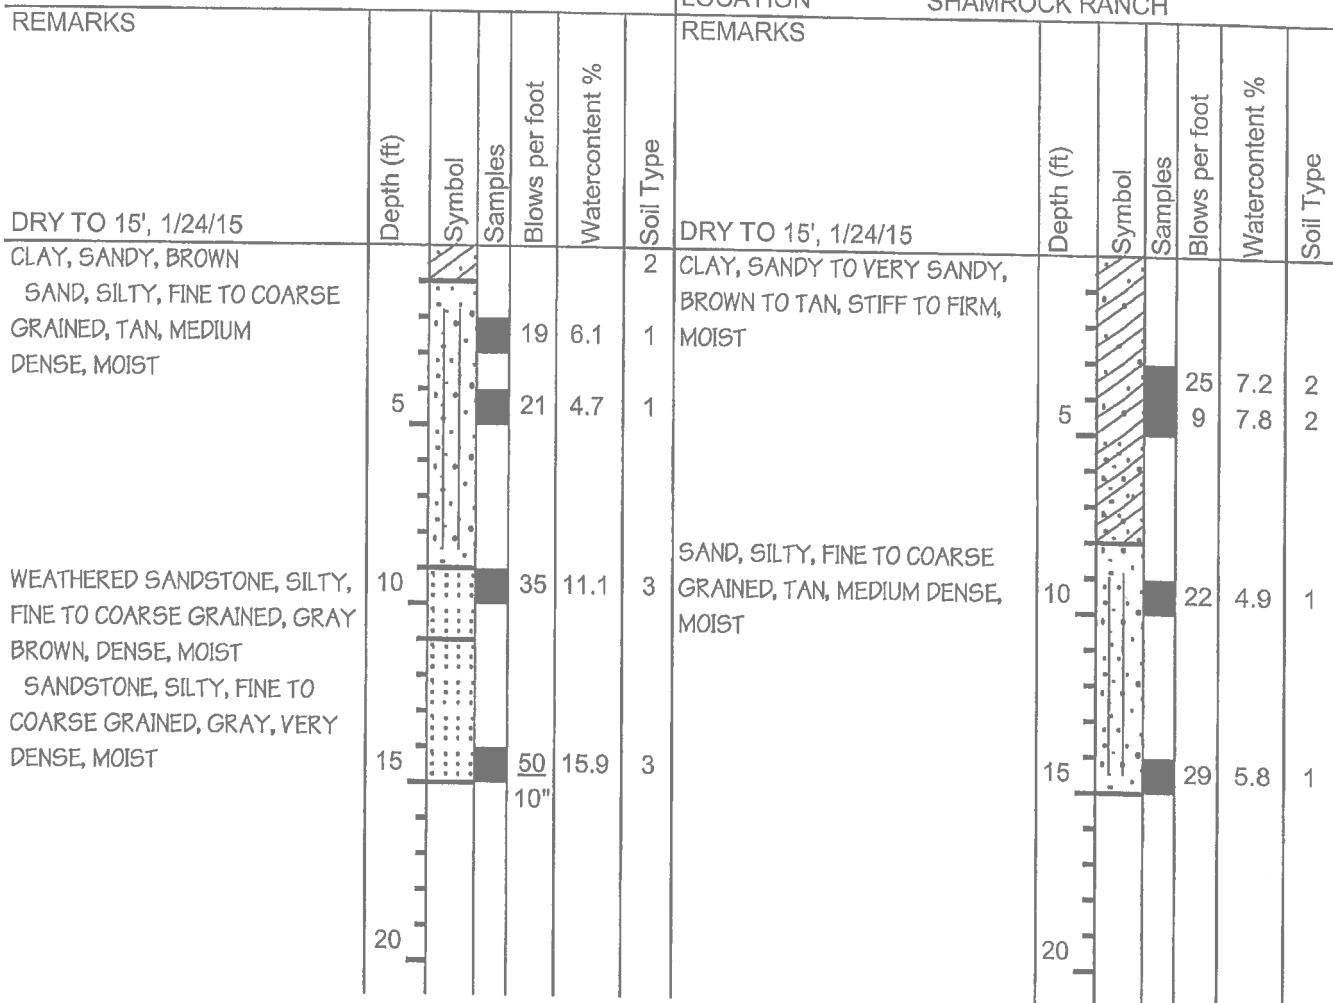
PROFILE HOLE NO. 1
 DATE DRILLED 1/23/2015
 Job # 141588

PROFILE HOLE NO. 2
 DATE DRILLED 1/23/2015
 CLIENT NES, INC.
 LOCATION SHAMROCK RANCH
