**SOIL, GEOLOGY, GEOLOGIC HAZARD STUDY
FLYING HORSE NORTH**

~~FILING NO. 2~~
EL PASO COUNTY, COLORADO

Flying Horse Development, LLC
2138 Flying Horse Club Drive
Colorado Springs, Colorado 80921

March 8, 2022

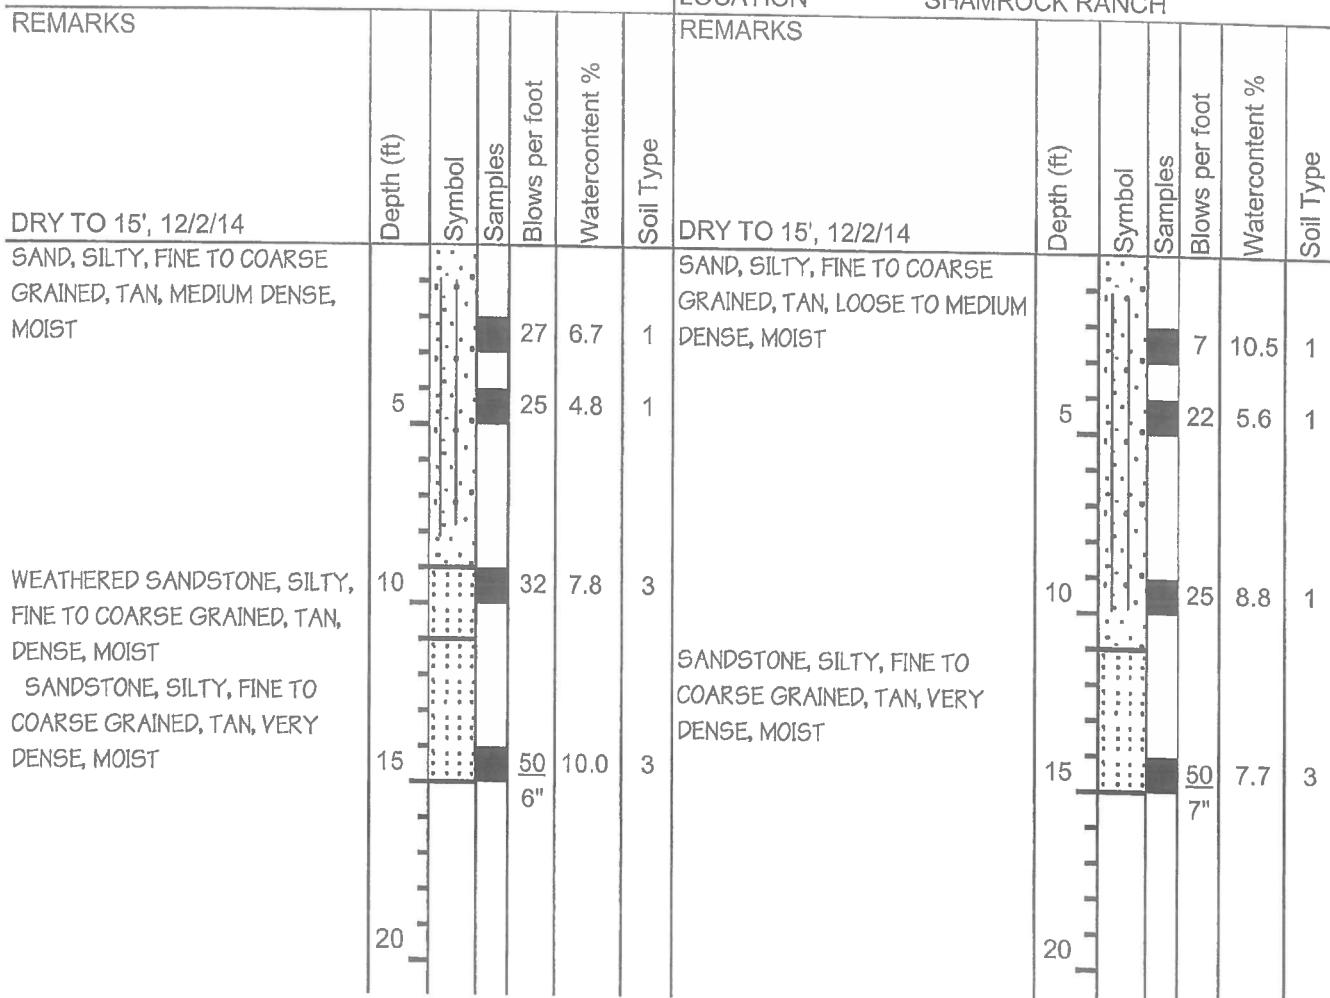
PROFILE HOLE NO. 11
 DATE DRILLED 12/1/2014
 Job # 141588

PROFILE HOLE NO. 12
 DATE DRILLED 12/1/2014
 CLIENT NES, INC.
 LOCATION SHAMROCK RANCH
