SOIL AND GEOLOGY STUDY

**Hidden Creek Estates
Lots 1-6
El Paso County, Colorado**

JOB NO. 195873

March 20, 2025

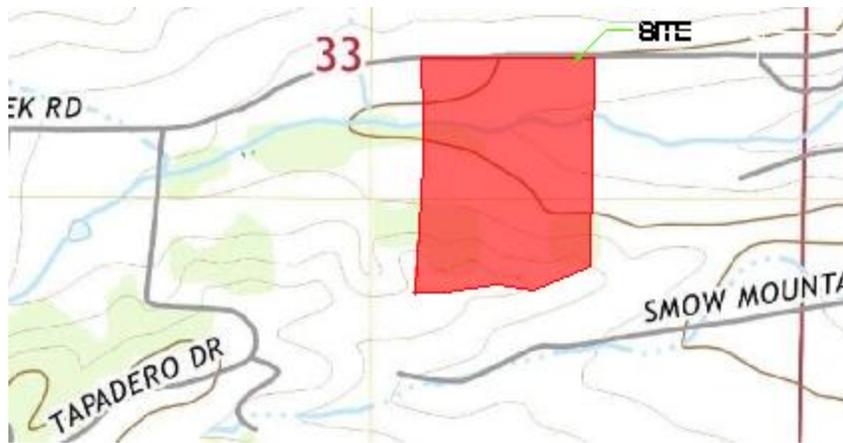
The site surface characteristics were observed to consist of rolling hills with low lying grasses and weeds across the entire site. Deciduous trees are scattered along the northern, southern property boundaries and along Hay Creek, with additional trees located sporadically across the proposed new lots. At the time of our site visit on April 17, 2024, the drainageway was moist, with a trace of "free" water with indications that surface water was recently present, mostly likely due to snow melt at the time. The topography from the Palmer Lake Quadrangle is presented below. The red indicates the approximate location of the site in reference to Hay Creek, the blue line.

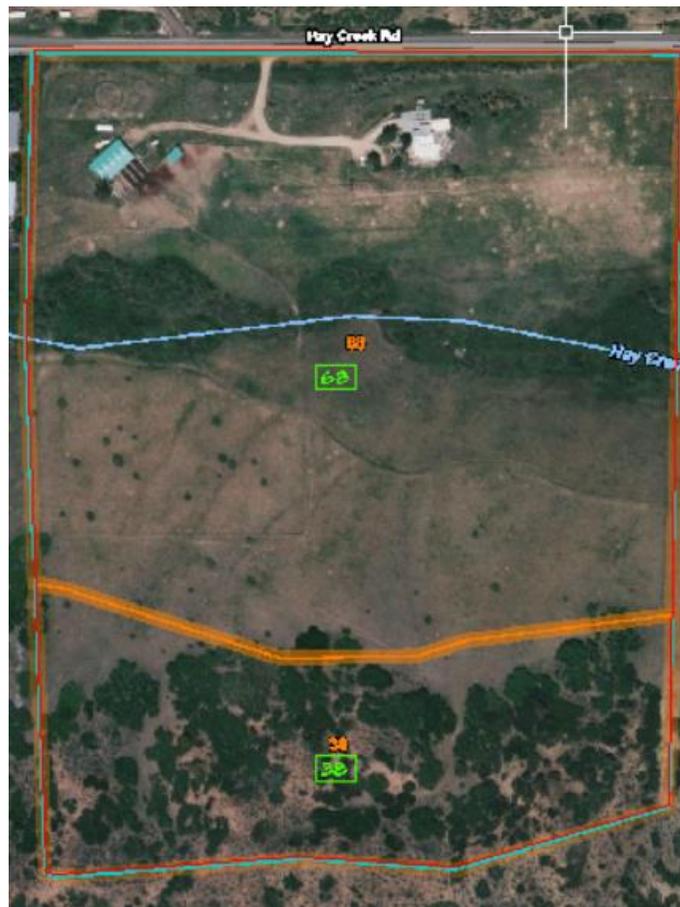
Insert from USDA, website <https://websoilsurvey.sc.egov.usda.gov/App/WebSoilSurvey.aspx>

The USDA map is included below. The bold orange line indicates the boundary between the soil conditions.

- 38 – Jarre-Tecolote complex with 8 to 65 percent slopes. The Jarre-Tecolote complex was mapped by the USDA to encompass the southern third of the property, south of the creek. Properties of the Jarre-Tecolote complex include well drained soils, depth of the water table is anticipated to be greater than 80 inches, runoff is anticipated to be medium, frequency of flooding and/or ponding is none, and landforms include alluvial fans.
- 68 – Peyton-Pring complex, 3 to 8 percent slopes. The Peyton-Pring complex was mapped by the USDA to encompass the remainder of the property. Properties of the Peyton-Pring complex include, well-drained soils, depth of the water table is anticipated to be greater than 6.5 feet, runoff is anticipated to be low, frequency of flooding and ponding is none, and landforms include hills.

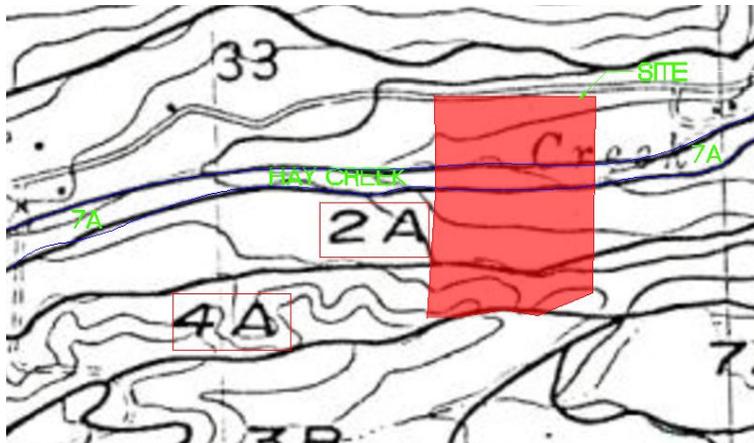
Insert from Environmental & Engineering Geologic Map, Charles S. Robinson & Associates, 1977

The engineering geology units mapped by Charles S. Robinson (1977) at the site are shown below and on the Engineering and Geology Map, Figure 8.

- 2A – Stable alluvium, colluvium and bedrock on gentle to moderate slopes (5%-12%).
- 4A – Potentially unstable colluvium and bedrock on moderate to steep slopes (12%-24%).
- 7A – Physiographic floodplain where erosion and deposition presently occur and is generally subject to recurrent flooding. Includes 100-year flood-plain along major streams where floodplain studies have been conducted.

Based on review of relevant geologic maps, we identified the geologic conditions (listed below) affecting the development, these conditions are indicated on the Engineering and Geology Map, Figure 8.

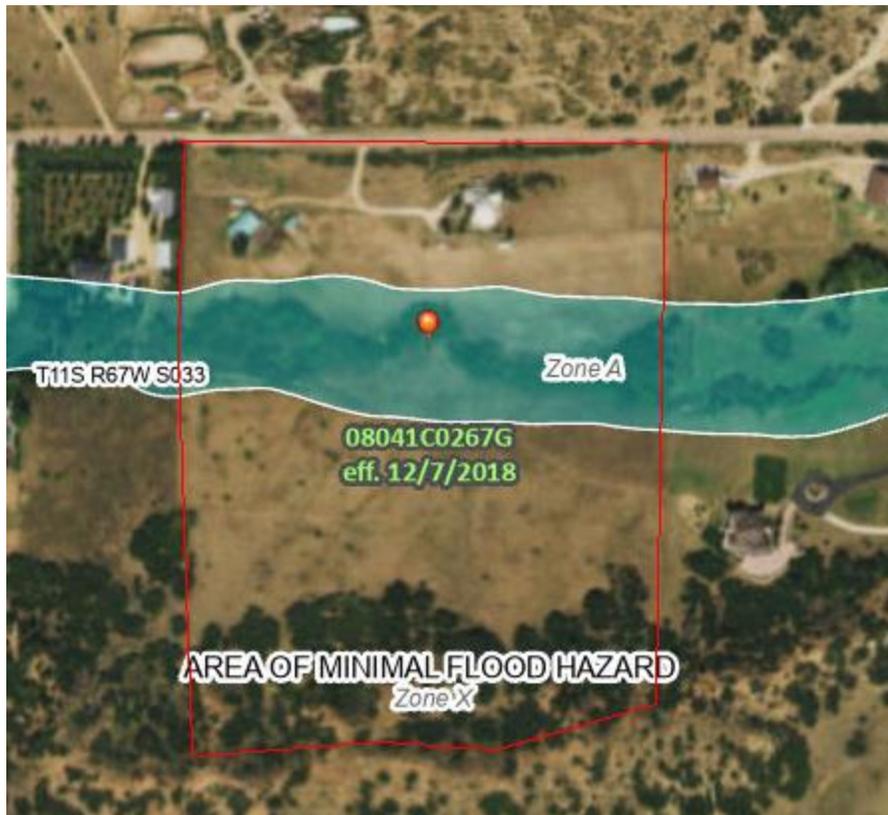
Insert from National Flood Hazard Layer FIRMette – USGS National Map 2023

The majority of the site is zoned Zone X, which is defined as an area with 0.2% annual chance flood hard, area of 1% annual chance flood with average depth less than one foot or with drainage areas or less than one square mile. Zone A is defined by FEMA as an area without Base Flood Elevations (BFE). Zone A is limited to Hay Creek as shown on the FEMA Map below.

Based on our review of the FEMA Community Panel No. 08041C0267G and the online ArcGIS El Paso County Risk Map, a portion of the eastern site lies within a 100-year floodplain.

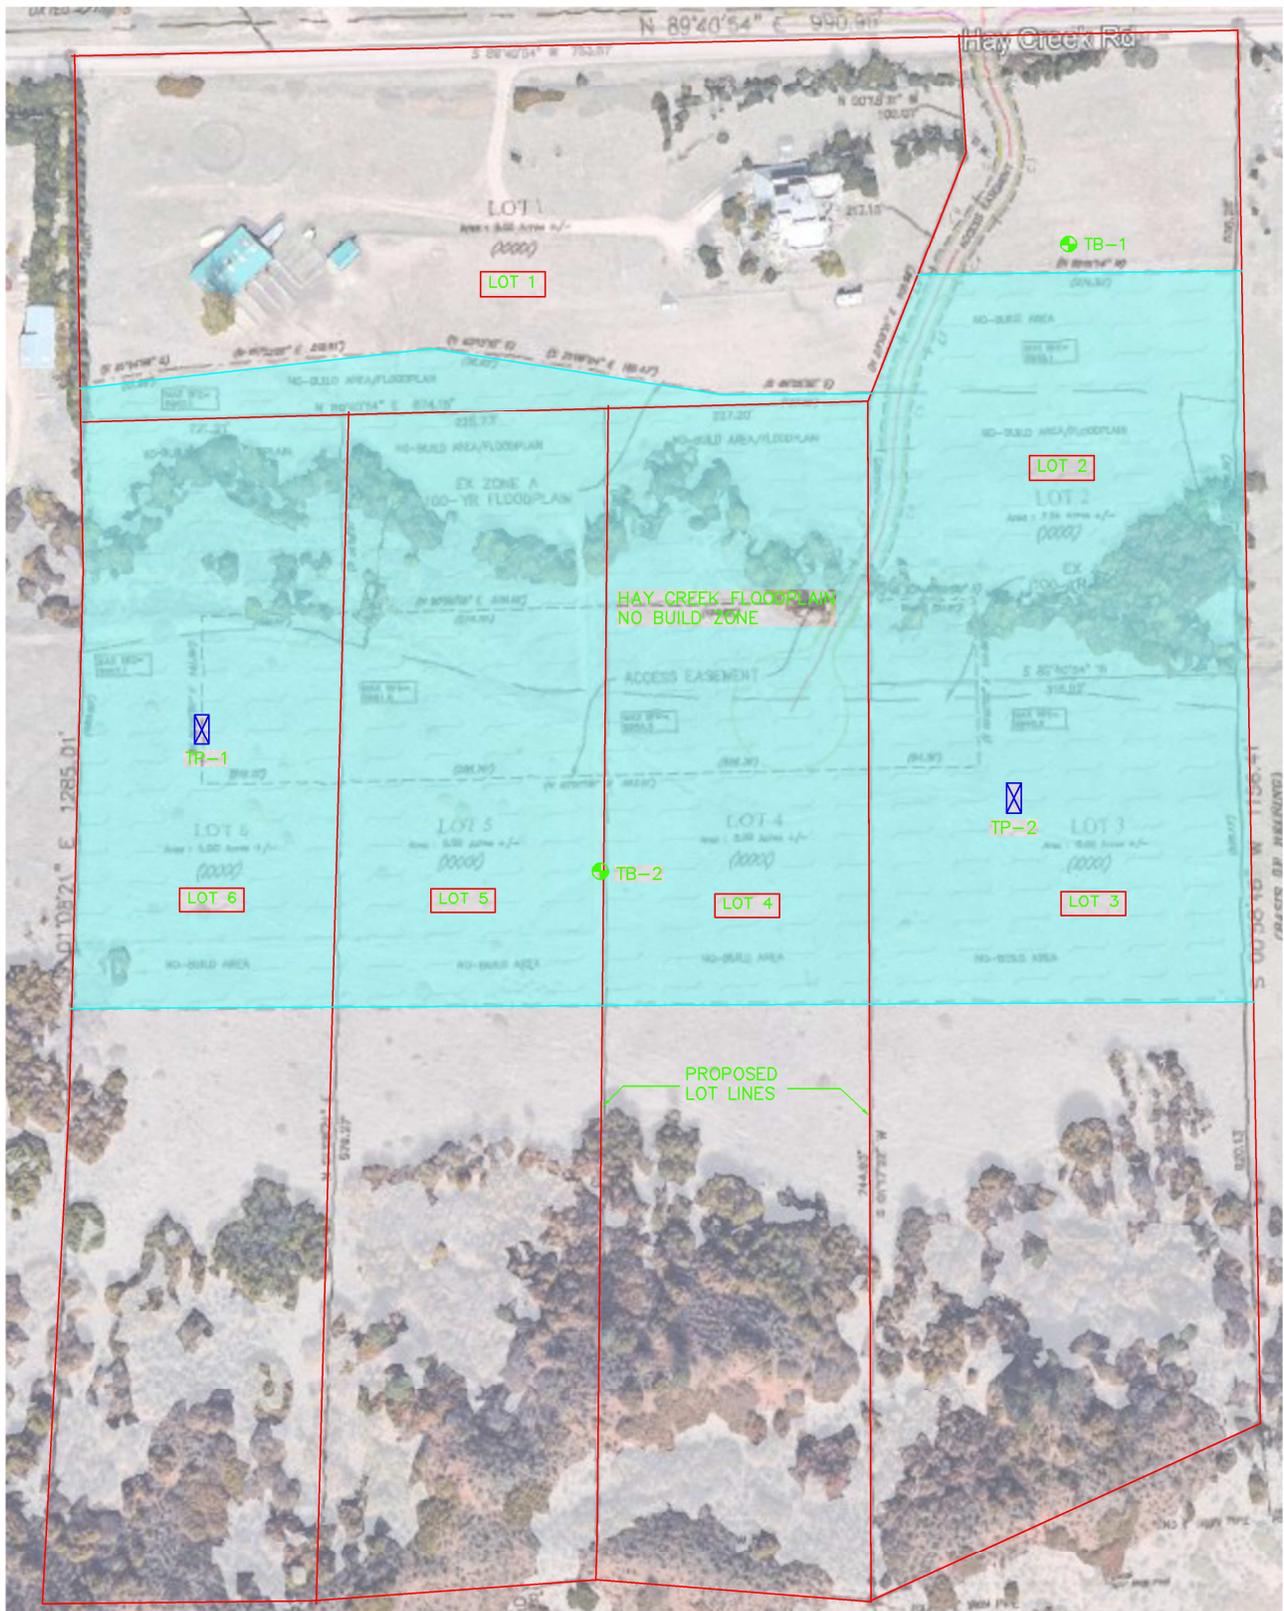
☒ DENOTES APPROXIMATE LOCATION OF TEST PITS

Two exploratory borings were performed to explore the subsurface soil conditions and provide preliminary recommendations for the design and construction of the proposed new foundations on the approved subdivided lots. The borings extended to depths of approximately 20 and 30 feet below the existing ground surface. The test borings were spaced to provide soil information for the lots. The approximate locations of the test borings are presented on the Test Boring/Test Pit Location Plan, Figure 3.

The test pits were located by RMG, based on the preliminary concept plan provided by Vertex Consulting, showing the proposed new lot lines. The two test pits were excavated to approximately 8 feet below the ground surface by Munson Landscaping and observed by RMG at the time of excavation. The approximate locations of the test pits are presented on the Test Boring/Test Pit Location Plan, Figure 3.

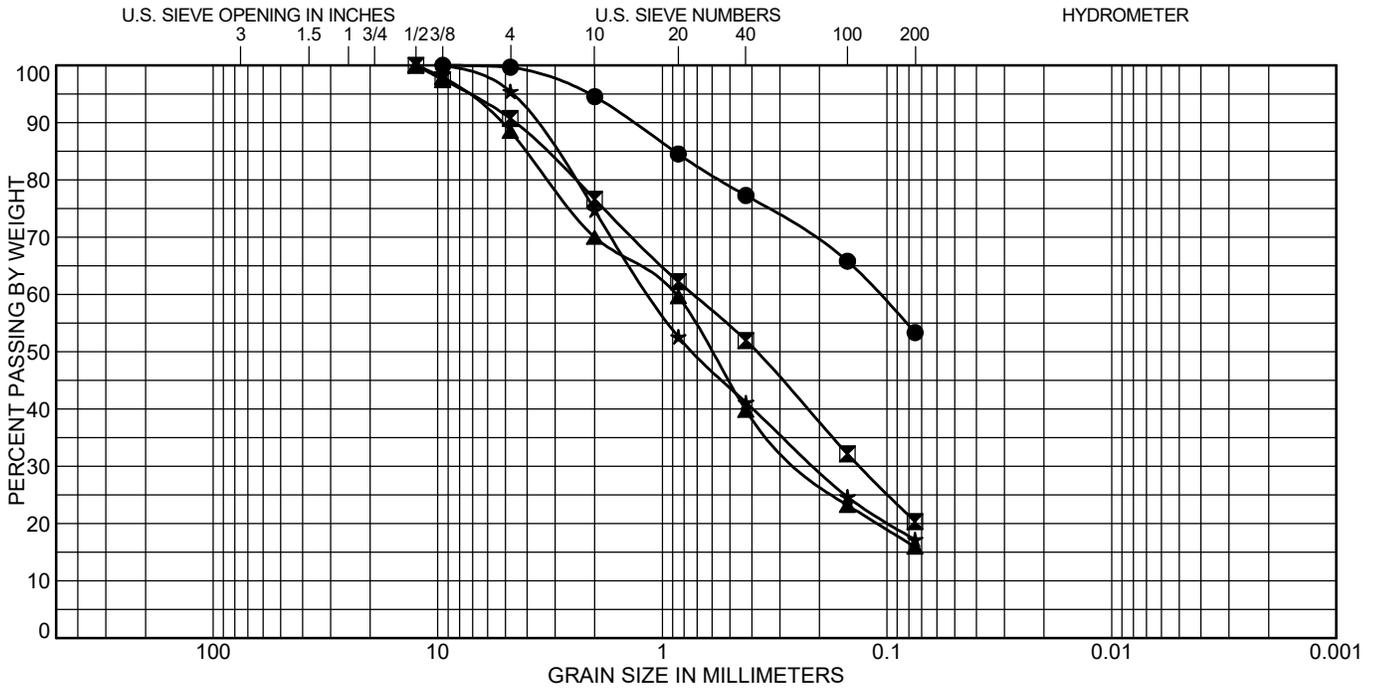
COBBLES	GRAVEL		SAND			SILT OR CLAY
	coarse	fine	coarse	medium	fine

Test Boring	Depth (ft)	Classification	LL	PL	PI
● 1	14.0	SANDY LEAN CLAY(CL)	28	19	9
◻ 2	4.0	SILTY SAND(SM)	NP	NP	NP
▲ 2	9.0	SILTY SAND(SM)	NP	NP	NP
★ 2	19.0

representative swell test could not be performed. However, given the depth of the expansive soils/bedrock in the test borings and available mitigation measures commonly utilized in this area, the expansive soils will not preclude development of the proposed lots. A Summary of Laboratory Test Results is presented in Figure 6. Soil Classification Data are presented in Figure 7.

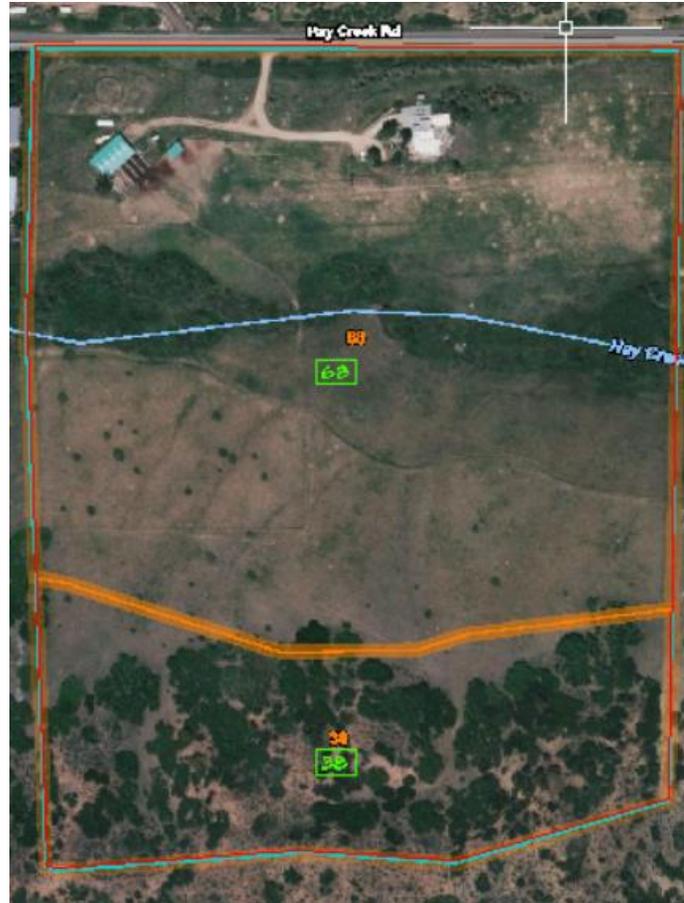
The USDA map is included below. The bold orange line indicates the boundary between the soil conditions.

- 38 – Jarre-Tecolote complex with 8 to 65 percent slopes. The Jarre-Tecolote complex was mapped by the USDA to encompass the southern third of the property, south of the creek. Properties of the Jarre-Tecolote complex include well drained soils, depth of the water table is anticipated to be greater than 80 inches, runoff is anticipated to be medium, frequency of flooding and/or ponding is none, and landforms include alluvial fans.
- 68 – Peyton-Pring complex, 3 to 8 percent slopes. The Peyton-Pring complex was mapped by the USDA to encompass the remainder of the property. Properties of the Peyton-Pring complex include, well-drained soils, depth of the water table is anticipated to be greater than 6.5 feet, runoff is anticipated to be low, frequency of flooding and ponding is none, and landforms include hills.
