SOIL AND GEOLOGY STUDY

Hay Creek Road
Lots 1-6,
El Paso County, Colorado

JOB NO. 195873

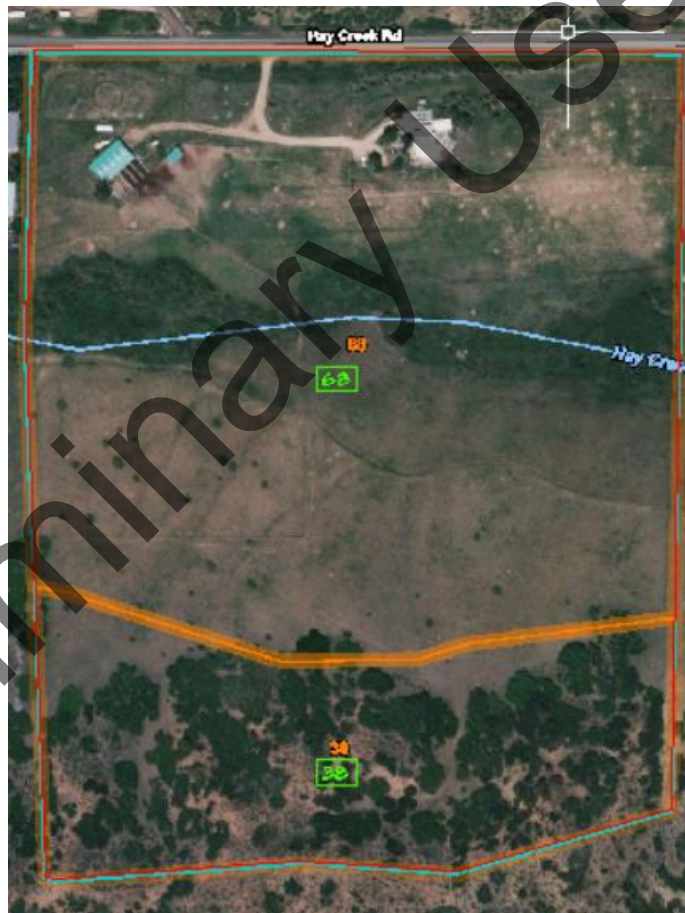
Insert from USDA, website <https://websoilsurvey.sc.egov.usda.gov/App/WebSoilSurvey.aspx>

The USDA map is included below. The bold orange line indicates the boundary between the soil conditions.

- 38 – Jarre-Tecolote complex with 8 to 65 percent slopes. The Jarre-Tecolote complex was mapped by the USDA to encompass the southern third of the property, south of the creek. Properties of the Jarre-Tecolote complex include well drained soils, depth of the water table is anticipated to be greater than 80 inches, runoff is anticipated to be medium, frequency of flooding and/or ponding is none, and landforms include alluvial fans.
- 68 – Peyton-Pring complex, 3 to 8 percent slopes. The Peyton-Pring complex was mapped by the USDA to encompass the remainder of the property. Properties of the Peyton-Pring complex include, well-drained soils, depth of the water table is anticipated to be greater than 6.5 feet, runoff is anticipated to be low, frequency of flooding and ponding is none, and landforms include hills.

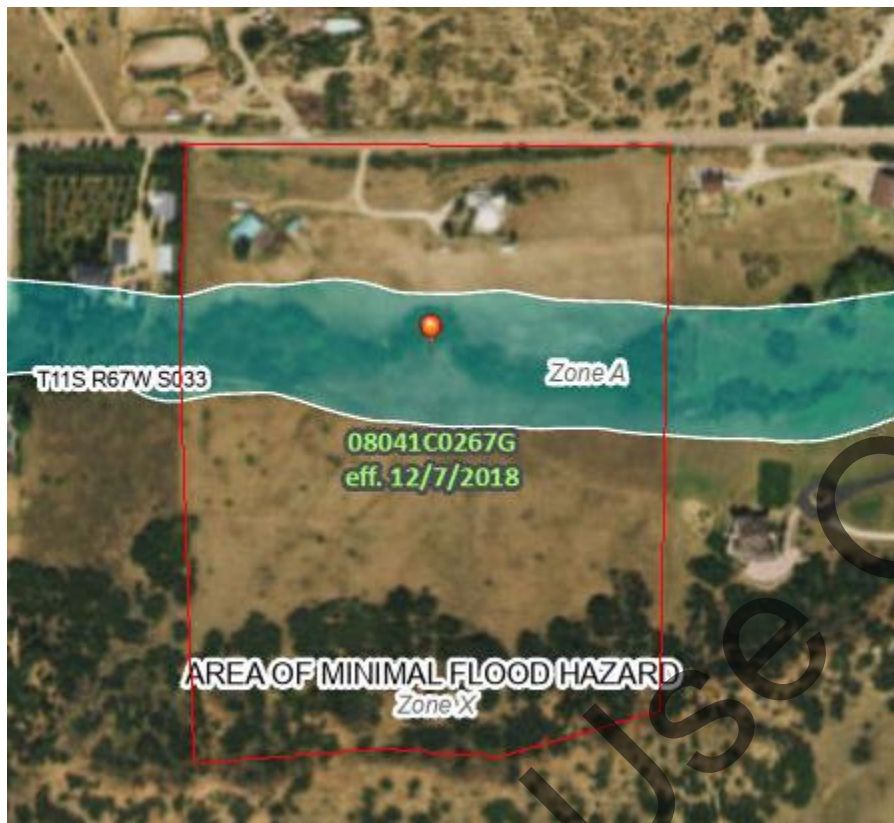
Insert from National Flood Hazard Layer FIRMette – USGS National Map 2023

The majority of the site is zoned Zone X, which is defined as an area with 0.2% annual chance flood hard, area of 1% annual chance flood with average depth less than one foot or with drainage areas or less than one square mile. Zone A is defined by FEMA as an area without Base Flood Elevations (BFE). Zone A is limited to Hay Creek as shown on the FEMA Map below.

Based on our review of the FEMA Community Panel No. 08041C0267G and the online ArcGIS El Paso County Risk Map, a portion of the eastern site lies within a 100-year floodplain.

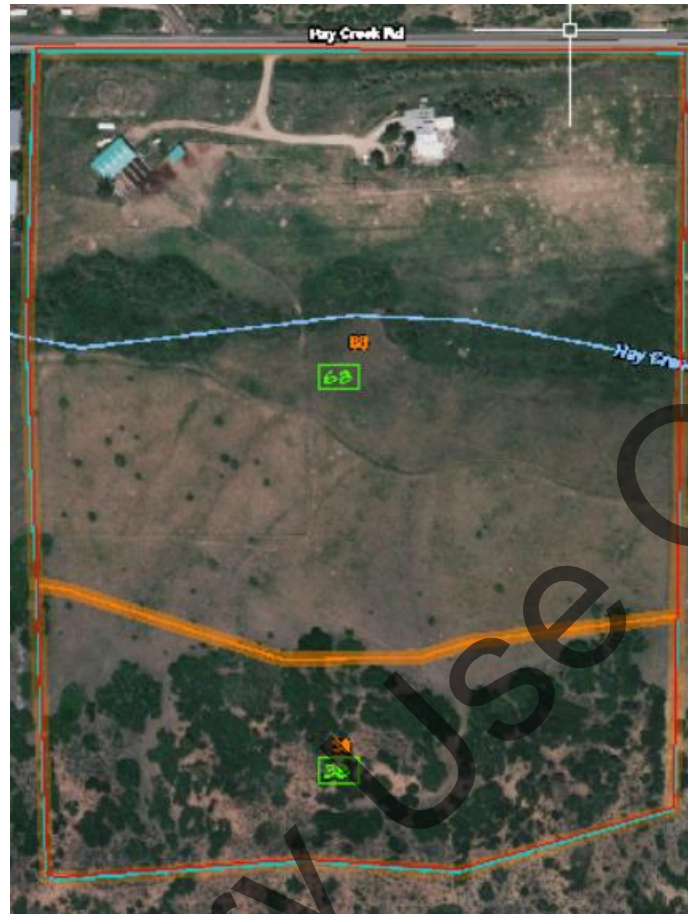
The USDA map is included below. The bold orange line indicates the boundary between the soil conditions.

- 38 – Jarre-Tecolote complex with 8 to 65 percent slopes. The Jarre-Tecolote complex was mapped by the USDA to encompass the southern third of the property, south of the creek. Properties of the Jarre-Tecolote complex include well drained soils, depth of the water table is anticipated to be greater than 80 inches, runoff is anticipated to be medium, frequency of flooding and/or ponding is none, and landforms include alluvial fans.
- 68 – Peyton-Pring complex, 3 to 8 percent slopes. The Peyton-Pring complex was mapped by the USDA to encompass the remainder of the property. Properties of the Peyton-Pring complex include, well-drained soils, depth of the water table is anticipated to be greater than 6.5 feet, runoff is anticipated to be low, frequency of flooding and ponding is none, and landforms include hills.
