SOIL AND GEOLOGY STUDY

Hay Creek Road
Lots 1-6,
El Paso County, Colorado

JOB NO. 195873

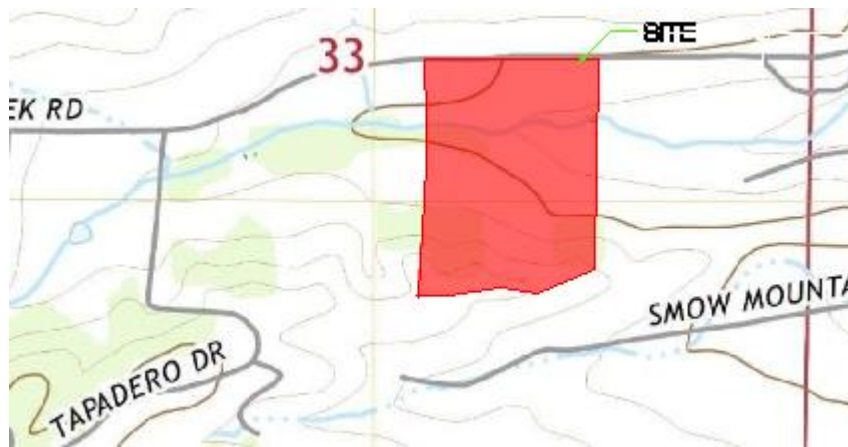
The site surface characteristics were observed to consist of rolling hills with low lying grasses and weeds across the entire site. Deciduous trees are scattered along the northern, southern property boundaries and along Hay Creek, with additional trees located sporadically across the proposed new lots. At the time of our site visit on April 17, 2024, the drainageway was moist, with a trace of "free" water with indications that surface water was recently present, mostly likely due to snow melt at the time. The topography from the Palmer Lake Quadrangle is presented below. The red indicates the approximate location of the site in reference to Hay Creek, the blue line.

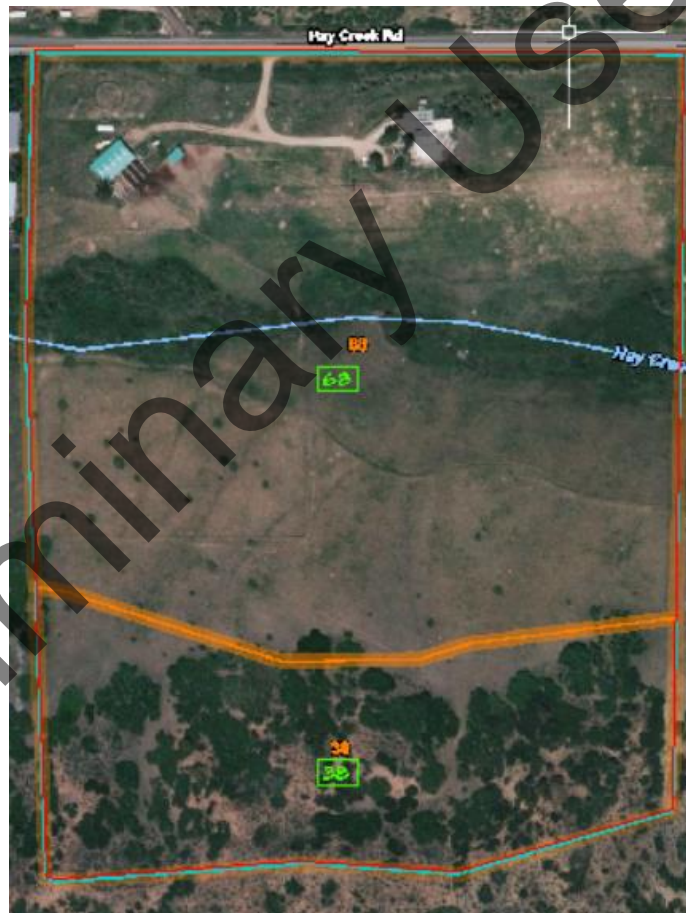
Insert from USDA, website <https://websoilsurvey.sc.egov.usda.gov/App/WebSoilSurvey.aspx>

The USDA map is included below. The bold orange line indicates the boundary between the soil conditions.

- 38 – Jarre-Tecolote complex with 8 to 65 percent slopes. The Jarre-Tecolote complex was mapped by the USDA to encompass the southern third of the property, south of the creek. Properties of the Jarre-Tecolote complex include well drained soils, depth of the water table is anticipated to be greater than 80 inches, runoff is anticipated to be medium, frequency of flooding and/or ponding is none, and landforms include alluvial fans.
- 68 – Peyton-Pring complex, 3 to 8 percent slopes. The Peyton-Pring complex was mapped by the USDA to encompass the remainder of the property. Properties of the Peyton-Pring complex include, well-drained soils, depth of the water table is anticipated to be greater than 6.5 feet, runoff is anticipated to be low, frequency of flooding and ponding is none, and landforms include hills.

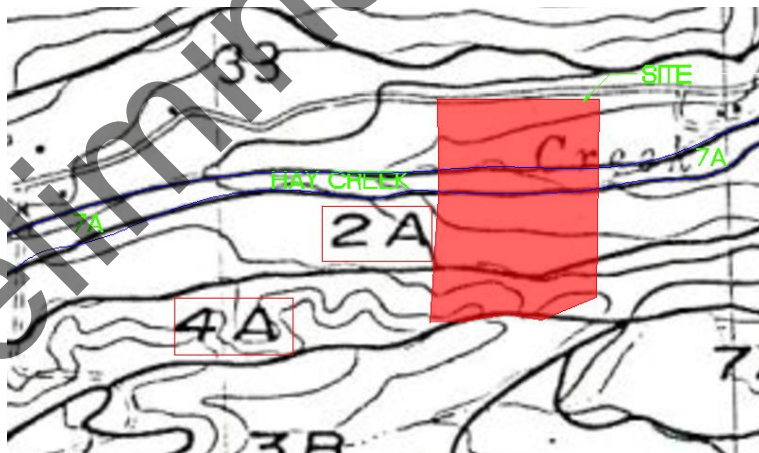
Insert from Environmental & Engineering Geologic Map, Charles S. Robinson & Associates, 1977

- 2A – Stable alluvium, colluvium and bedrock on gentle to moderate slopes (5%-12%).
- 4A – Potentially unstable colluvium and bedrock on moderate to steep slopes (12%-24%).
- 7A – Physiographic floodplain where erosion and deposition presently occur and is generally subject to recurrent flooding. Includes 100-year flood-plain along major streams where floodplain studies have been conducted.

Based on review of relevant geologic maps, we identified the geologic conditions (listed below) affecting the development, these conditions are indicated on the Engineering and Geology Map, Figure 8.

The engineering geology units mapped by Charles S. Robinson (1977) at the site are shown below and on the Engineering and Geology Map, Figure 8.

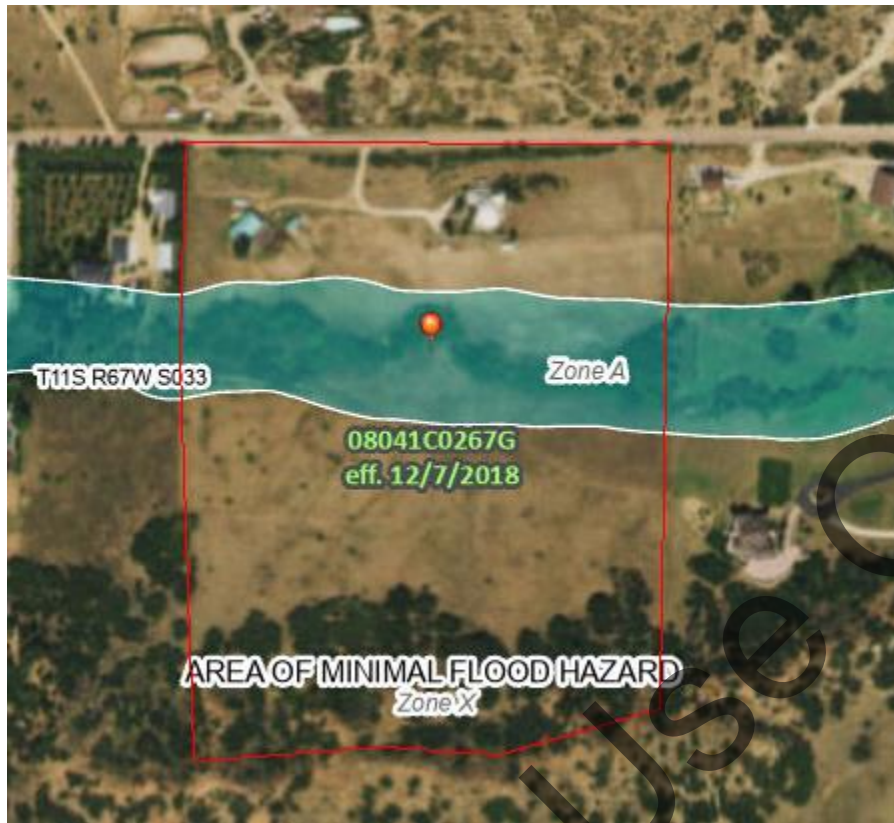
Insert from National Flood Hazard Layer FIRMette – USGS National Map 2023

The majority of the site is zoned Zone X, which is defined as an area with 0.2% annual chance flood hard, area of 1% annual chance flood with average depth less than one foot or with drainage areas or less than one square mile. Zone A is defined by FEMA as an area without Base Flood Elevations (BFE). Zone A is limited to Hay Creek as shown on the FEMA Map below.

Based on our review of the FEMA Community Panel No. 08041C0267G and the online ArcGIS El Paso County Risk Map, a portion of the eastern site lies within a 100-year floodplain.

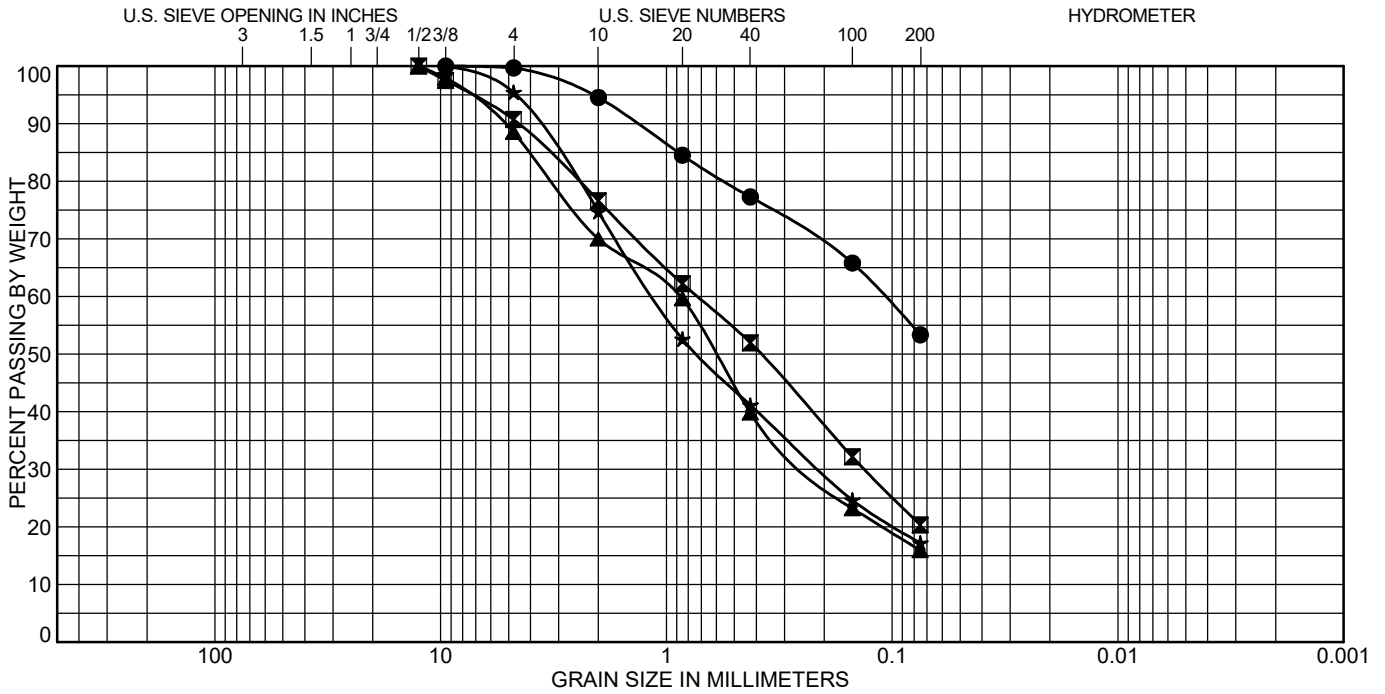
JOB No. 195873
 FIGURE No. 6
 PAGE 1 OF 1
 DATE Jul/02/2024

SUMMARY OF LABORATORY TEST RESULTS

pertinent engineering properties. Due to sample disturbance caused by gravel in the sample, a representative swell test could not be performed. However, given the depth of the expansive soils/bedrock in the test borings and available mitigation measures commonly utilized in this area, the expansive soils will not preclude development of the proposed lots. A Summary of Laboratory Test Results is presented in Figure 6. Soil Classification Data are presented in Figure 7.

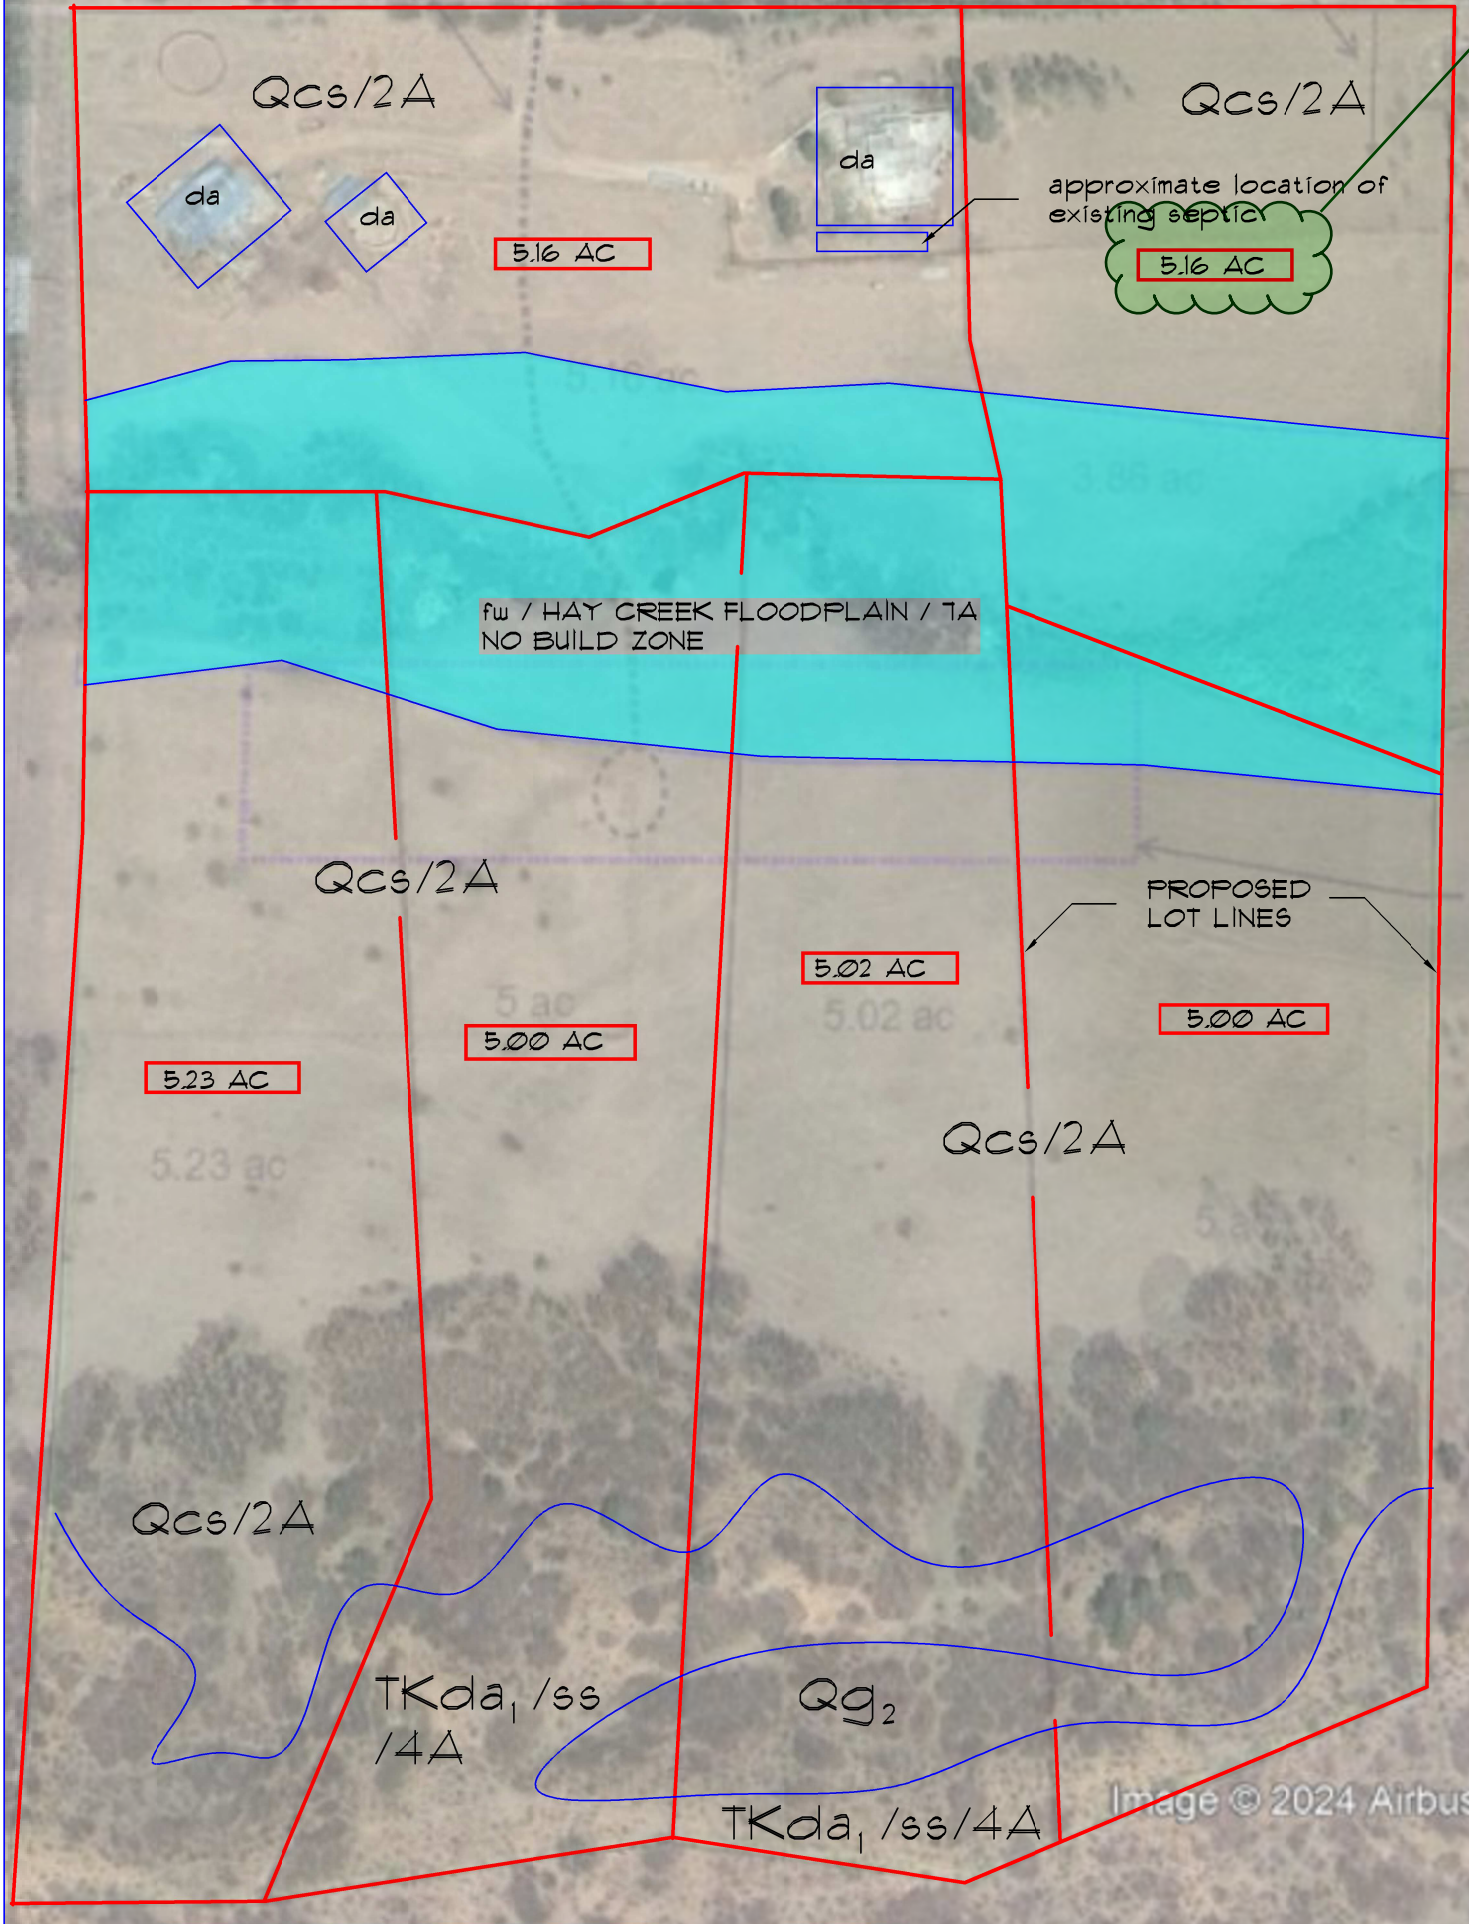
SHEET No.
FIG-8

APPROXIMATE PROPERTY BOUNDARIES
