GEOLOGIC HAZARD STUDY

**6881 Eagle Mountain Rd – Rose Residence
Site 122, Crystal Park
El Paso County, Colorado**

JOB NO. 196396

May 17, 2024

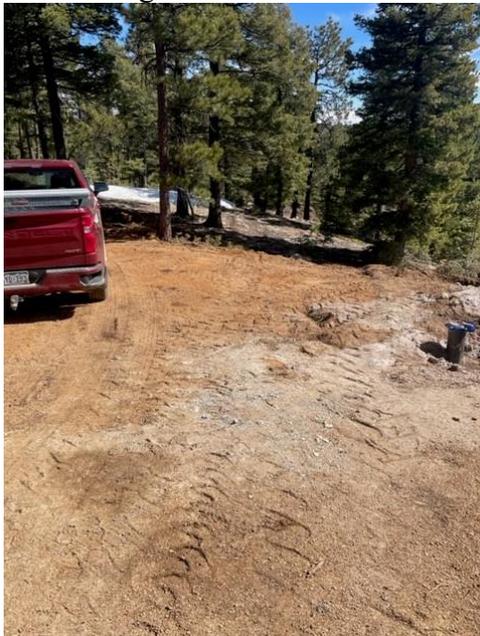
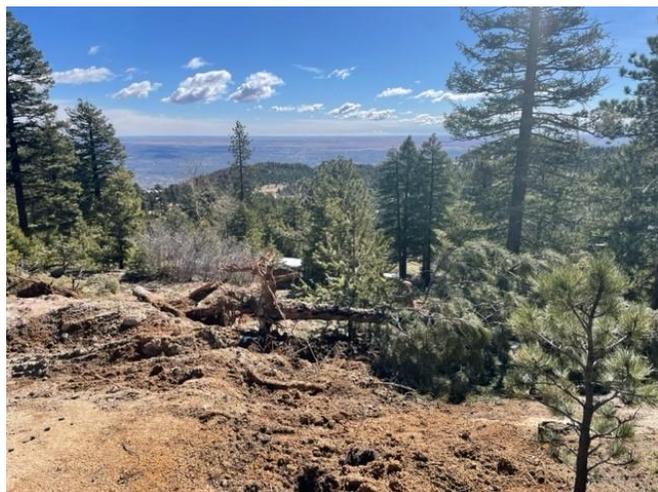
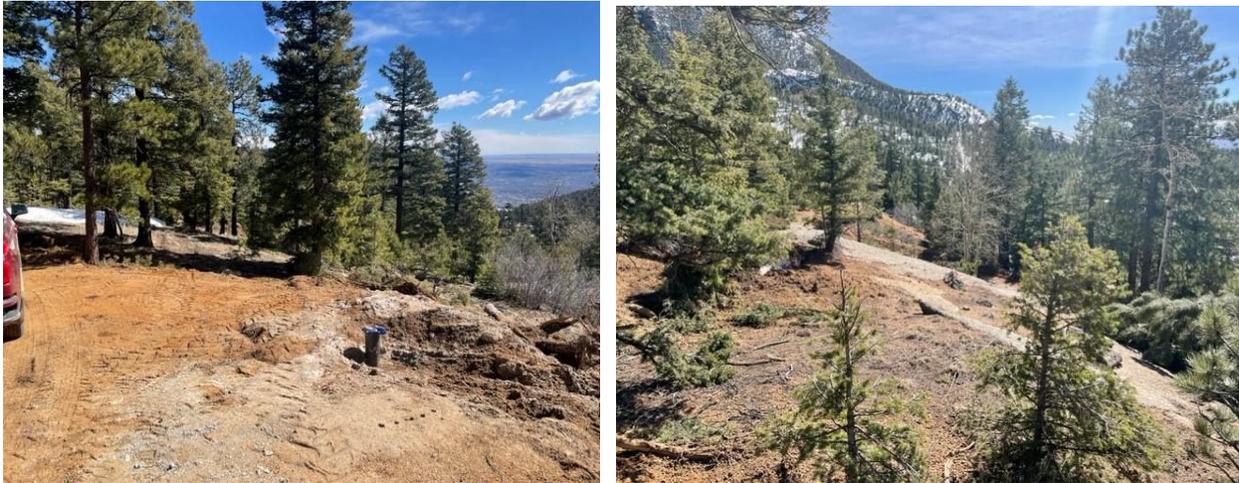
We performed a field reconnaissance on April 16, 2024. At the time of the field reconnaissance, the site consisted of vacant, undeveloped land and is generally located about 2 miles from the gated entrance in the northeast portion of the Crystal Park subdivision. The ground surface within the proposed building area had been cleared of vegetation.

Surrounding the building and septic field pads, vegetation consisted of moderate- to high-growth coniferous trees, small rocks, boulders, native grasses and weeds. Topographically, the site resides near the top of Eagle Mountain which generally slopes down towards the south and east at approximately 60 to 70 percent. The site has a relatively flatter building pad (5 to 10%) with good drainage in the form of surficial sheet flow directed to the south and east.

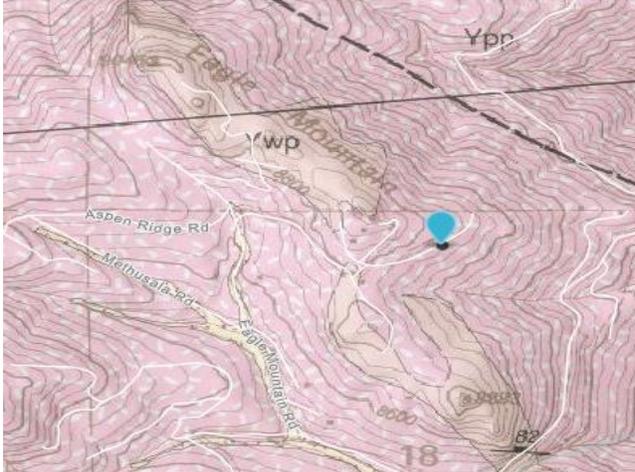
Based upon mapping presented by the Colorado Geological Survey (CGS) (¹Keller et al, 2003), the bedrock underlying the subject site is comprised of the Pikes Peak Granite (Middle Proterozoic) geologic map unit Ypp, as indicated by the salmon color below. The blue pin indicates the approximate site location.

The rocks of this mountain and surrounding area represent the Pikes Peak Batholith, a fairly large, late Mesoproterozoic-aged igneous intrusion that was emplaced approximately 1.8 billion years ago. Pikes Peak Granite is comprised of feldspar-biotite migmatite, quartzose gneiss, biotite schist, and amphibolite gneiss. The granite was exposed in the driveway and at the surface across the site. The surficial deposits observed during our site visit consisted primarily of decomposed granite and gravel rock fragments. Evidence of recent natural rockfall or debris flow deposits were not observed in the vicinity of the building site.

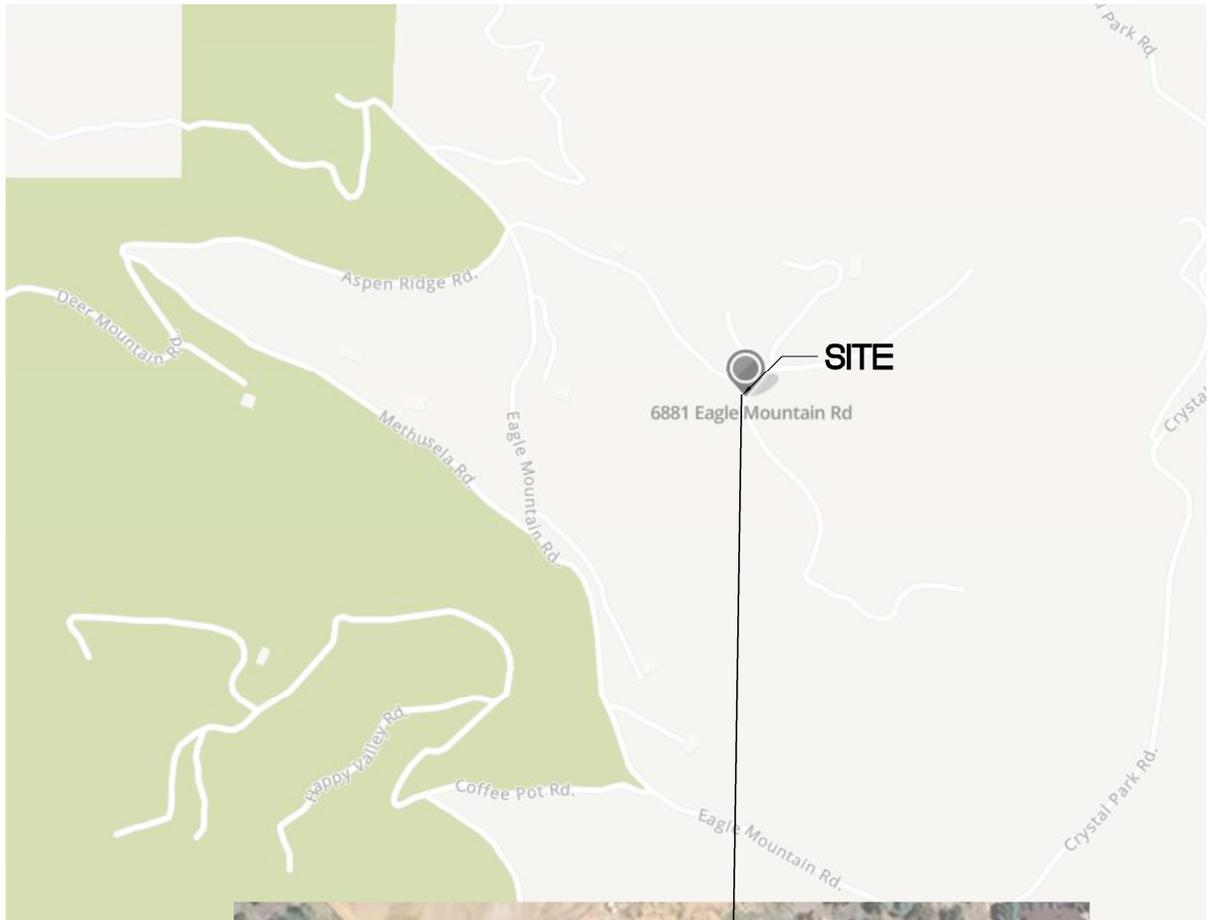
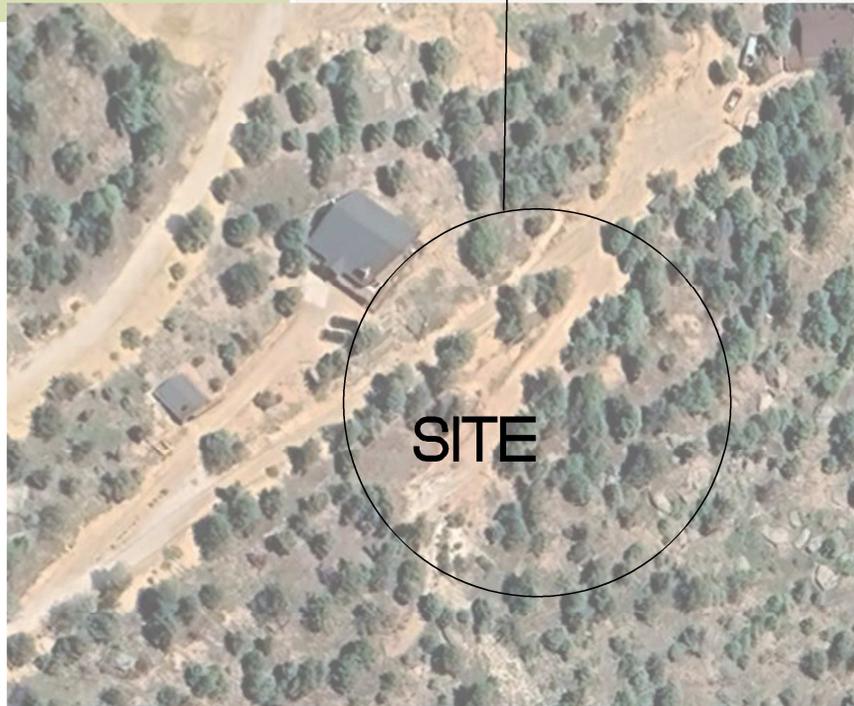
FIG No. 1

NOT TO SCALE

The site currently consists of an approximately 0.7 acre vacant residential lot. The proposed land use is to construct a new single-family residence. The subject property is identified as Site S-122 (RR) within the Crystal Park subdivision, Filing No. 2, zoned as “PUD” Planned Unit Development per El Paso County zoning. The approximate location of the site is shown on the Site Vicinity Map, Figure 1.

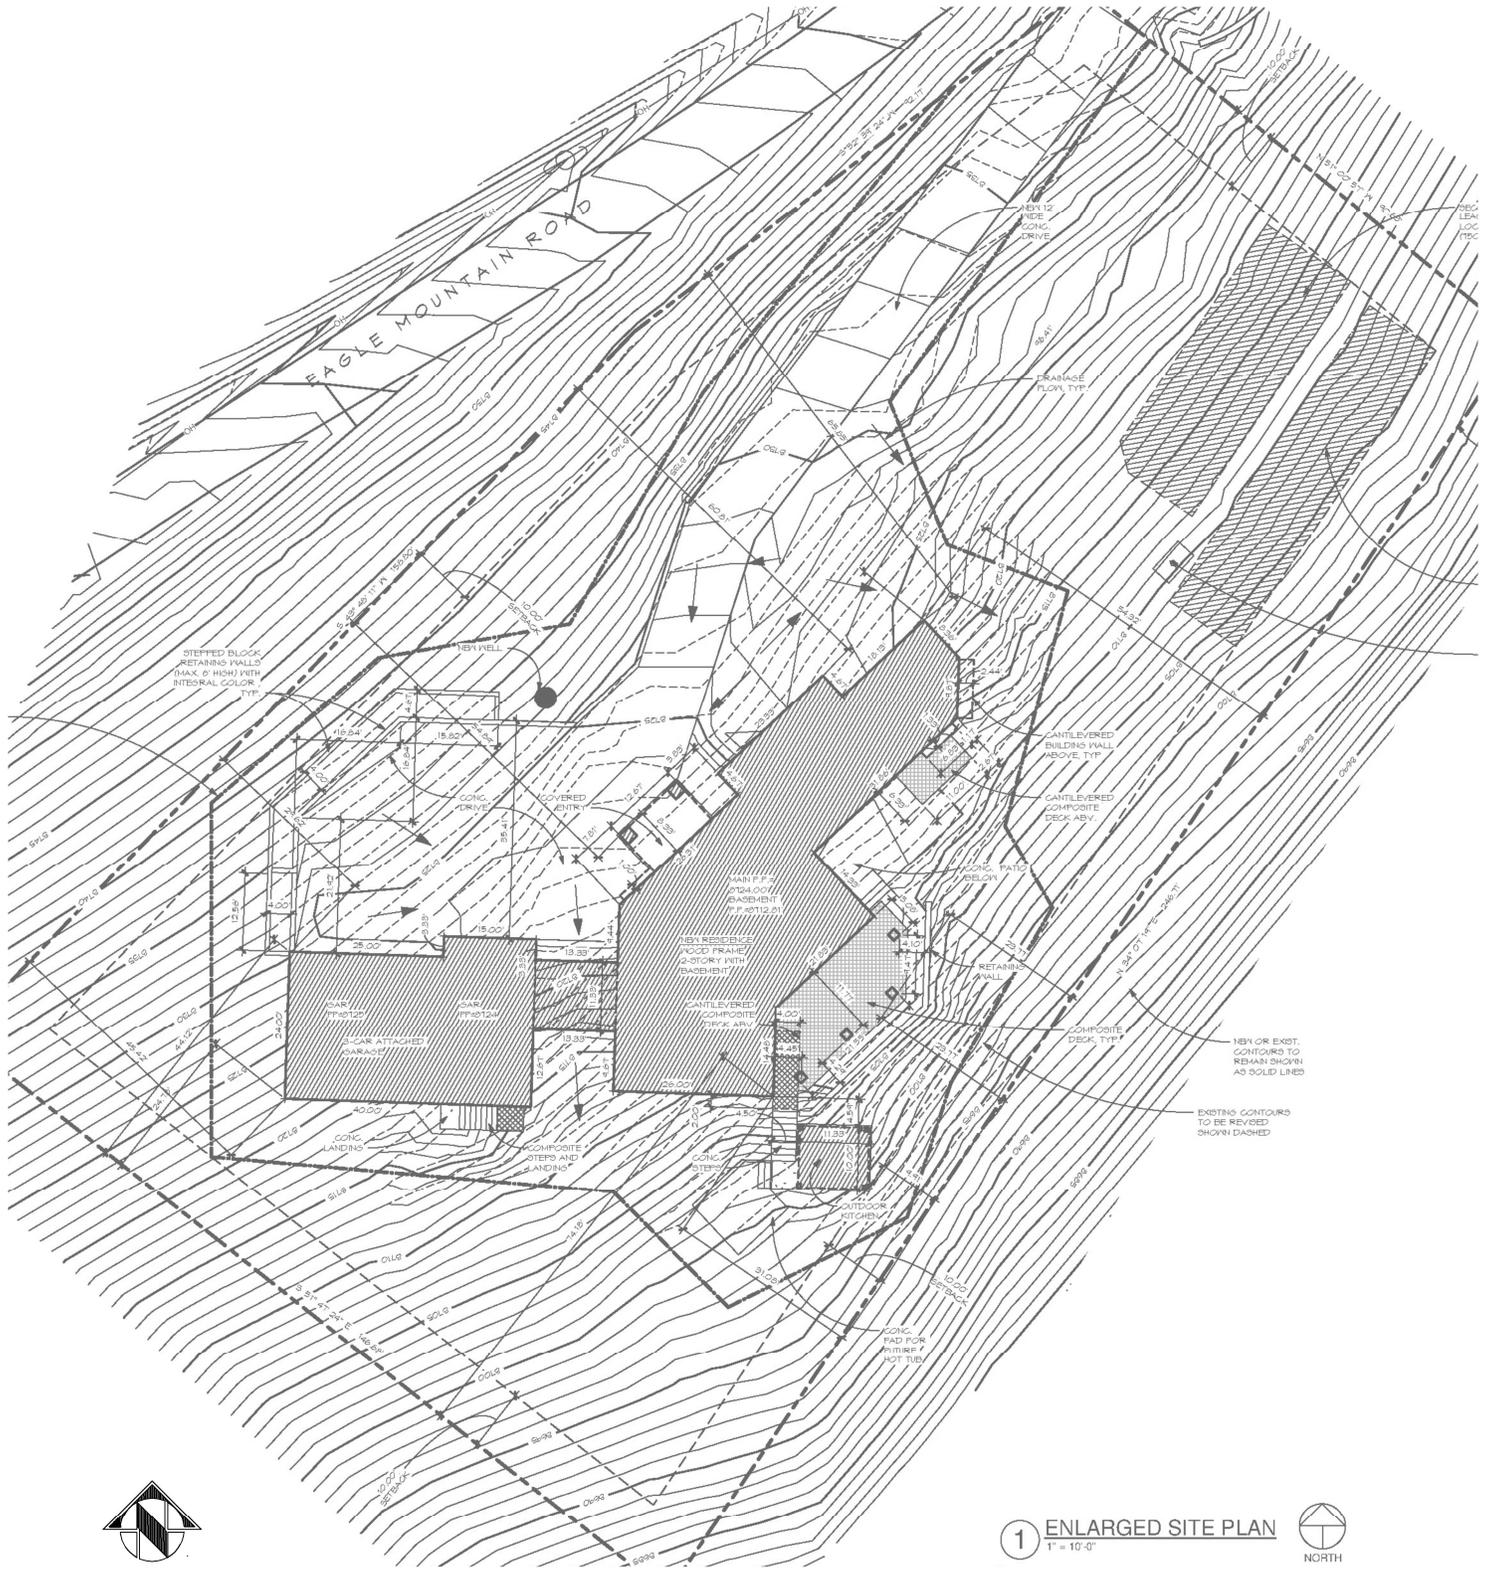
NOT TO SCALE
 SITE PLAN PREPARED BY LGA STUDIOS

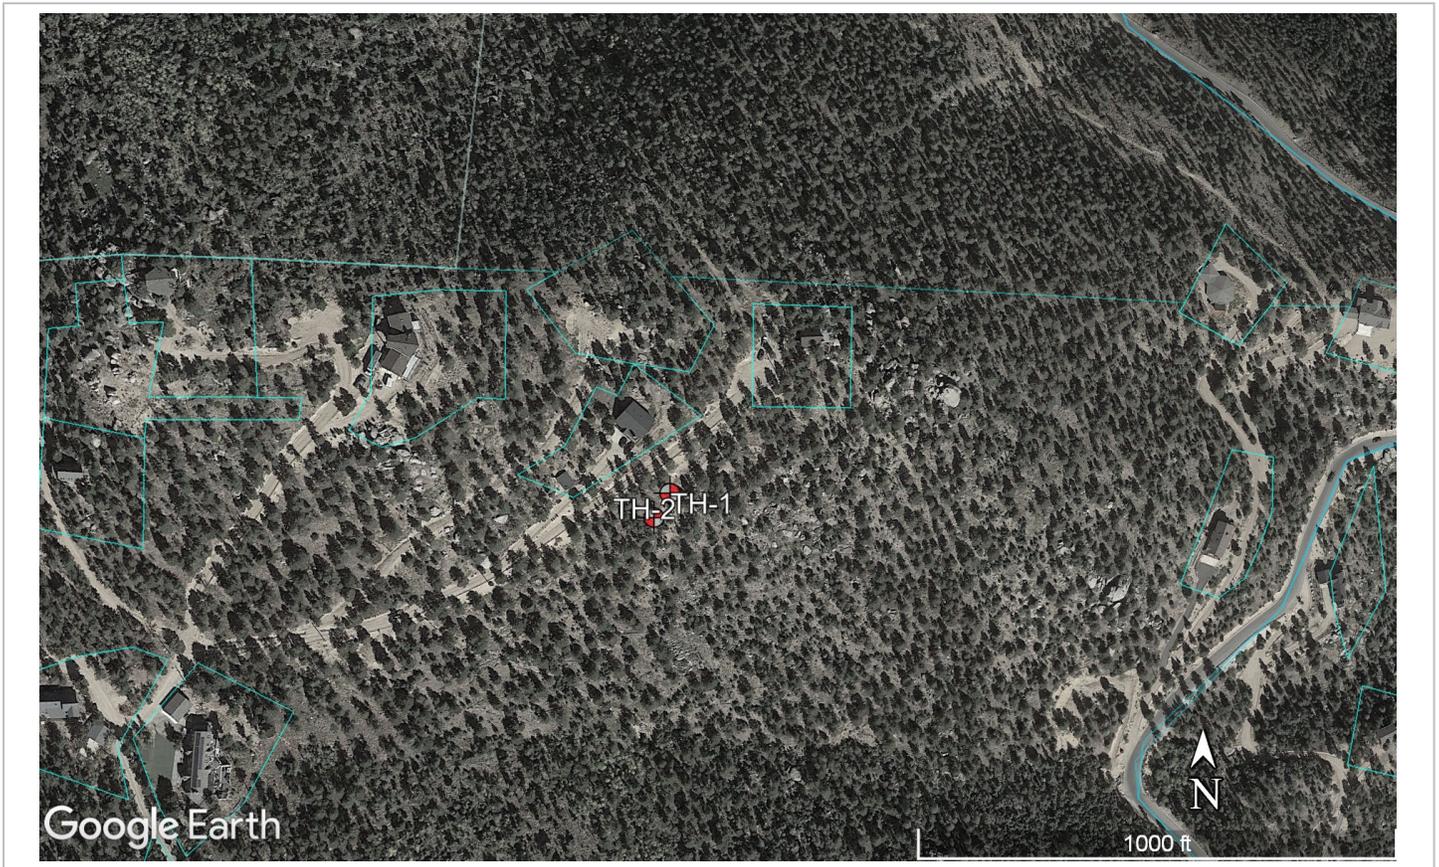
Bore Hole	Latitude	Longitude
TH-1	38.838230	-104.931074
TH-2	38.838188	-104.931114

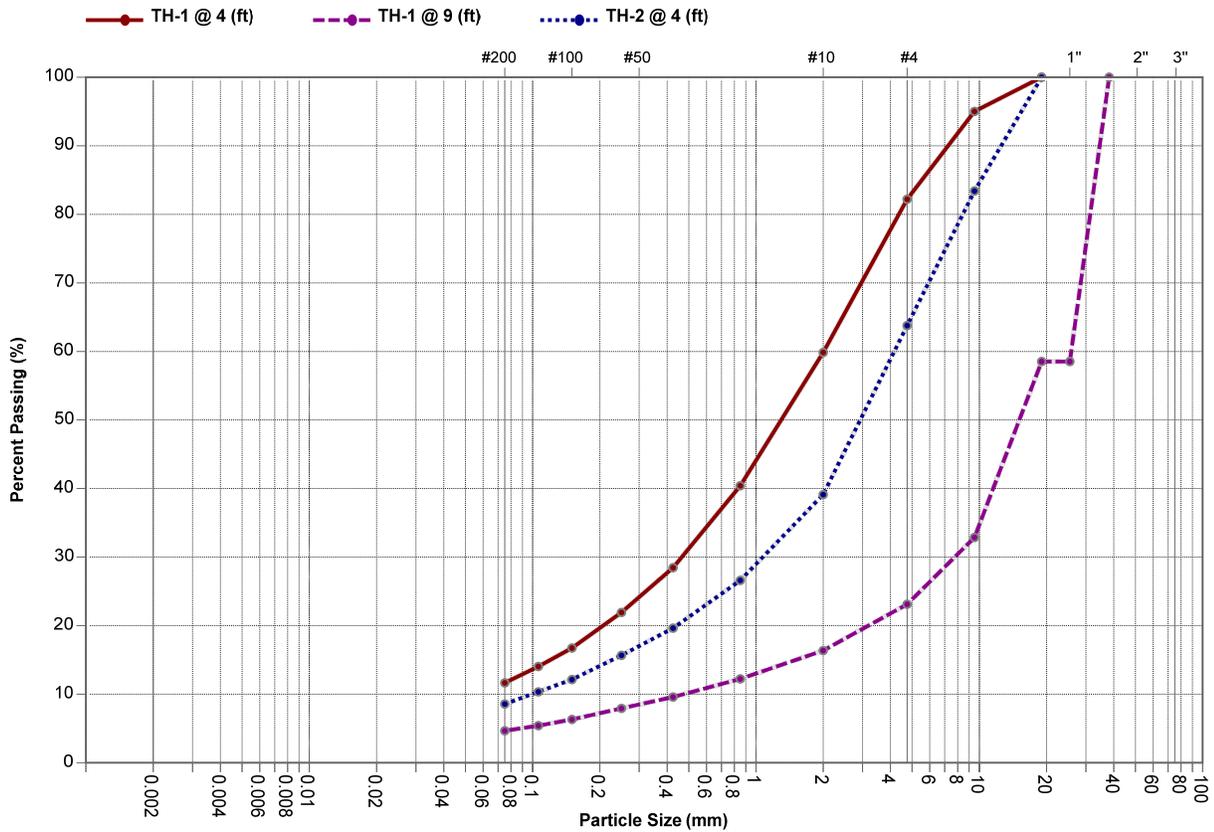
ASTM D6913

Clay	Silt	Sand	Gravel	Cobbles
	11.6	70.5	17.8	0.1
	4.7	18.5	76.9	-
	8.6	55.2	36.2	-

Borehole	Sample Depth (ft)	D10 (mm)	D30 (mm)	D50 (mm)	D60 (mm)	Cc	Cu	LL (%)	PI (%)	Disp. (%)	USCS	AASHTO
TH-1	4	-	0.465	1.297	2.012	107.468	-	-	-	N/A	SP-SM	A-1-b(0)
TH-1	9	0.474	7.755	15.099	25.771	4.923	54.369	-	-	N/A	GP	A-1-b(0)
TH-2	4	0.099	1.072	2.93	4.162	2.789	42.04	-	-	N/A	SW-SM	A-1-b(0)

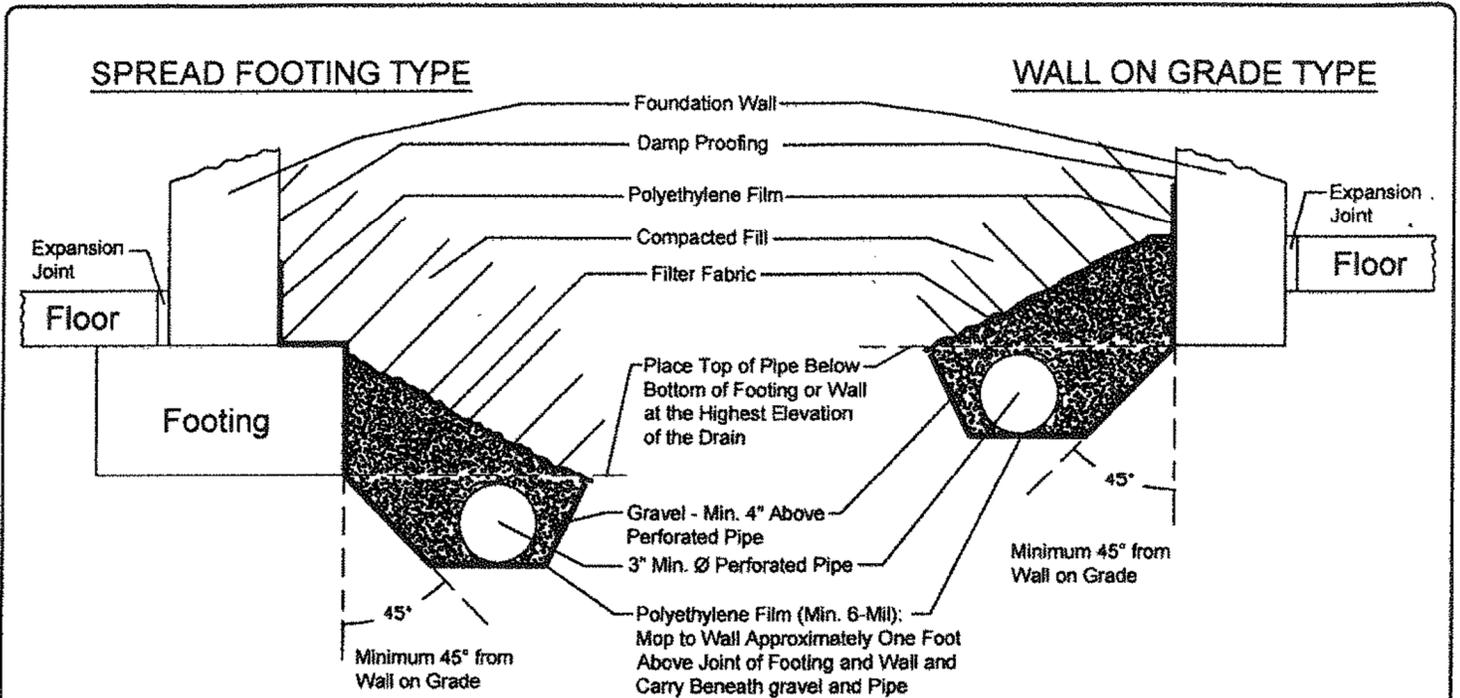
Exterior Drain Detail

1. Gravel to be Not More Than 1-1/2" and Not Less Than 1/2" Diameter.
2. Perforated Pipe Diameter Varies With Expected Seepage. 3"Ø and 4"Ø are Most Common. ABS and PVC are Most Common Materials for Pipe. We approve the use of an "EZ Flow Drainage System" by Infiltrator. All specifications in this drain detail are still applicable.

3. Pipe to be Laid out in a Minimum Slope of 1" in 10'.
4. Gravity Outfall is Desired if Possible. Portion of Pipe in Area Not Drained Shall be Non-Perforated. Daylight Must be Maintained Clear of Debris in Order to Function Properly.
