RE: Response to Colorado Geological Survey Comments, 5050 Neeper Valley Road, Geoquest #17-1043

Reference: Geologic Hazard Report, Geoquest #17-1043, 21 June 2021
 Comments from Colorado Geological Survey, 10 September 2021

Slope stability analysis

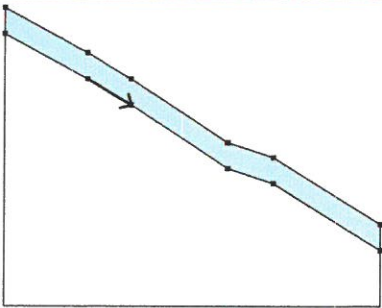
Assigning and surfaces

No.	Surface position	Coordinates of surface points [ft]				Assigned soil
		x	z	x	z	
1

22.33	46.00	34.00	39.00	DG

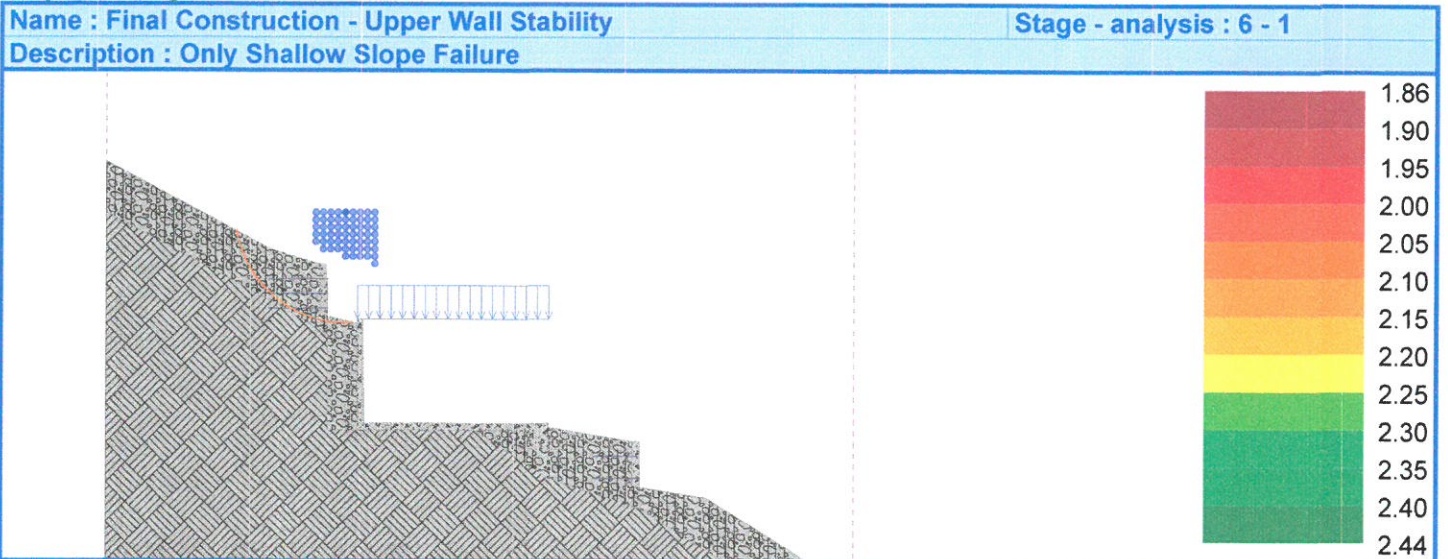
Analysis 2 (stage 6)

Circular slip surface

Stage - analysis : 6 - 2

Description : Pass

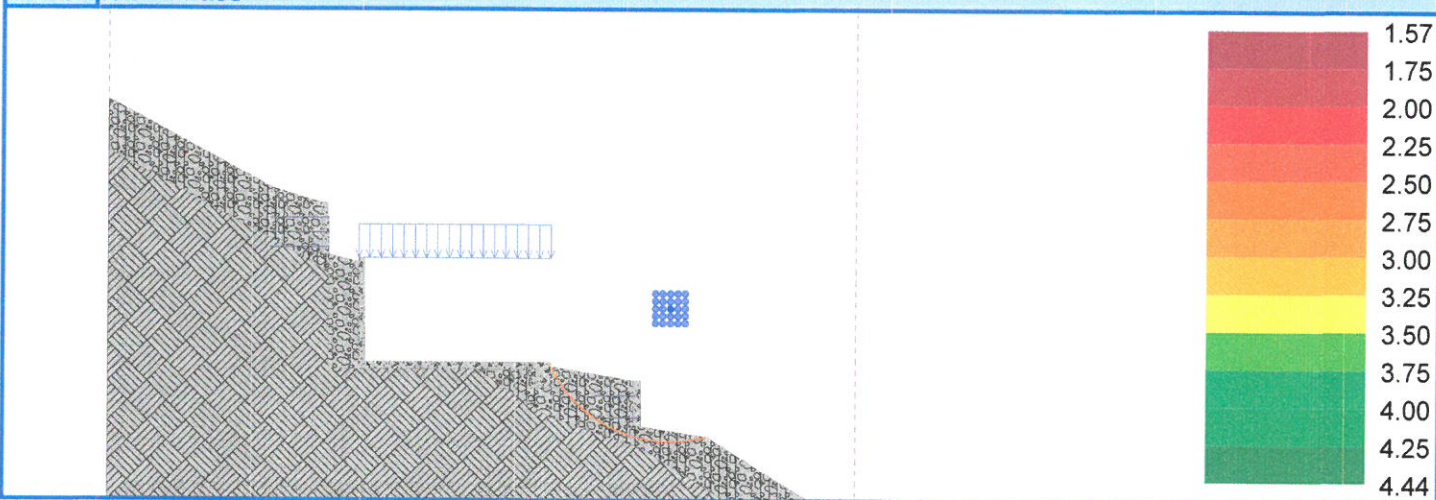
Analysis 3 (stage 6)

Circular slip surface

Stage - analysis : 6 - 3

Description : Only Shallow Slope Failure

Second, CGS requested further explanation regarding the results of the slope stability analysis. We found the existing site to have a factor of safety of 1.07 in the current state. This is a result of the steep loose decomposed granite overlying the solid bedrock. The failure modes are very shallow slip surfaces.

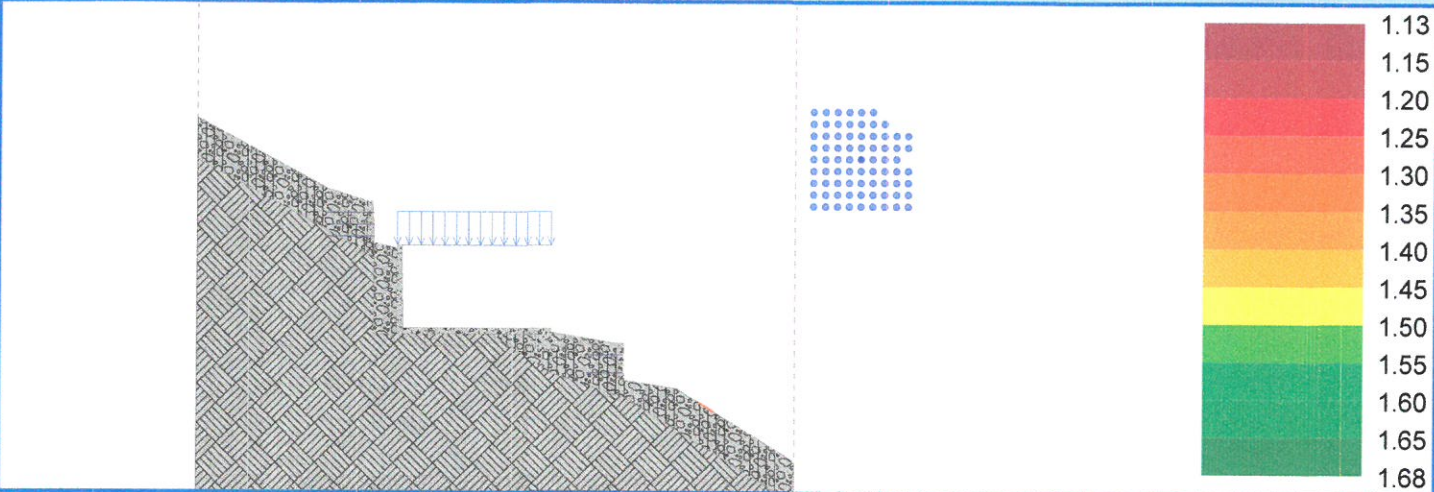
Analysis 4 (stage 7)

Results (Stage of construction 7)

Name : Final Global Slope Stability

Stage - analysis : 7 - 4

Regarding the final slope stability, CGS indicated the upper wall stability was inadequate. This is correct, based on the given topography and proposed wall heights, the slope stability is inadequate at the upper wall. This can easily be corrected by extending the top of wall up two feet and properly reinforcing or including shear keys. This wall should be designed by a licensed Colorado Professional Engineer, either a MSE wall or reinforced concrete is recommended. The wall design should include analysis of slope stability. We believe a properly designed wall will be able to achieve a slope stability of greater than 1.50.

The slope stability analysis has also been updated with seismic analysis as requested by CGS. Seismic effects have been applied to "Stage of Construction 7". A Horizontal Seismic Coefficient (K_h) of 0.08 was applied based on a PGA of 8%g. A Vertical Seismic Coefficient (K_v) of 0.04 was applied based on an assumption that $K_v = 1/2 * K_h$. The final global slope stability is 1.66. Please see the attached "Revised Slope Stability Analysis".
