**WASTEWATER REPORT
LATIGO TRAILS FILINGS 9 AND 10, 78 LOTS
SOUTHWEST OF EASTONVILLE ROAD
AND LATIGO BOULEVARD
EL PASO COUNTY, COLORADO**

Project No. CS19409-115

October 7, 2021

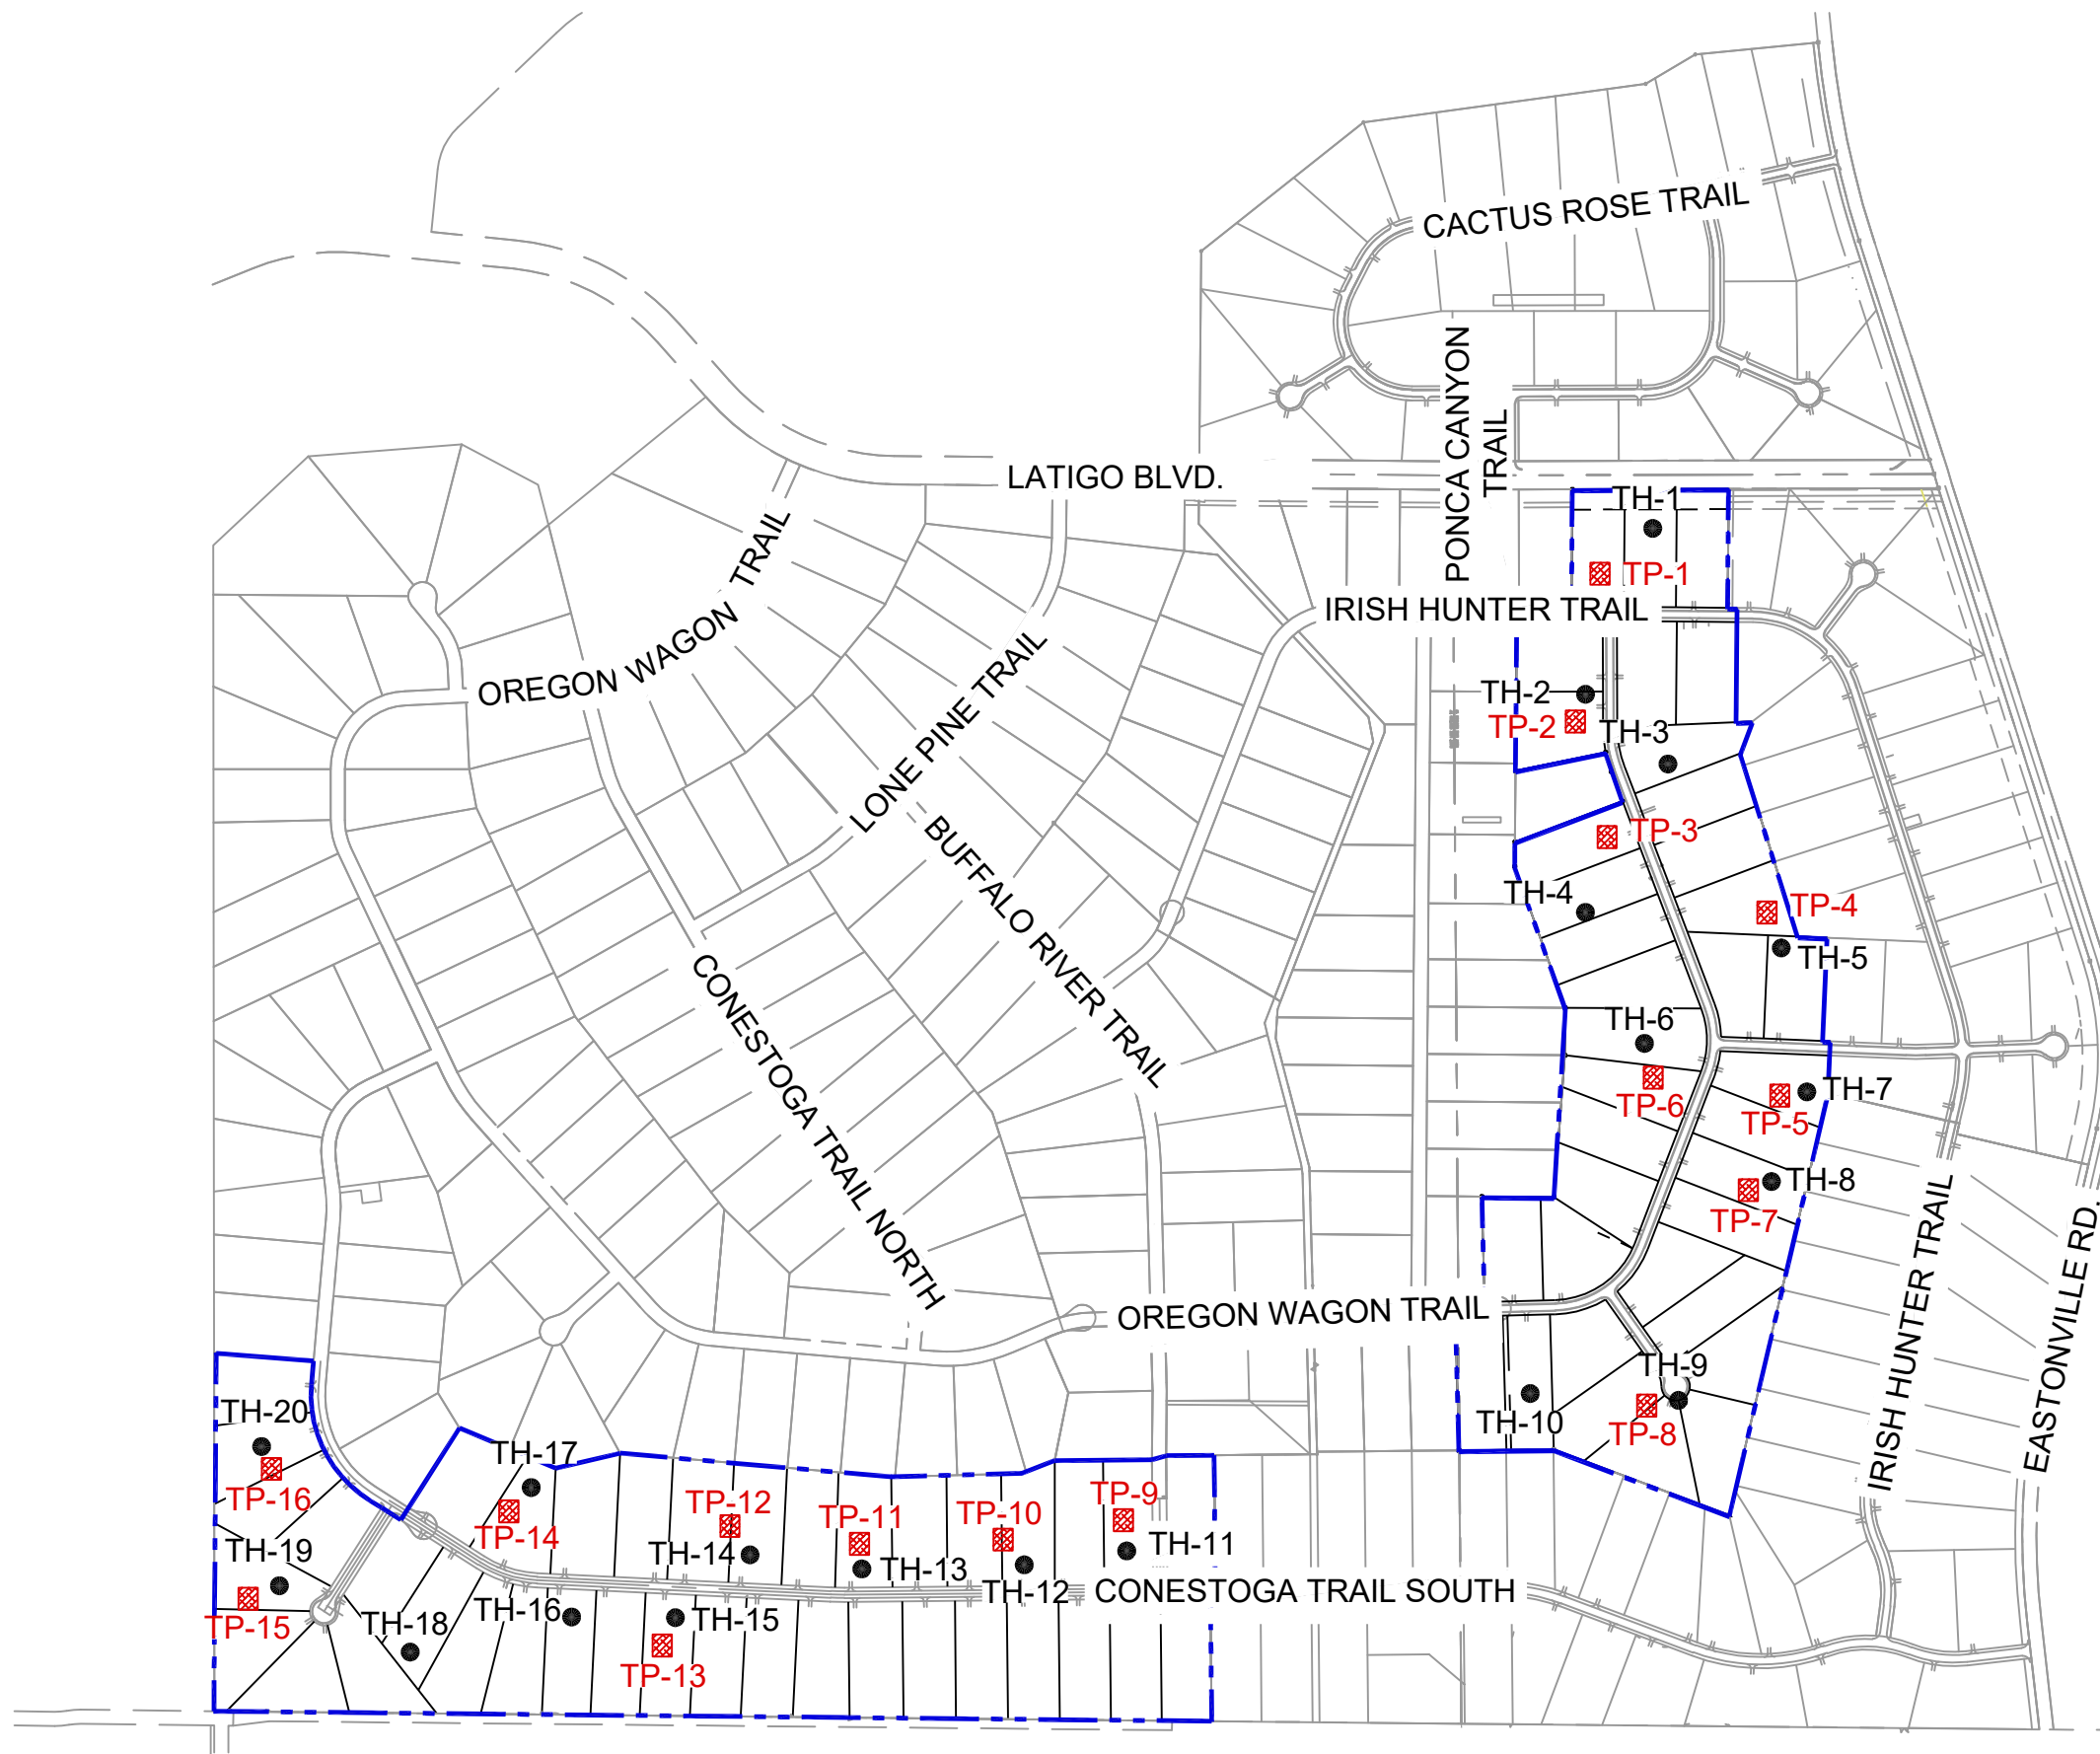
- LEGEND:**
- TH-1 ● APPROXIMATE LOCATION OF EXPLORATORY BORING.
 - TP-1 ■ APPROXIMATE LOCATION OF SOIL PROFILE TEST PIT.
 - PROJECT BOUNDARY

**LOCATION OF
EXPLORATORY
BORINGS
AND
SOIL PROFILE
TEST PITS**

FIG. 1 – LOCATIONS OF EXPLORATORY BORINGS AND SOIL PROFILE
TEST PITS

We investigated subsurface conditions June 14th through June 23rd, 2021 by drilling and sampling twenty exploratory borings. Additionally, we excavated a total of sixteen test pits on July 29, 2021. The approximate locations of our borings and test

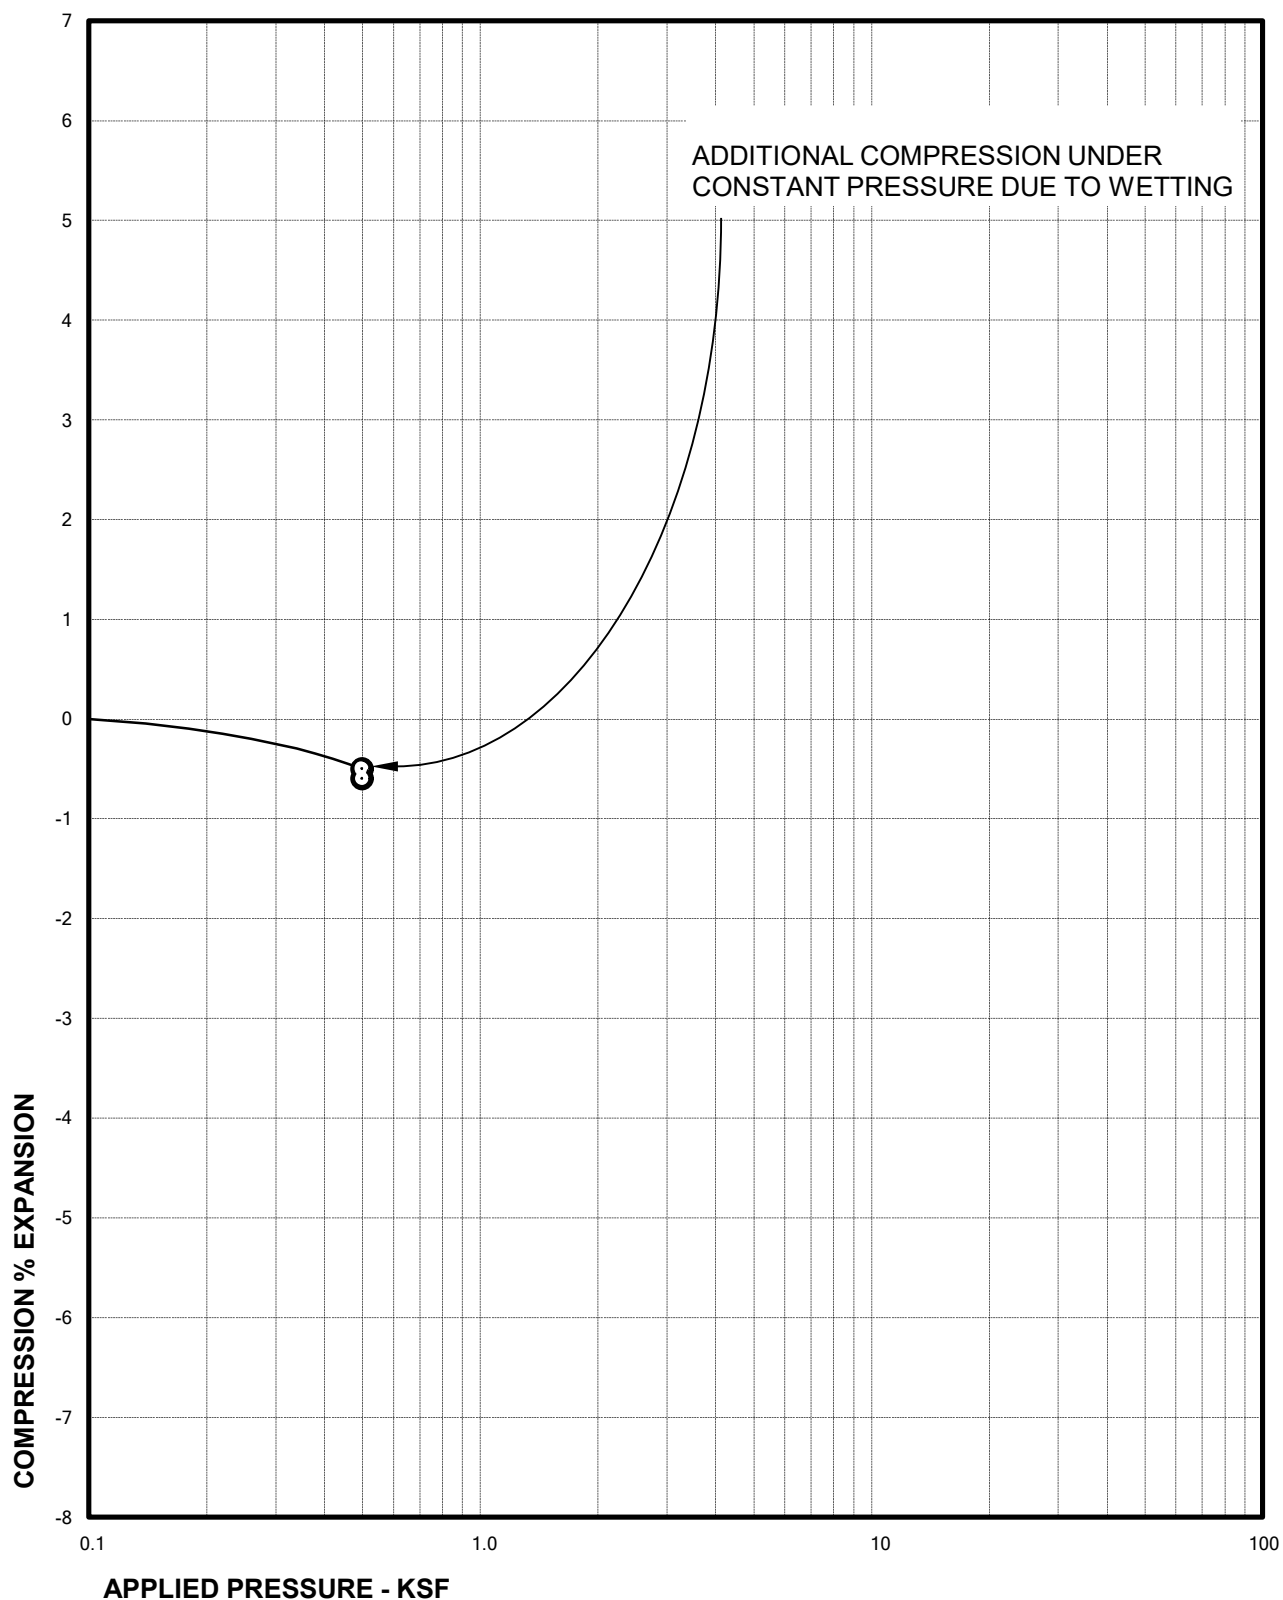
Sample of SANDSTONE, VERY CLAYEY
From TH-7 AT 9 FEET

DRY UNIT WEIGHT= 126 PCF
MOISTURE CONTENT= 9.3 %

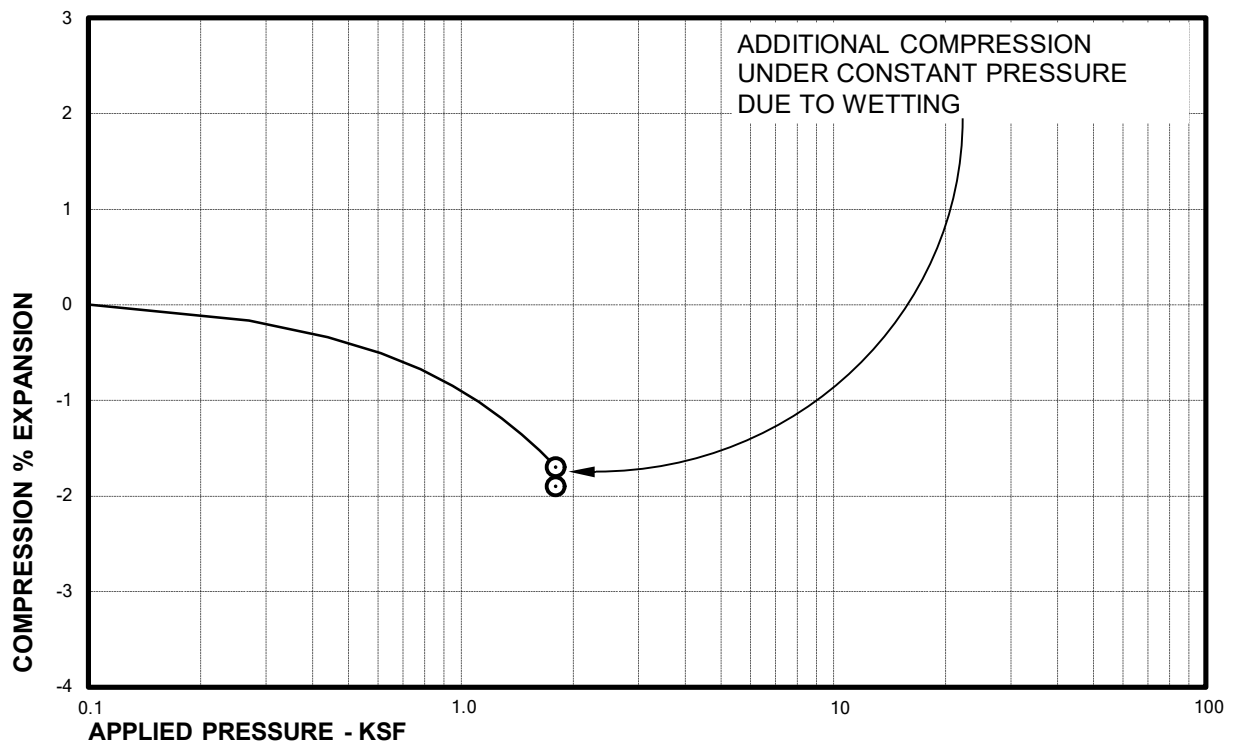
Sample of SANDSTONE, VERY SILTY
From TH-13 AT 14 FEET

DRY UNIT WEIGHT= 122 PCF
MOISTURE CONTENT= 11.2 %

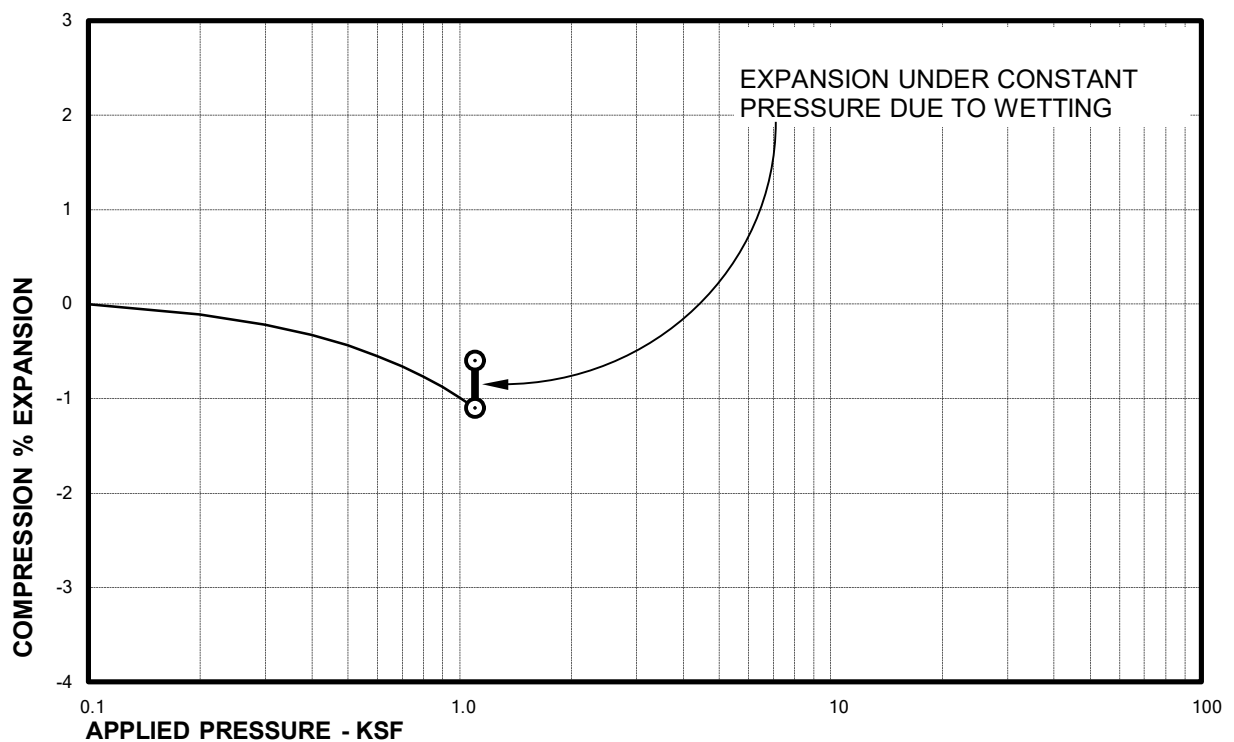
Sample of CLAYSTONE, VERY SANDY
From TH-17 AT 9 FEET

DRY UNIT WEIGHT= 124 PCF
MOISTURE CONTENT= 10.1 %

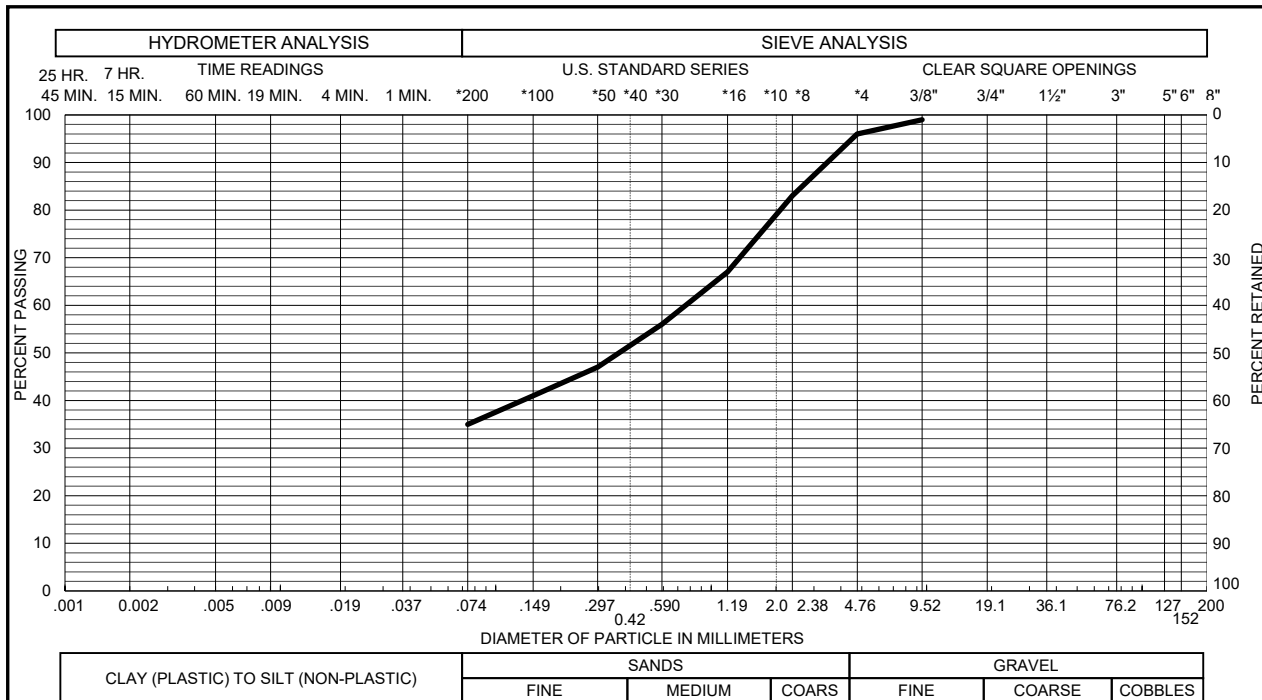
Sample of SANDSTONE, SILTY GRAVEL 4 % SAND 61 %
From TH - 2 AT 9 FEET SILT & CLAY 35 % LIQUID LIMIT %
PLASTICITY INDEX %

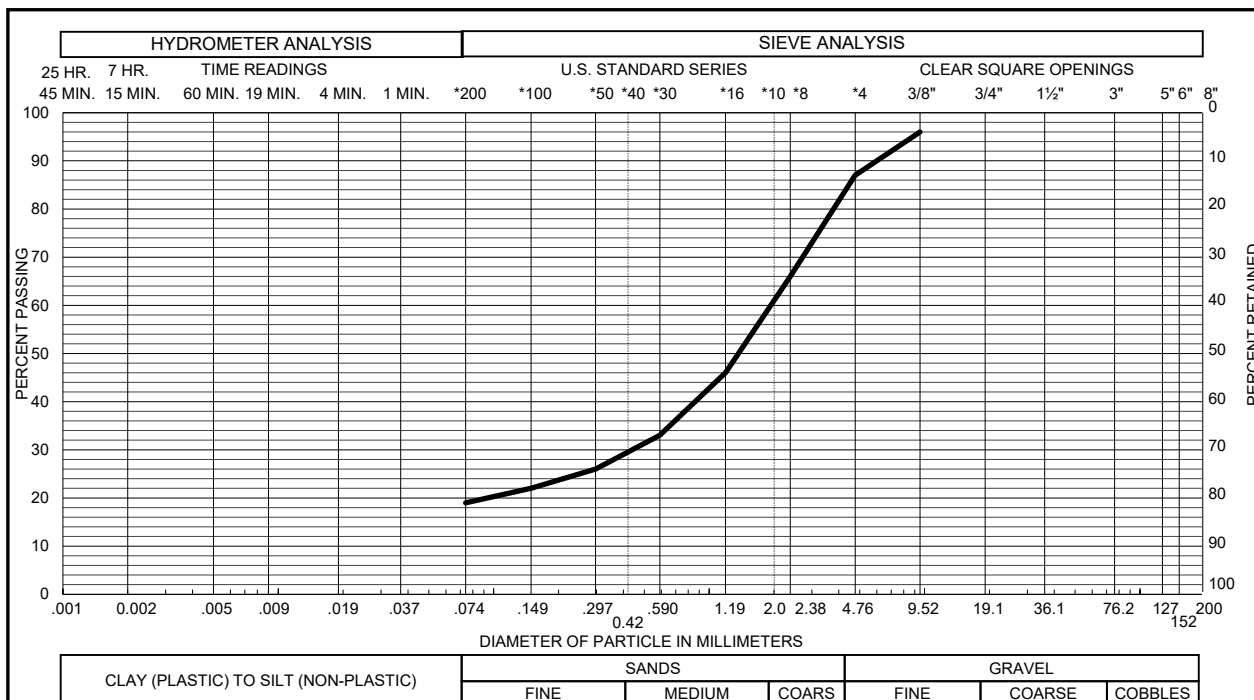
Sample of SANDSTONE, SILTY GRAVEL 13 % SAND 68 %
From TH - 3 AT 4 FEET SILT & CLAY 19 % LIQUID LIMIT %
PLASTICITY INDEX %

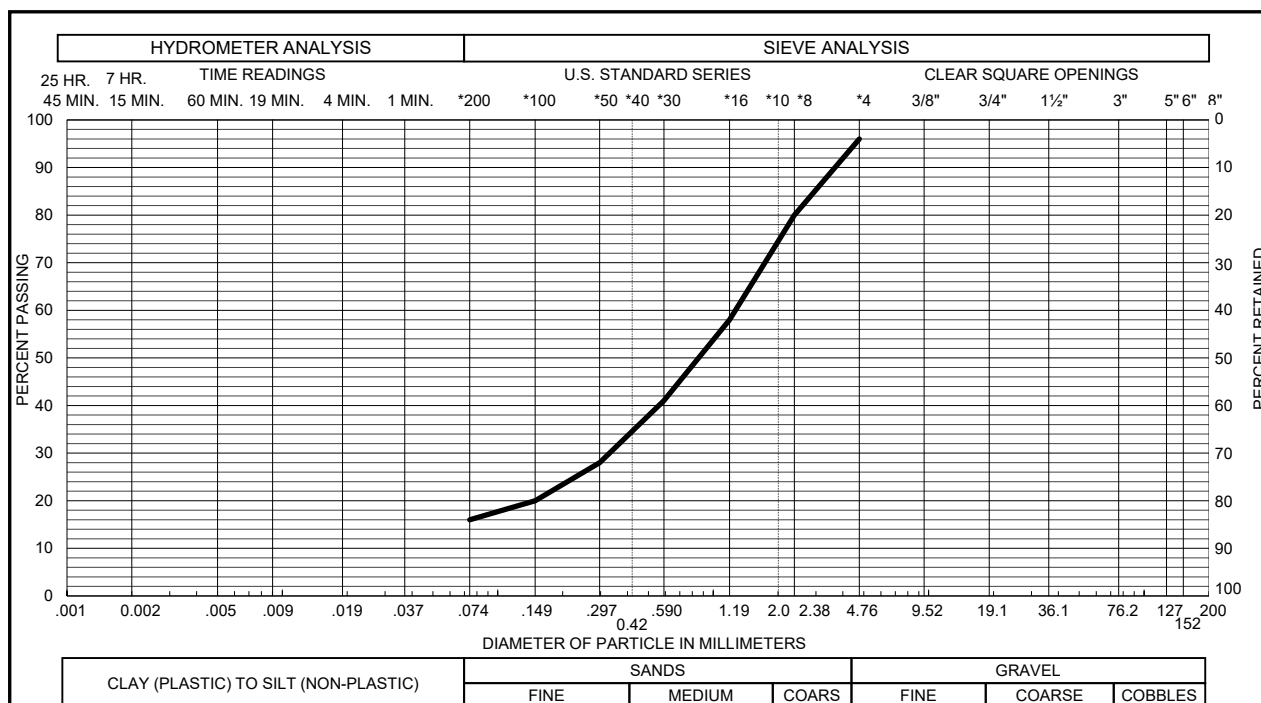
Sample of SANDSTONE, SILTY GRAVEL 4 % SAND 80 %
From TH - 6 AT 4 FEET SILT & CLAY 16 % LIQUID LIMIT %
PLASTICITY INDEX %

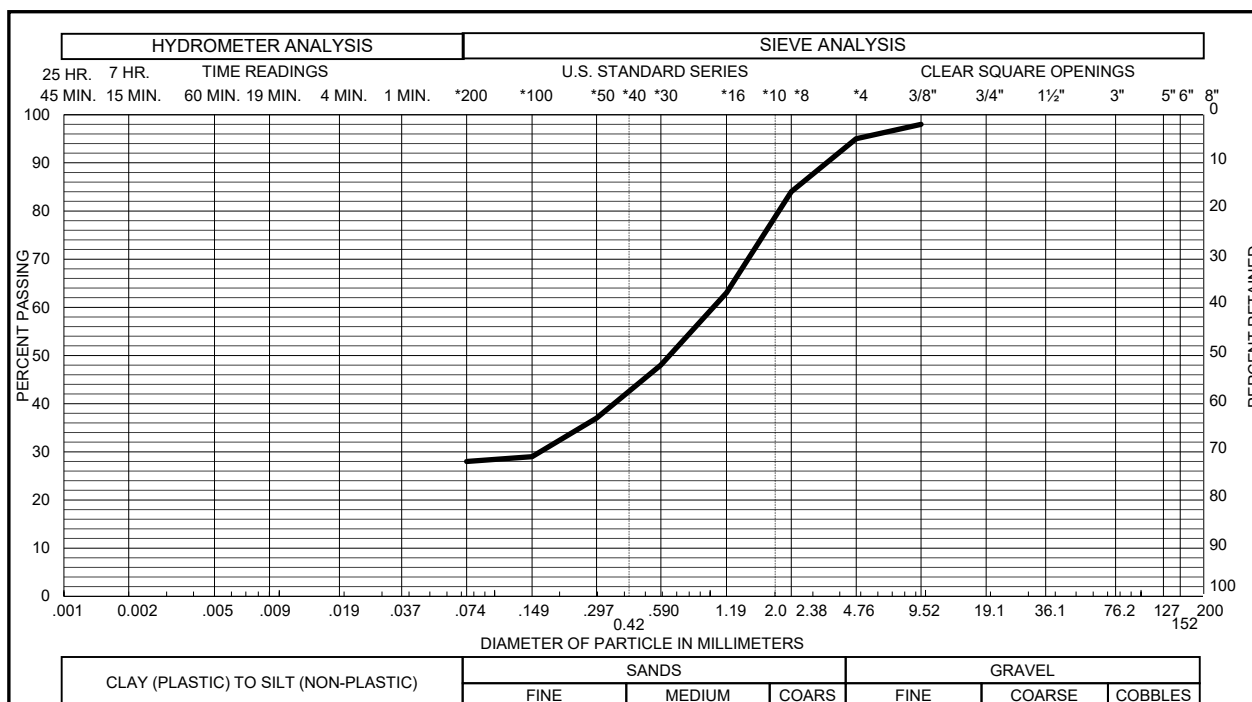
Sample of SANDSTONE, CLAYEY GRAVEL 5 % SAND 67 %
From TH - 10 AT 4 FEET SILT & CLAY 28 % LIQUID LIMIT %
PLASTICITY INDEX %
