**WASTEWATER REPORT  
LATIGO TRAILS FILINGS 9 AND 10, 78 LOTS  
SOUTHWEST OF EASTONVILLE ROAD  
AND LATIGO BOULEVARD  
EL PASO COUNTY, COLORADO**

Project No. CS19409-115

October 7, 2021

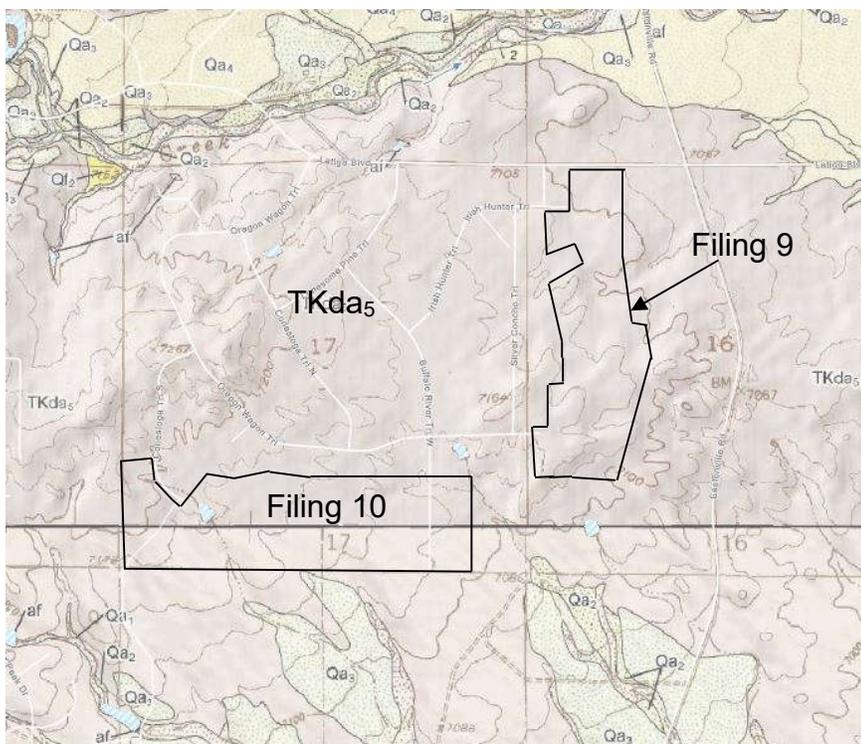
Excerpt from Eastonville and Falcon 7.5 minute Geologic Maps

The entire site is mapped as Dawson Formation bedrock, facies 5 (TKda<sub>5</sub>). The bedrock generally consists of sandstone with occasional interbedded layers of sandy claystone. Conditions at the site were found to be similar to the mapped conditions with the exception of a surficial layer of silty to clayey sand overlying the bedrock. The geologic map is shown below.

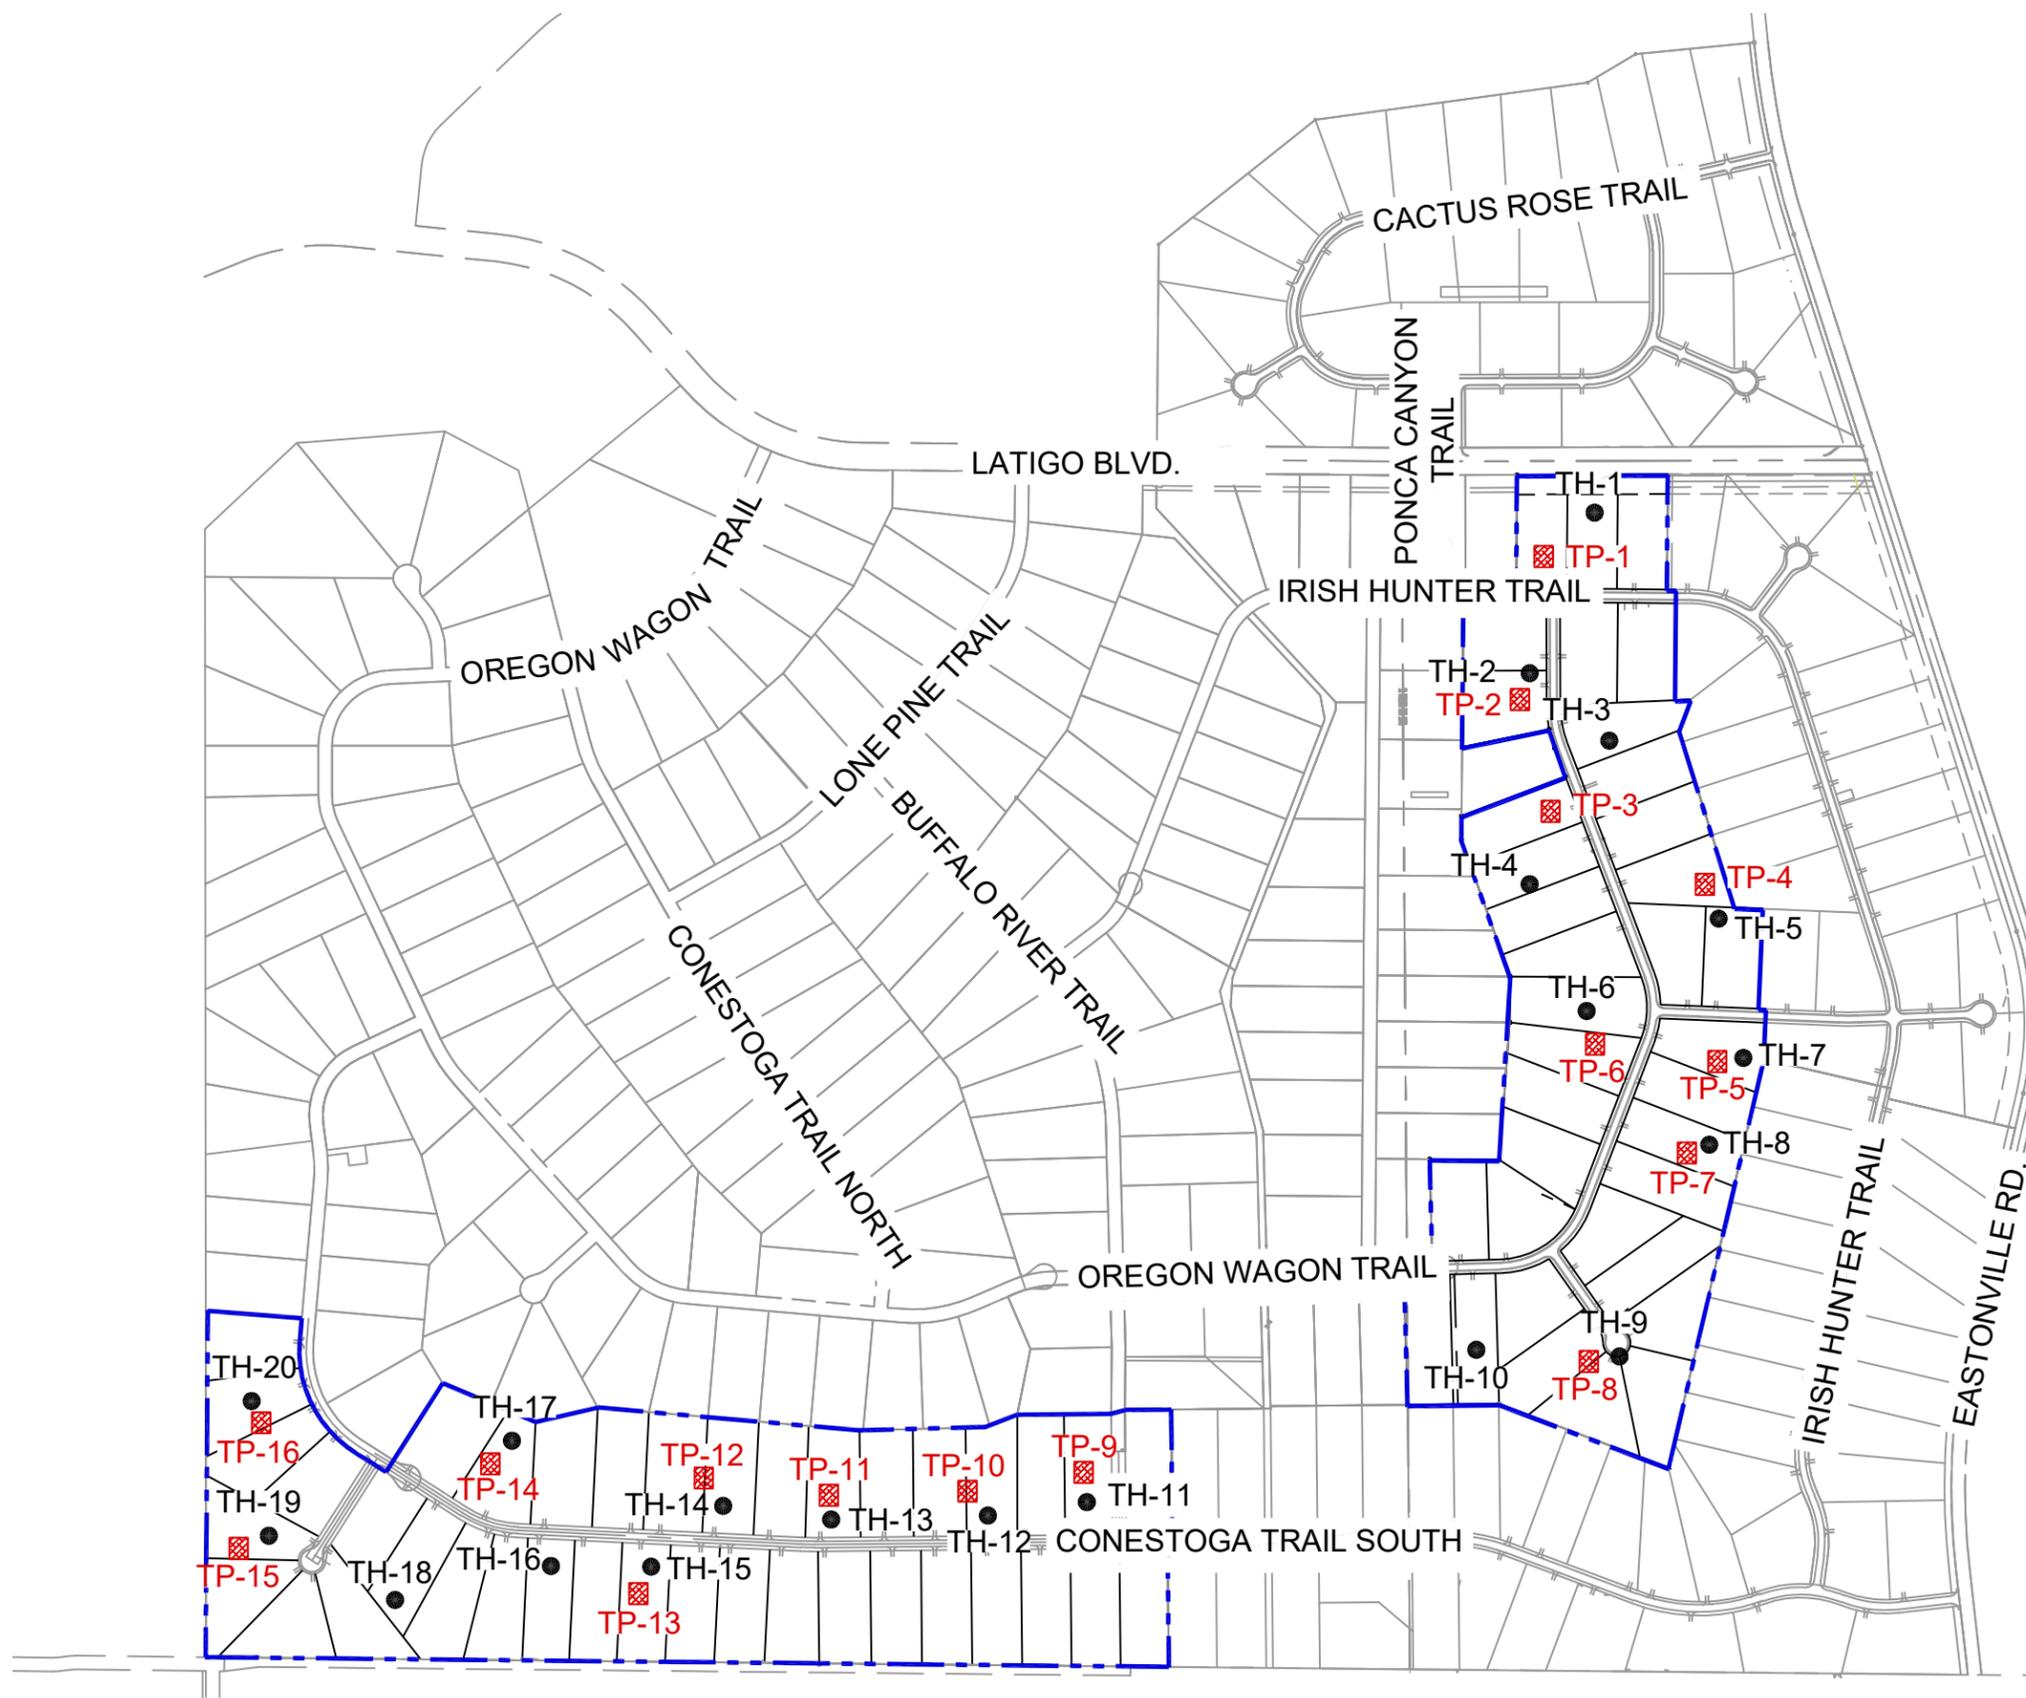
**LOCATION OF EXPLORATORY BORINGS AND SOIL PROFILE TEST PITS**

- LEGEND:
- TH-1 APPROXIMATE LOCATION OF EXPLORATORY BORING.
  - TP-1 APPROXIMATE LOCATION OF SOIL PROFILE TEST PIT.
  - - - PROJECT BOUNDARY

FIG. 1 – LOCATIONS OF EXPLORATORY BORINGS AND SOIL PROFILE  
TEST PITS

We investigated subsurface conditions June 14<sup>th</sup> through June 23<sup>rd</sup>, 2021 by drilling and sampling twenty exploratory borings. Additionally, we excavated a total of sixteen test pits on July 29, 2021. The approximate locations of our borings and test

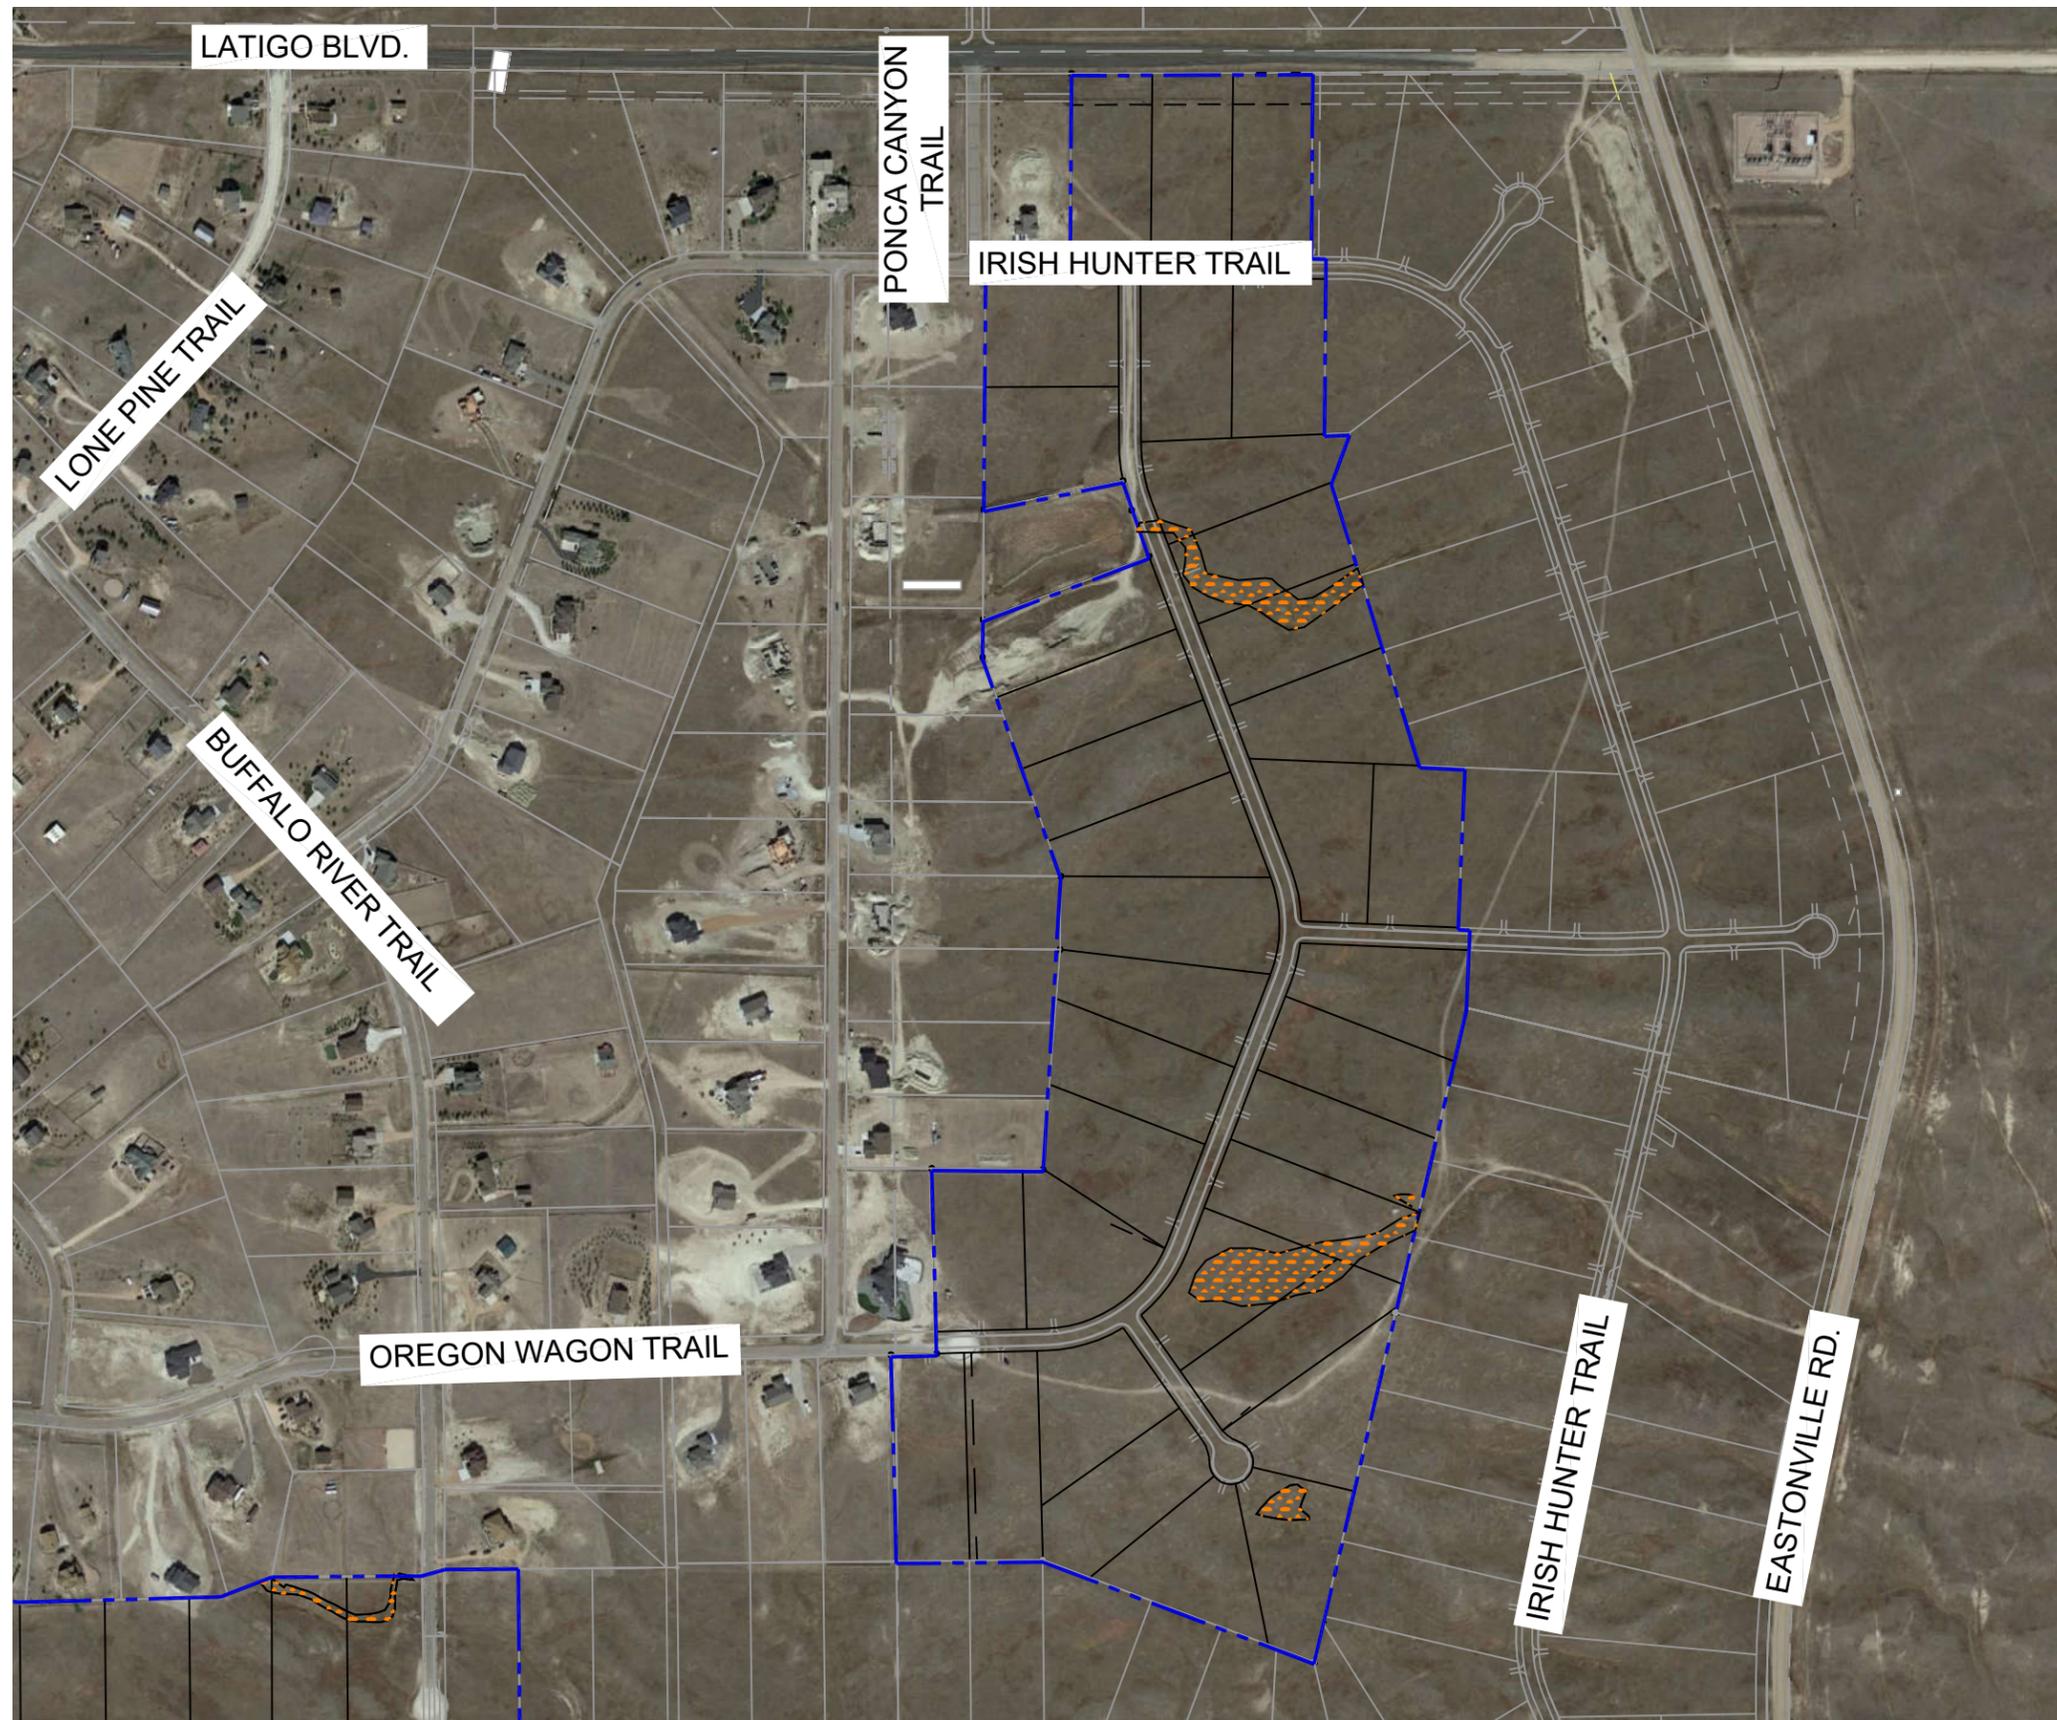
**FILLING 9  
SEPTIC  
SUITABILITY  
MAP**

AREAS WHERE SEPTIC SYSTEMS ARE NOT RECOMMENDED.

FIGS. 2 and 3 – SEPTIC SUITABILITY MAPS

Drainages and seasonally moist areas currently identified on the site have been noted on Figs. 2 and 3 as areas where septic systems are not recommended.

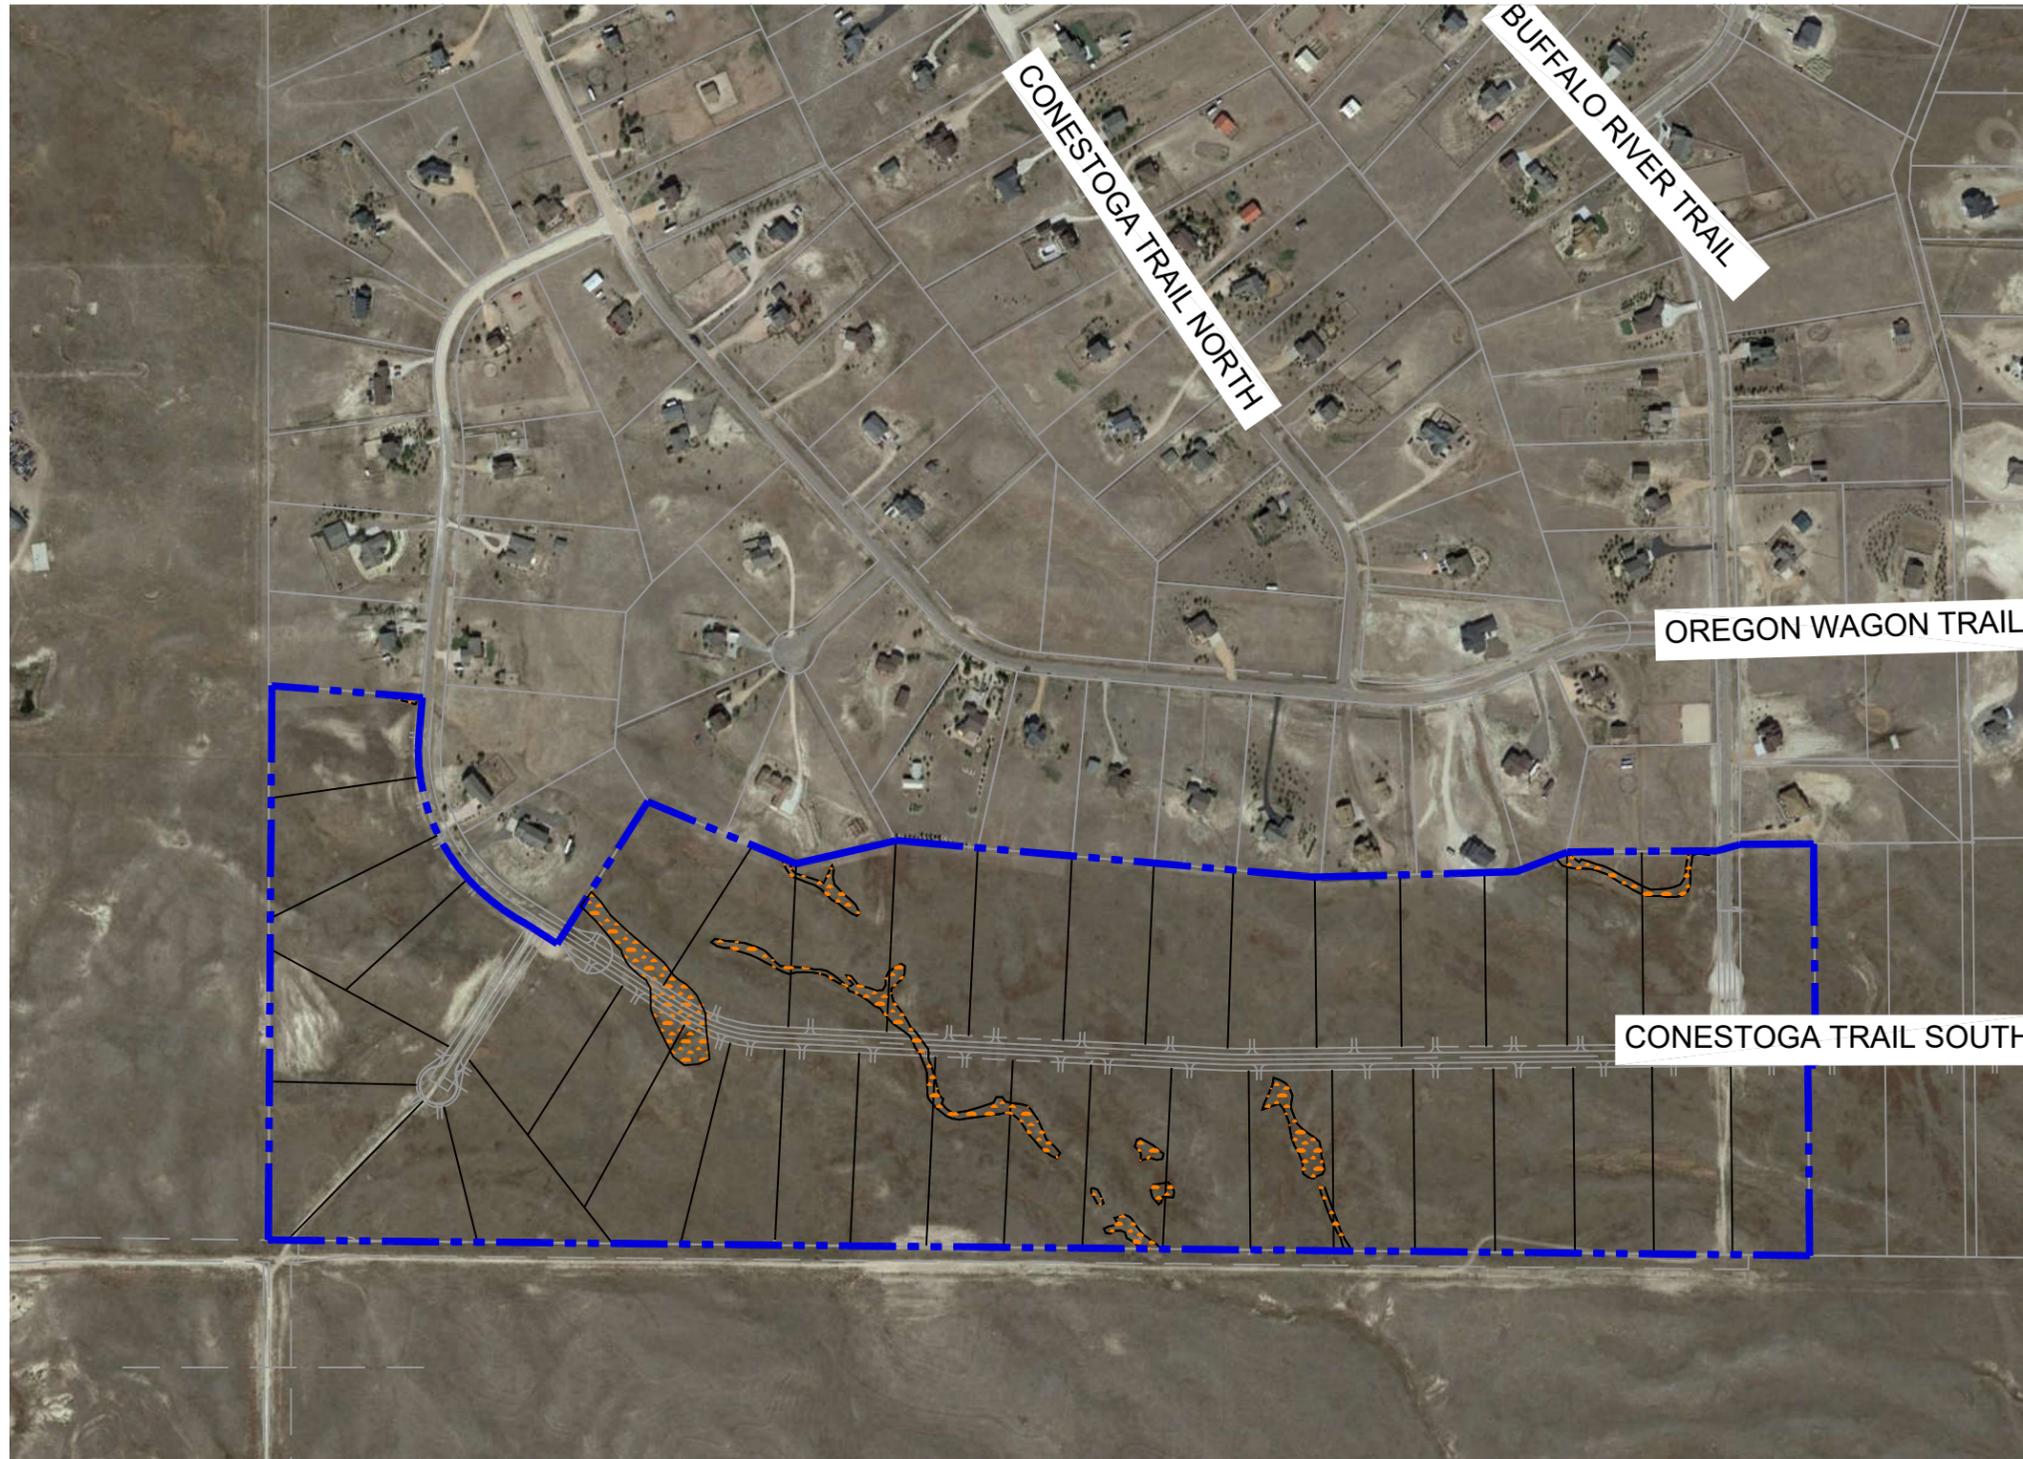
**FILLING 10  
SEPTIC  
SUITABILITY  
MAP**

AREA WHERE SEPTIC SYSTEMS ARE NOT RECOMMENDED.
-

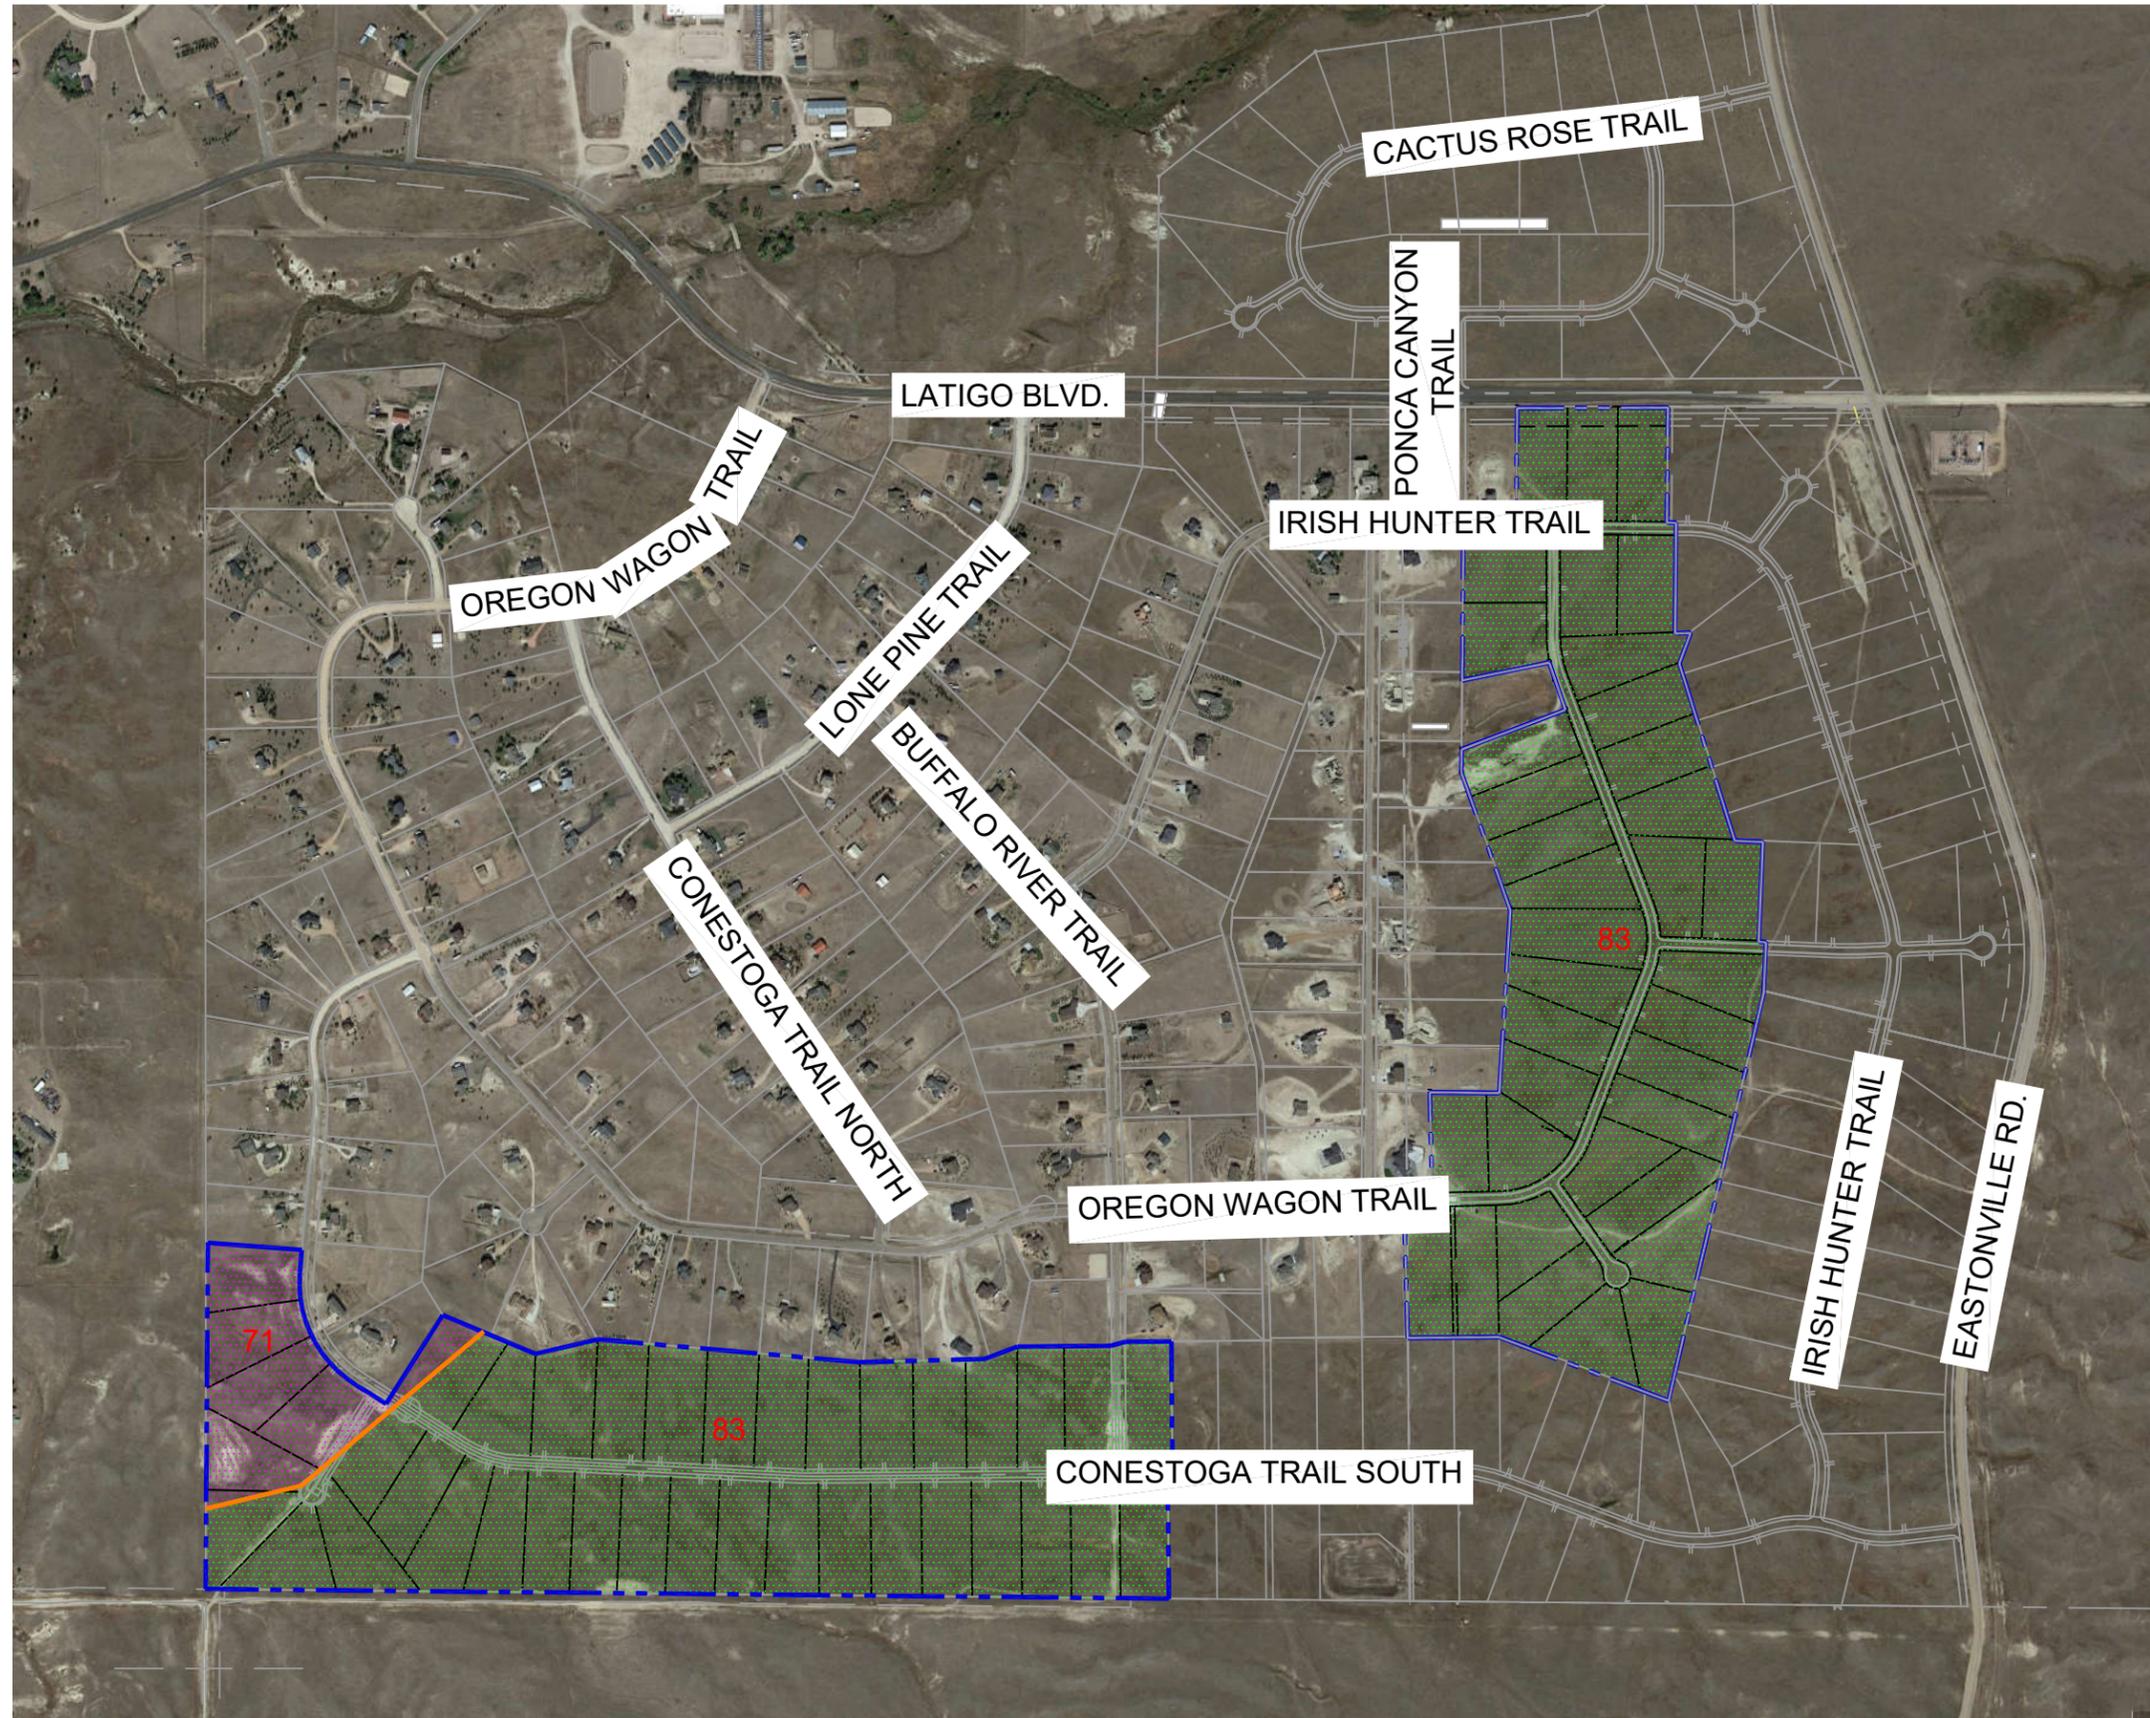
APPROXIMATE BOUNDARY OF SOIL SURVEY CONTACT.
-

71 PRING COARSE SANDY LOAM, 3 TO 8 PERCENT SLOPES.
-

83 STAPLETON SANDY LOAM, 3 TO 8 PERCENT SLOPES.

FIG. 4 – NRCS SOIL SURVEY MAP

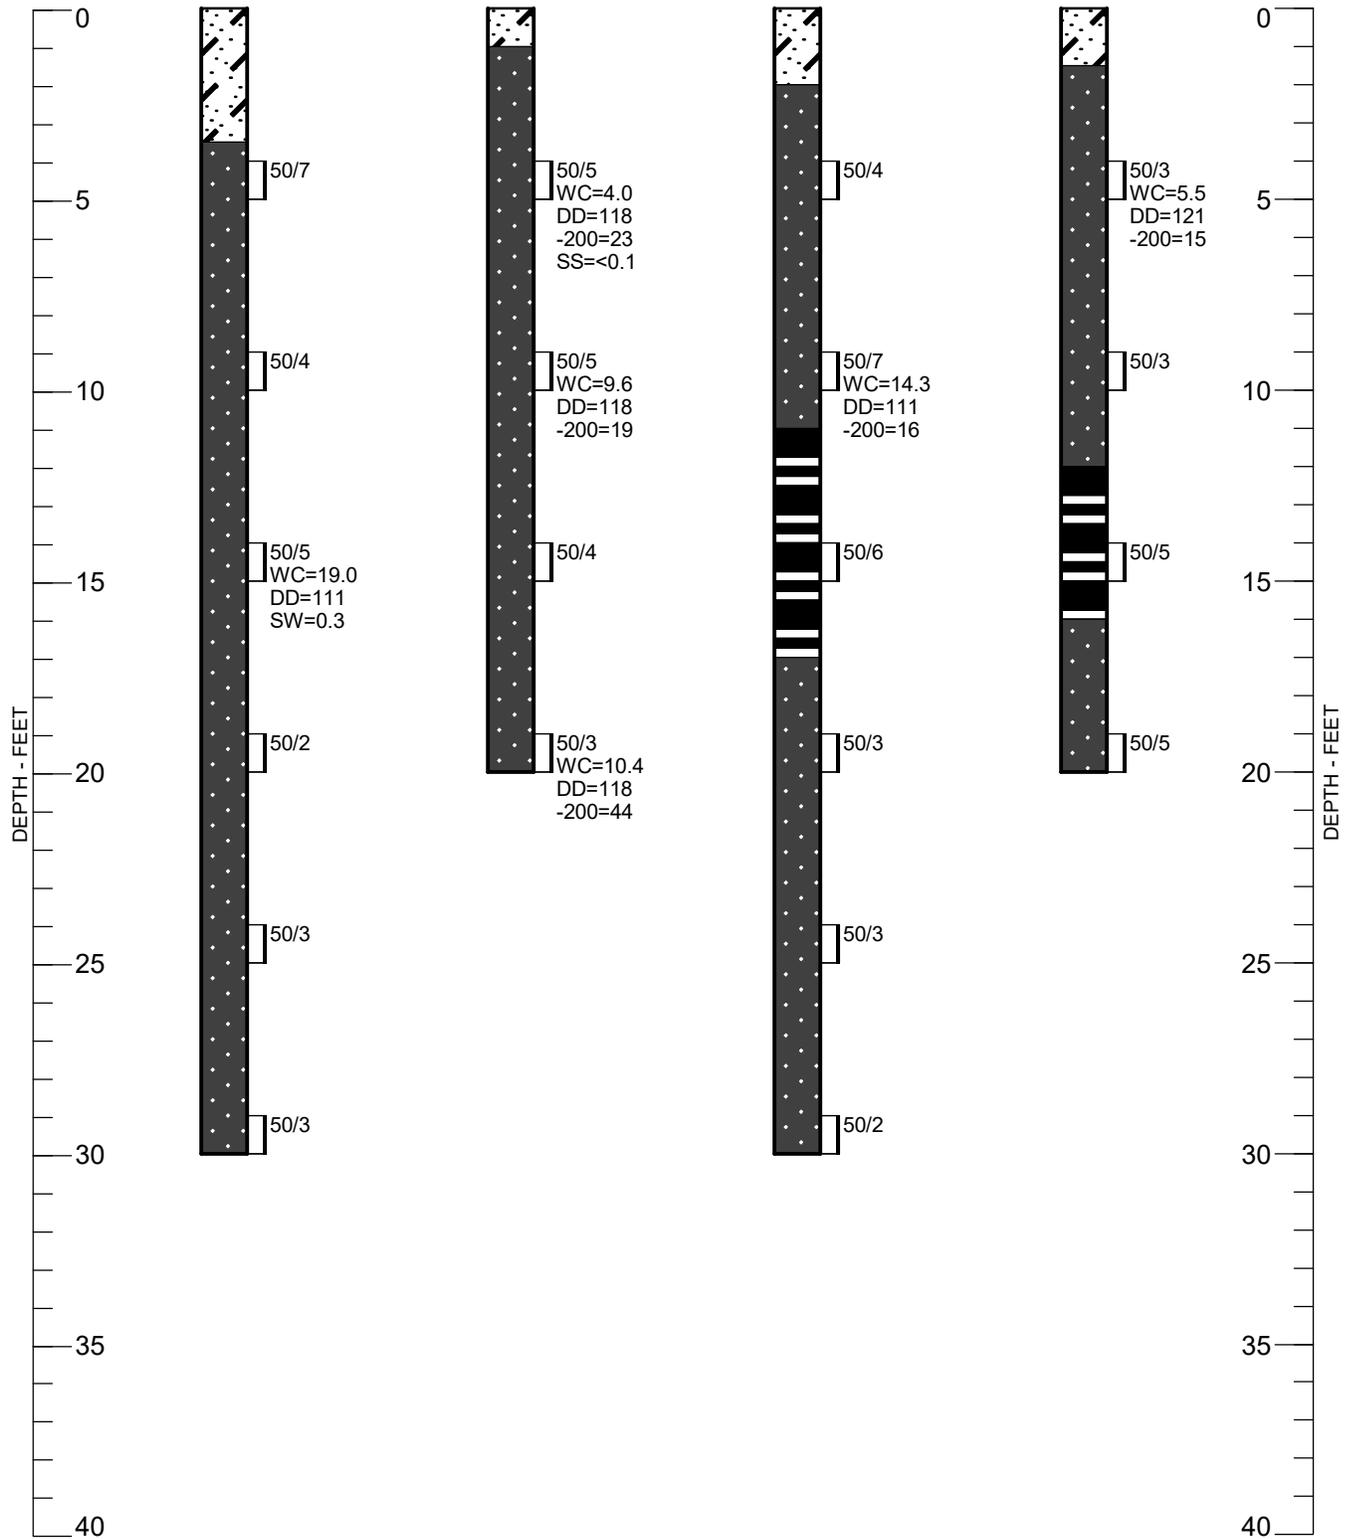
### Summary Logs of Exploratory Borings

TH - 13

TH - 15

TH - 16

The soils encountered in our test pits consisted predominantly of Type 1 sand and loamy sand and Type 2 sandy loam with localized areas of silty clay loam and sandy clay. Bedrock was identified in fourteen of our test pits at depths between 2 and 9 feet. It is noted that bedrock was identified in our borings at depths of 1 to 3 feet; however, the borings were drilled for the purpose of geotechnical engineering and the methodology for determining bedrock for OWTS purposes differs slightly. The observations in the test pits were generally relied upon for this report. The near surface bedrock was typically sandstone with some shallow claystone beds in the southeastern portion of Filing 9. The soil and bedrock layers encountered in our test pits are summarized below in Table A. Our boring logs are presented in Appendix A.

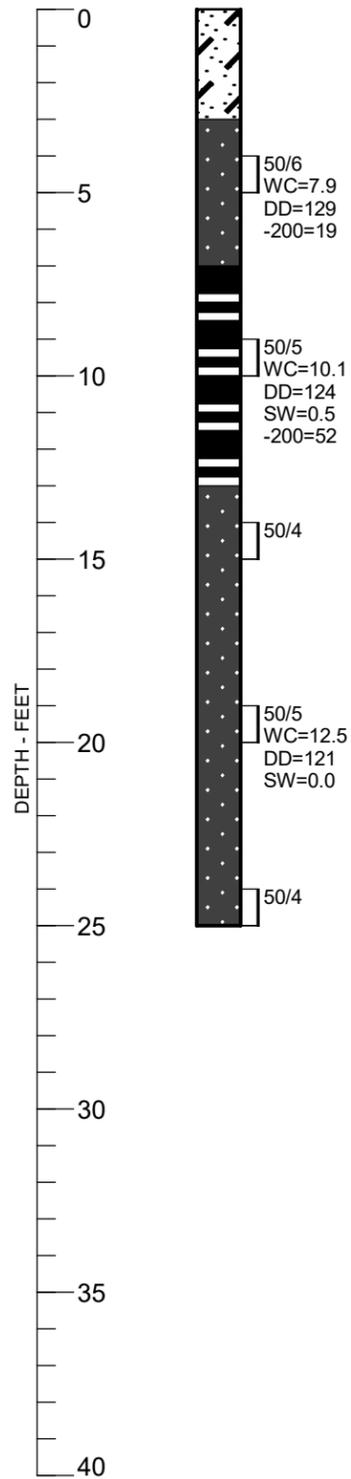
TH - 18

- CLAY, SAND, SLIGHTLY MOIST TO MOIST, LIGHT BROWN TO BROWN (SC).
- SANDSTONE, SLIGHTLY SILTY TO VERY SILTY, CLAYEY TO VERY CLAYEY, HARD TO VERY HARD, DRY TO MOIST VARIOUS SHADES OF BROWN AND GRAY.
- CLAYSTONE, SANDY TO VERY SANDY, VERY HARD, SLIGHTLY MOIST TO MOIST, GRAY TO BROWN.

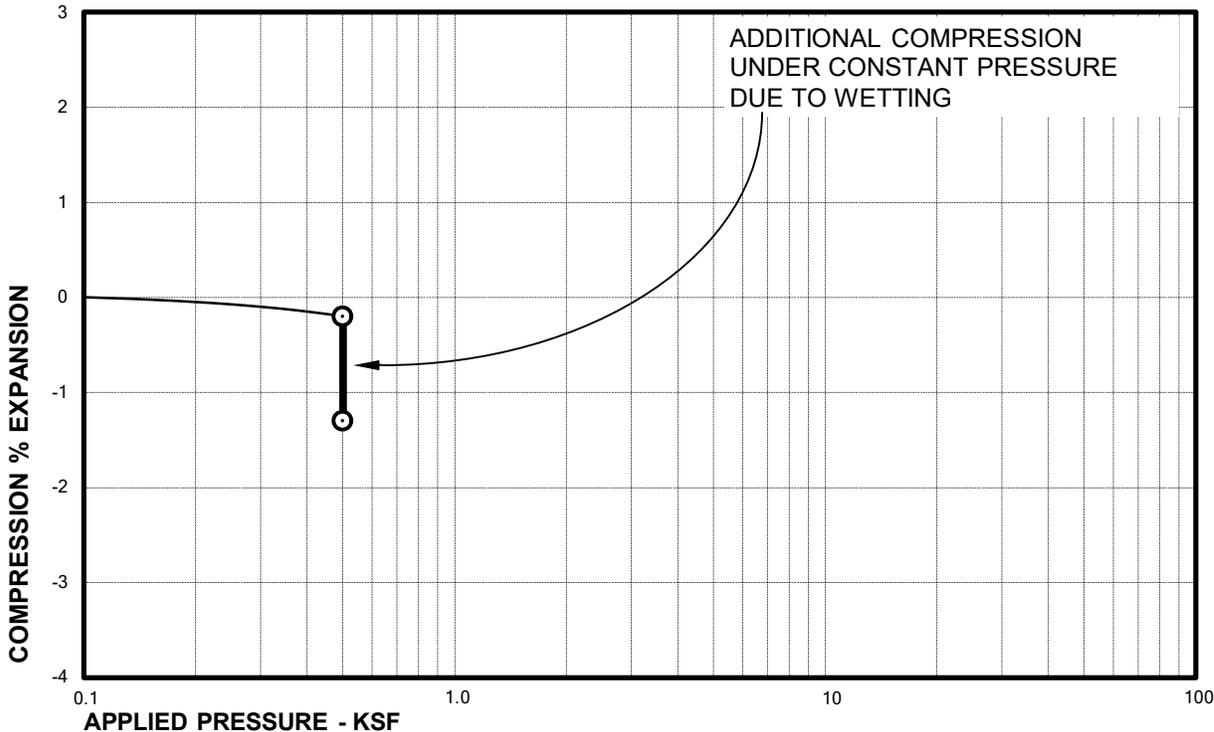
Sample of SANDSTONE, CLAYEY  
From TH-1 AT 4 FEET

DRY UNIT WEIGHT= 121 PCF  
MOISTURE CONTENT= 5.5 %

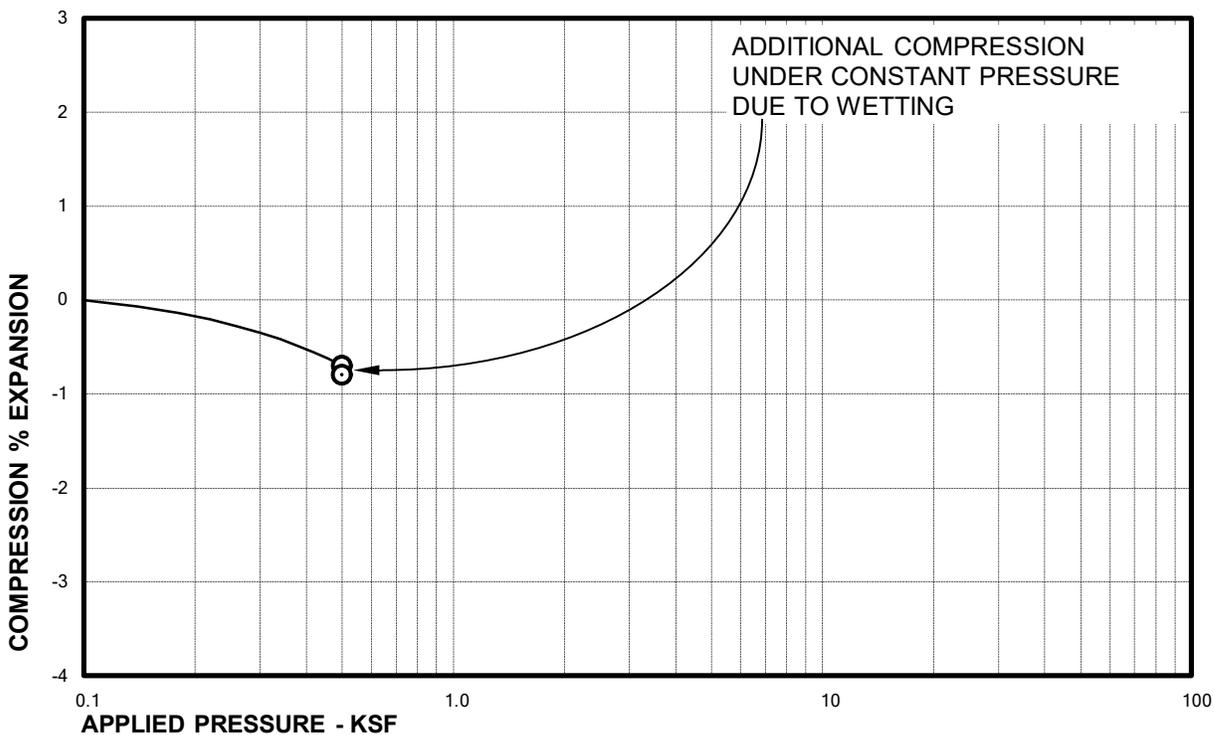
Sample of SANDSTONE, SILTY  
From TH-2 AT 4 FEET

DRY UNIT WEIGHT= 124 PCF  
MOISTURE CONTENT= 6.9 %

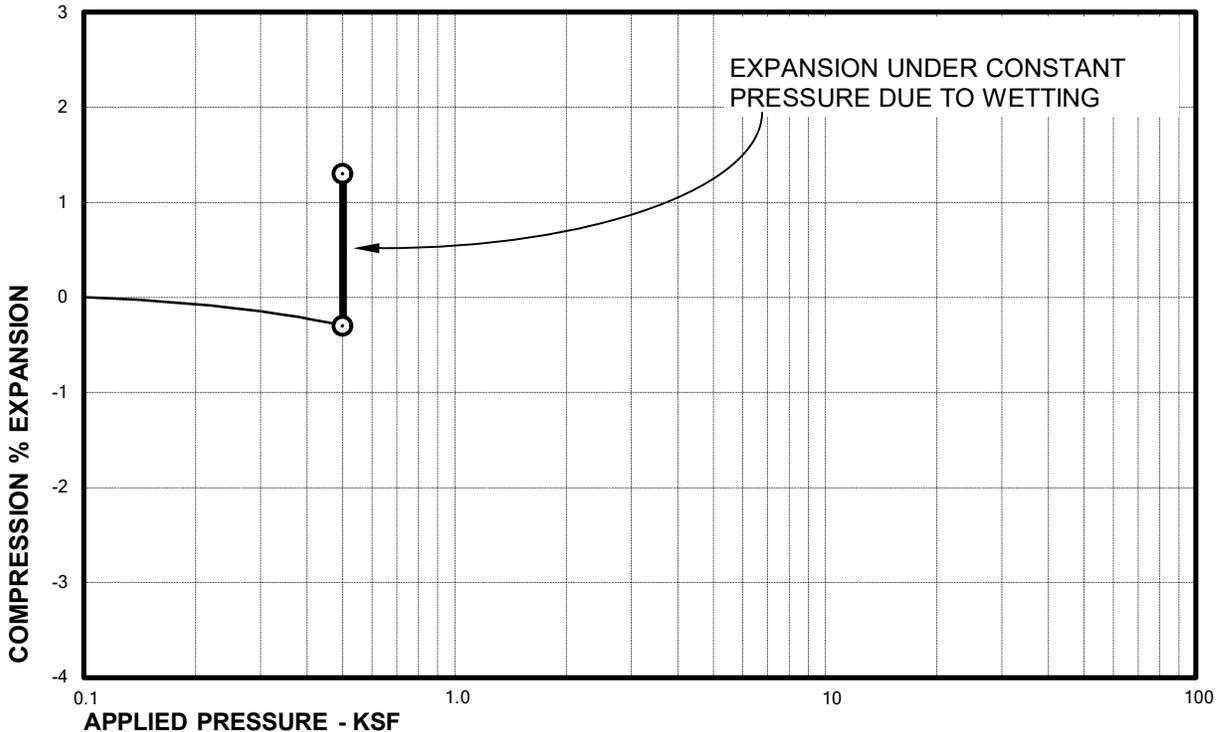
Sample of SANDSTONE, VERY CLAYEY  
From TH-4 AT 4 FEET

DRY UNIT WEIGHT= 125 PCF  
MOISTURE CONTENT= 8.2 %

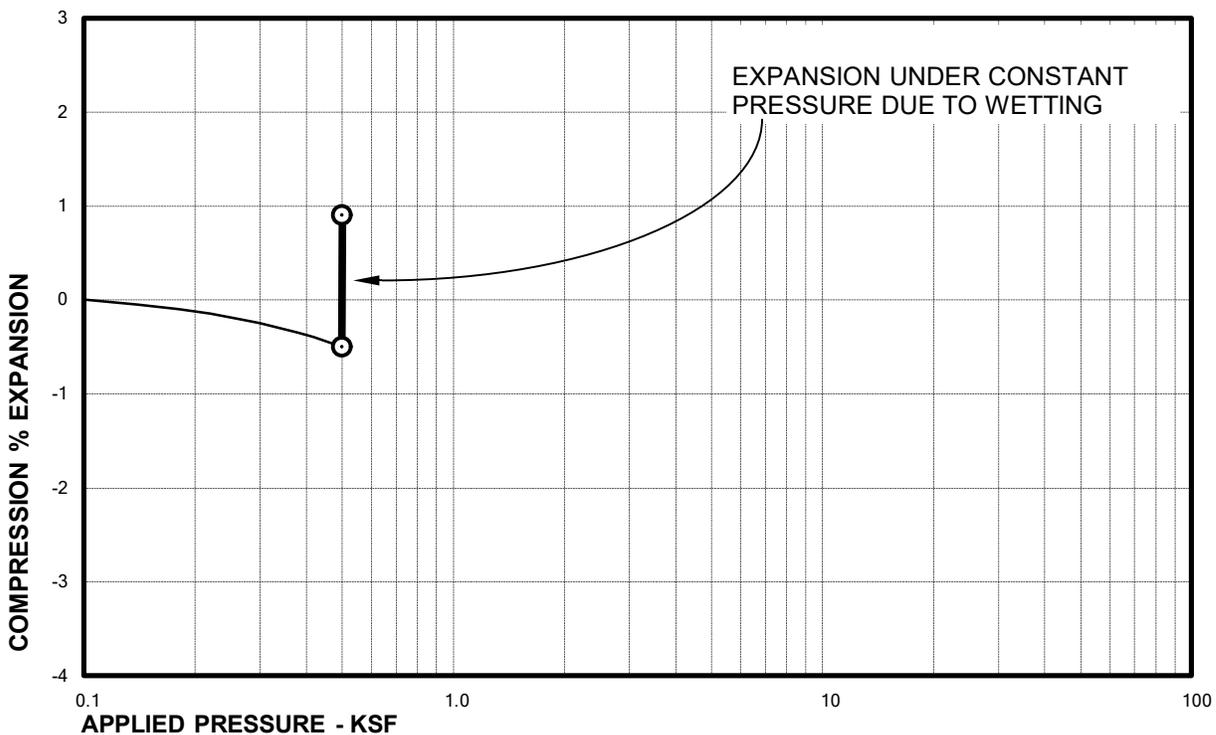
Sample of CLAYSTONE, SANDY  
From TH-7 AT 4 FEET

DRY UNIT WEIGHT= 119 PCF  
MOISTURE CONTENT= 12.4 %

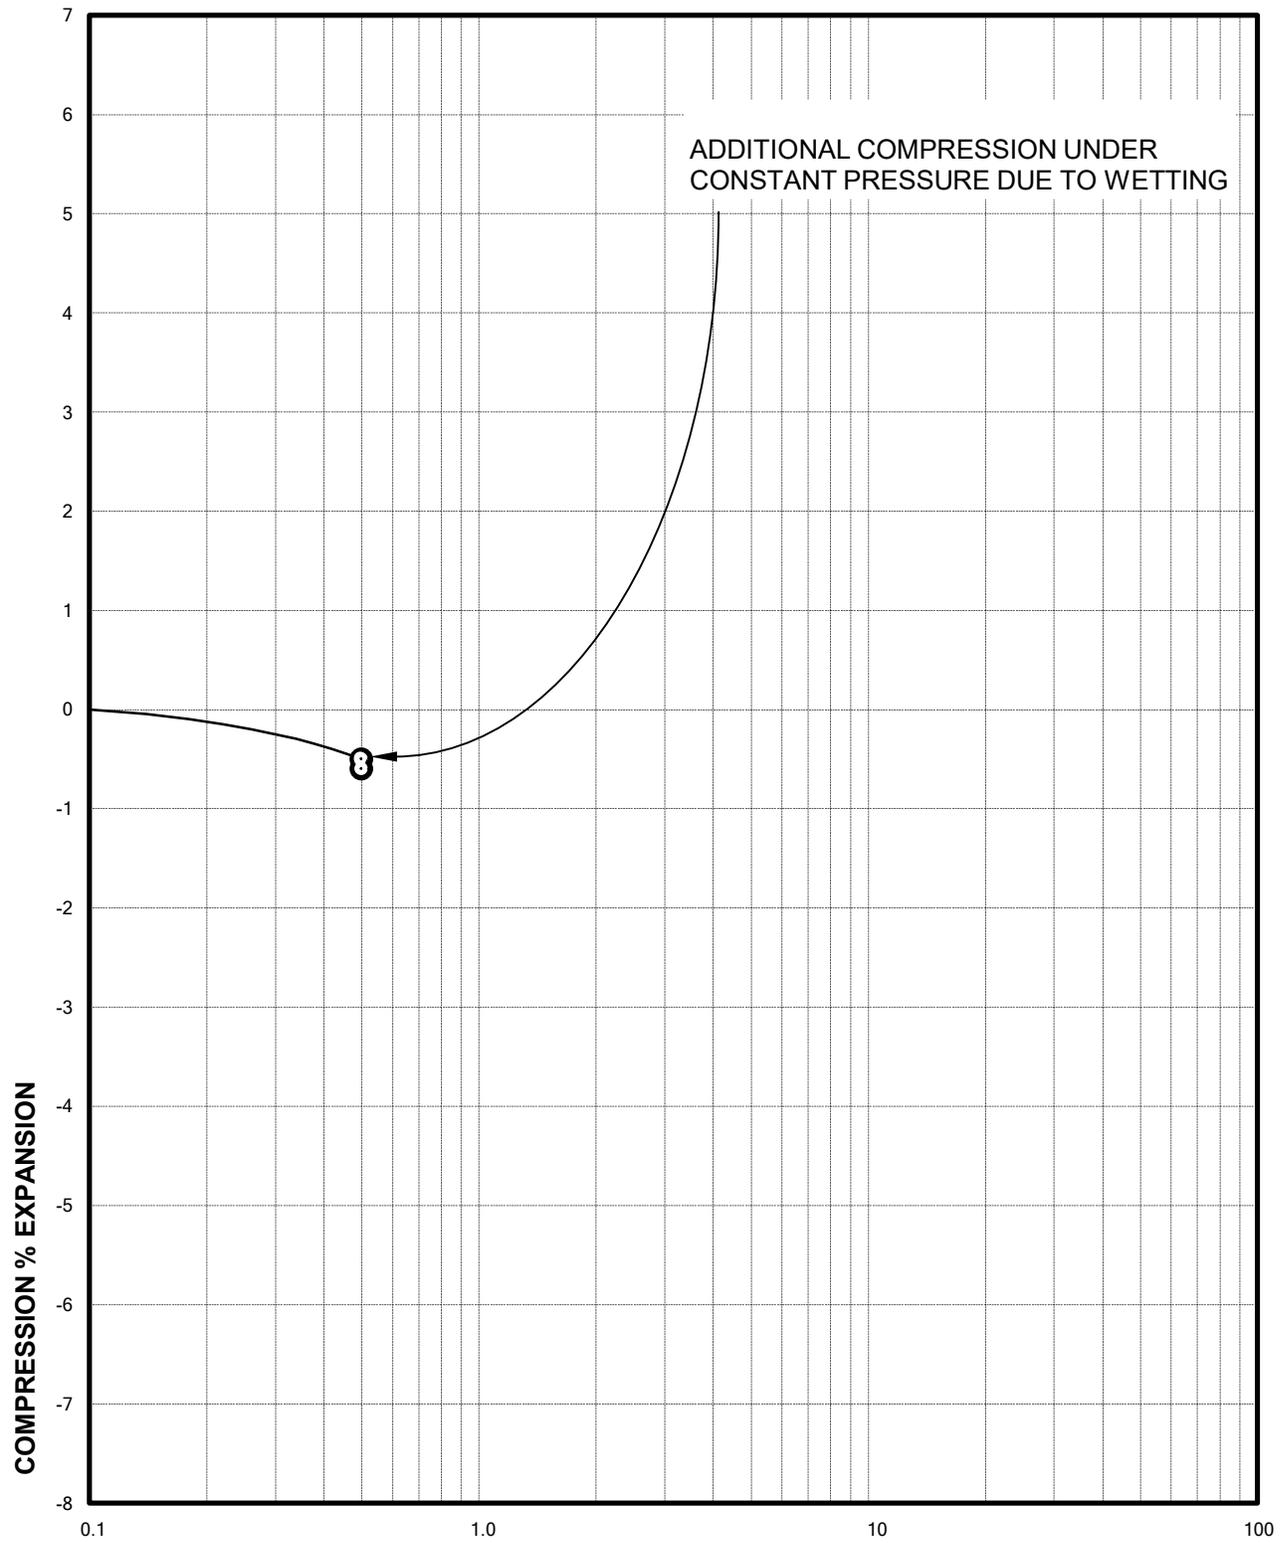
**APPLIED PRESSURE - KSF**  
Sample of SANDSTONE, VERY CLAYEY  
From TH-7 AT 9 FEET

DRY UNIT WEIGHT= 126 PCF  
MOISTURE CONTENT= 9.3 %
