**WASTEWATER REPORT  
LATIGO TRAILS FILINGS 9 AND 10, 78 LOTS  
SOUTHWEST OF EASTONVILLE ROAD  
AND LATIGO BOULEVARD  
EL PASO COUNTY, COLORADO**

Project No. CS19409-115

October 7, 2021

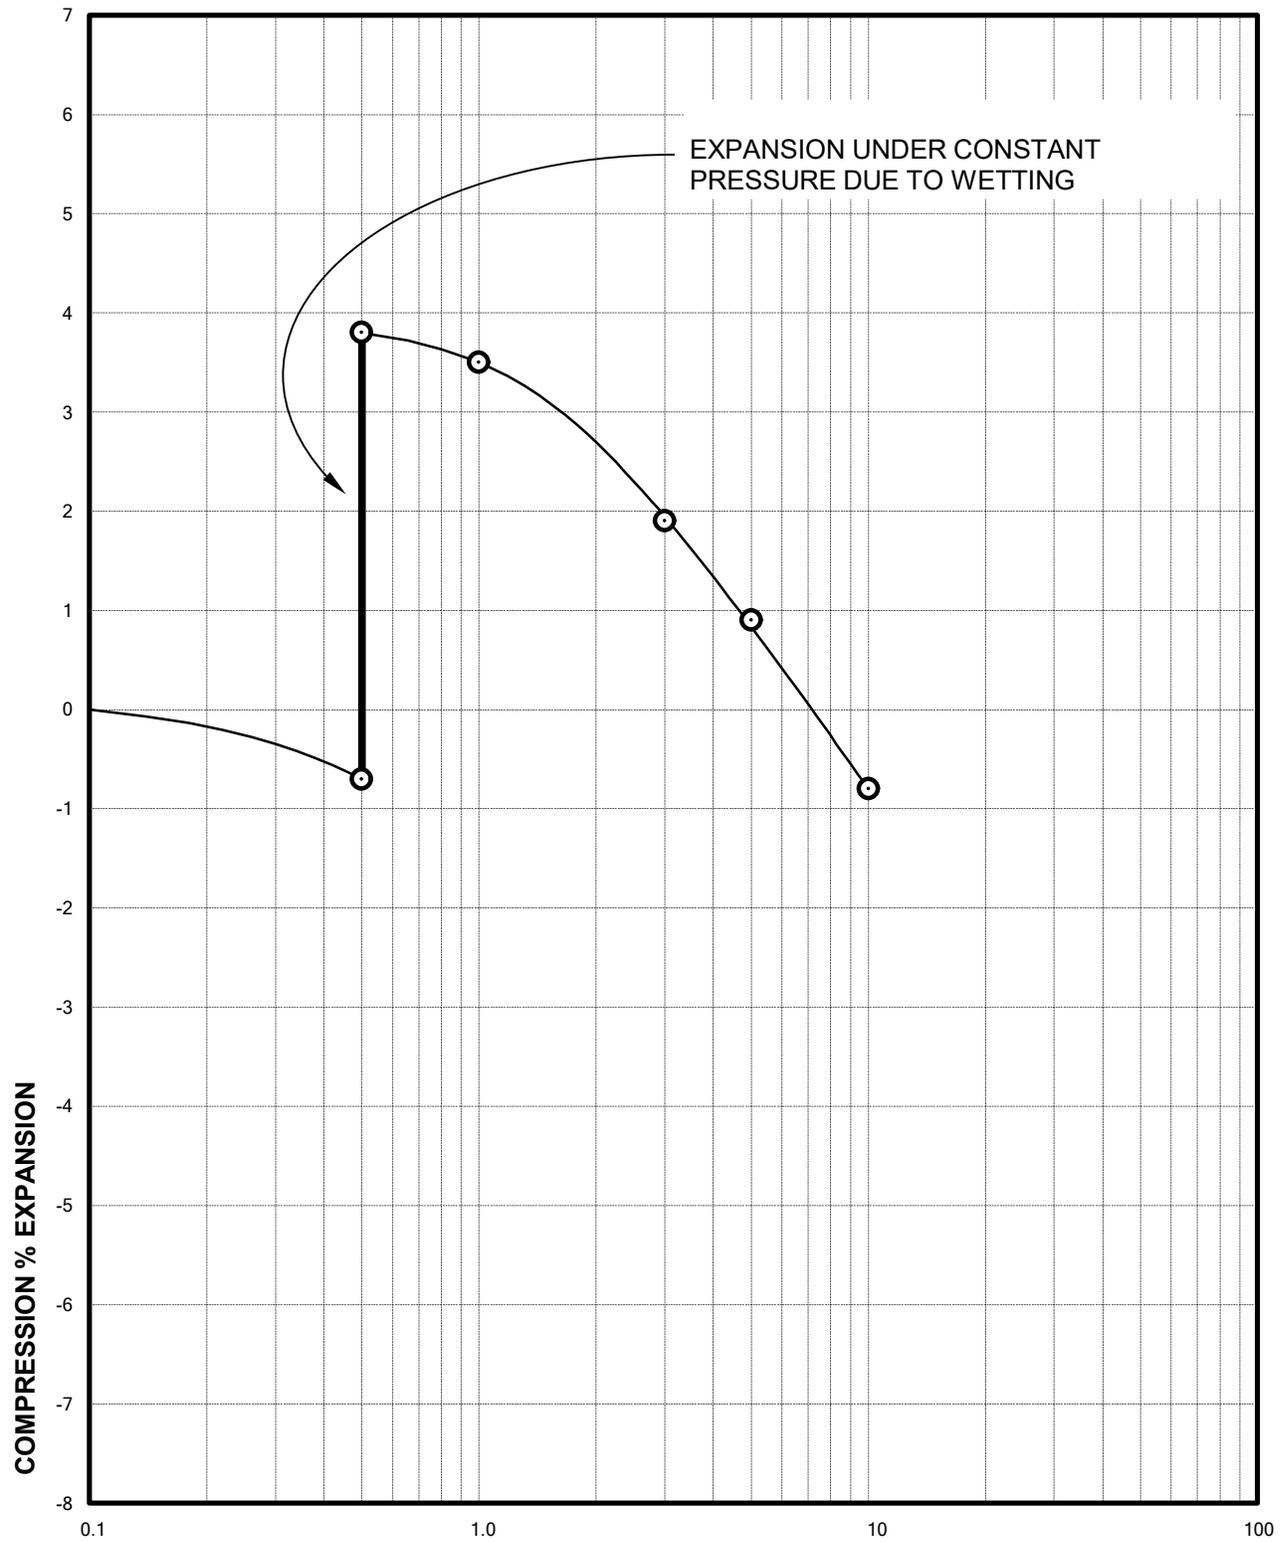
**APPLIED PRESSURE - KSF**  
Sample of CLAYSTONE, VERY SANDY  
From TH-8 AT 4 FEET

DRY UNIT WEIGHT= 124 PCF  
MOISTURE CONTENT= 8.5 %

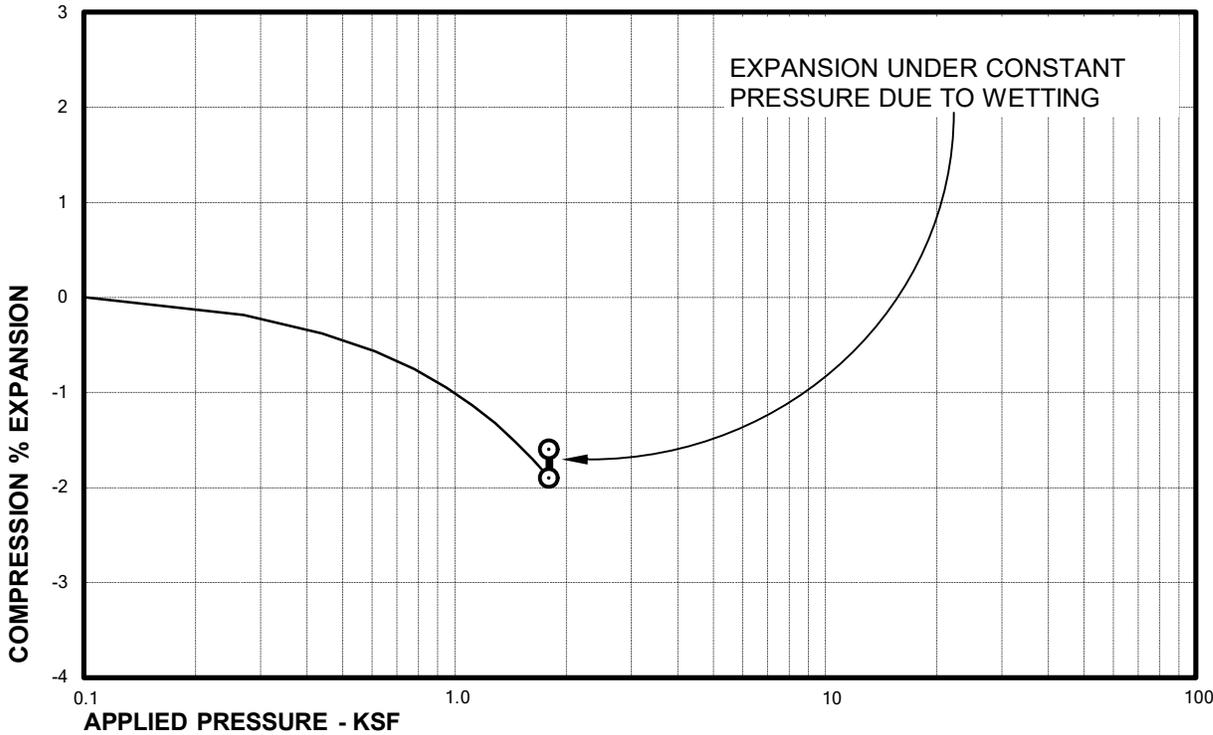
Sample of SANDSTONE, VERY CLAYEY  
From TH-9 AT 14 FEET

DRY UNIT WEIGHT= 111 PCF  
MOISTURE CONTENT= 19.0 %

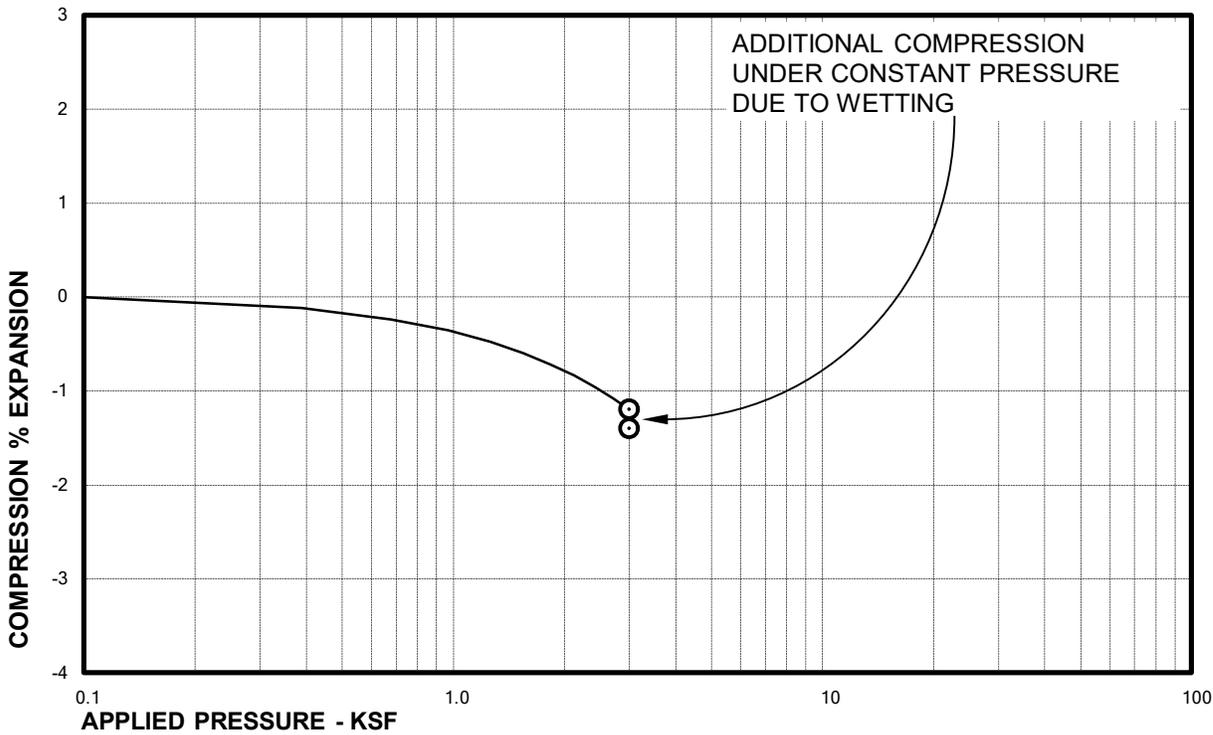
Sample of SANDSTONE, CLAYEY  
From TH-11 AT 24 FEET

DRY UNIT WEIGHT= 111 PCF  
MOISTURE CONTENT= 14.3 %

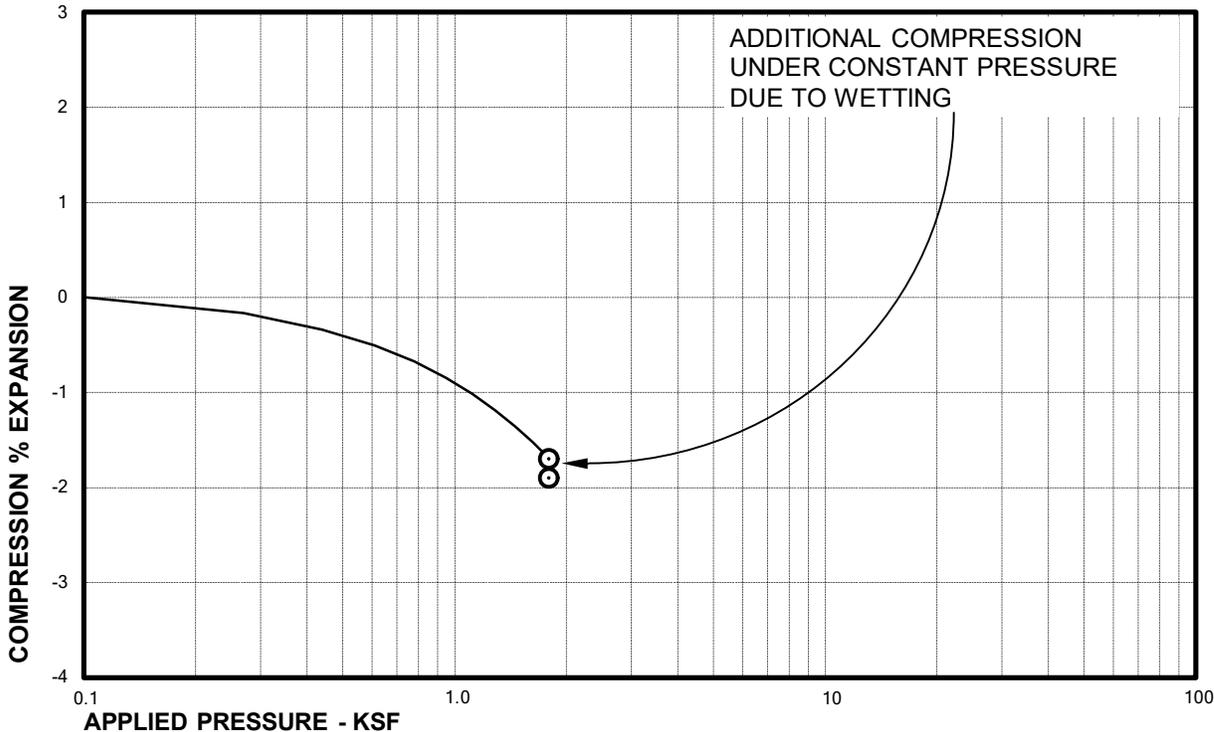
Sample of SANDSTONE, VERY SILTY  
From TH-13 AT 14 FEET

DRY UNIT WEIGHT= 122 PCF  
MOISTURE CONTENT= 11.2 %

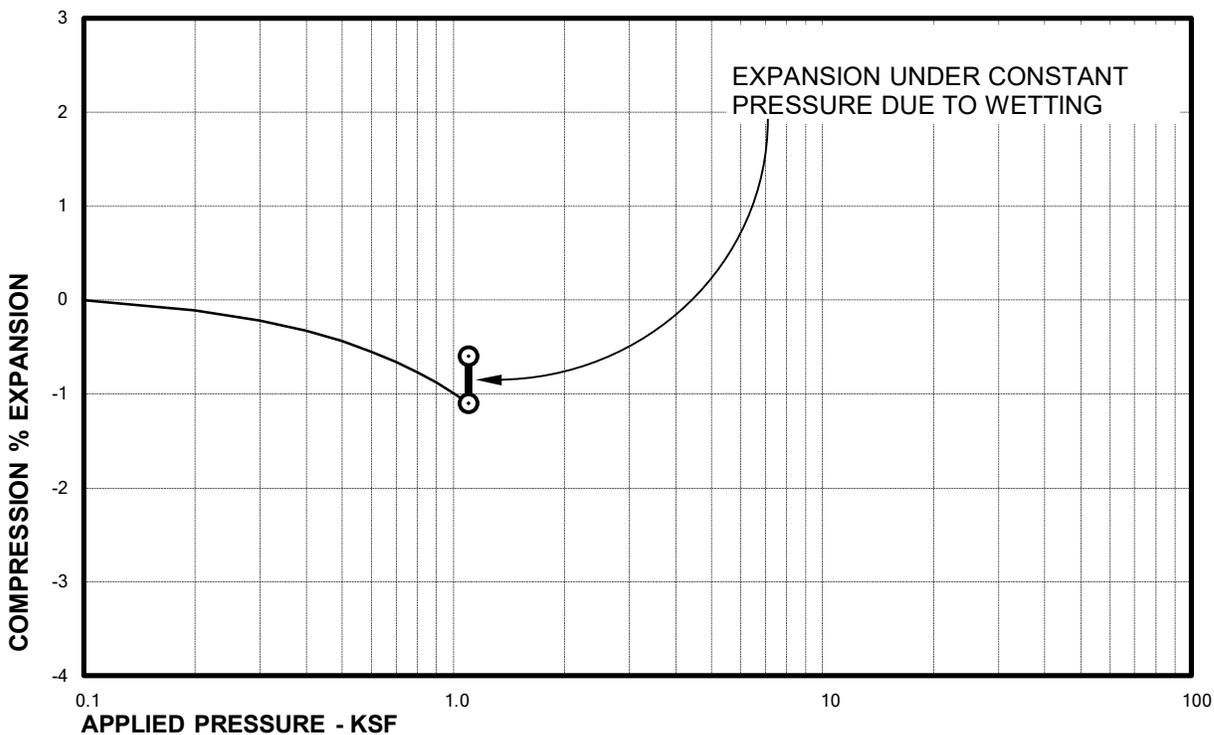
Sample of CLAYSTONE, VERY SANDY  
From TH-17 AT 9 FEET

DRY UNIT WEIGHT= 124 PCF  
MOISTURE CONTENT= 10.1 %

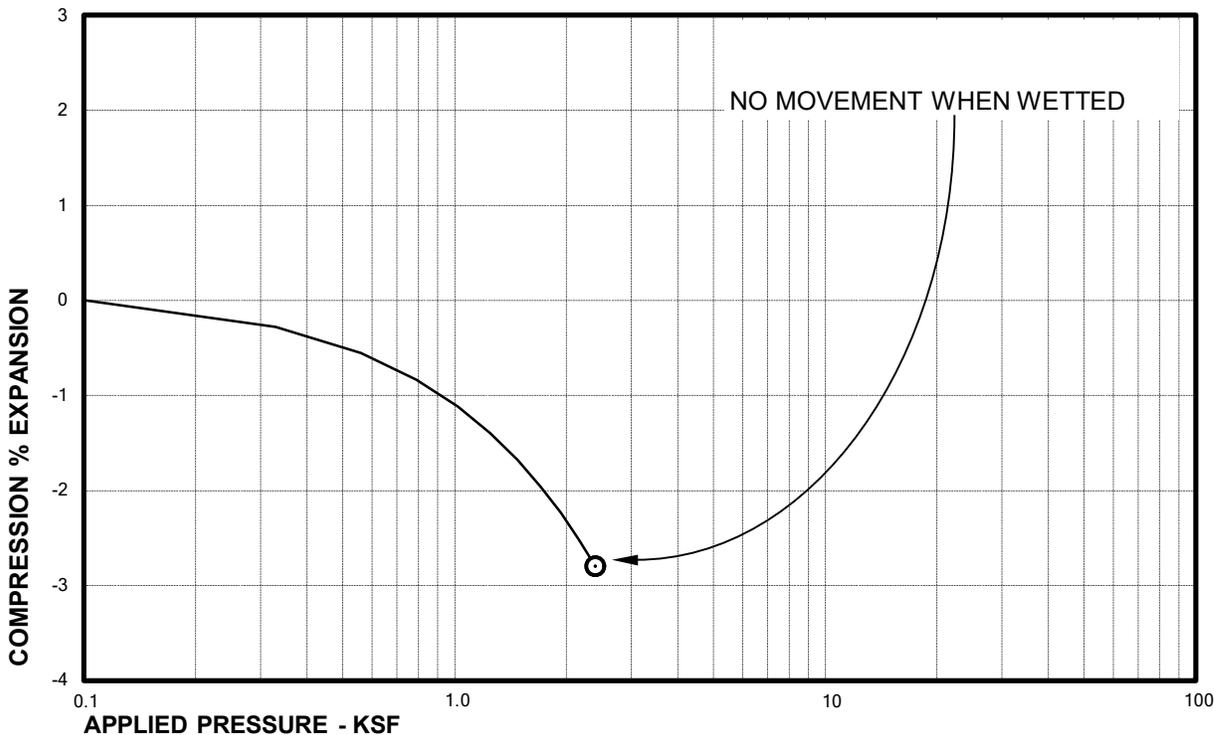
Sample of SANDSTONE  
From TH-17 AT 19 FEET

DRY UNIT WEIGHT= 121 PCF  
MOISTURE CONTENT= 12.5 %

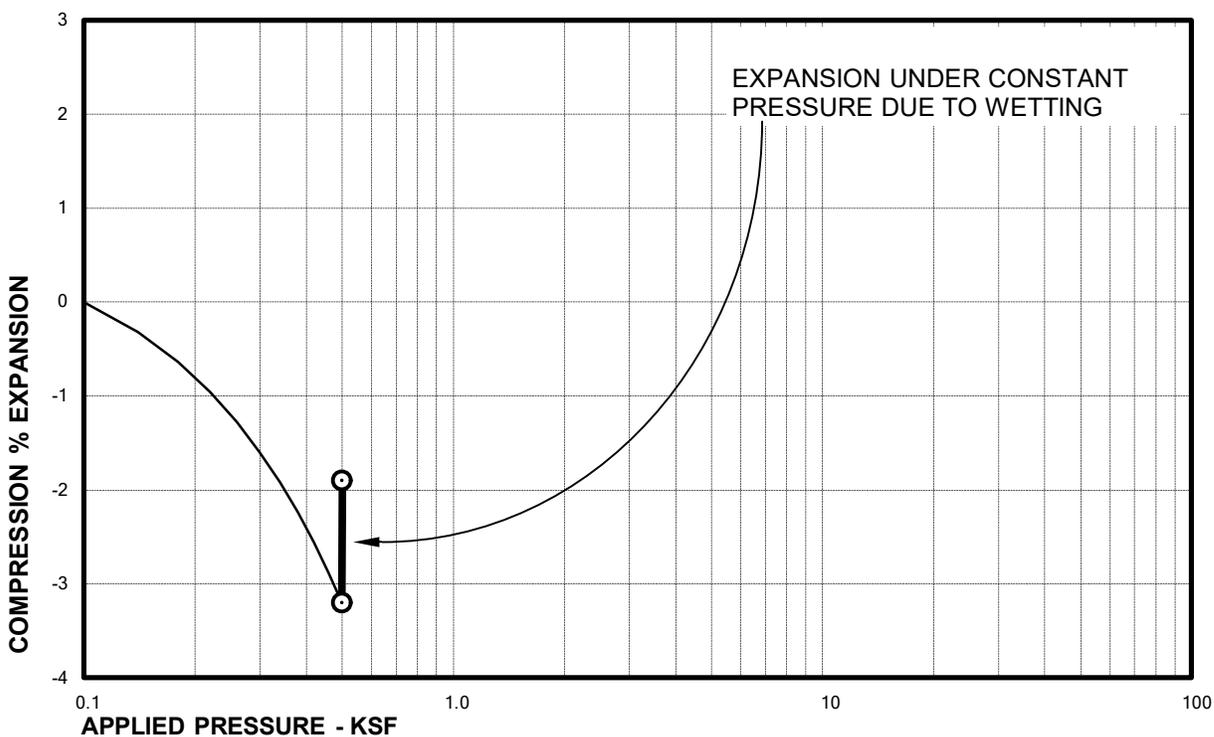
Sample of SANDSTONE, VERY CLAYEY  
From TH-18 AT 4 FEET

DRY UNIT WEIGHT= 124 PCF  
MOISTURE CONTENT= 9.7 %

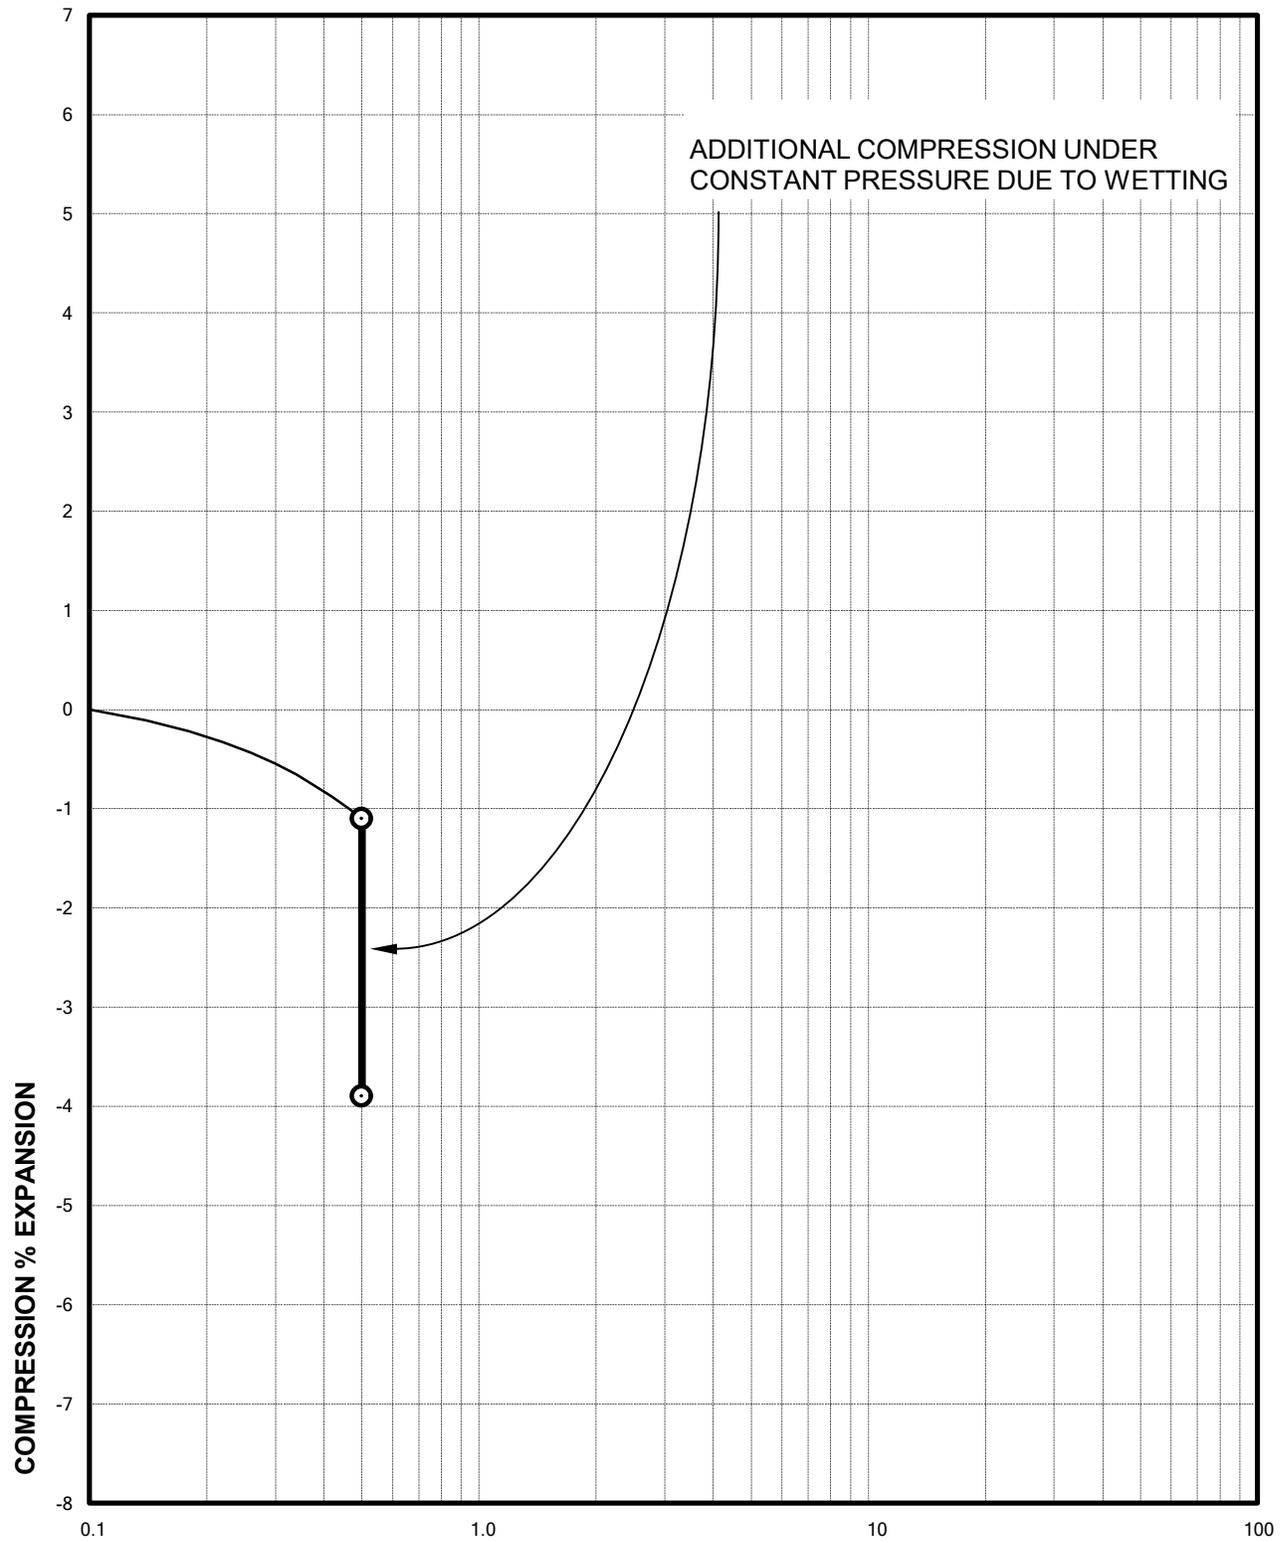
**APPLIED PRESSURE - KSF**  
Sample of CLAYSTONE, VERY SANDY  
From TH-19 AT 4 FEET

DRY UNIT WEIGHT= 104 PCF  
MOISTURE CONTENT= 10.5 %

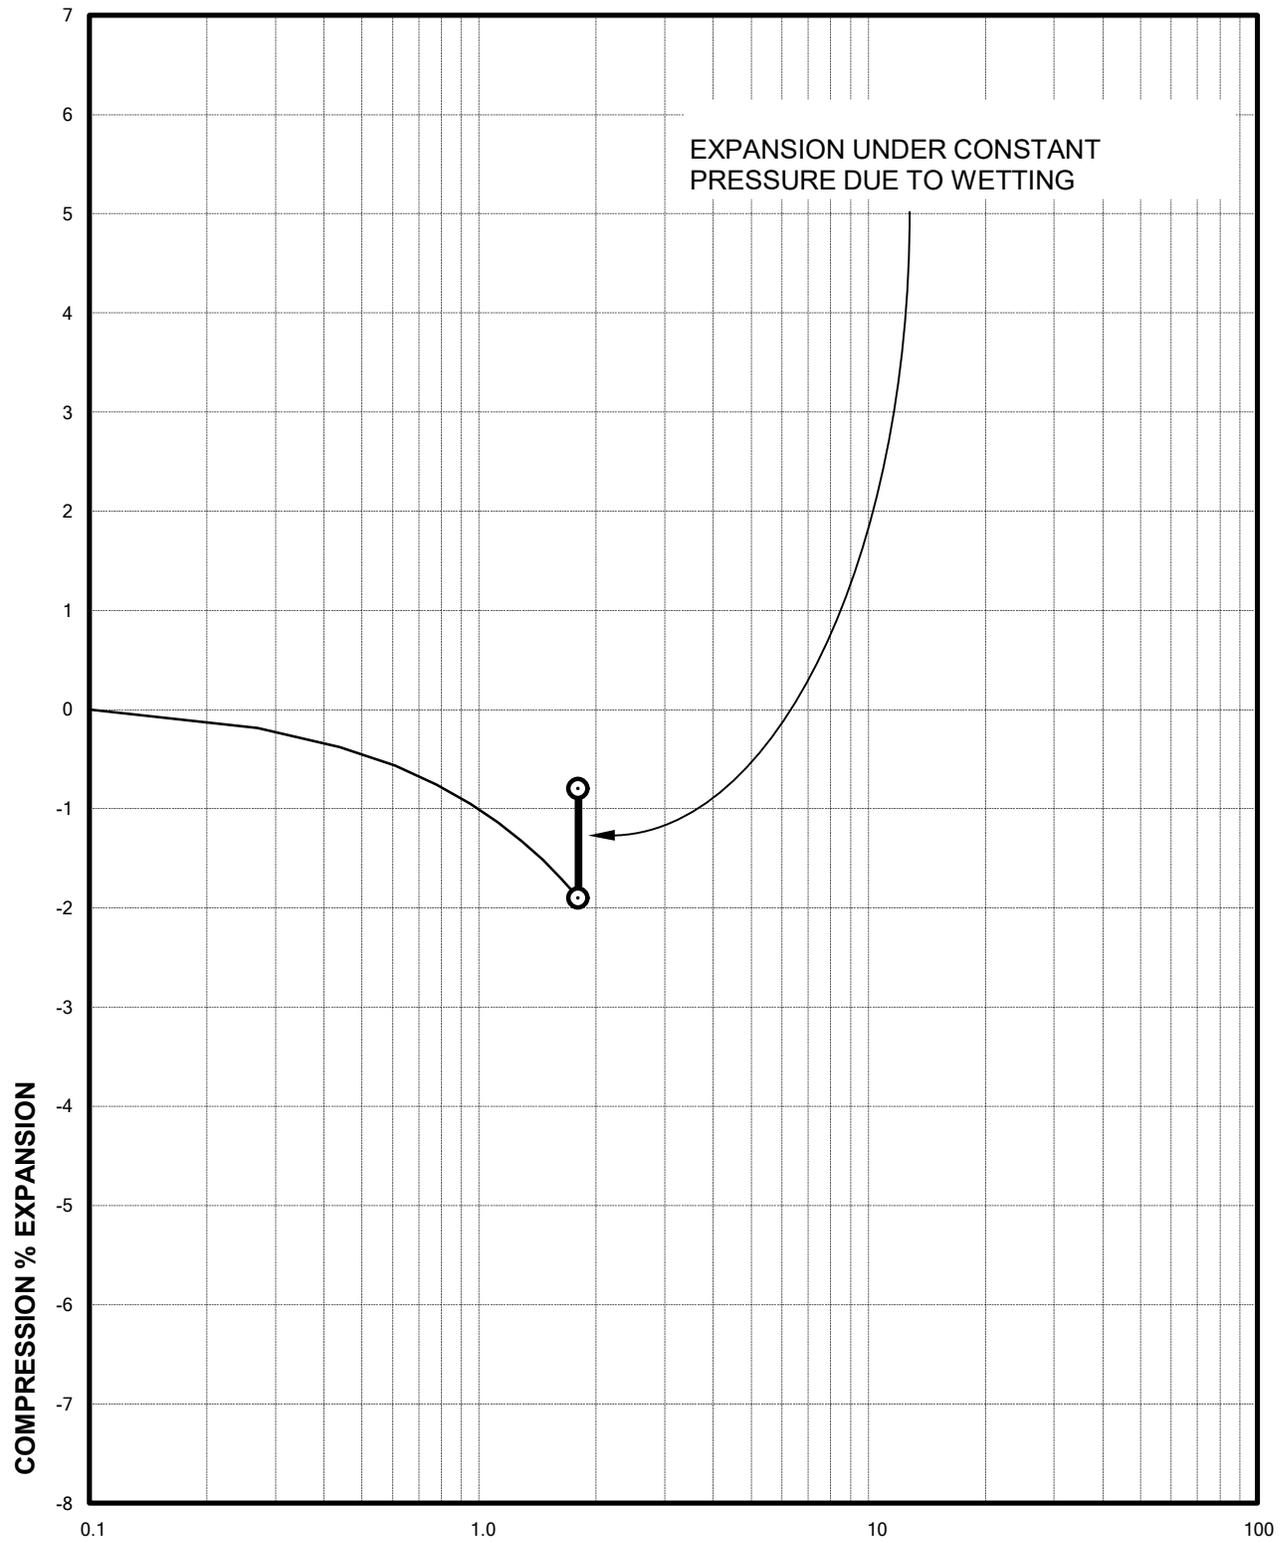
**APPLIED PRESSURE - KSF**  
Sample of SANDSTONE, CLAYEY  
From TH-20 AT 14 FEET

DRY UNIT WEIGHT= 121 PCF  
MOISTURE CONTENT= 12.0 %

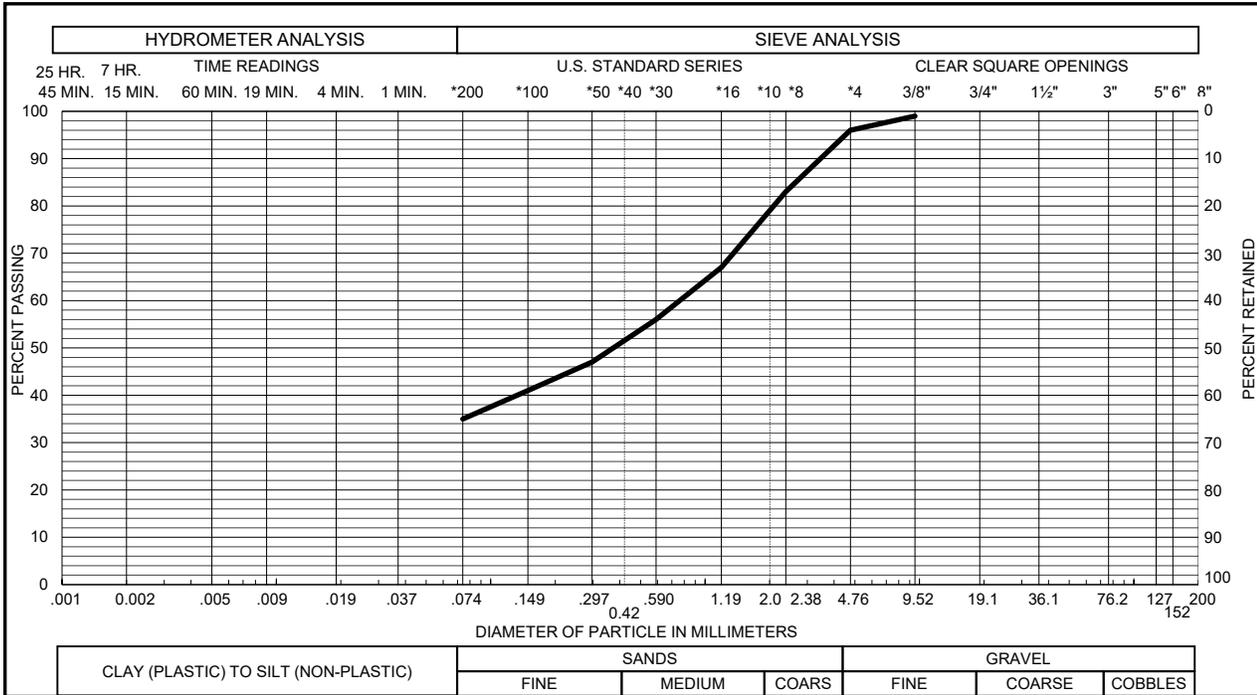
Sample of SANDSTONE, SILTY GRAVEL 4 % SAND 61 %  
 From TH - 2 AT 9 FEET SILT & CLAY 35 % LIQUID LIMIT     %   
 PLASTICITY INDEX     %

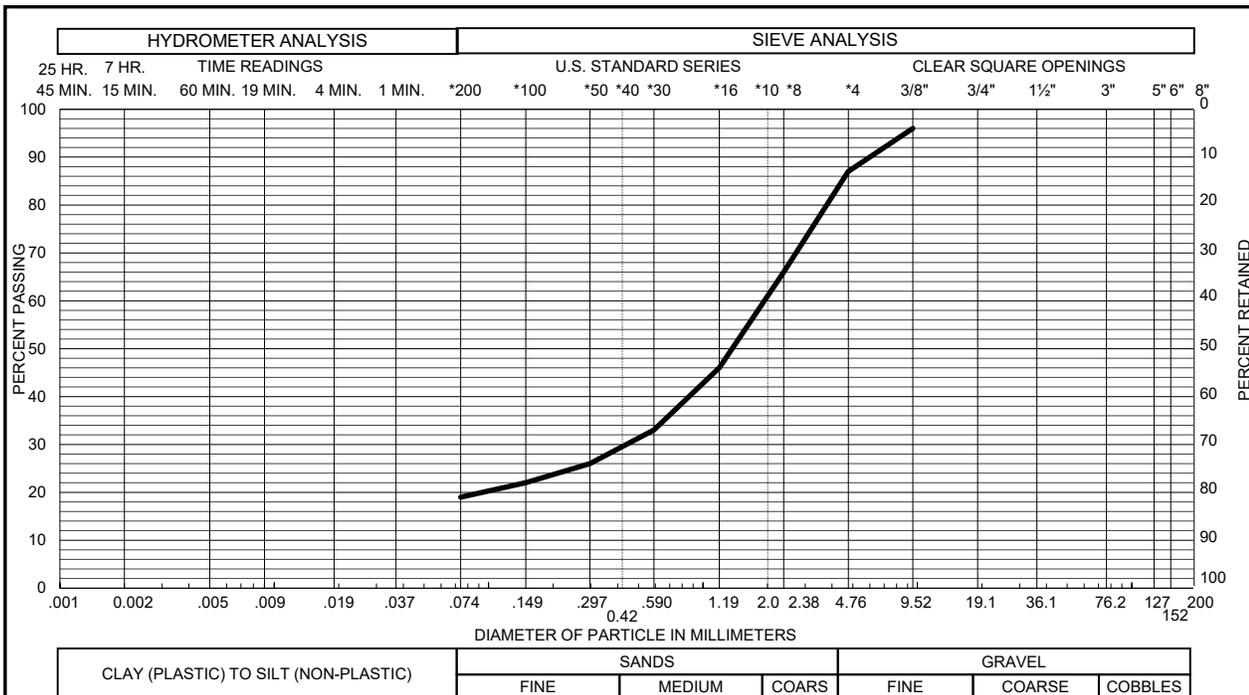
Sample of SANDSTONE, SILTY GRAVEL 13 % SAND 68 %  
 From TH - 3 AT 4 FEET SILT & CLAY 19 % LIQUID LIMIT     %   
 PLASTICITY INDEX     %

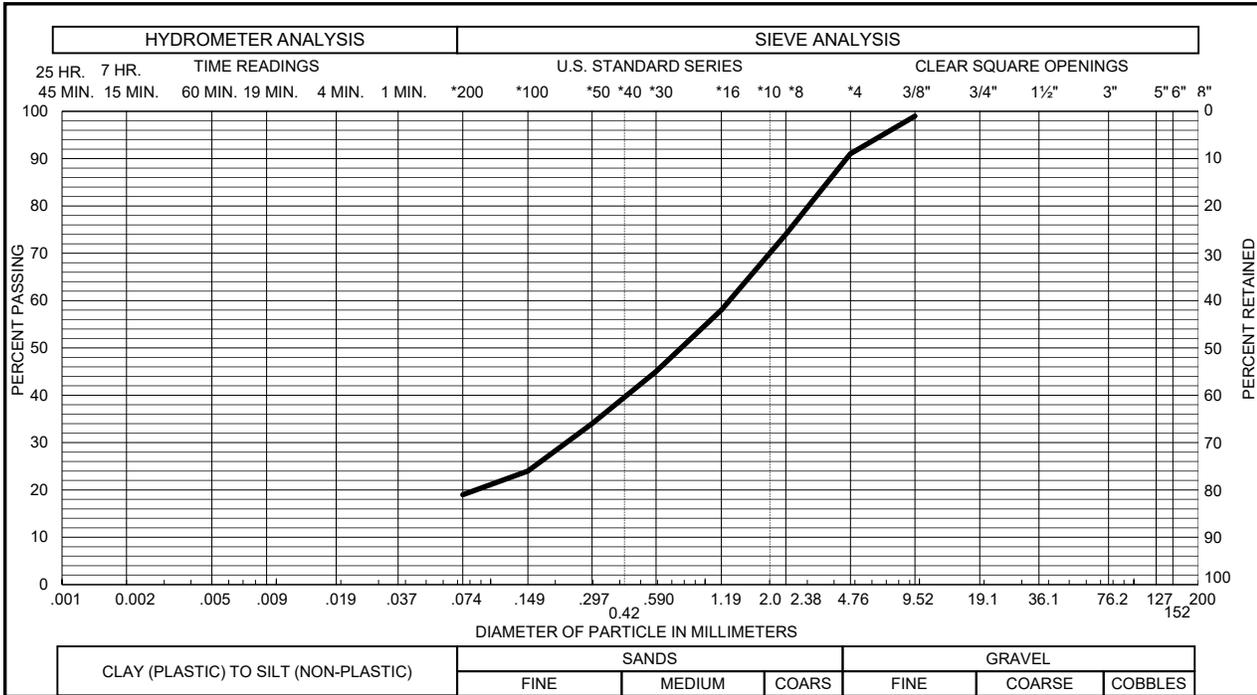
Sample of SANDSTONE, SILTY GRAVEL 9 % SAND 72 %  
 From TH - 4 AT 14 FEET SILT & CLAY 19 % LIQUID LIMIT     %   
 PLASTICITY INDEX     %

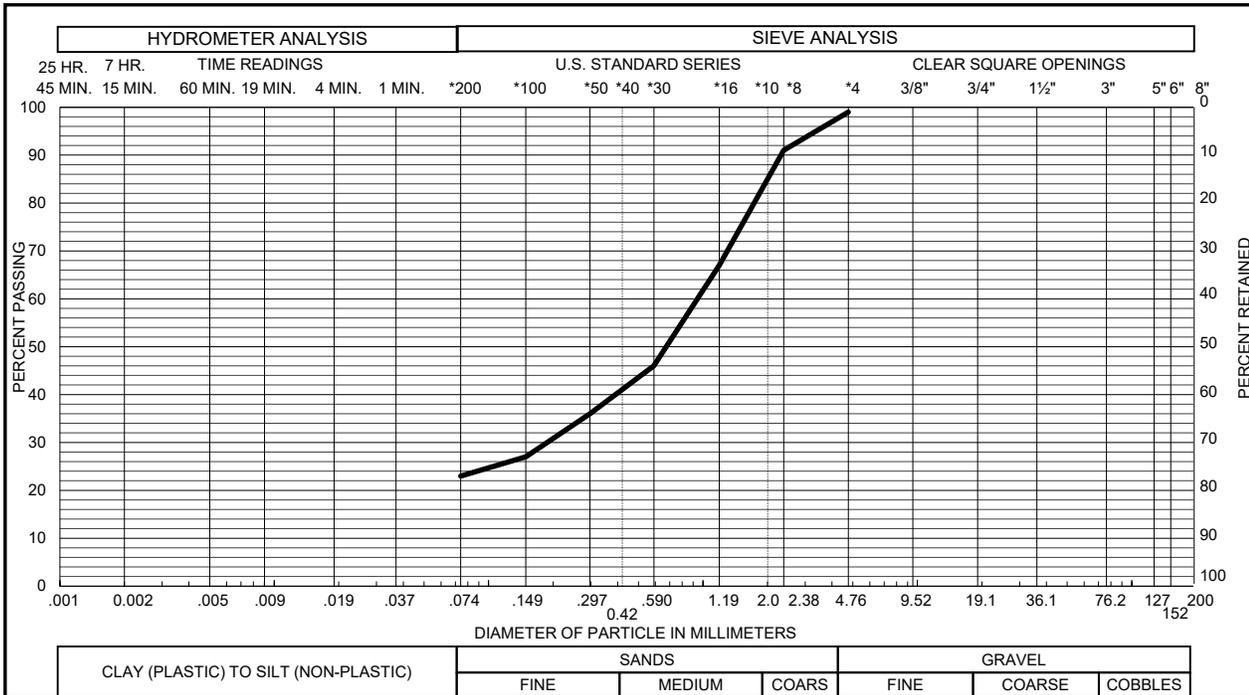
Sample of SANDSTONE, SILTY GRAVEL 1 % SAND 76 %  
 From TH - 5 AT 9 FEET SILT & CLAY 23 % LIQUID LIMIT     %   
 PLASTICITY INDEX     %

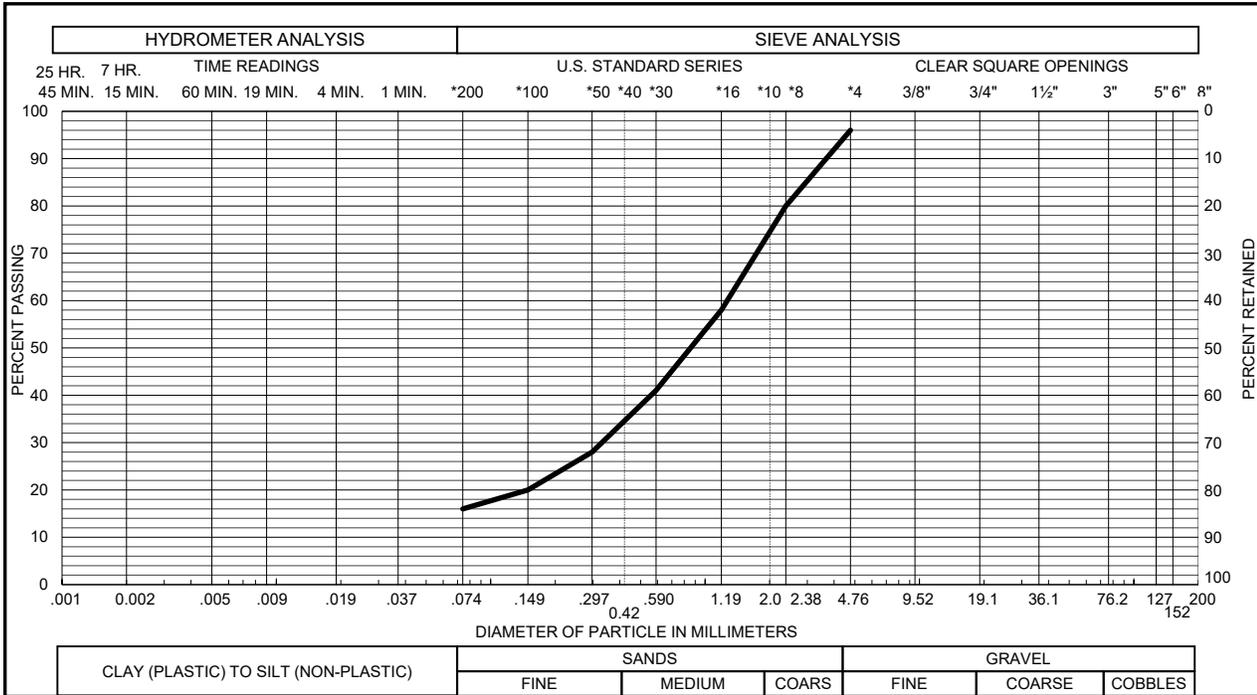
Sample of SANDSTONE, SILTY GRAVEL 4 % SAND 80 %  
 From TH - 6 AT 4 FEET SILT & CLAY 16 % LIQUID LIMIT     %   
 PLASTICITY INDEX     %

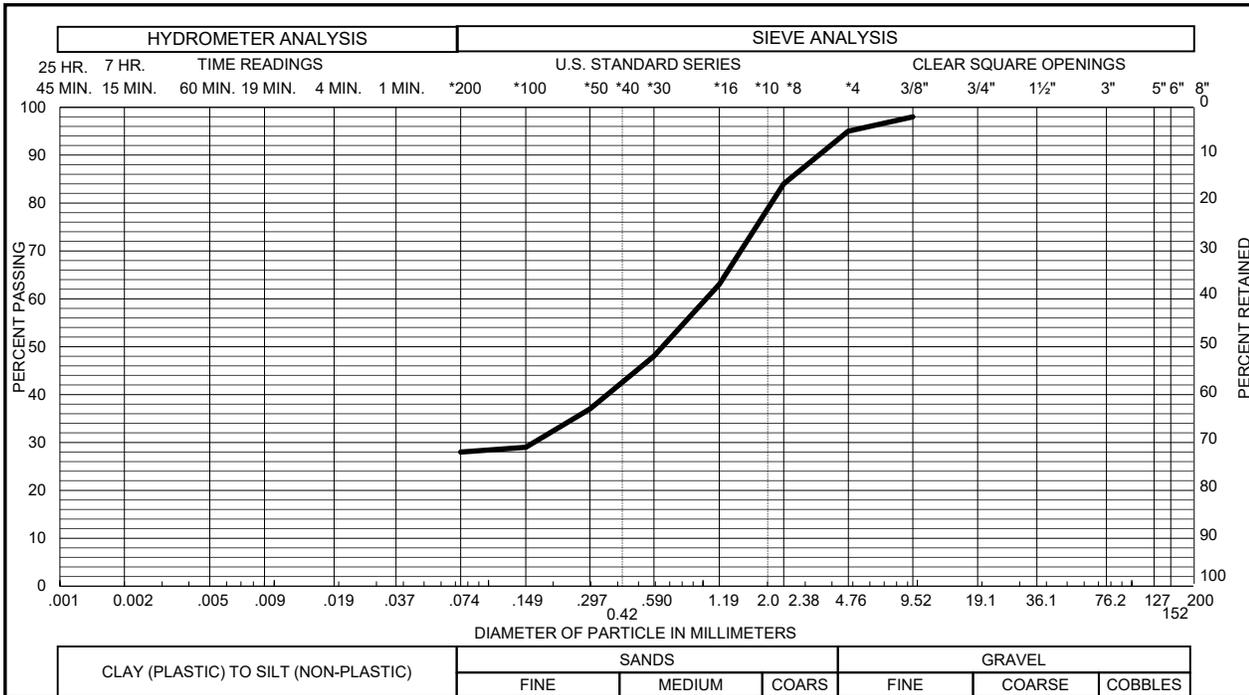
Sample of SANDSTONE, CLAYEY GRAVEL 5 % SAND 67 %  
 From TH - 10 AT 4 FEET SILT & CLAY 28 % LIQUID LIMIT     %   
 PLASTICITY INDEX     %

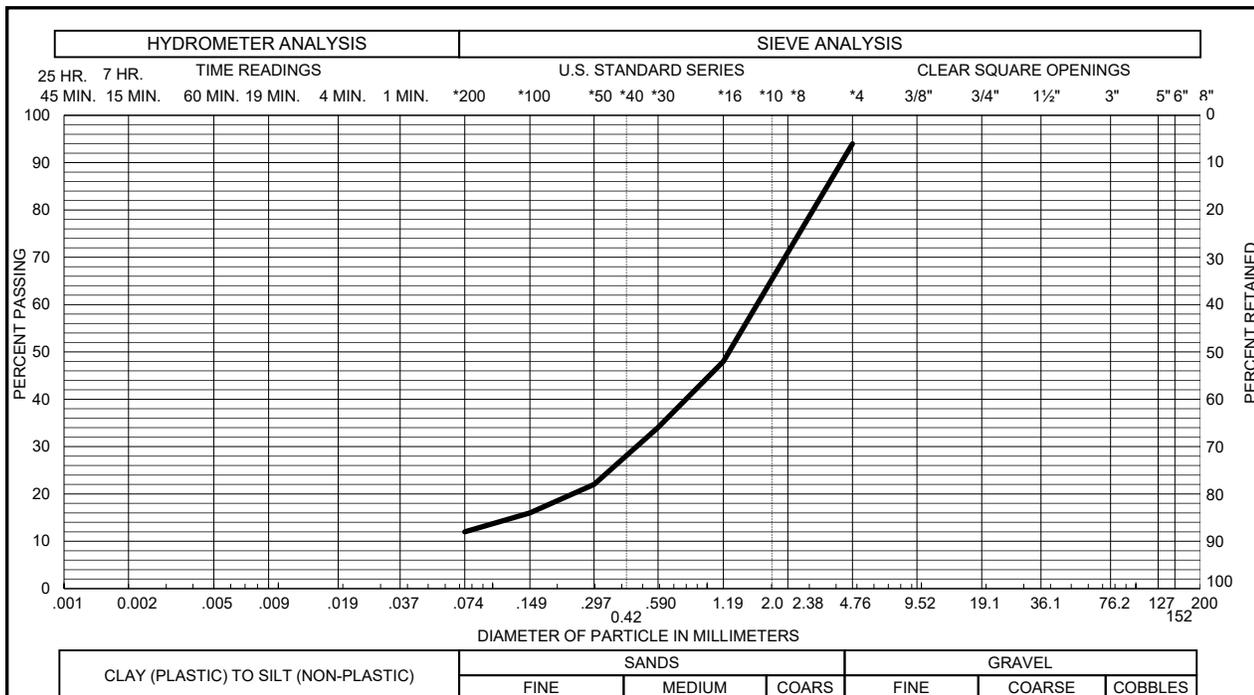
Sample of SANDSTONE, SLIGHTLY SILTY GRAVEL 6 % SAND 82 %  
 From TH - 20 AT 9 FEET SILT & CLAY 12 % LIQUID LIMIT \_\_\_\_\_ %  
 PLASTICITY INDEX \_\_\_\_\_ %

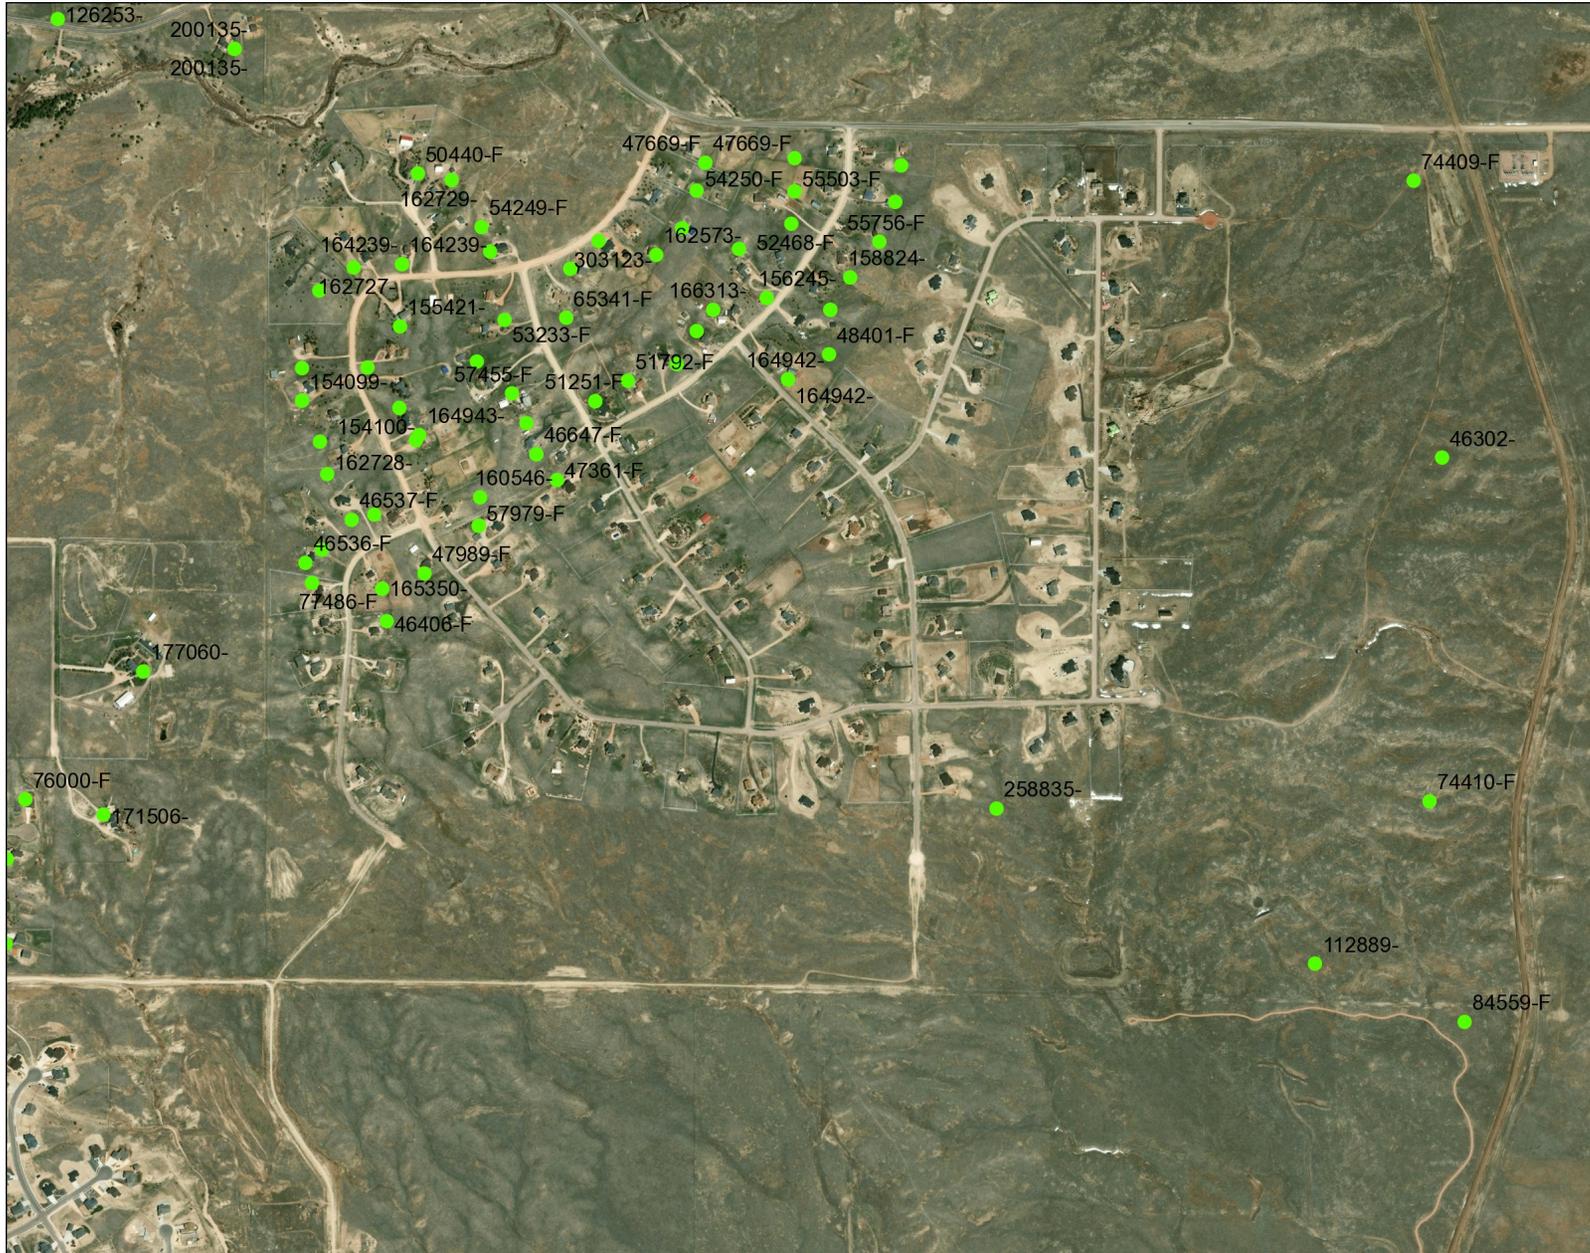
**APPENDIX D**  
**NEARBY WELL LOCATIONS**

- Well Constructed
- OGCC Well
- Final Permit
- County

Appendix D shows the location of constructed wells in the vicinity of the subject sites. The closest well is about 300 feet from the eastern side of Filing No. 10 (Permit No. 258835). The depth of the well is indicated at 945 feet where water is obtained from the Denver Aquifer. Additionally, a well is present about 300 feet from the east side of Filing No. 9 (Permit No. 46302), which is about 170 feet deep, within the Black Squirrel Drainage Basin. Other wells are in excess of 800 feet from the site.
