Prepared For:

BRJM, LLC
17 S. Wahsatch Avenue
Colorado Springs, CO 80903

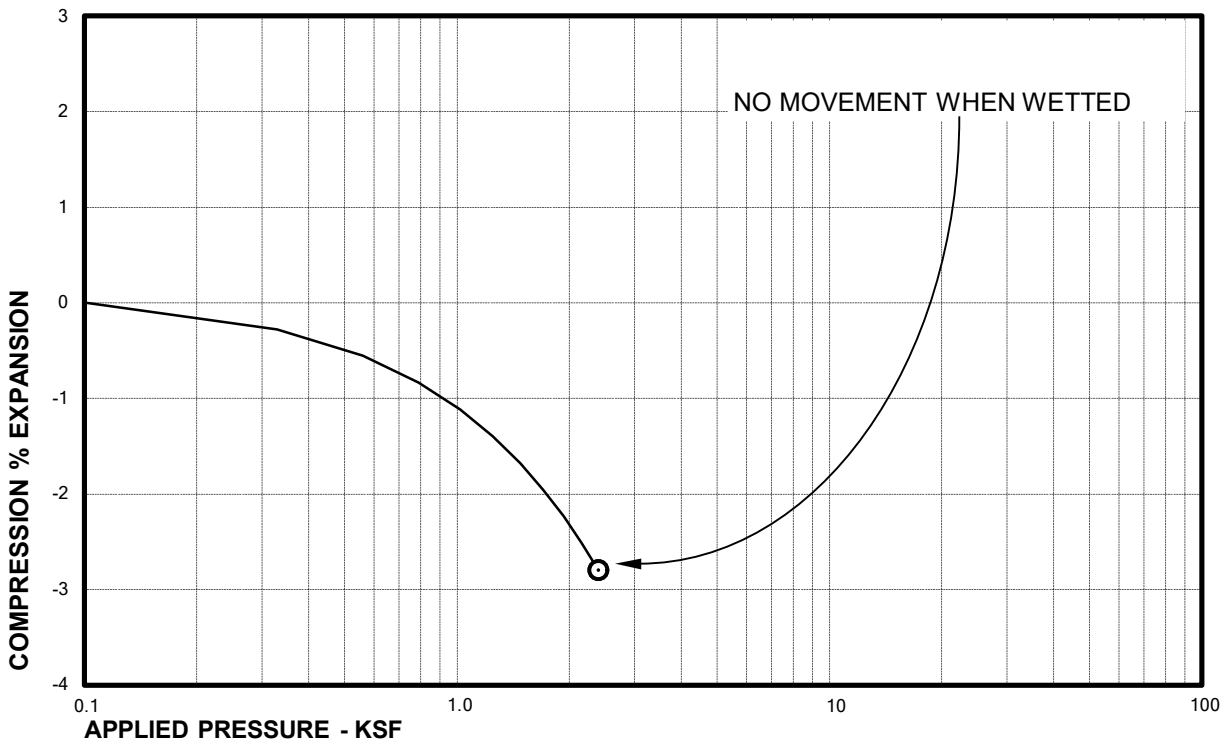
Sample of SANDSTONE
From TH-17 AT 19 FEET

DRY UNIT WEIGHT= 121 PCF
MOISTURE CONTENT= 12.5 %

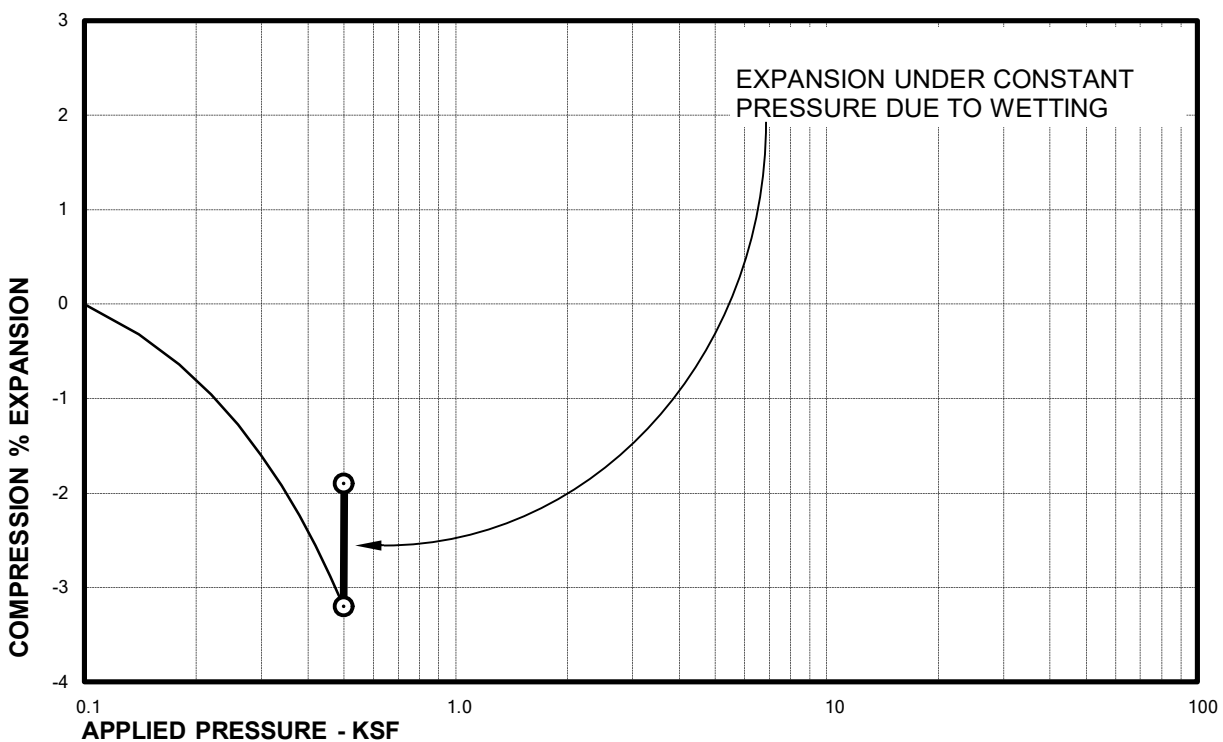
Sample of SANDSTONE, VERY CLAYEY
From TH-18 AT 4 FEET

DRY UNIT WEIGHT= 124 PCF
MOISTURE CONTENT= 9.7 %
