SOIL AND GEOLOGY STUDY

**11810 Stapleton Drive
Lot 2, The Shops, Filing No. 1 at Meridian Ranch
El Paso County, Colorado**

JOB NO. 192061

September 18, 2023

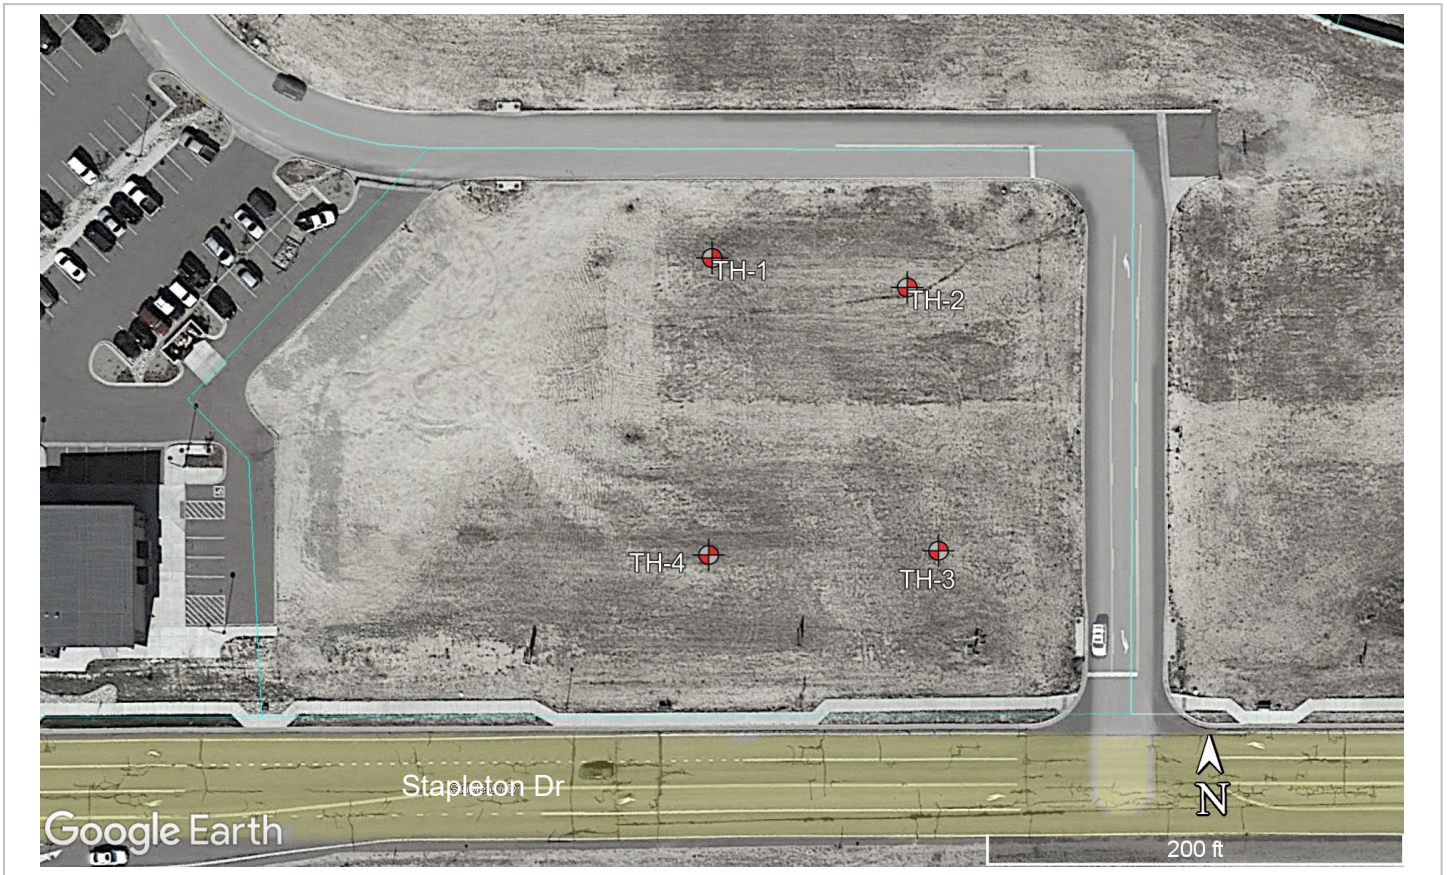
Coordinates

Bore Hole	Latitude	Longitude
TH-1	38.970510	-104.605493
TH-2	38.970471	-104.605169
TH-3	38.970131	-104.605118
TH-4	38.970128	-104.605502

Four test borings were reportedly performed by A Better Soil Solution on the site to explore the subsurface soil conditions and provide recommendations for design and construction of the proposed foundation. The test borings were extended to depths of approximately 15 feet below the existing ground surface. The results of their investigations are presented in the referenced reports, attached and included in Appendix B. The approximate locations of A Better Soil Solution test holes are presented on the Engineering Geology Map, Figure 4.
