SOILS AND GEOLOGY STUDY

**Canyon Creek Ranch
El Paso County, Colorado**

JOB NO. 189360

**June 24, 2022
Revised January 9, 2025**

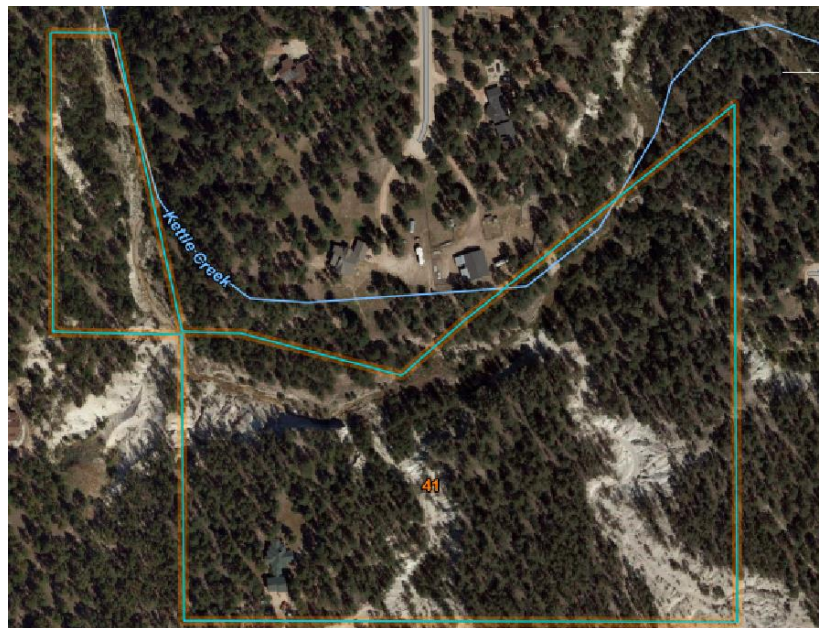
- 41 – Kettle Gravelly Loamy Sand, 8 to 40 percent slopes. Properties of the loamy sand include somewhat excessively drained soils, depth of the water table is anticipated to be greater than 80 inches, runoff is anticipated to be medium, frequency of flooding and/or ponding is none, and landforms include hills.

The USDA Soil Survey Map is presented below.

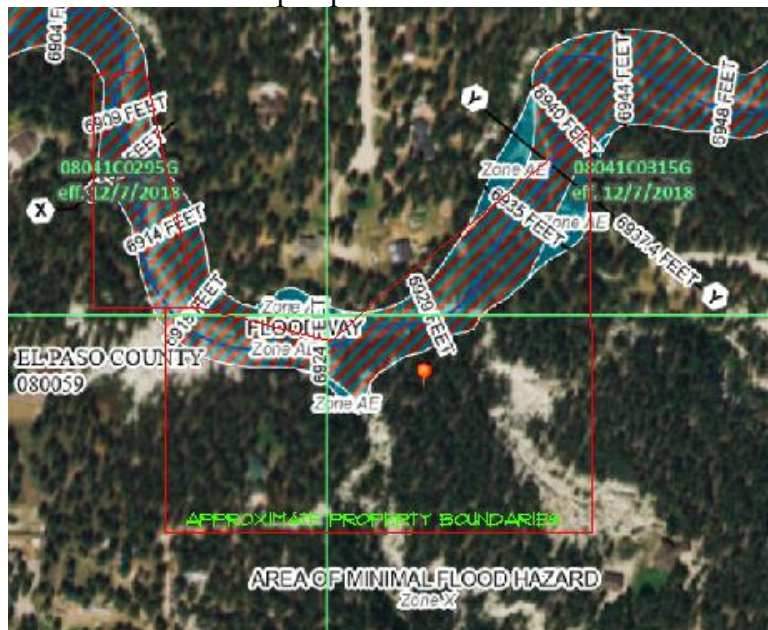
Based on our review of the Federal Emergency Management Agency (FEMA) Community Panel Nos. 08041C0295G, 08041C0315G, 08041C0507G, 08041C0526G and the online ArcGIS El Paso County Risk Map, the site lies within a 100-year floodplain and regulatory floodway that traverses the site from the northeast to the northwest along the northern boundary of the property. The remainder of the site is within the boundaries of Zone X. The FEMA Map is presented below.

Zone X is defined by FEMA as an area of minimal flood hazard that is determined to be outside the Special Flood Hazard Area and higher than the elevation of the 0.2-percent-annual-chance (or 500-year) flood.
