SOILS AND GEOLOGY STUDY

**Canyon Creek Ranch
El Paso County, Colorado**

JOB NO. 189360

June 24, 2022

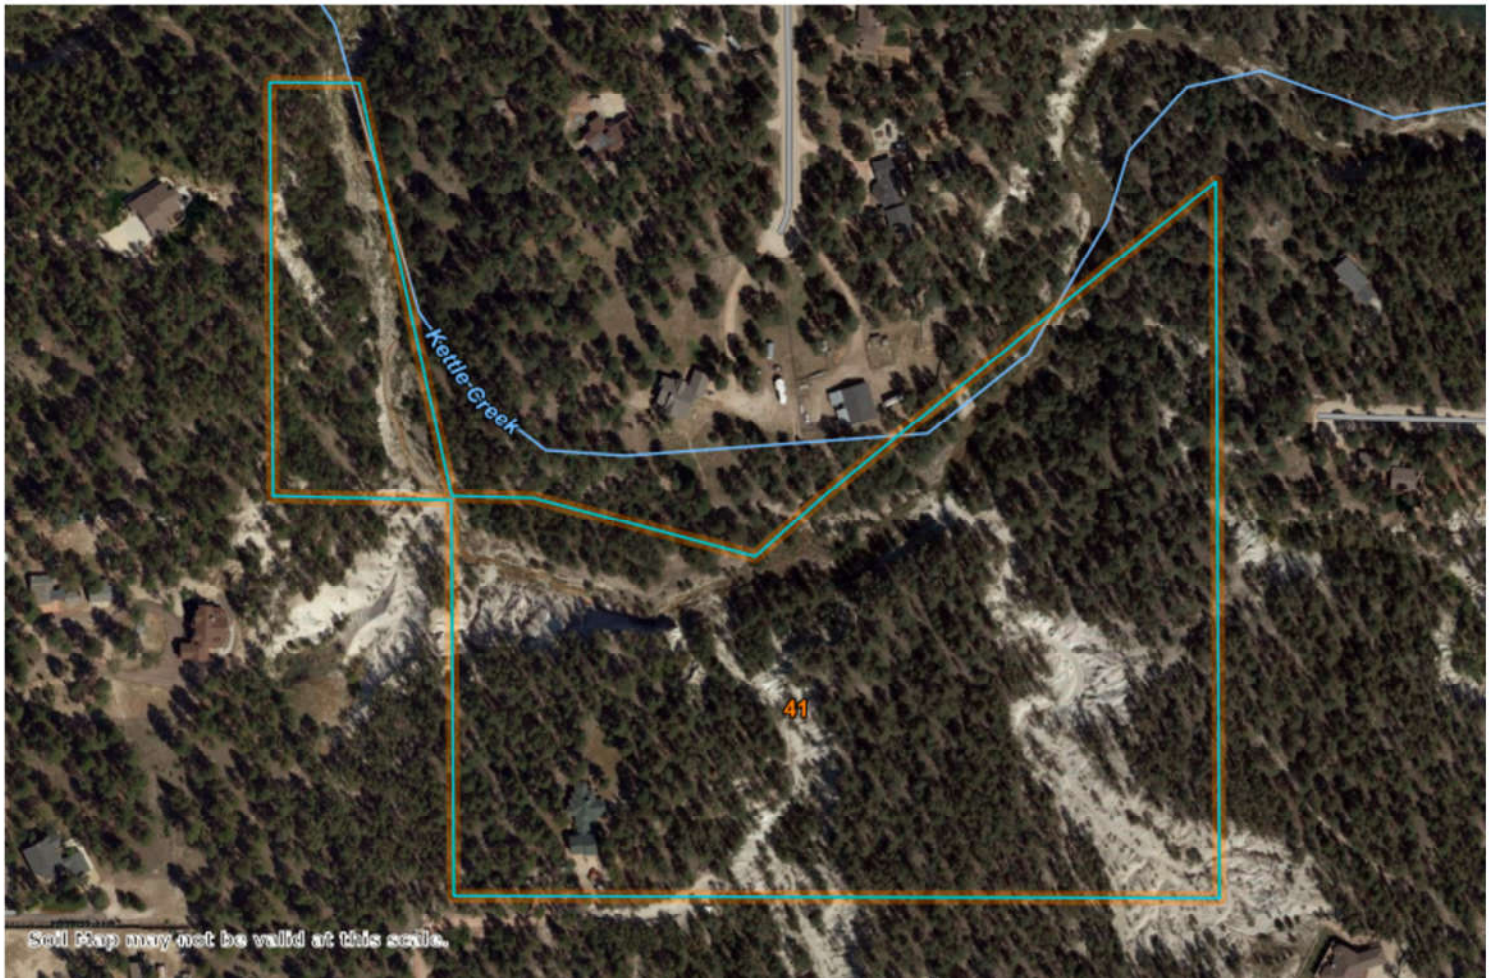
FIG No. 4

41 - Kettle Gravelly Loamy Sand, 8 to 40 Percent Slopes

The USDA Soil Survey Map is presented in Figure 4.
