## SOILS AND GEOLOGY STUDY

**Canyon Creek Ranch  
El Paso County, Colorado**

**JOB NO. 189360**

**June 24, 2022  
Revised January 9, 2025**

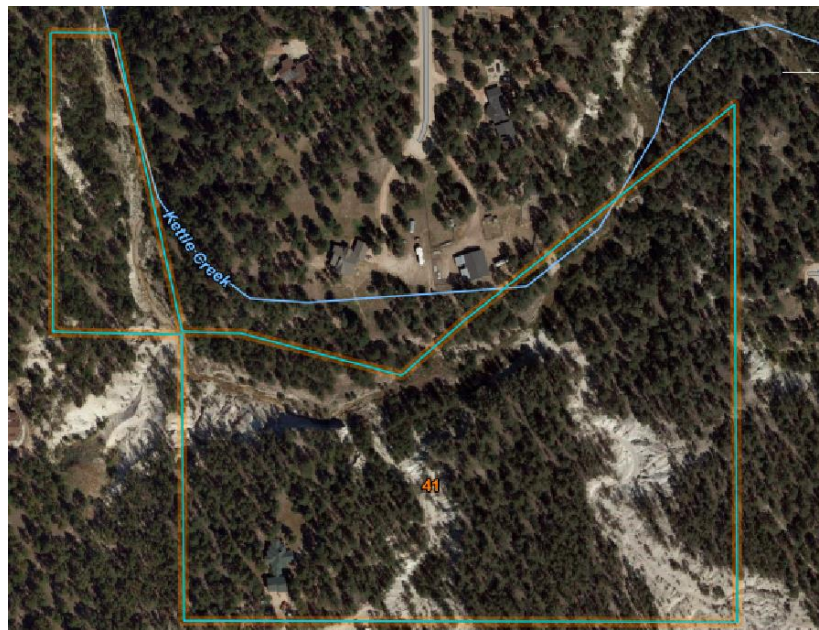
- 41 – Kettle Gravelly Loamy Sand, 8 to 40 percent slopes. Properties of the loamy sand include somewhat excessively drained soils, depth of the water table is anticipated to be greater than 80 inches, runoff is anticipated to be medium, frequency of flooding and/or ponding is none, and landforms include hills.

The USDA Soil Survey Map is presented below.

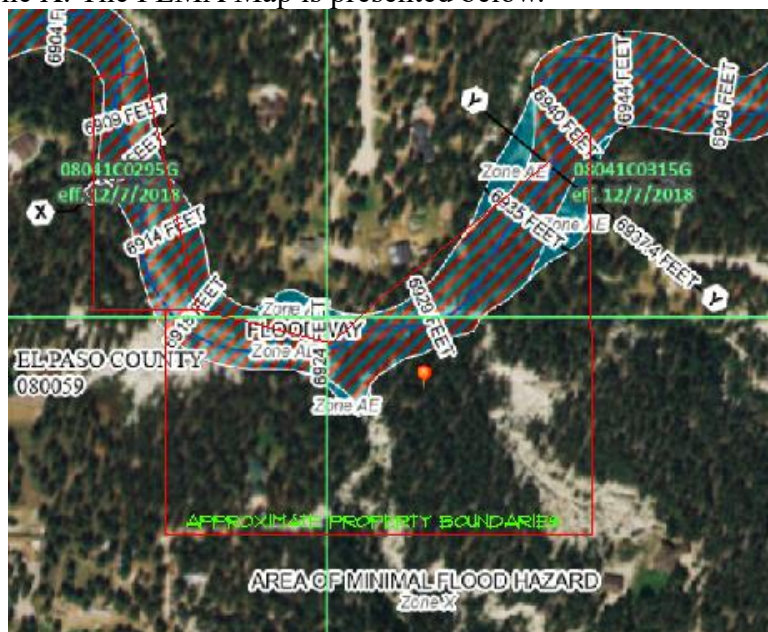
Based on our review of the Federal Emergency Management Agency (FEMA) Community Panel Nos. 08041C0295G, 08041C0315G, 08041C0507G, 08041C0526G and the online ArcGIS El Paso County Risk Map, the site lies within a 100-year floodplain and regulatory floodway that traverses the site from the northeast to the northwest along the northern boundary of the property. The remainder of the site is within the boundaries of Zone X. The FEMA Map is presented below.

Zone X is defined by FEMA as an area of minimal flood hazard that is determined to be outside the Special Flood Hazard Area and higher than the elevation of the 0.2-percent-annual-chance (or 500-year) flood.
