**ENTECH**  
ENGINEERING, INC.

**SOILS AND GEOLOGY STUDY  
MONUMENT ACADEMY 29 LOT SUBDIVISION  
PINEHURST CIRCLE AND HIGHWAY 83  
EL PASO COUNTY, COLORADO**

July 28, 2026

Entech Job No. 251792  
LLL/JCG

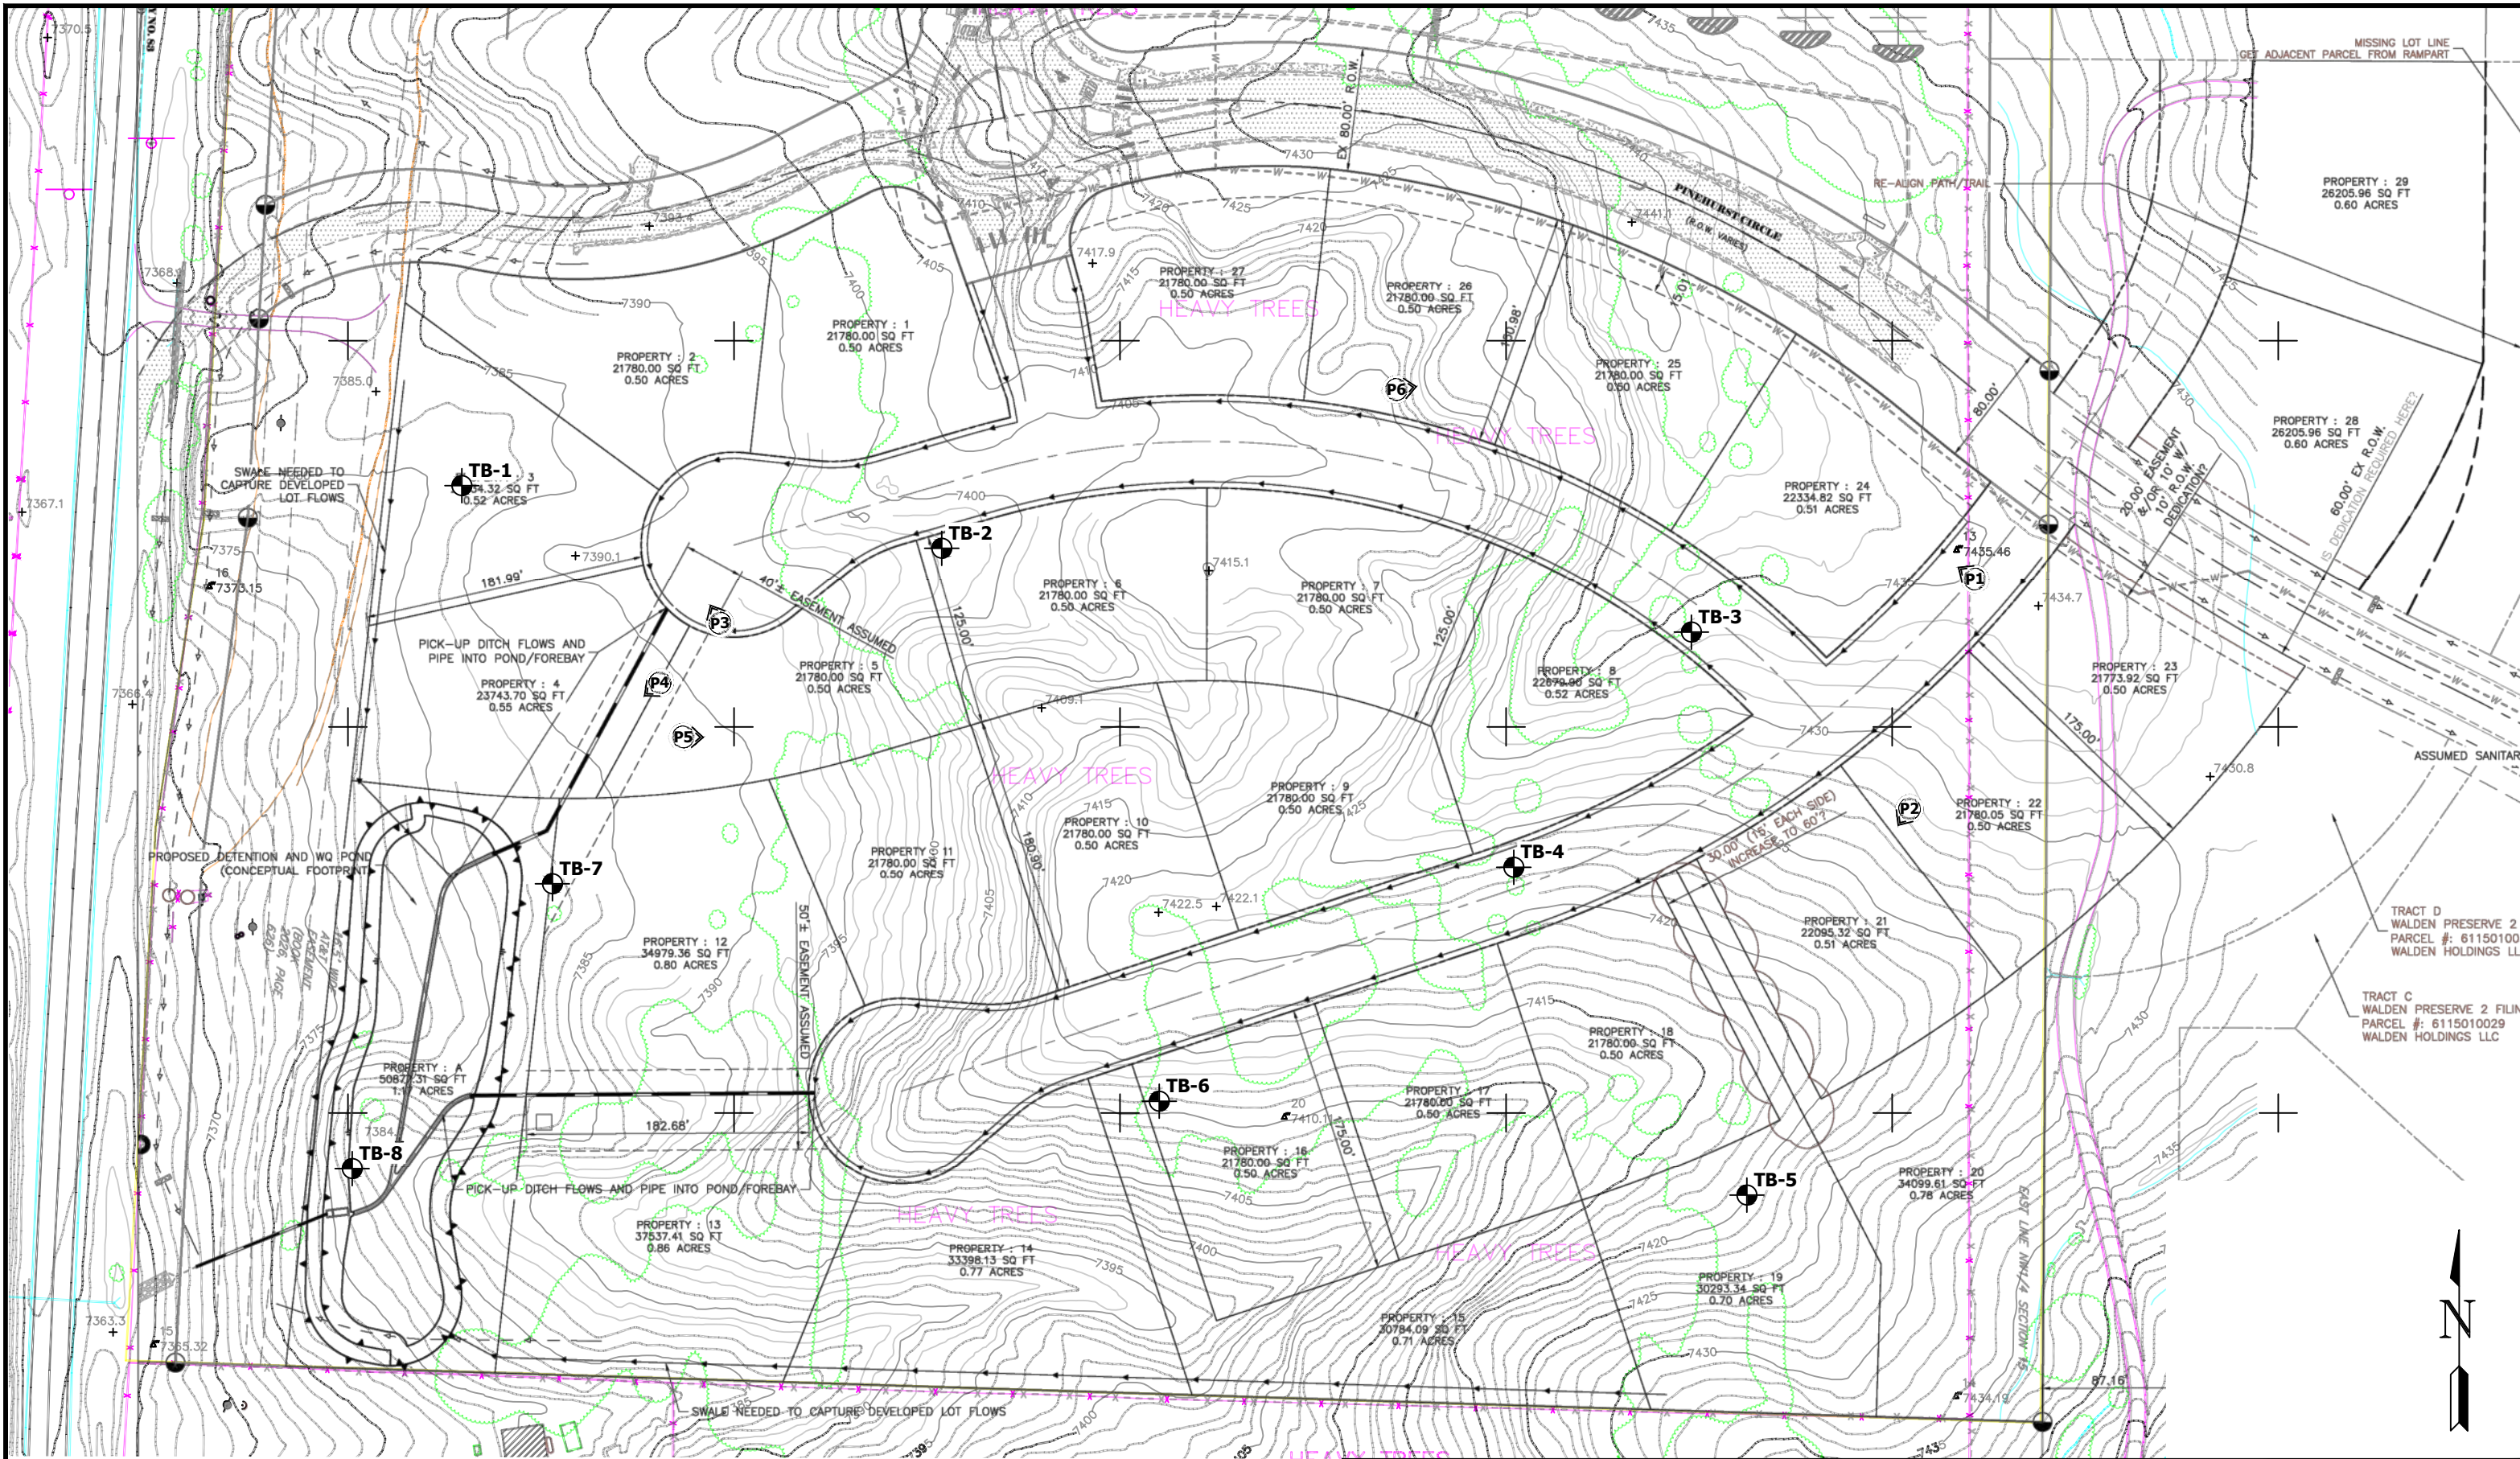
FIG. 3

- APPROXIMATE TEST BORING LOCATION AND NUMBER
- APPROXIMATE PHOTOGRAPH LOCATION AND NUMBER

The project consists twenty-nine lot residential subdivision is proposed for the approximate 24-acre parcel. The lots will be 0.5 to 0.86 acres and will be serviced by central water and sewer provided by the Walden Sanitation District. The proposed lot configuration is shown in the Site and Exploration Plan (Figure 3). Grading plans were not available at the time of this investigation, however, grading is anticipated limited to the roadways, proposed site drainage improvements, and the construction of the proposed detention and water quality pond.

The locations of the test borings are indicated on the Site and Exploration Plan (Figure 3). The Test Boring Logs are included in Appendix B, and Laboratory Test Results are included in Appendix C. The results of the testing will be discussed later in this report.
