January 09, 2023  
JR Engineering  
5475 Tech Center Drive  
Colorado Springs, CO 80919

RE: Addressing Geologic Hazard and Soils Report for Vollmer RV Storage, Lot A, McClintock Station

The purpose of this letter is to address the need for a geologic hazard and soils report to support the proposed development of Lot A, McClintock Station known as Vollmer RV Storage.

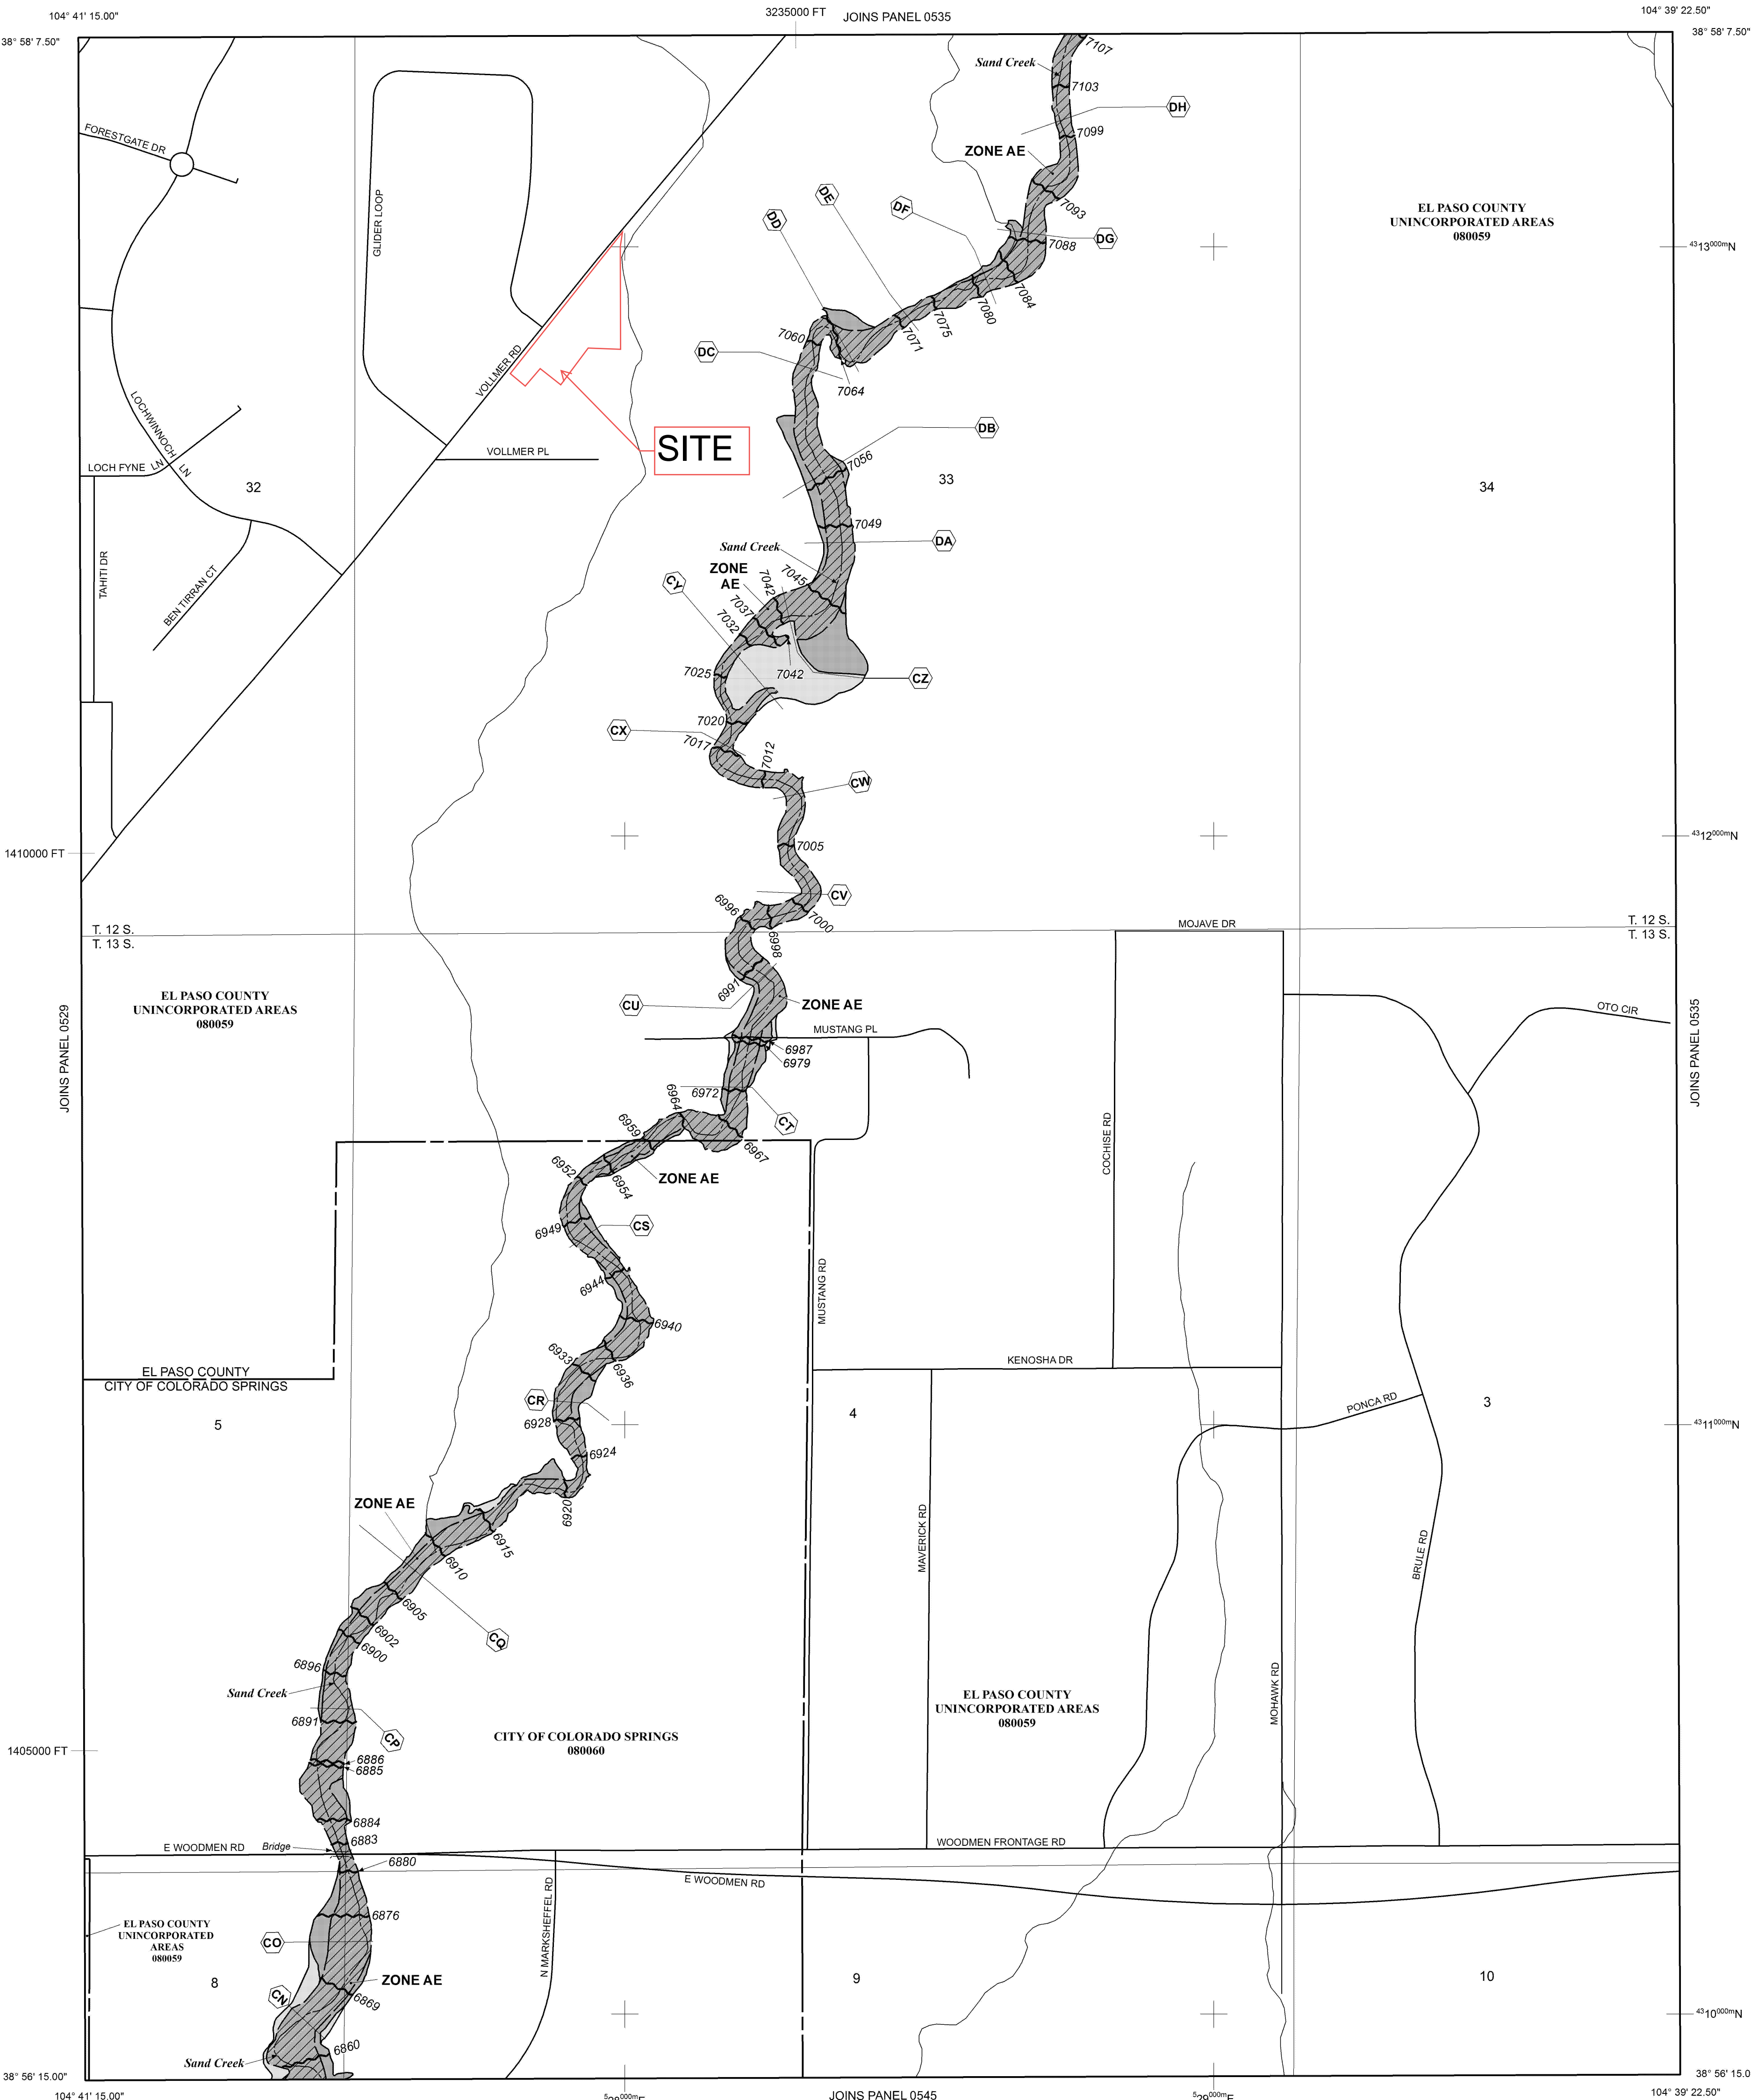
**NFIP** **PANEL 0533G**

NOTE: MAP AREA SHOWN ON THIS PANEL IS LOCATED WITHIN TOWNSHIP 12 SOUTH, RANGE 65 WEST, AND TOWNSHIP 13 SOUTH, RANGE 65 WEST.

It should be noted that no structures are proposed with this site. The entire site lies outside of any mapped flood plain according to FEMA Map No. 08041C0533G, dated December 7, 2018 (see attached).

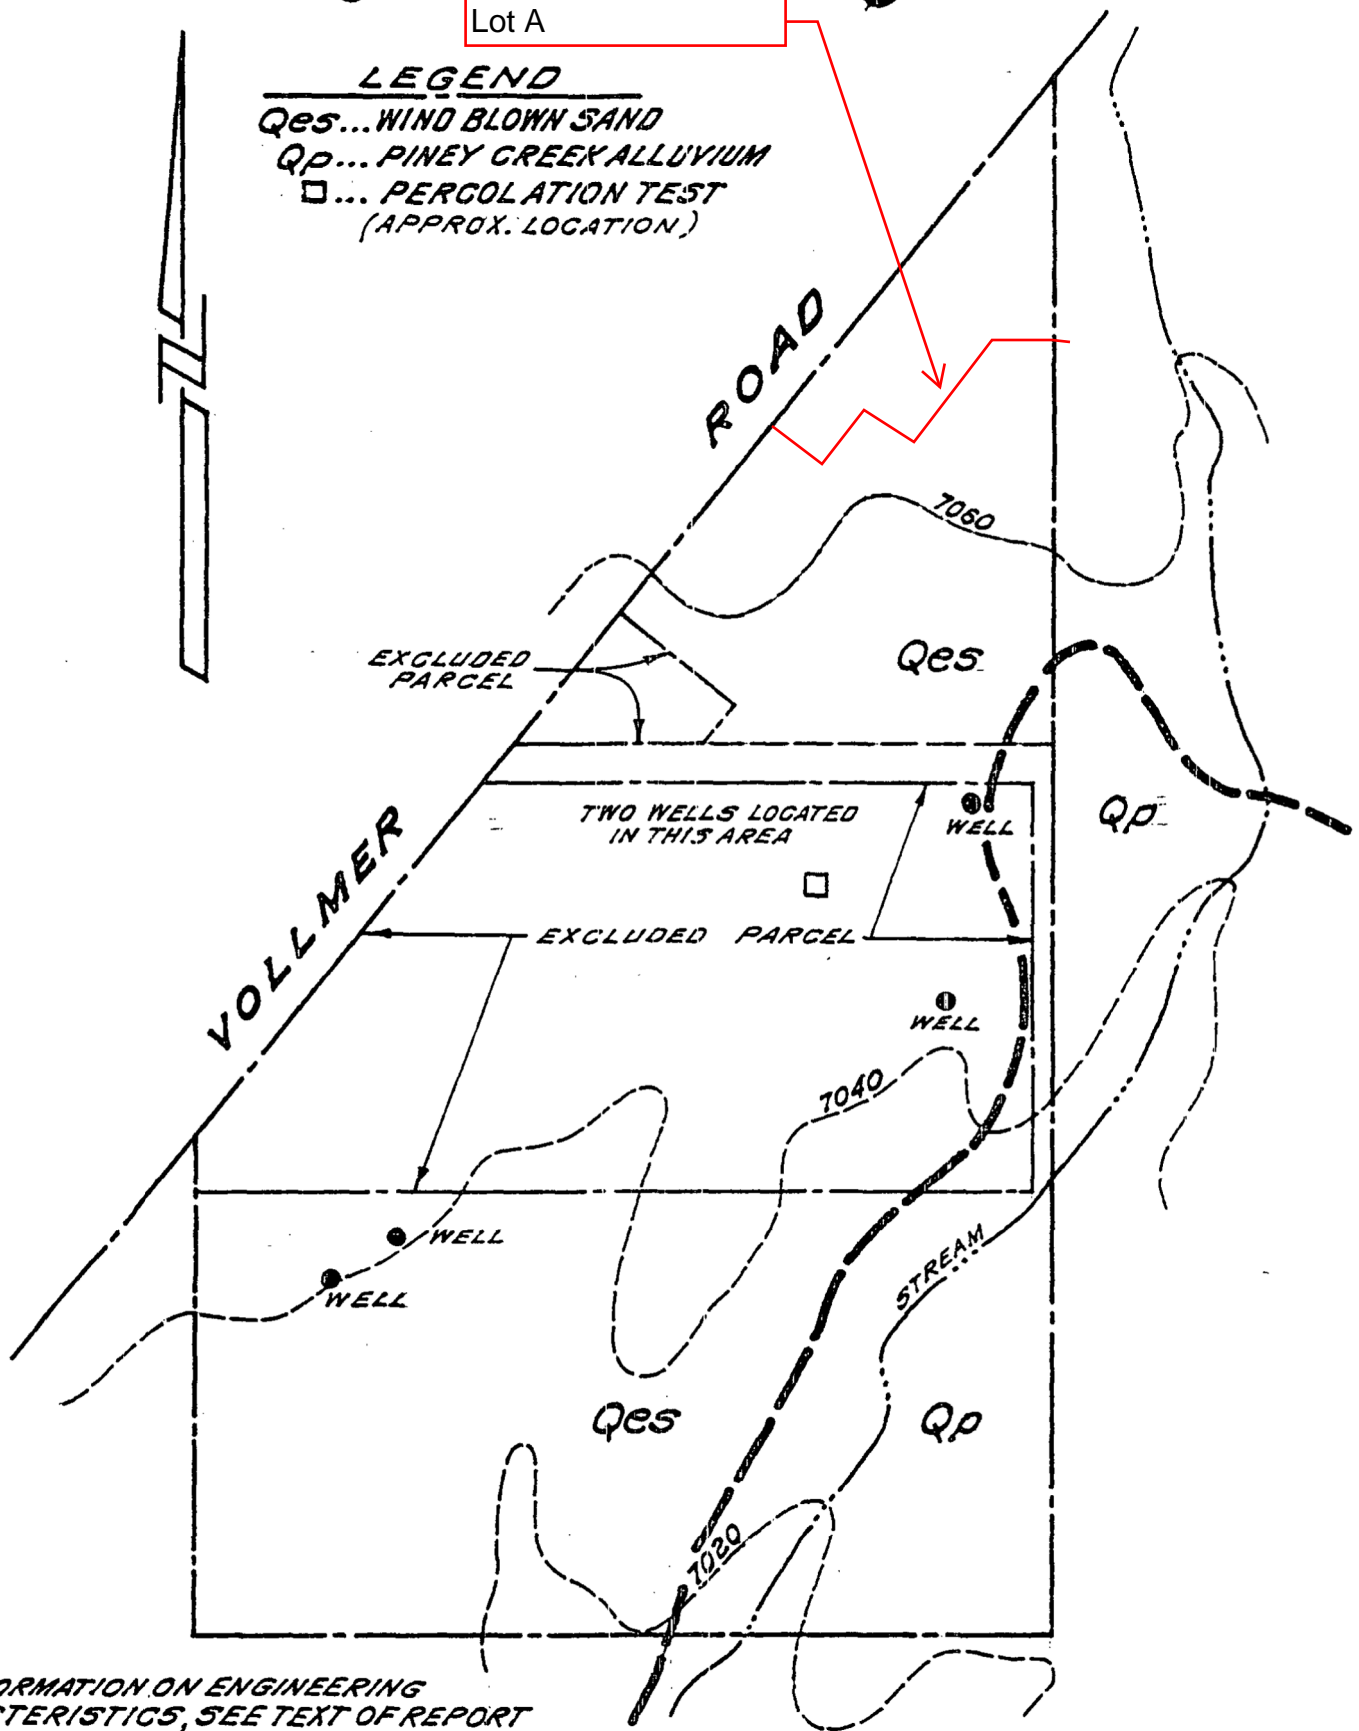
- Qes... WIND BLOWN SAND
- Qp... PINEY CREEK ALLUVIUM
- ... PERCOLATION TEST (APPROX. LOCATION)

NOTE:  
FOR INFORMATION ON ENGINEERING  
CHARACTERISTICS, SEE TEXT OF REPORT

SCALE: 1" = 300'

Site specific geologic mapping was performed as a part of the Original Report and is included in the attached. The site is mapped as Qes: Eolian Sand of Quaternary Age, & Qp: Piney Creek Alluvium of Quaternary age.
