Subject: Due Diligence Geotechnical Investigation and Geologic Hazard Evaluation
Hannah Ridge (AKA Feathergrass)
El Paso County, Colorado
CTL|T Project No. CS19005-115

This letter presents the results of our Due Diligence Geotechnical Investigation and Geologic Hazard Evaluation for the Hannah Ridge (AKA Feathergrass) parcel. The site is located on the east and west side of Hannah Ridge Drive, south of the intersection of Hannah Ridge Drive and Constitution Avenue, in El Paso County Colorado (Fig. 1).

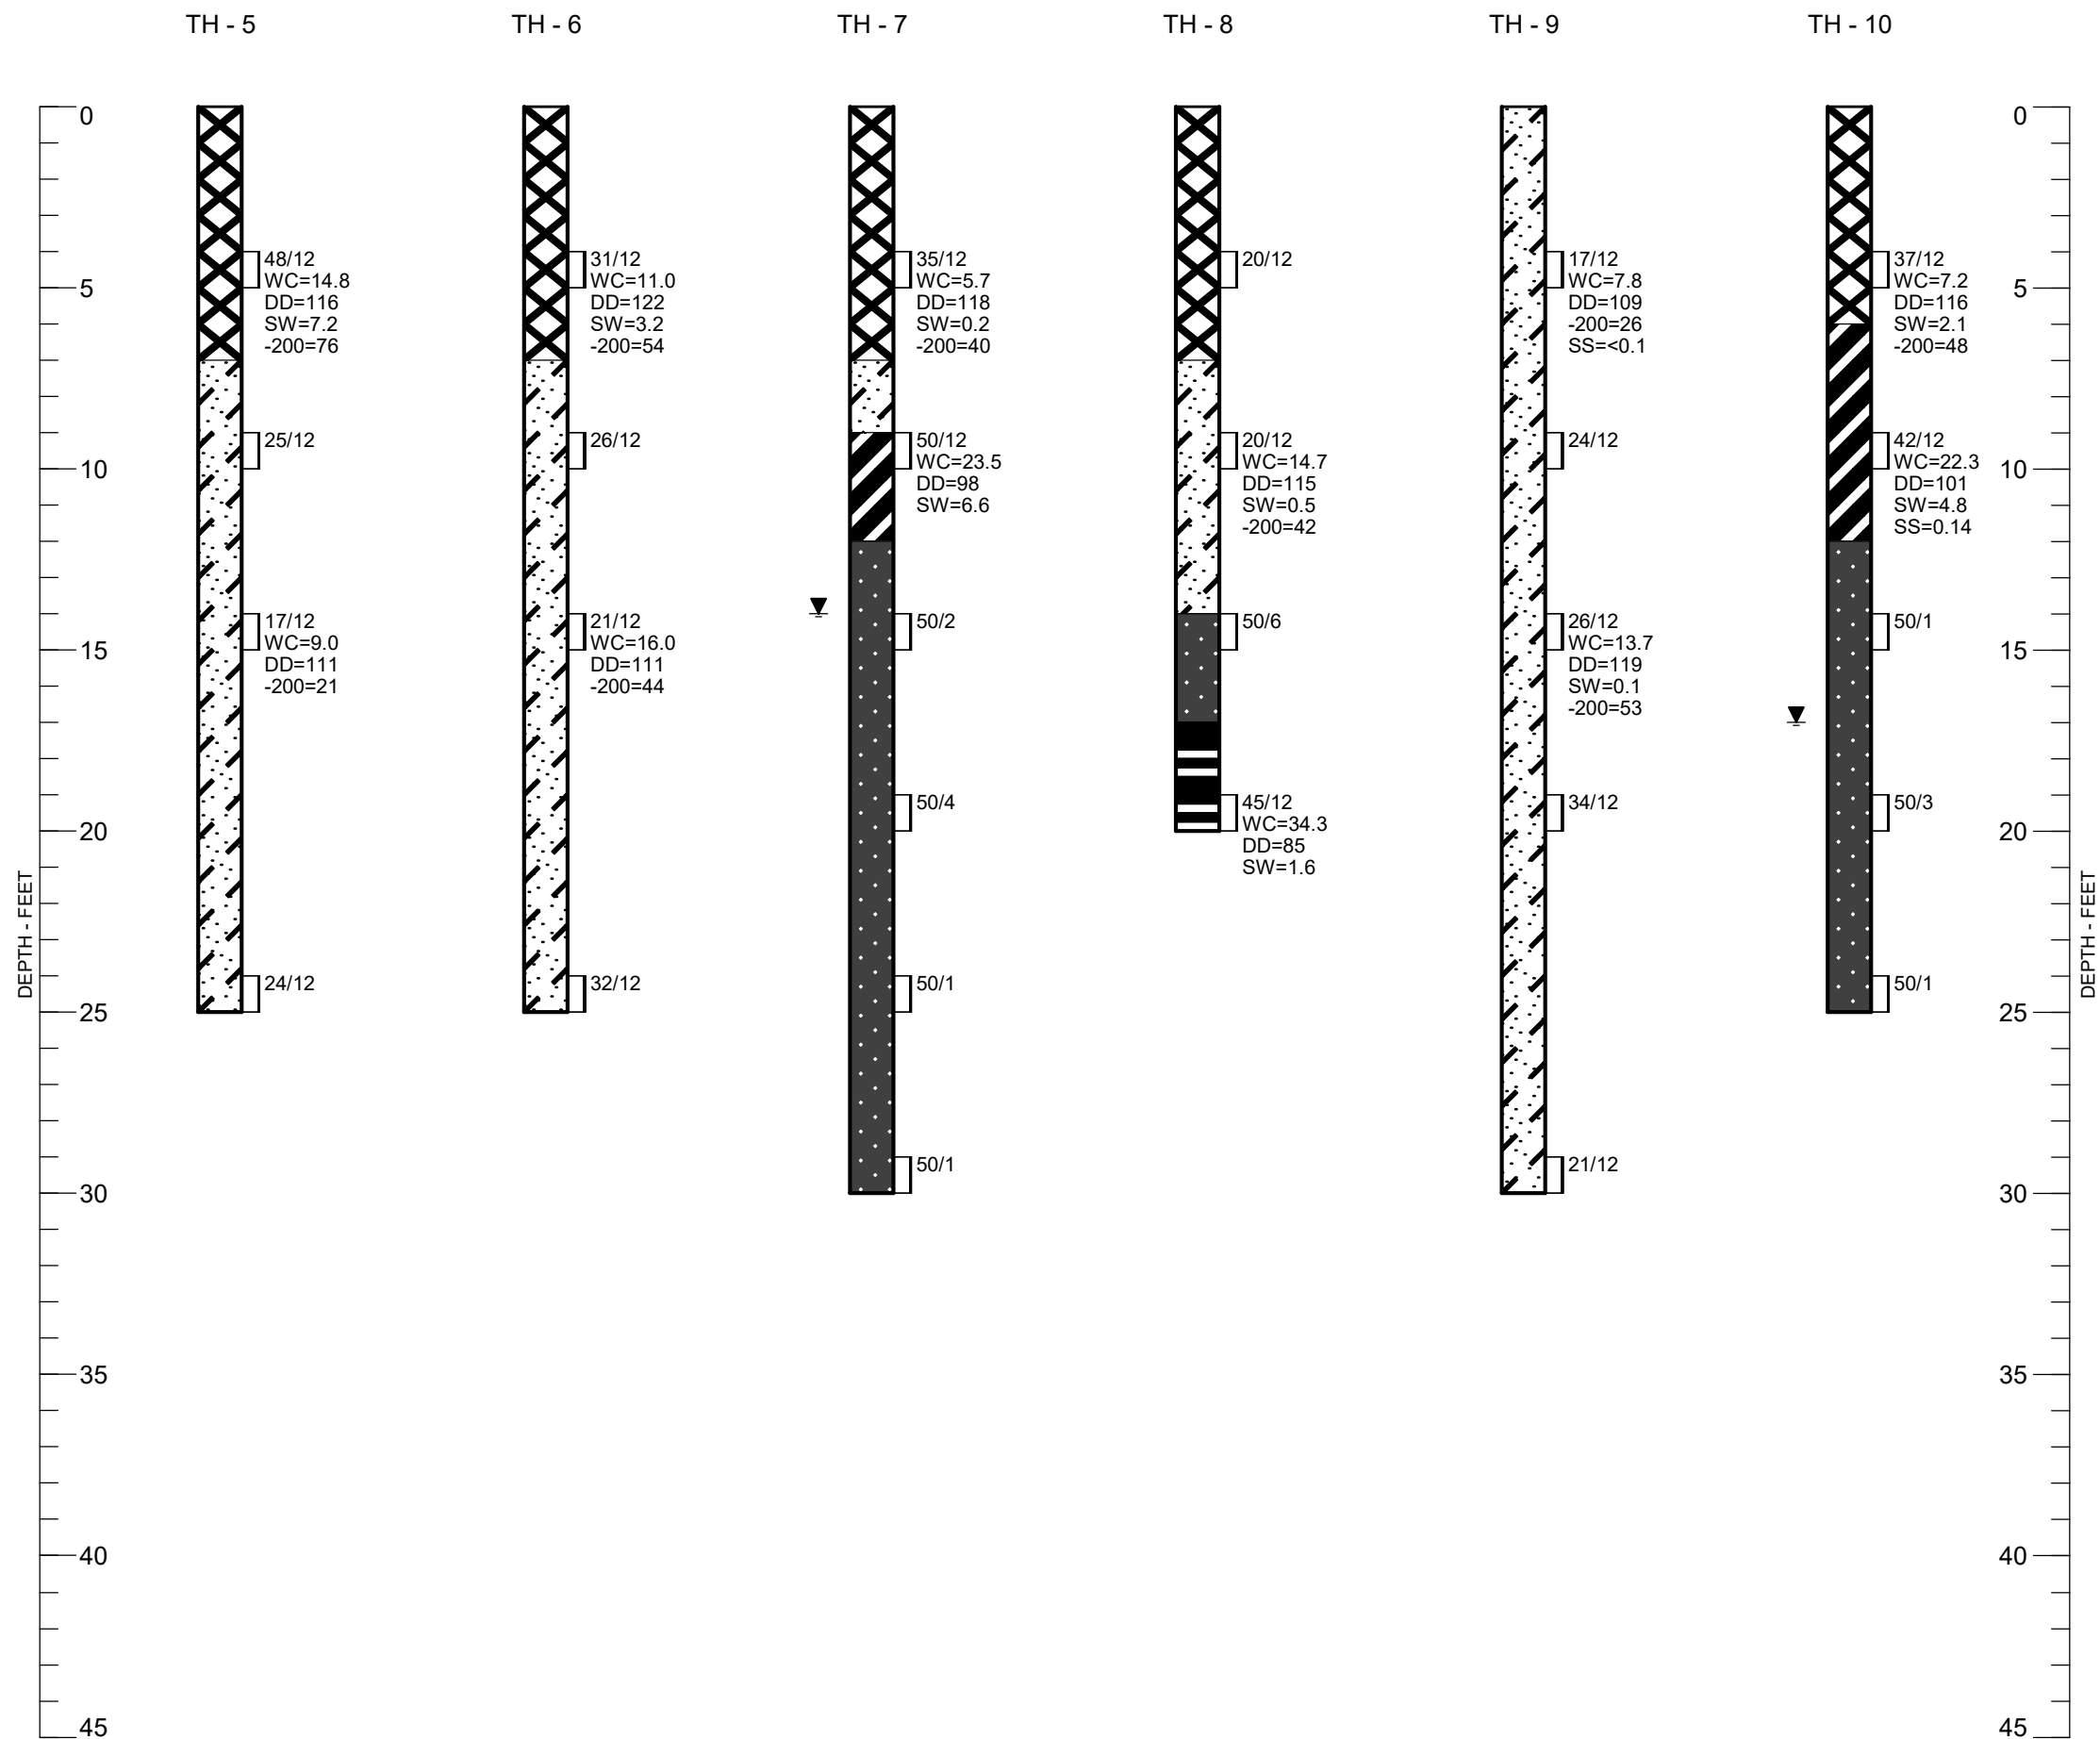
LEGEND:

- FILL, CLAY, SANDY TO VERY SANDY AND SAND, VERY CLAYEY, VERY STIFF, SLIGHTLY MOIST TO MOIST, BROWN, DARK BROWN.
- SAND, CLAYEY TO VERY CLAYEY, WITH CLAY, VERY SANDY LENSES, MEDIUM DENSE TO DENSE, MOIST, BROWN. (SC)
- WEATHERED CLAYSTONE, SANDY, MEDIUM HARD TO HARD, MOIST, BROWN.
- BEDROCK. SANDSTONE, CLAYEY, VERY HARD, MOIST, GRAY, BROWN.
- BEDROCK. CLAYSTONE, SANDY, MEDIUM HARD, VERY MOIST, YELLOWISH BROWN.
- DRIVE SAMPLE. THE SYMBOL 15/12 INDICATES 15 BLOWS OF A 140-POUND HAMMER FALLING 30 INCHES WERE REQUIRED TO DRIVE A 2.5-INCH O.D. SAMPLER 12 INCHES.
- GROUNDWATER LEVEL MEASURED EIGHT DAYS AFTER DRILLING.

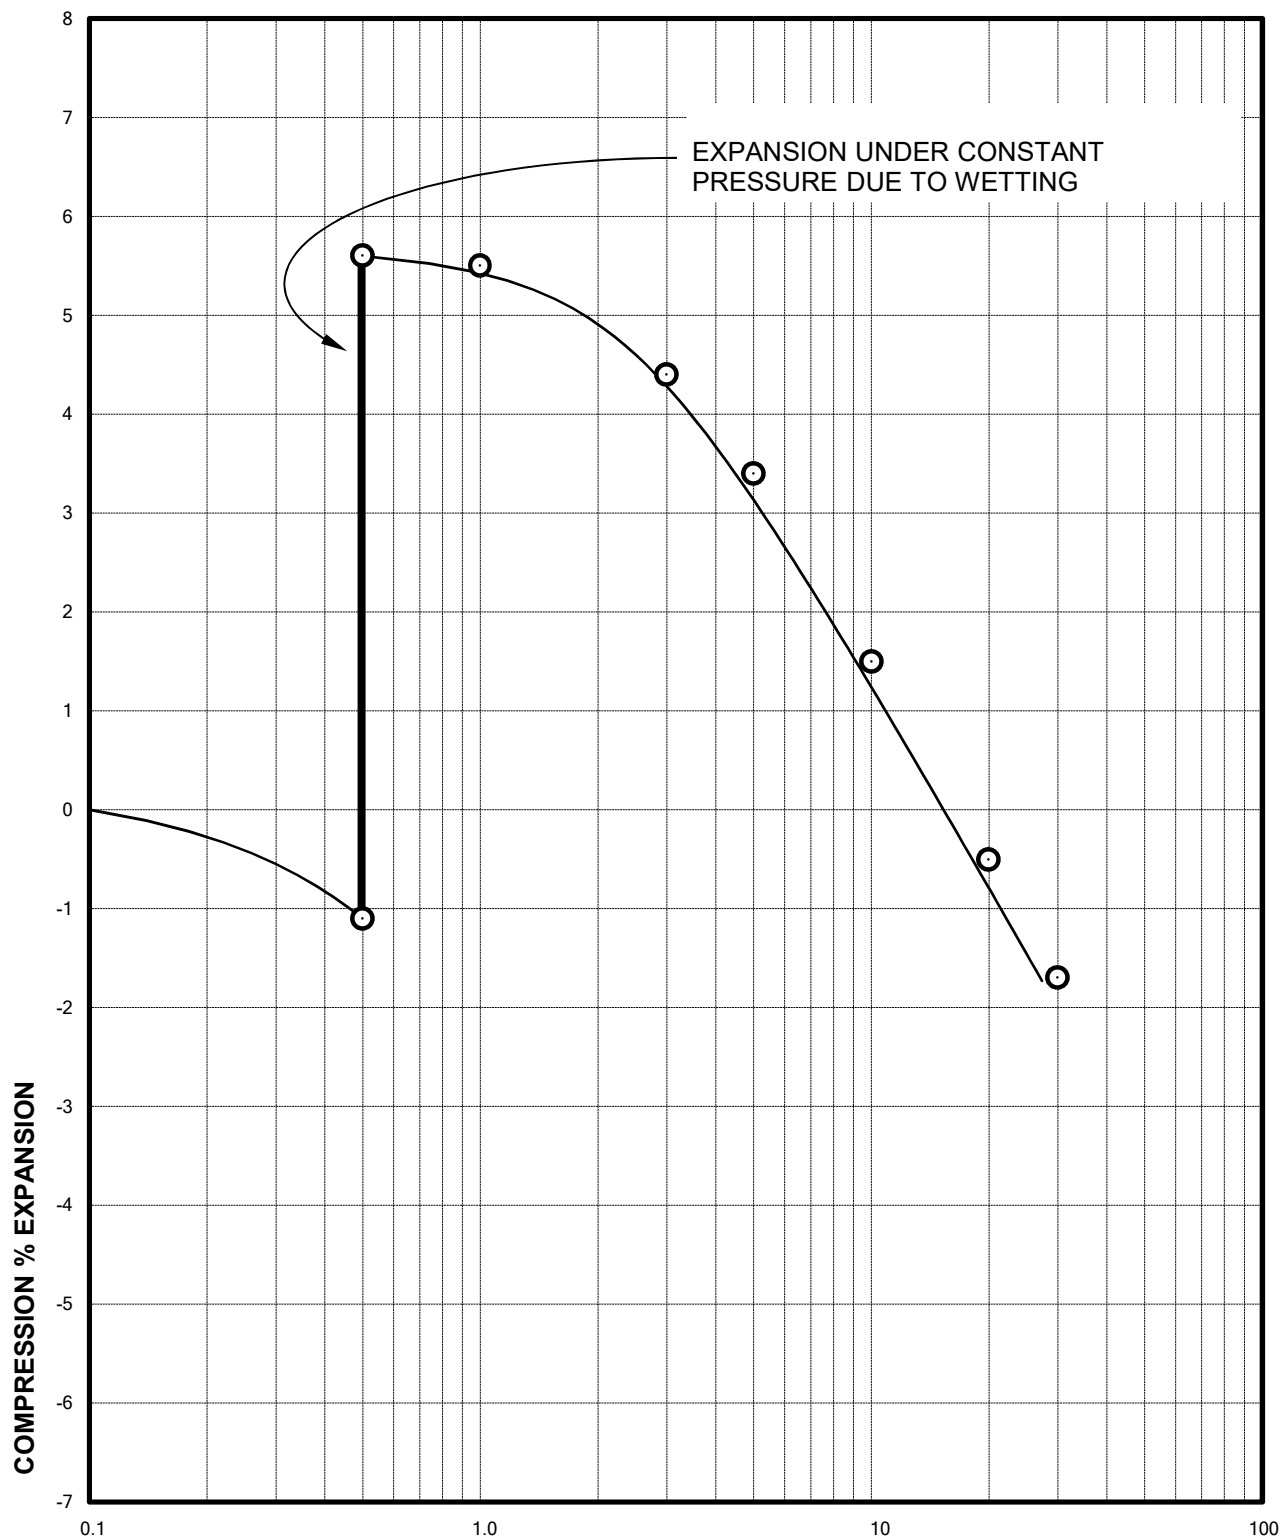
APPLIED PRESSURE - KSF
Sample of FILL, CLAY, SANDY
From TH-2 AT 4 FEET

DRY UNIT WEIGHT= 118 PCF
MOISTURE CONTENT= 15.2 %

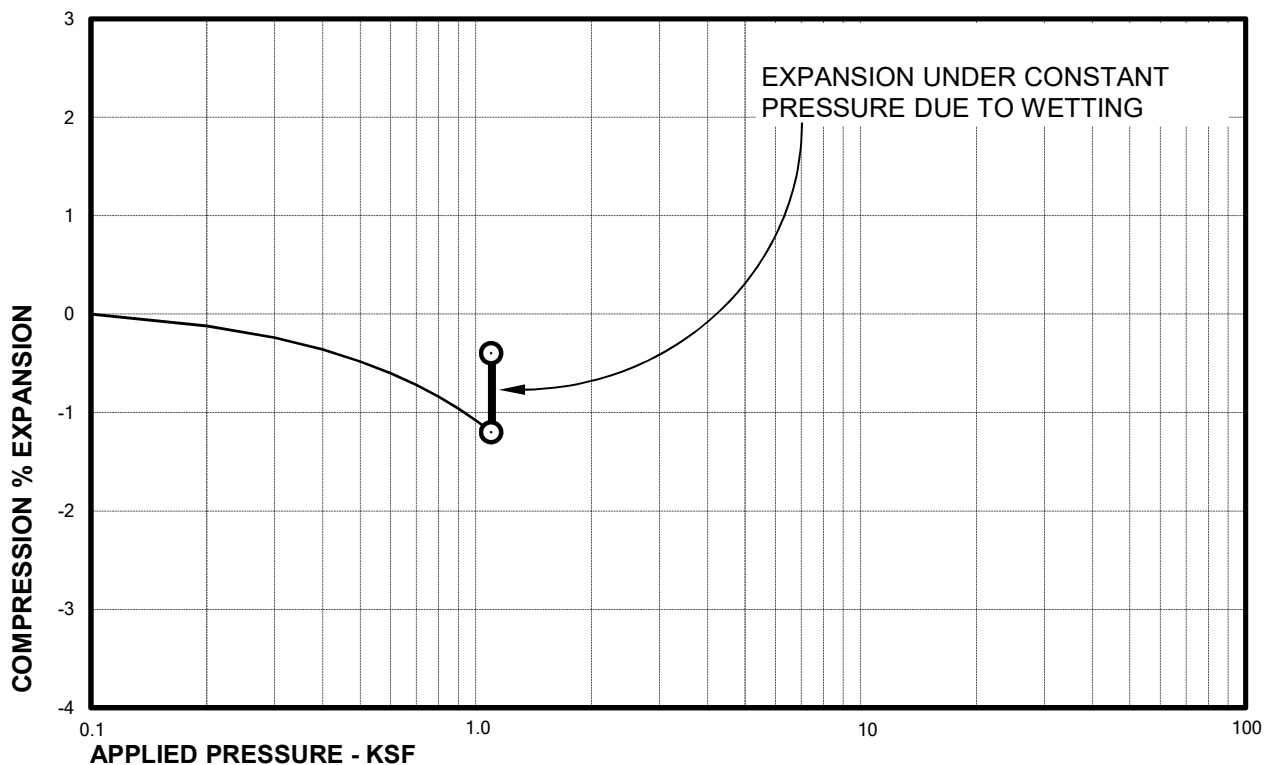
Sample of CLAY, VERY SANDY (CL)
From TH-2 AT 9 FEET

DRY UNIT WEIGHT= 109 PCF
MOISTURE CONTENT= 16.4 %

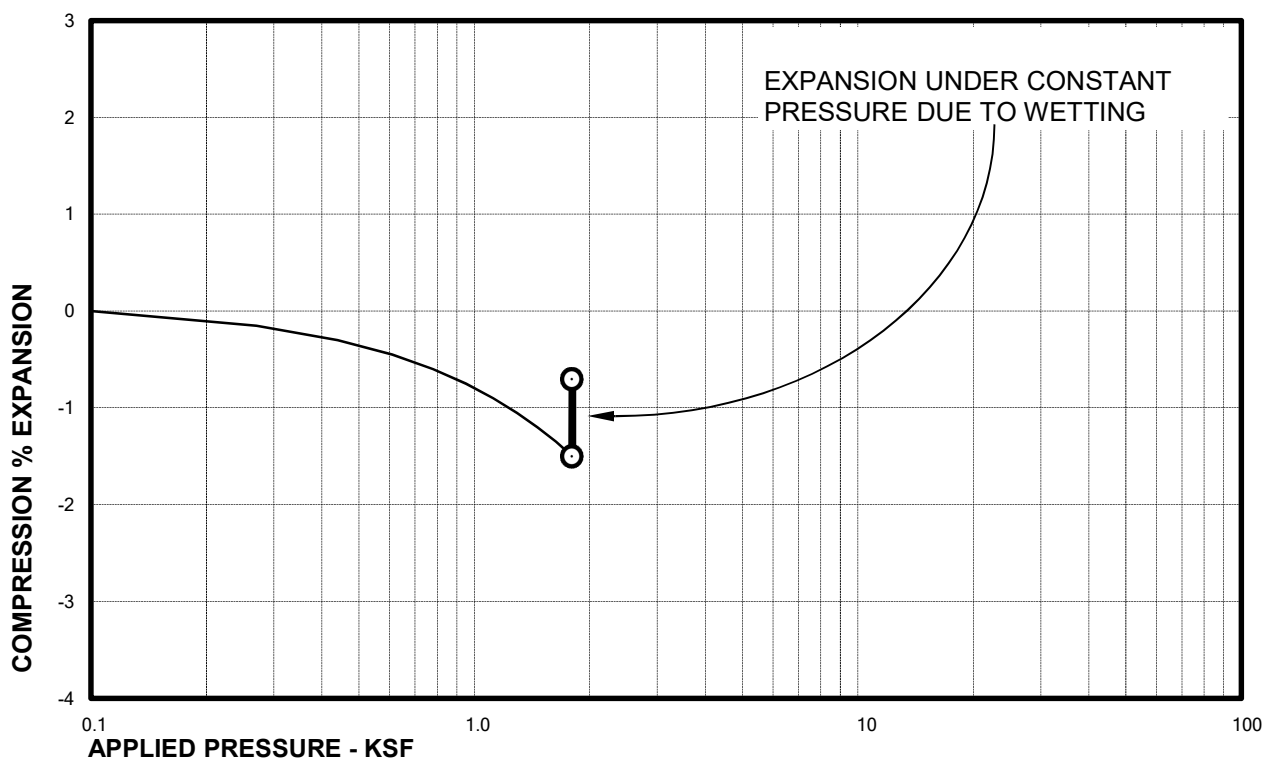
Sample of SAND, CLAYEY (SC)
From TH-2 AT 14 FEET

DRY UNIT WEIGHT= 107 PCF
MOISTURE CONTENT= 19.9 %

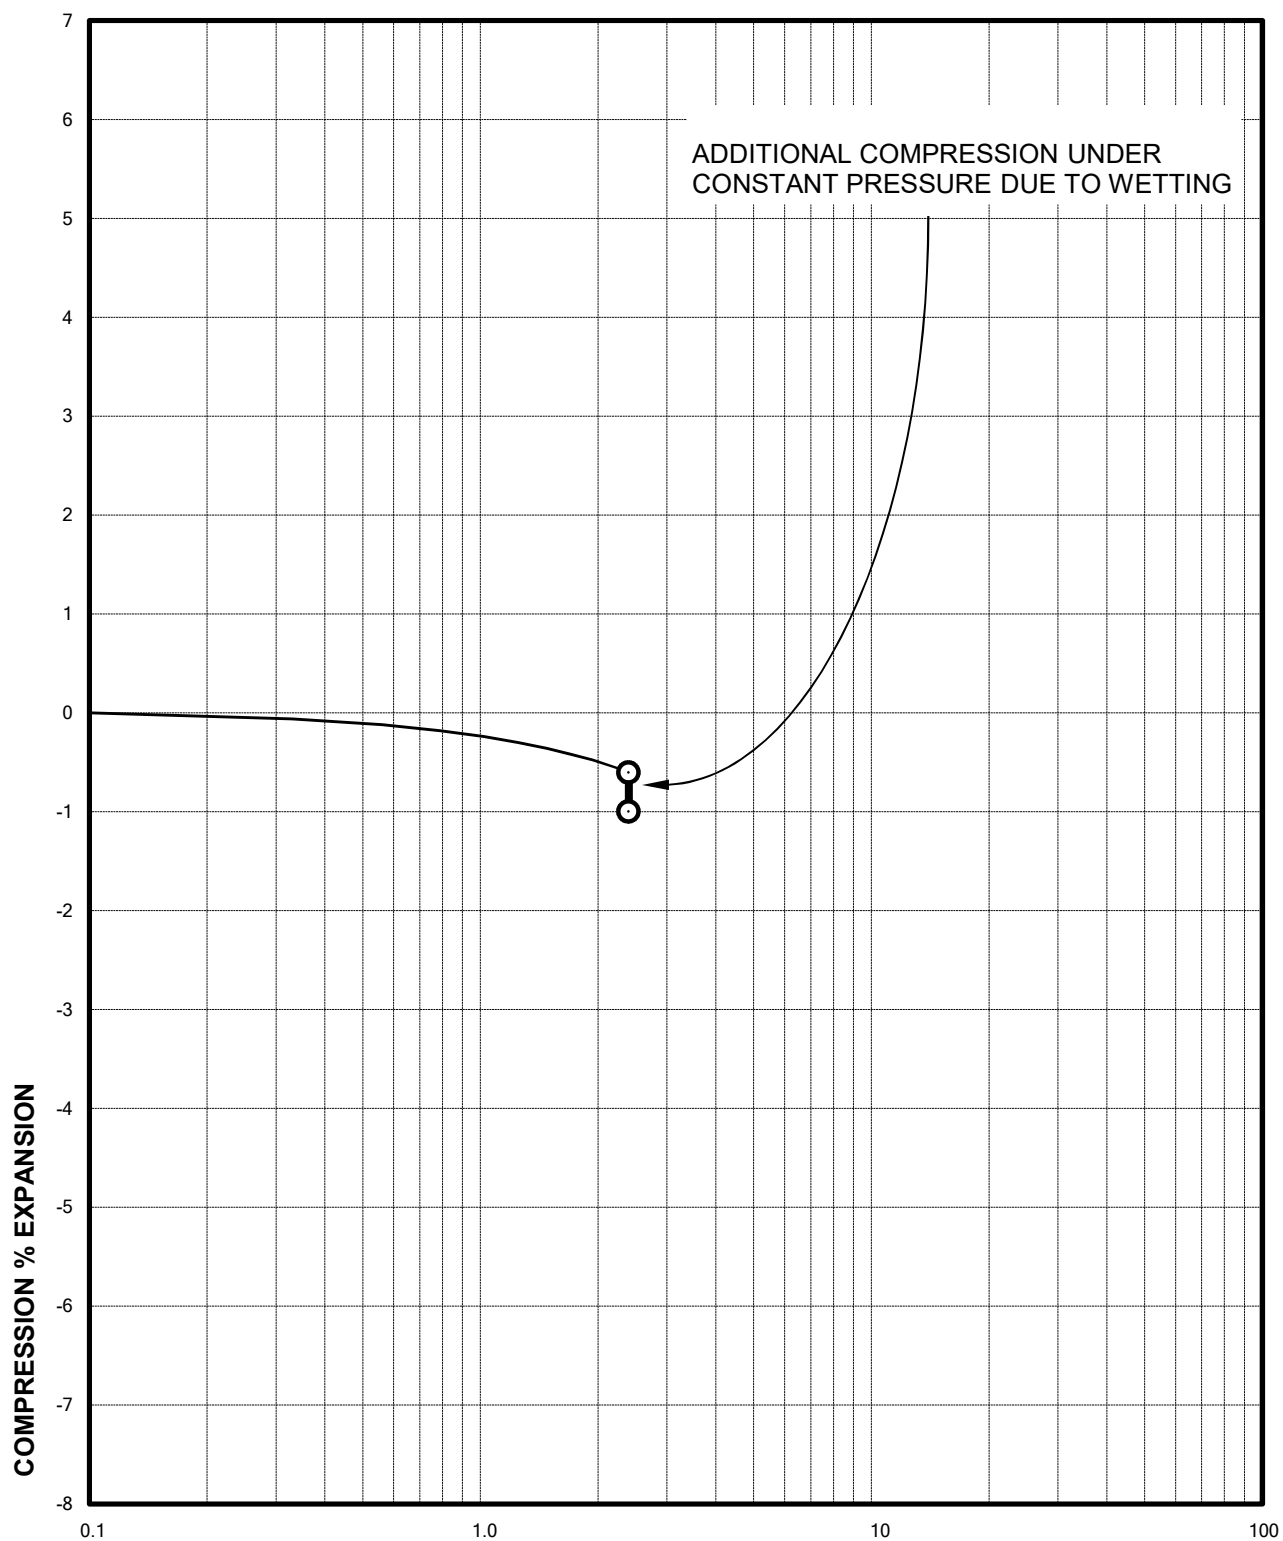
APPLIED PRESSURE - KSF
Sample of SAND, CLAYEY (SC)
From TH-2 AT 19 FEET

DRY UNIT WEIGHT= 112 PCF
MOISTURE CONTENT= 11.7 %

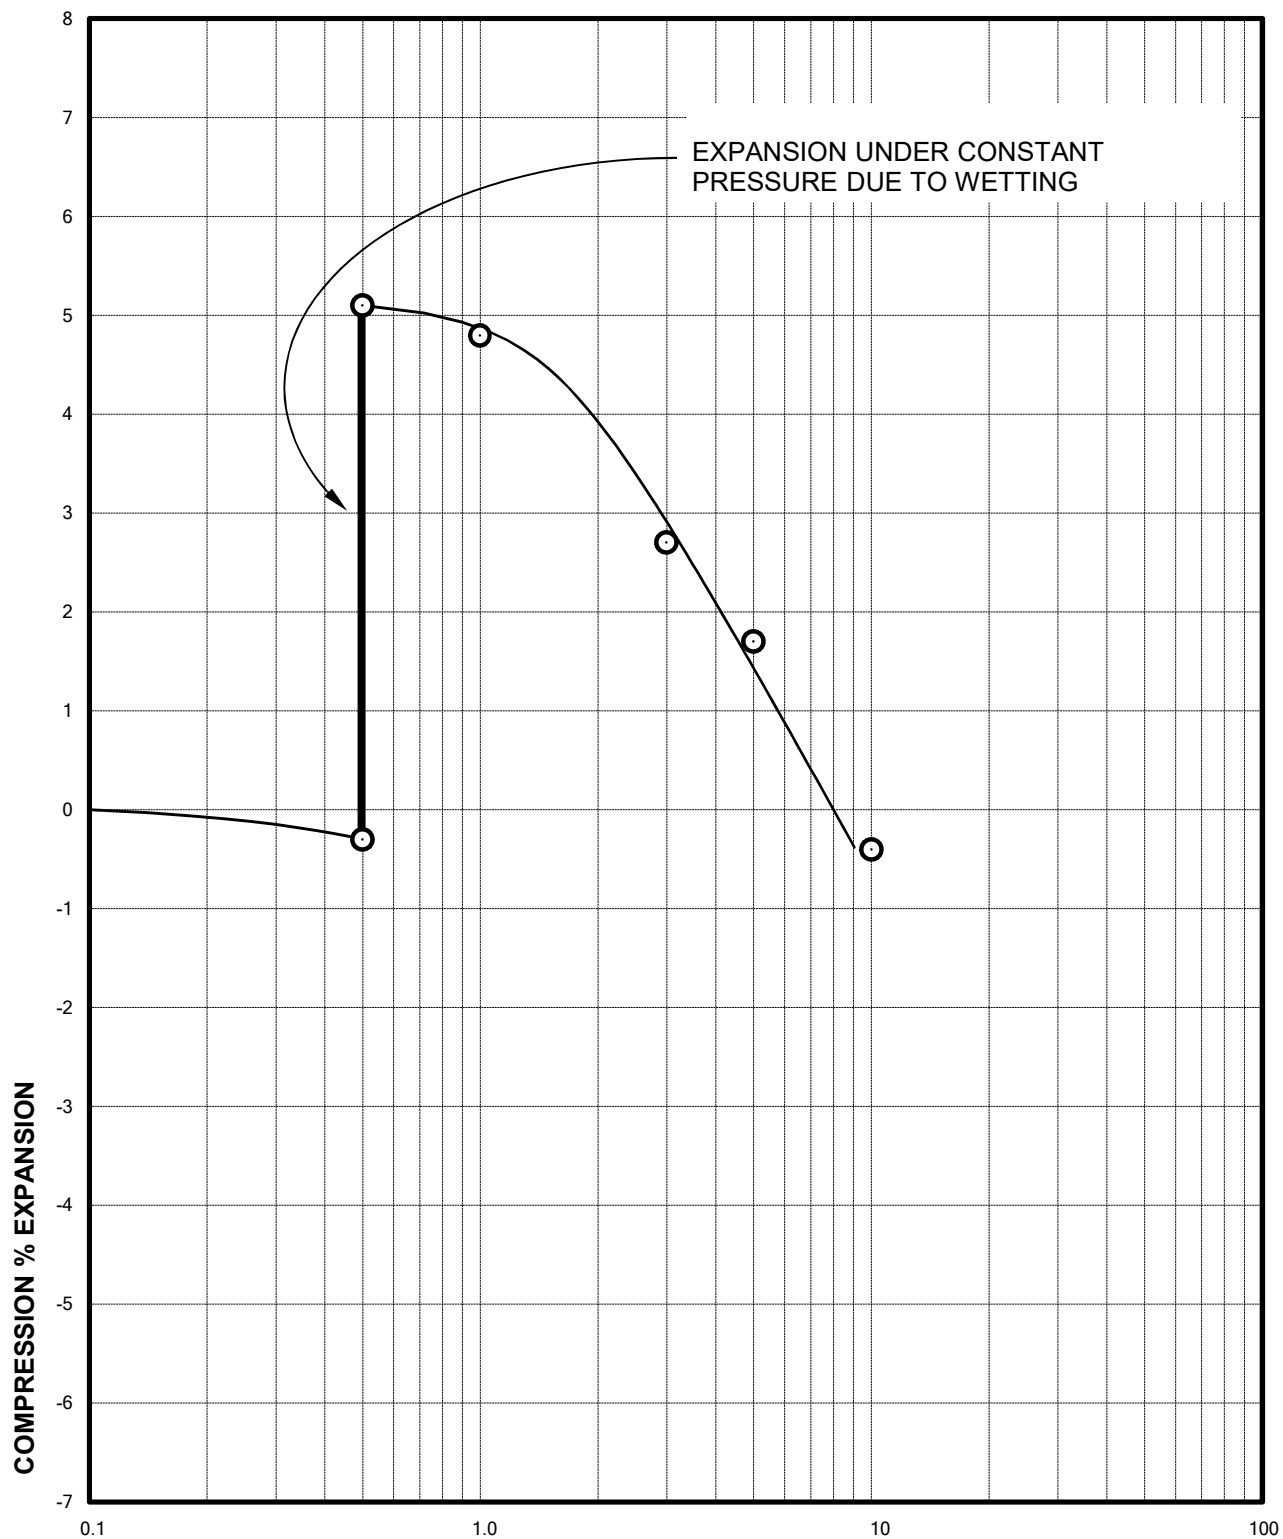
APPLIED PRESSURE - KSF
Sample of FILL, CLAY, SANDY
From TH-3 AT 4 FEET

DRY UNIT WEIGHT= 108 PCF
MOISTURE CONTENT= 9.9 %

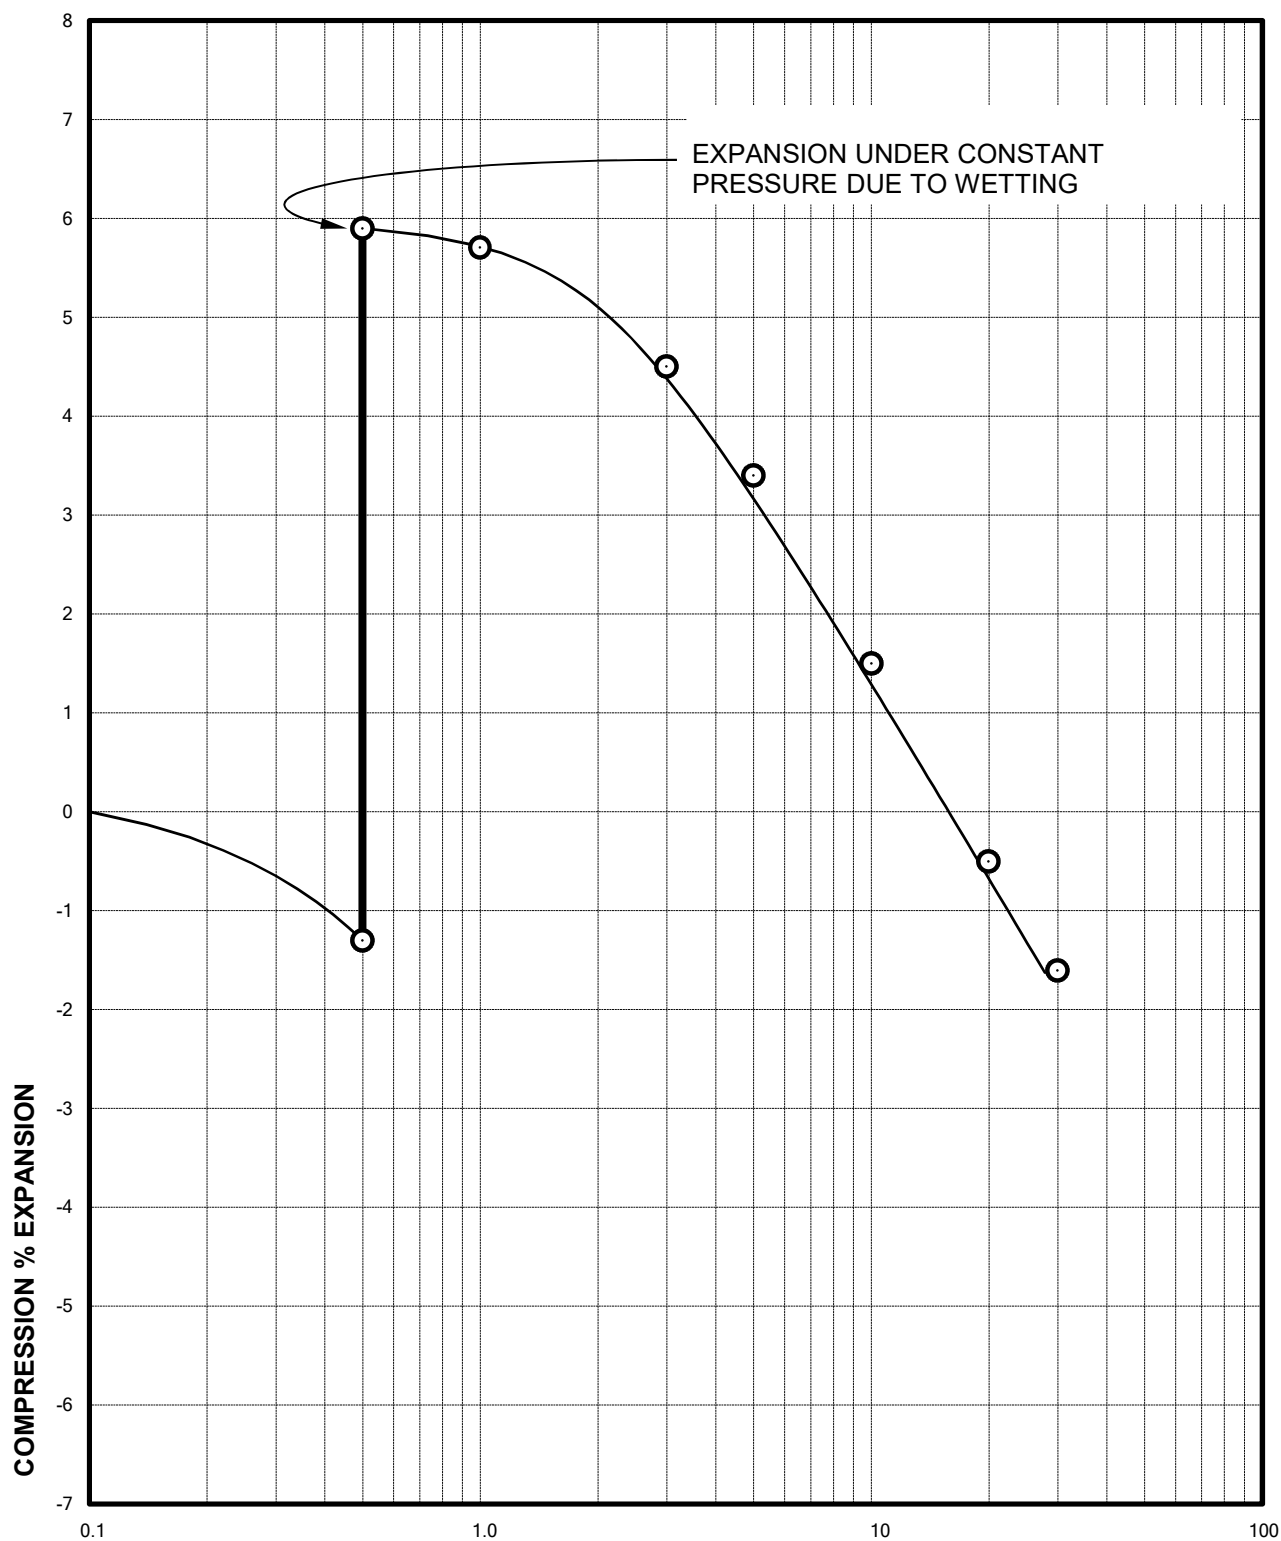
APPLIED PRESSURE - KSF
Sample of FILL, CLAY, SANDY
From TH-5 AT 4 FEET

DRY UNIT WEIGHT= 116 PCF
MOISTURE CONTENT= 14.8 %

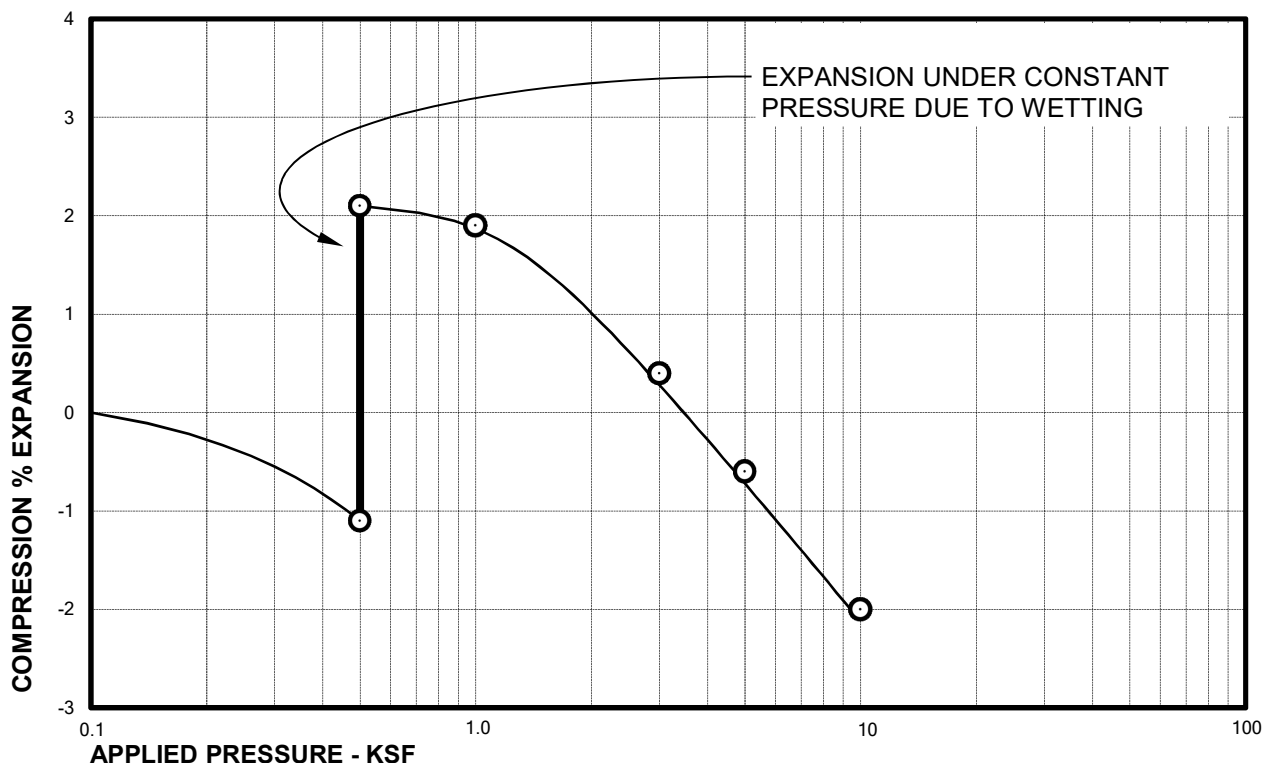
Sample of FILL, CLAY, VERY SANDY
From TH-6 AT 4 FEET

DRY UNIT WEIGHT= 122 PCF
MOISTURE CONTENT= 11.0 %

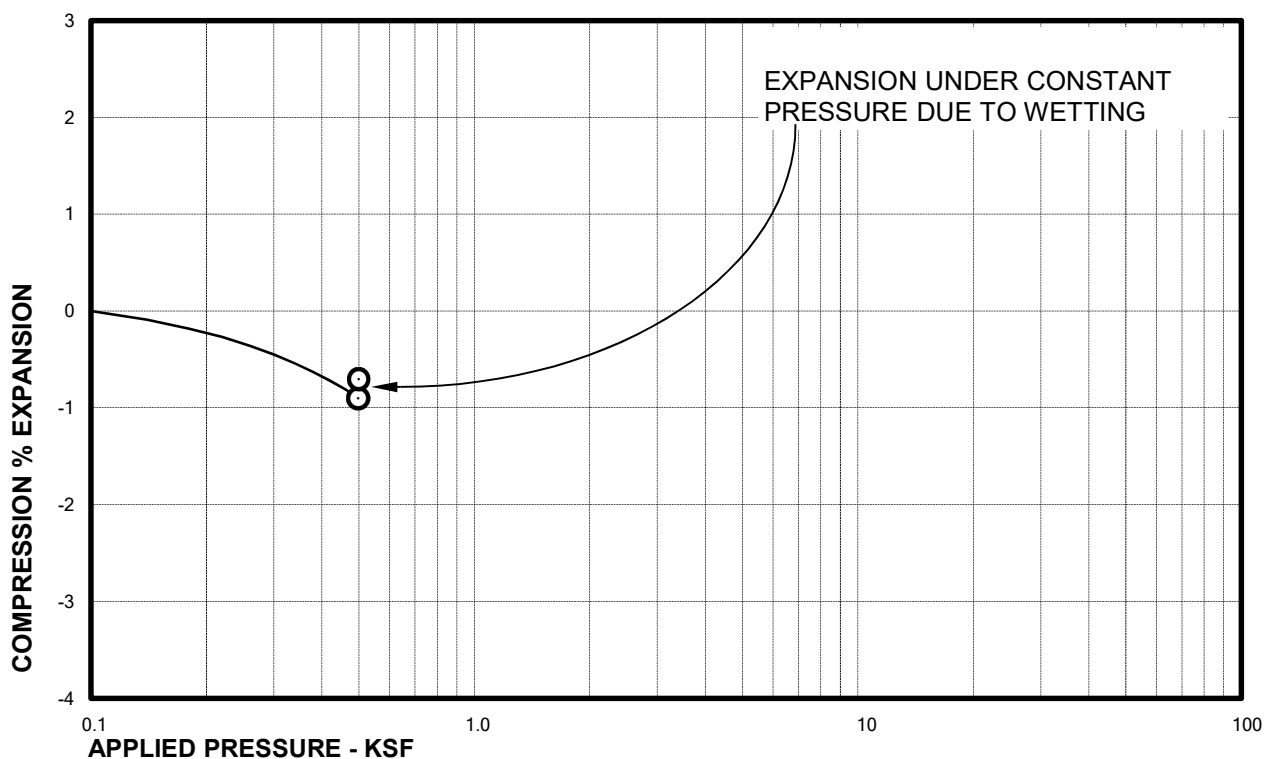
Sample of FILL, SAND, VERY CLAYEY
From TH-7 AT 4 FEET

DRY UNIT WEIGHT= 118 PCF
MOISTURE CONTENT= 5.7 %

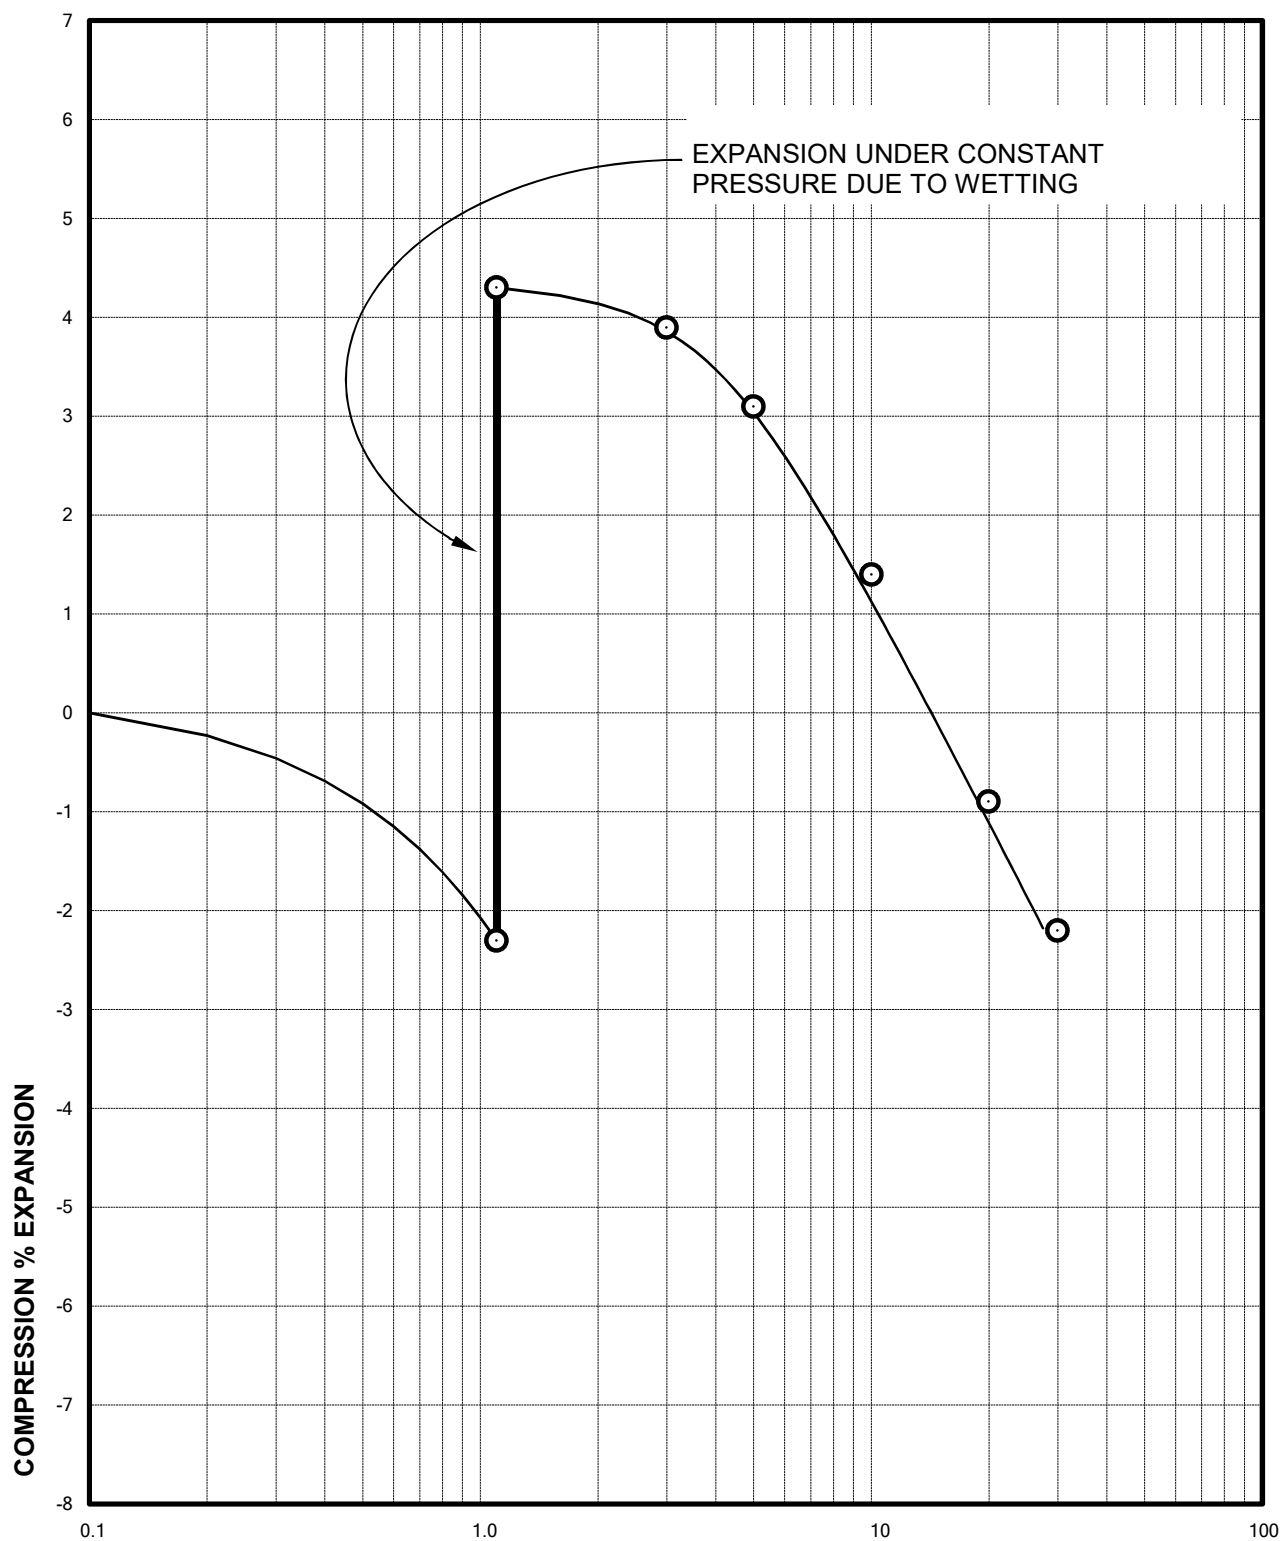
APPLIED PRESSURE - KSF
Sample of CLAYSTONE, WEATHERED
From TH-7 AT 9 FEET

DRY UNIT WEIGHT= 98 PCF
MOISTURE CONTENT= 23.5 %

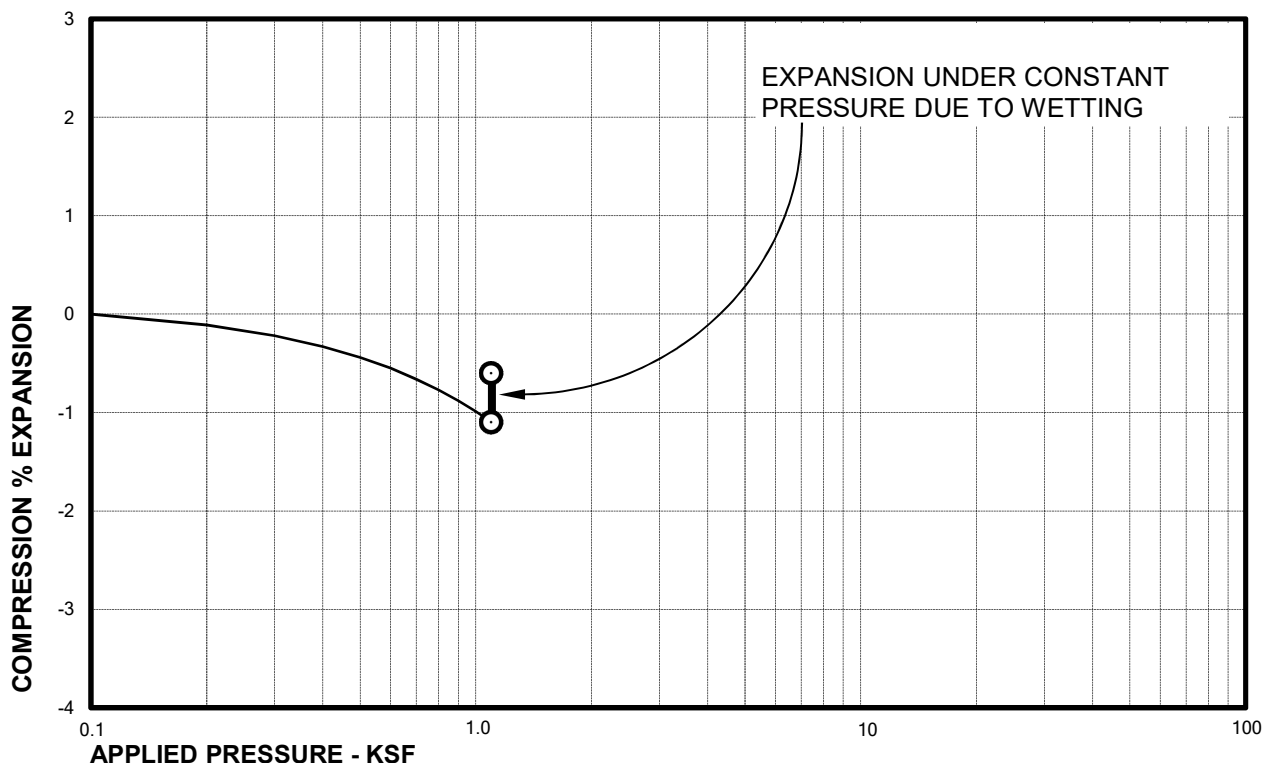
Sample of SAND, VERY CLAYEY (SC)
From TH-8 AT 9 FEET

DRY UNIT WEIGHT= 115 PCF
MOISTURE CONTENT= 14.7 %

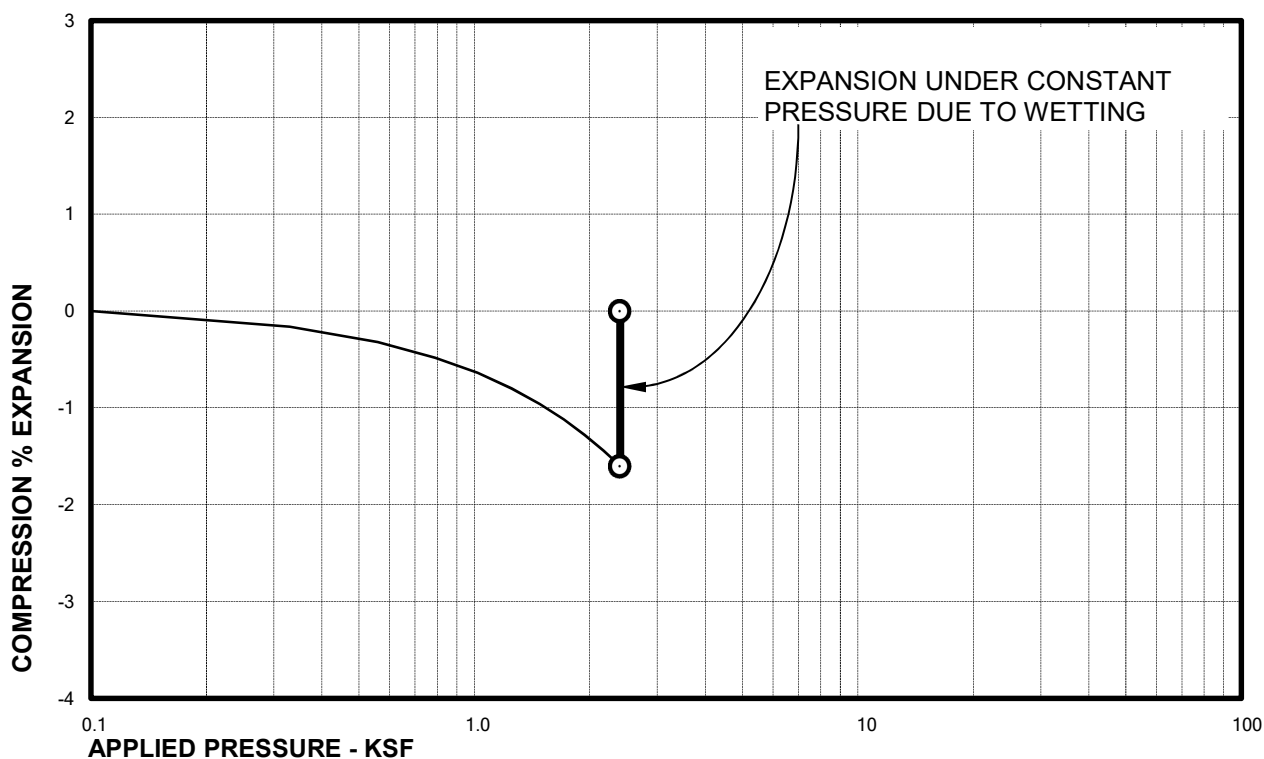
Sample of CLAYSTONE, SANDY
From TH-8 AT 19 FEET

DRY UNIT WEIGHT= 85 PCF
MOISTURE CONTENT= 34.3 %

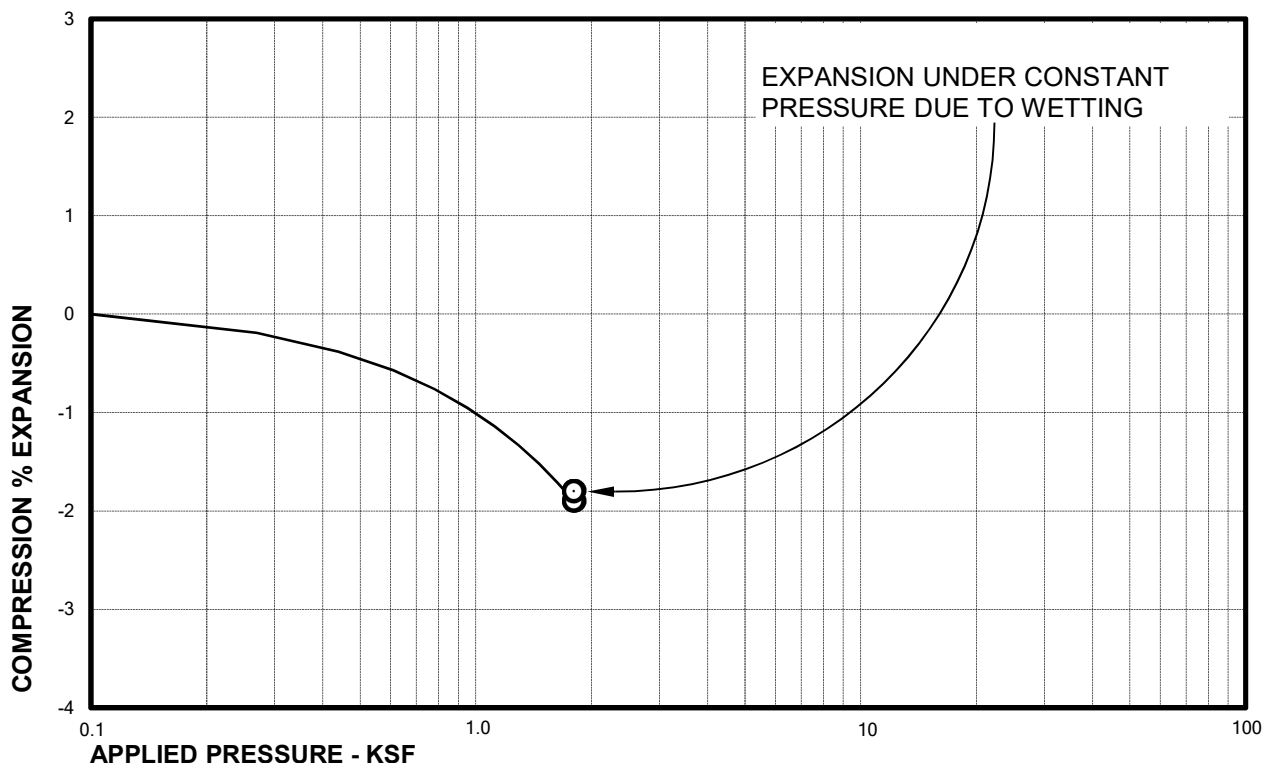
Sample of CLAY, VERY SANDY (CL)
From TH-9 AT 14 FEET

DRY UNIT WEIGHT= 119 PCF
MOISTURE CONTENT= 13.7 %

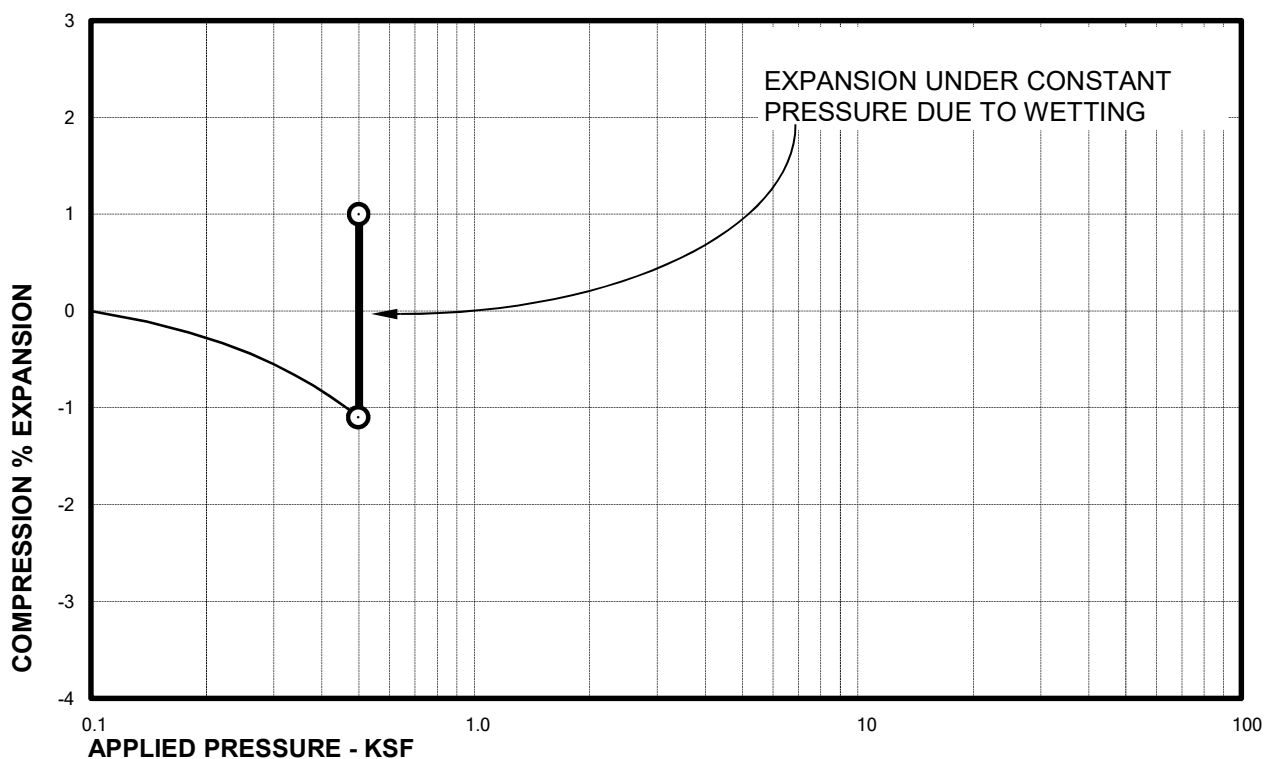
Sample of FILL, SAND, VERY CLAYEY
From TH-10 AT 4 FEET

DRY UNIT WEIGHT= 116 PCF
MOISTURE CONTENT= 7.2 %
